Advisory Visit to the Upp Hall Fishery,  
River Rib,  
Undertaken on behalf of the Wild Trout  
Trust, by Vaughan Lewis, Windrush  
AEC Ltd

September 2004

This report forms the output of a site visit undertaken to the Upp Hall fishery, on the River Rib near Puckeridge, Herts. on 15 September 2004.

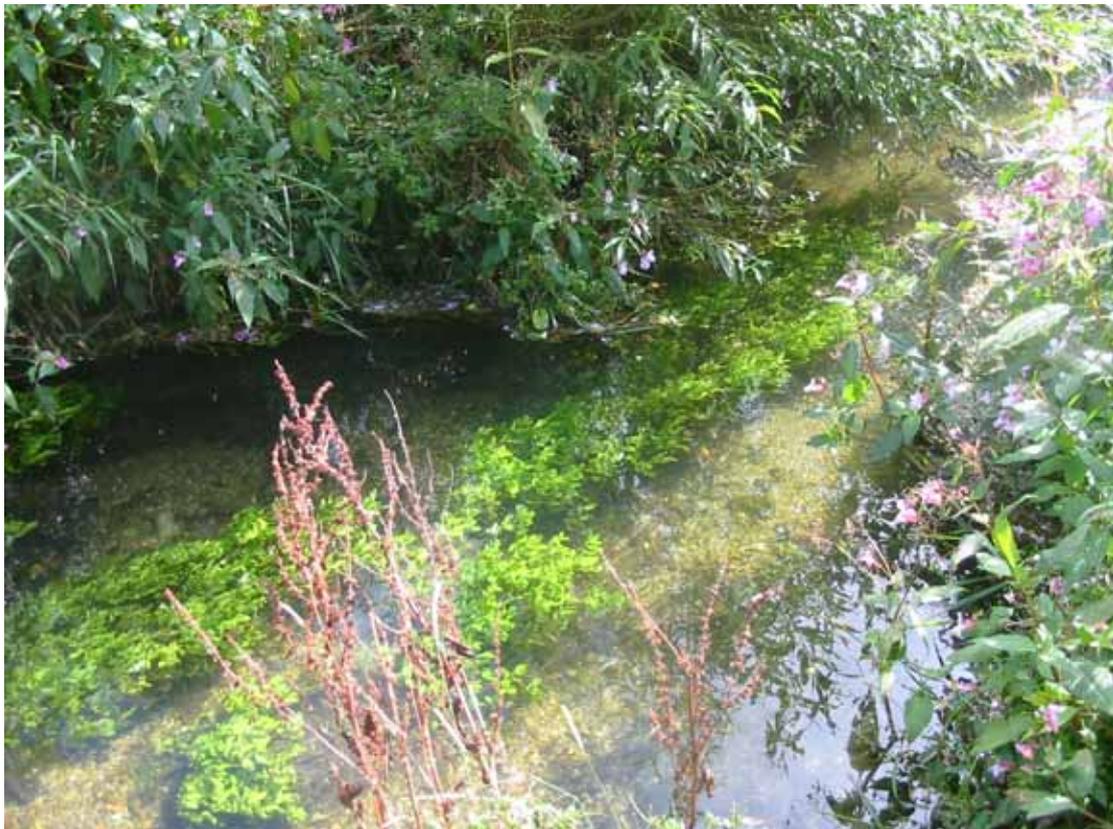
**Free flowing section of the Rib upstream of central bridge**

The restored channel had a wetted width of between 2m and 4m and a relatively steep gradient. It had become significantly more free-flowing as a consequence of the sluice removal, with lengths of exposed gravel and submerged vegetation including water forget-me-not *Myosotis scorpioides*, water parsnip *Berula erecta* and water crowfoot *Ranunculus spp.* present. The marginal fringe had good growths of fool's cress *Apium nodiflorum*, branched bur-reed *Sparganium erectum*, reed canary grass *Phalaris arundinacea*, and Himalayan Balsam *Impatiens glandulifera*.

Despite the restoration scheme, the bed of the river remained relatively unsorted, with little variation in bed profile, and limited availability of adult brown trout habitat.

- Upstream of the central bridge, the river was in generally excellent physical condition. There were however a few sections that were overshadowed. These would benefit from a programme of rotational coppicing to increase light penetration.

- The bed of the river was poorly sorted in this upstream reach, with limited variation in bed profile restricting the availability of adult habitat and the quality of the spawning gravel present. In order to address this, it is recommended that a significant amount of Large Woody Debris is introduced in the form of tree trunks and larger limbs arising from the coppicing work suggested above. Trunks should be pinned into the channel facing upstream at an angle of around 30° in order to create scour and sort the substrate without significantly increasing the risk of bank erosion.

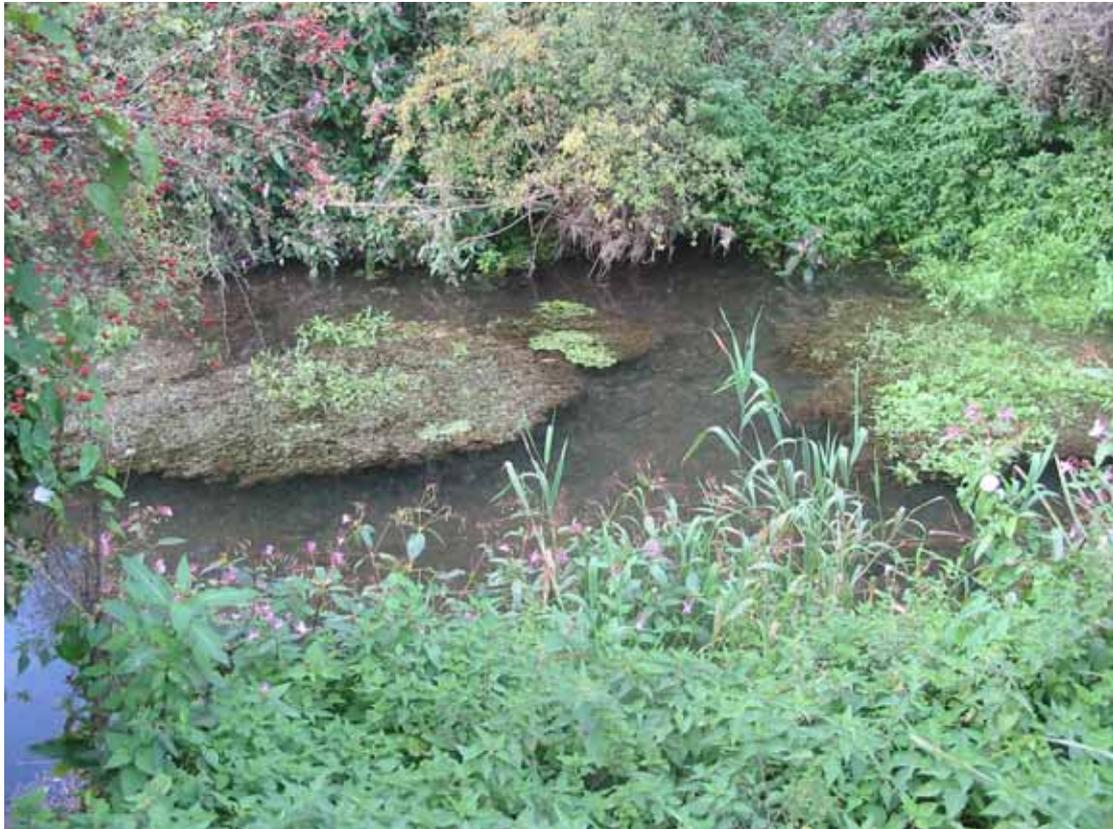
Downstream of the central bridge, the channel was well fringed with marginal vegetation, with a strong growth of water crowfoot in places. Much of this was covered with a mixture of epiphytic algae and silt, causing localised die back of the crowfoot.

### **Typical section of channel downstream of the central bridge**

The RB was heavily fringed with deciduous trees and shrubs, providing cover for adult fish. Some of the alder *Alnus glutinosa* trees had clear evidence of *Phytophthora* infection, with die back of the crown evident in some individual trees.

At some locations the growth of riparian trees was dense enough to cause shading of the banks, reducing growth of instream and marginal vegetation.

The presence of a raised bank profile on the LB was clear evidence of past dredging of the channel. As a result of the dredging, the channel was significantly incised with reduced hydrological connectivity with the flood plain.

The downstream reach had adequate lengths of deeper holding water for adult fish, and cover for juvenile trout. However, there was limited availability of suitably sized, clean gravel for spawning trout.

- Downstream of the central bridge, an opportunity exists to cut and screen the raised spoil ridge on the LB. This would create a significant volume of gravel that could be re-introduced to the river, as well as increasing the hydrological linkage between the river and its floodplain. However, this is a significant undertaking that should not be considered without further detailed advice, probably from the Environment Agency.

- Where the channel was wider, existing stands of mid-river emergent vegetation could be stabilised using faggot bundles and wooden stakes in order to create small, semi-stable island features. Small amounts of imported gravel (diameter 20-40mm) could be introduced in the runs between these islands, creating sections of valuable trout spawning and juvenile habitat.

- As with the upstream reach, there were sections of the channel where overshadowing was restricting the growth of vegetation. Rotational coppicing would be beneficial at these locations.

- Careful cutting of the submerged weed could be used to train flow in order to scour gravel. The timing of the cutting of water crowfoot is critical, with cutting during spring and early summer encouraging more growth. In contrast, cutting after flowering and natural senescence has a tendency to reduce vegetative growth in the succeeding year.

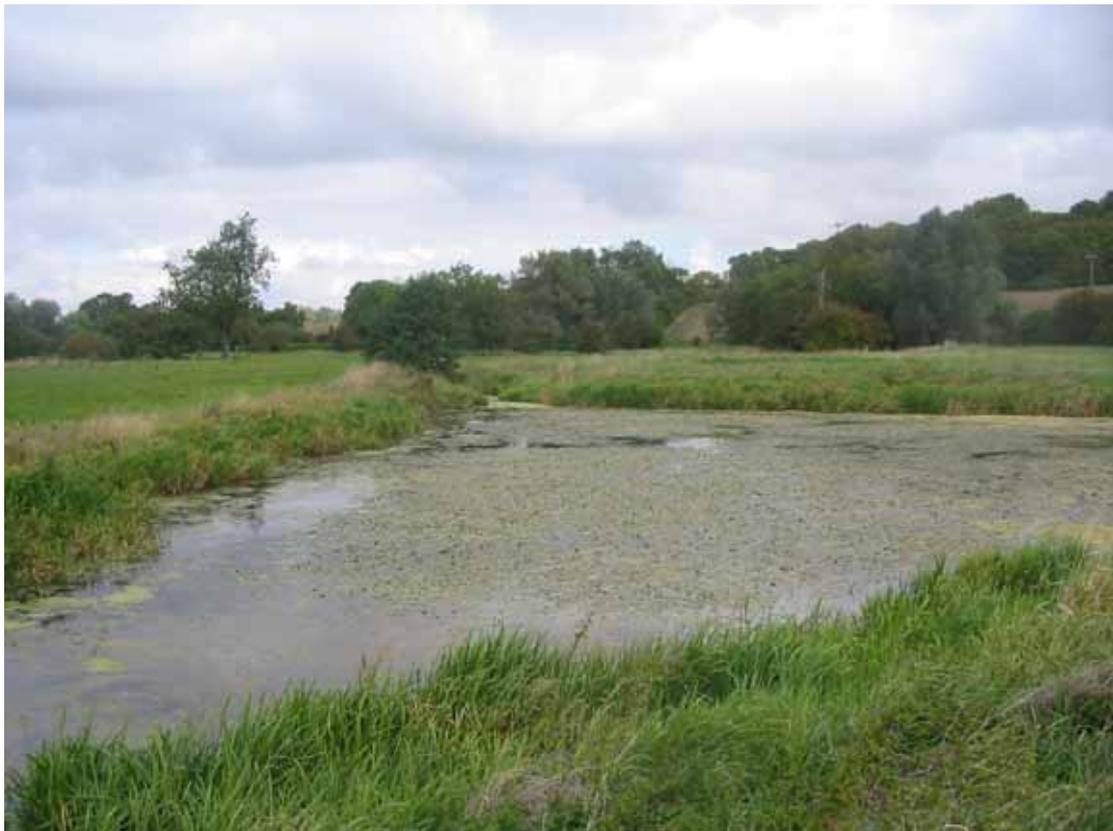
A small, heavily silted pond was present in the LB field towards the lower end of the fishery. This was connected to the river via short inflow and outflow channels and was originally excavated as a recreational rainbow trout fishery.

### **Floodplain pond connected to river**

However, a dense growth of both filamentous algae and broad-leaved pondweed *Potamogeton natans* over most of the pond's area, a heavy accumulation of silt and cormorant predation had resulted in the closure of the fishery.

- It had been suggested that the outlet and inlet streams to the pond could provide sections of valuable spawning habitat if suitably modified. This course of action is not endorsed. In order to create sufficient flow along the channels, a significant volume of water would need to be abstracted from the river into the pond, thus depriving valuable flow from some 200m of the river. In addition, the increased throughput of water would increase the rate of siltation of both the inlet/outlet channels and the pond, leading to considerable management difficulties over time.
