Habitat Advisory visit to the Wellow Brook,
Somerset, undertaken by Vaughan Lewis,
Windrush AEC Ltd. on behalf of the Five
Valleys Trust and the Avon and Tributaries
Angling Association,
September 2004

1.0 Introduction

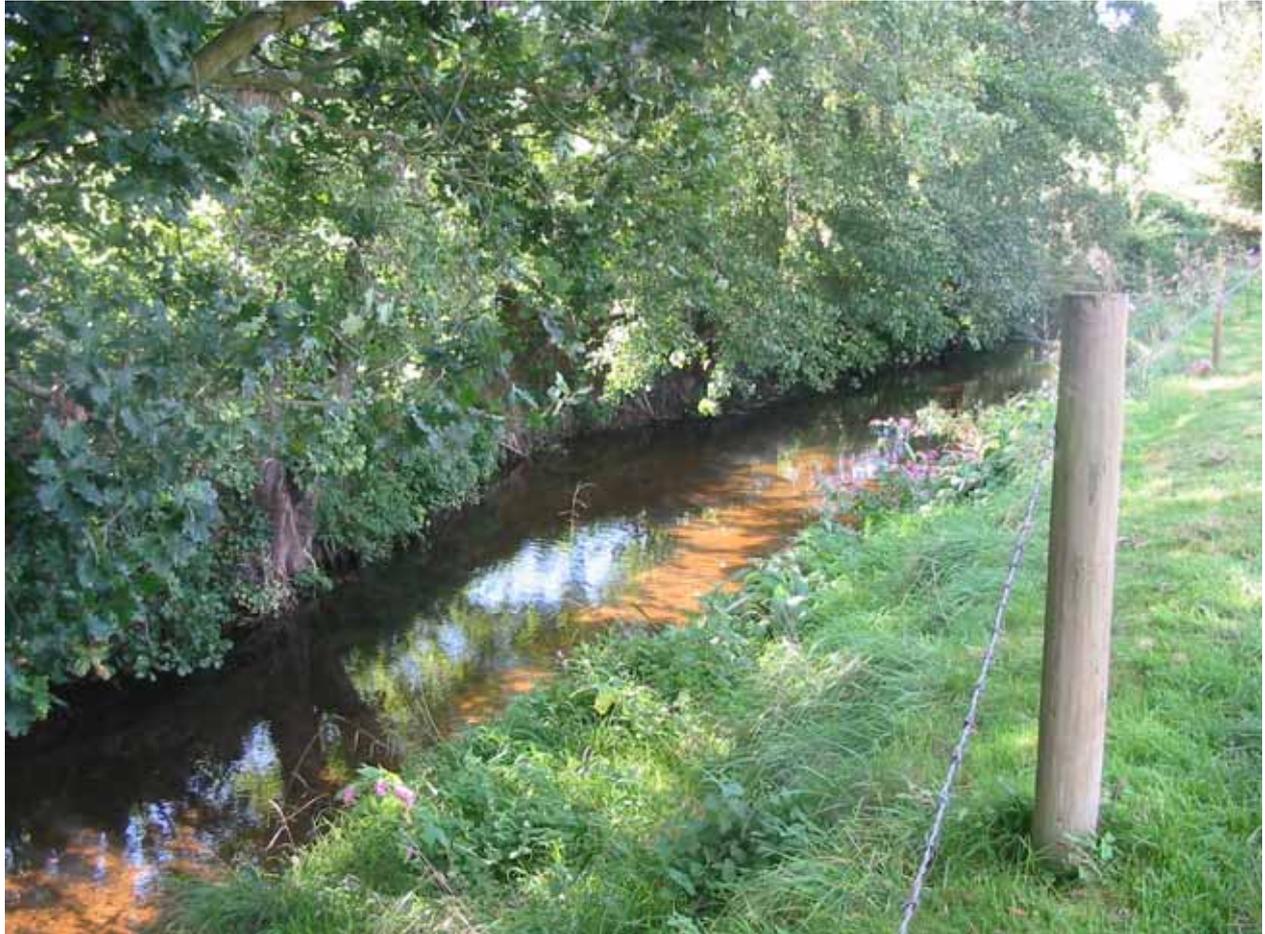
Above Hinton road bridge, the Wellow Brook had a moderately meandering planform, with a good gradient and a channel width that varied between 3-5m. The channel was significantly incised, possibly due to past dredging, with its banks heavily wooded by deciduous trees and shrubs, including hazel *Corylus avellana*, alder *Alnus glutinosa* and goat willow *Salix caprea*. The alder trees were infected with *Phytophthora*, with a number of individual specimens showing well advanced symptoms of the disease. The exposed tree roots present provided excellent instream cover for both juvenile and adult lifestages of brown trout *Salmo trutta*.

Wellow Brook upstream of Hinton Road Bridge

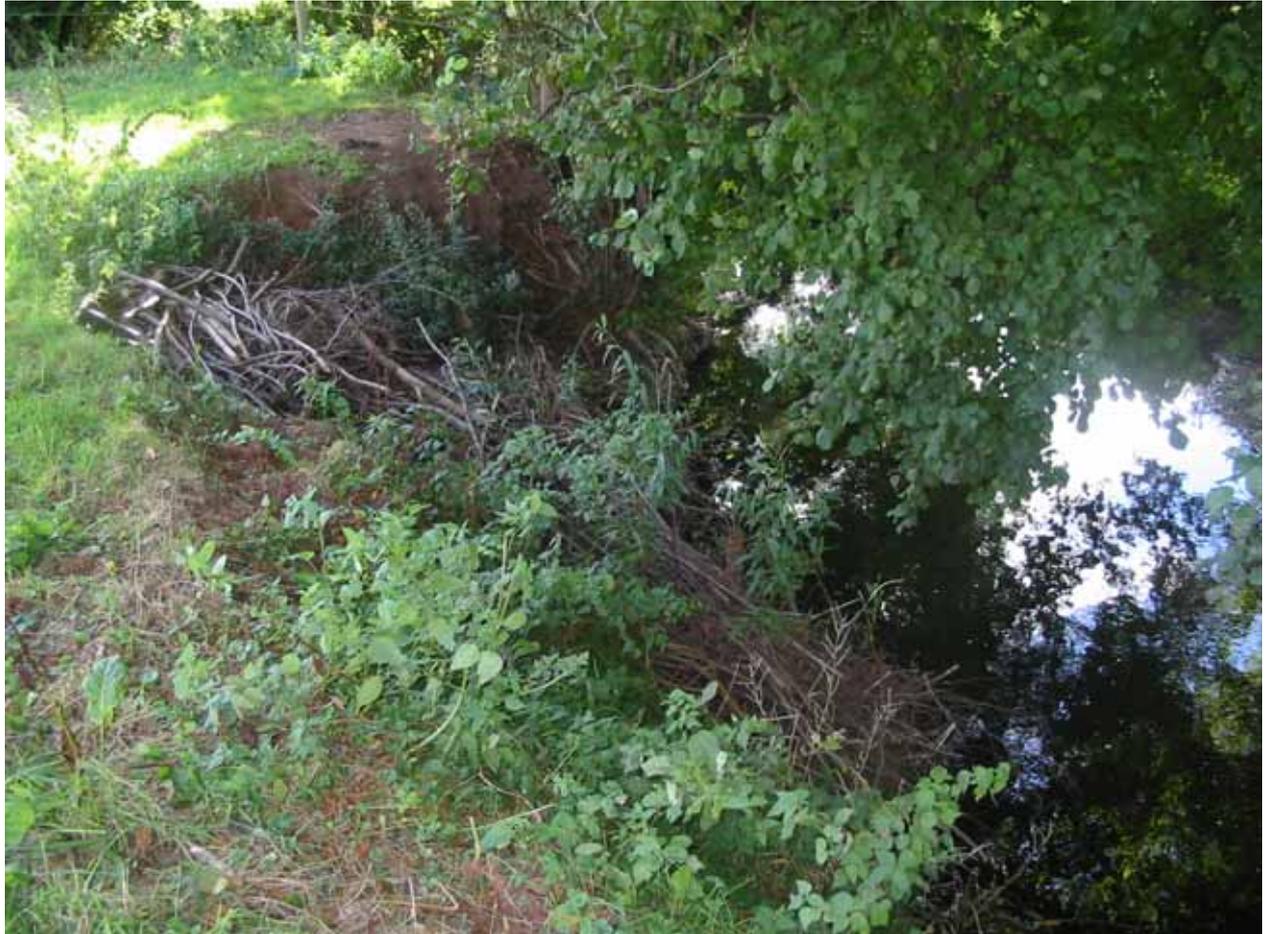
The exposed banks of the channel were comprised of what appeared to be friable sandstone. As a consequence, areas of significant local erosion were present in places. The process of erosion was also exacerbated by the presence of large amounts of Himalayan Balsam *Impatiens glandulifera*. This invasive alien plant shades out all ground cover, leaving large sections of bare earth on banks, increasing their vulnerability to erosion. The club had utilised a mix of live willow and deadwood faggots to protect the most vulnerable eroding areas. These had worked well, with willow cuttings having rooted in a number of instances.

Live willow and deadwood faggot bank protection. Note growing willow cuttings in centre of picture

- The presence of Himalayan Balsam is undesirable. This species is classified as an alien invasive weed species. With respect to Himalayan Balsam, chemical control with the herbicide glyphosate when the plant is actively growing in early spring should be effective. Alternatively, the plants can be cut at ground level before the flowering stage (June) or they can be pulled up by the roots and disposed of by composting or burning unless seeds are present. However, it should be noted that both species can re-colonise a site by transport of seeds or plant material from upstream colonies. It is thus better if control is attempted on a catchment basis, working from the upstream limit of the river system.

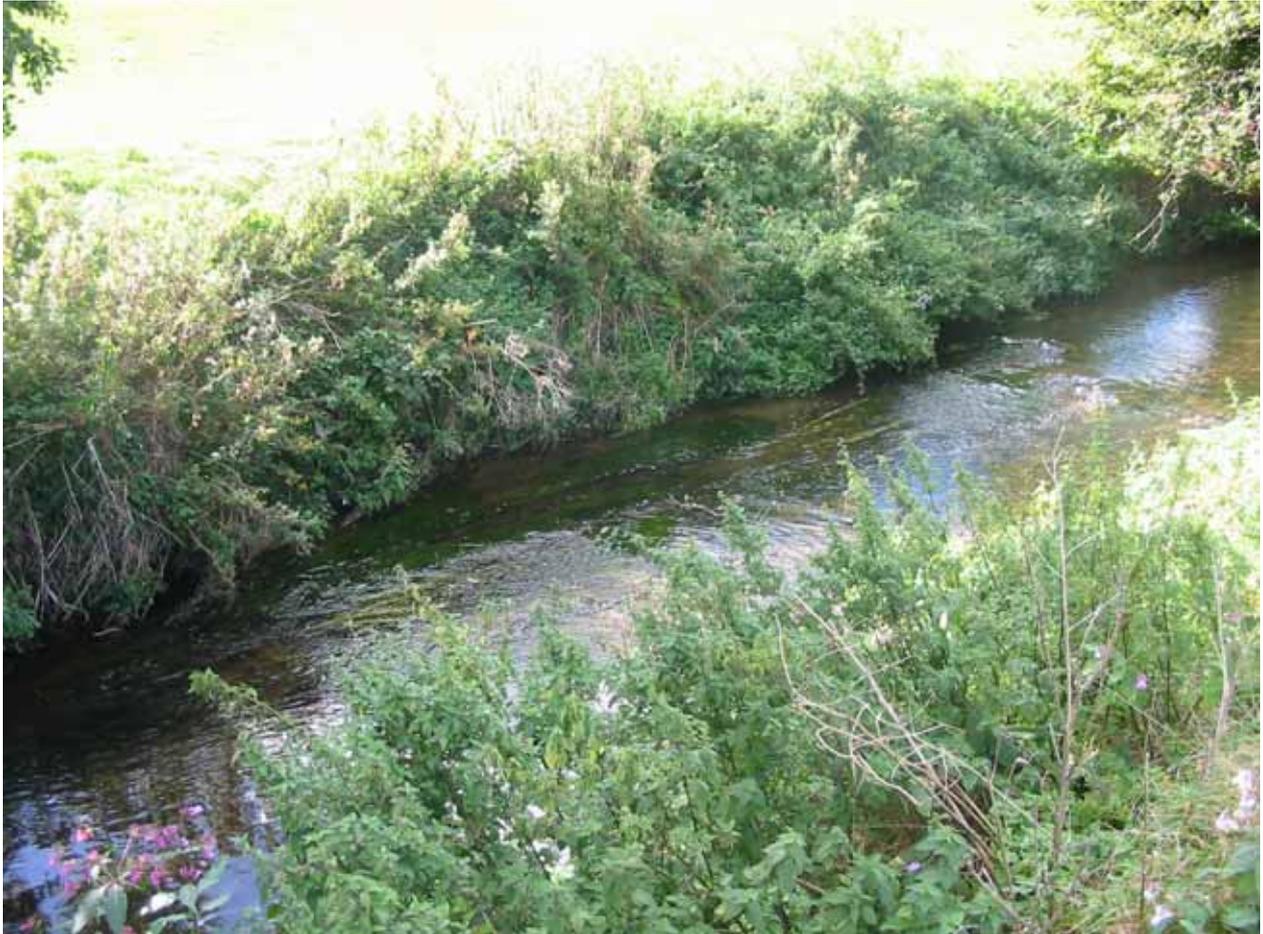
Instream habitat quality was generally good, with a moderately well developed pool-riffle sequence. However, the sections of shallow riffle present, were generally poorly sorted with an homogeneous mix of fine gravel and sand dominating the substrate. Some short sections of larger stone/bed rock were visible, producing runs of steeper gradient. Instream vegetation (small stands of fool's cress *Apium nodiflorum*, and water crowfoot *Ranunculus spp.*) had developed in these runs. Branched bur-reed *Sparganium erectum* that had developed on the inside of meanders was the main emergent species present. The river was fenced along its LB, reducing access to the banks for agricultural stock.

Faster riffle section, showing stands of water crowfoot and horned pondweed

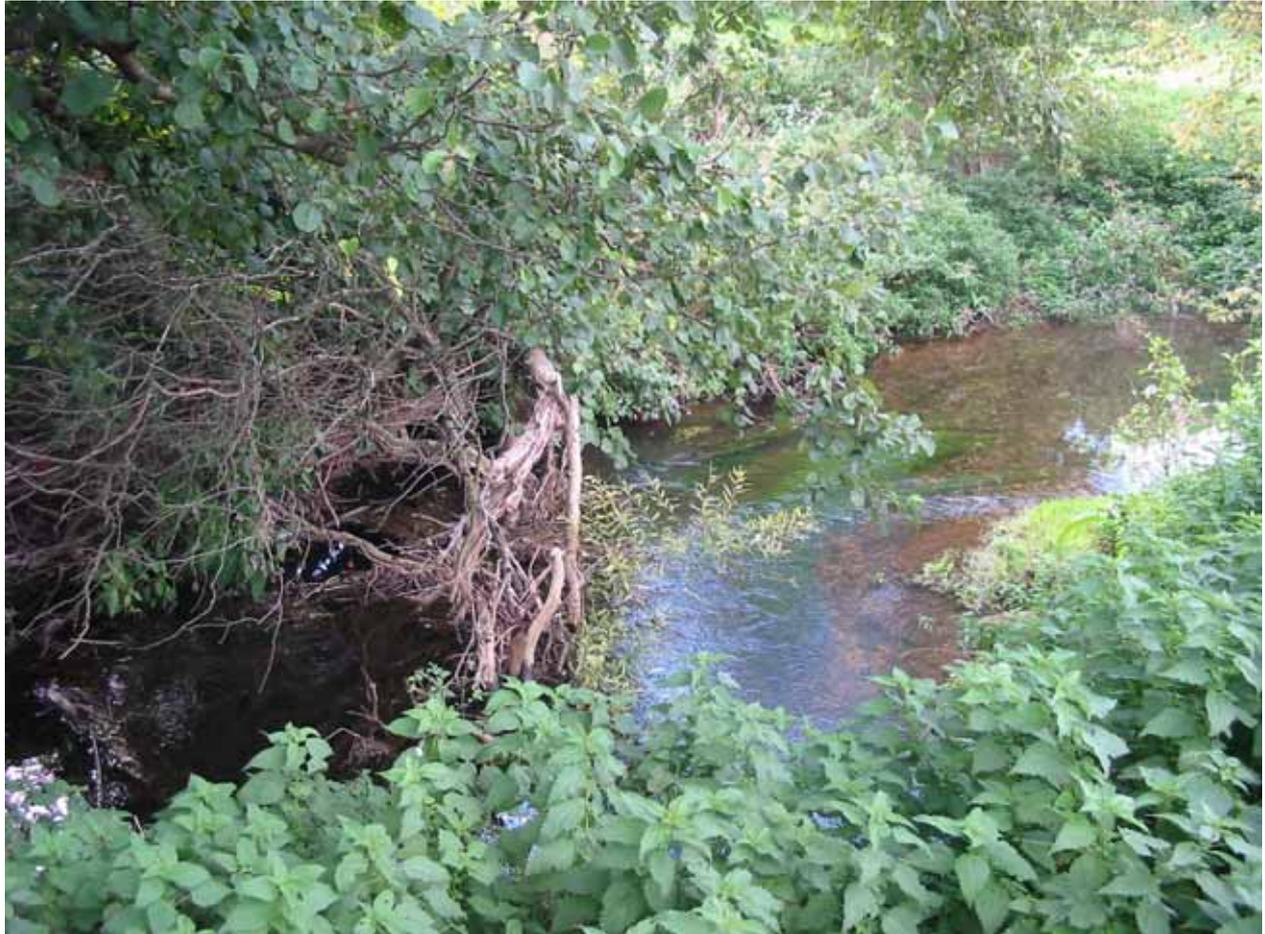
Instream habitat generally improved towards the upstream end of the fishery, with increasing amounts of LWD enhancing the diversity of the bed profile and sorting of the substrate. This process was aided by the generally good gradient on this reach of the river. However, heavy shading of the channel by riparian trees continued to restrict in-channel vegetation growth, with the trees also restricting access for angling.

Section of the upper fishery, showing presence of LWD dam, and water crowfoot on gravel riffles.

- In many places, the bed of the river was relatively uniform, with a poorly sorted substrate. This resulted in a reduction not only in the diversity of in-channel habitat, but also in the quality of the gravel available for spawning and juvenile trout. In low energy streams such as the Wellow Brook, fallen timber (LWD) would normally provide the means by which flow was concentrated and energy increased locally. There was however a relative dearth of LWD in the brook. In order to rectify this situation, it is recommended that a programme of rotational coppicing of riparian trees is instigated adjacent to shallow riffle areas. This will reduce shading, and provide ample timber that could be placed in the channel in order to increase flow velocity locally. The simplest way of achieving this is to pin tree limbs to the bank facing upstream. More complex triangular groynes could also be constructed. Details can be found in the Wild Trout Trust's Guide to Improving Trout Streams. Whichever design is chosen for the brook, it is imperative that adequate care is taken to avoid significant erosion of the river's banks.

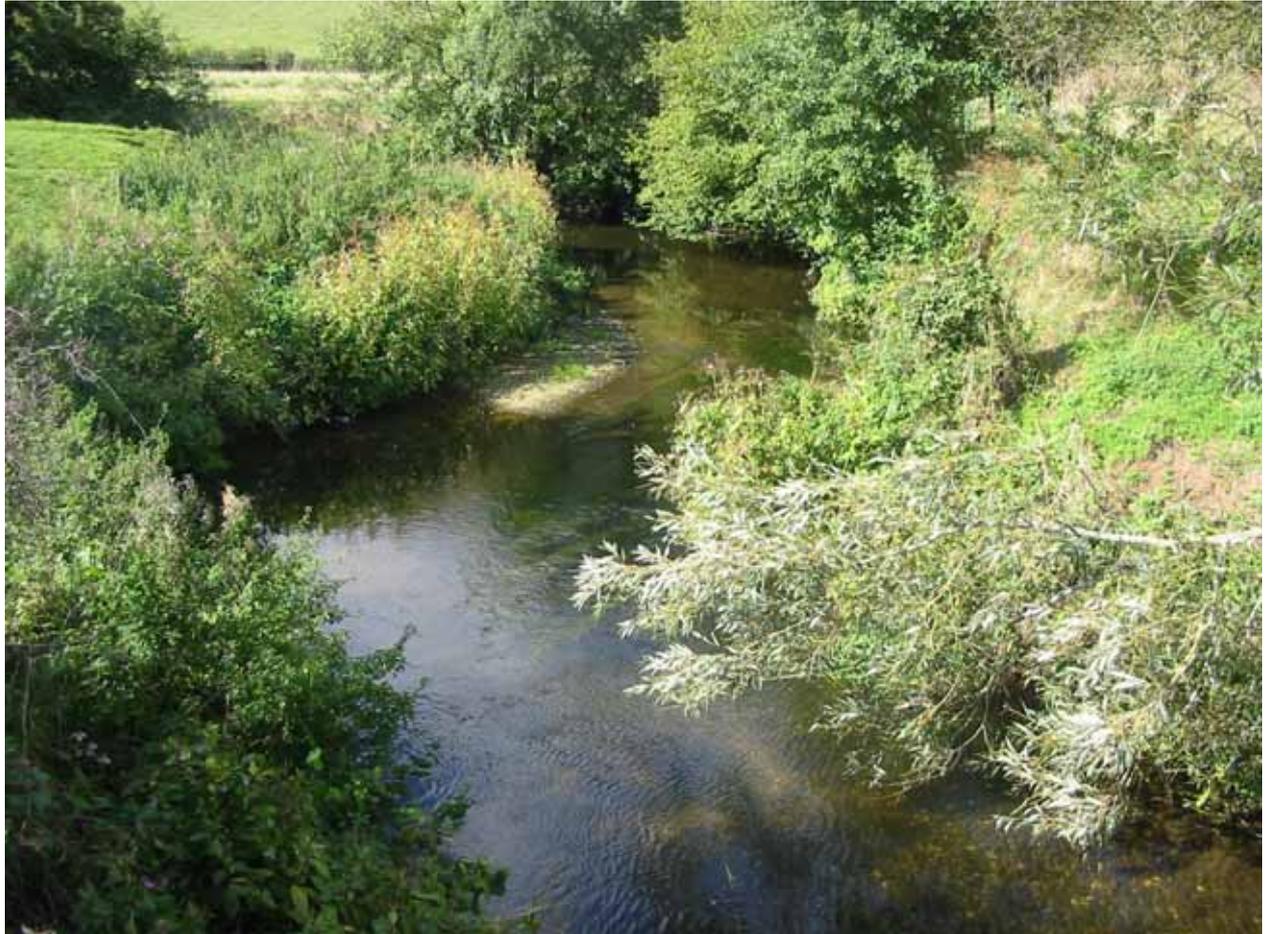
Habitat quality in the reach was generally good, although the channel was significantly incised. The river had a meandering planform with a good gradient. There was a number of deep pools that had developed on bends due to erosion of the steep, friable banks. These pools were interspersed with shallow, gravel dominated riffles. As with the upstream reach, these gravels were often poorly sorted, with a significant volume of sand present. Strongly growing stands of water crowfoot were present on the riffle areas.

Gravel point bars had developed on the inside of many of the meanders, showing that there was some active transport of bed material along sections of the brook. LWD was relatively scarce in this reach, with the felled timber having been stacked or removed from the site.

Typical section of the river downstream of Hinton road bridge. Note deeper pools on the bend, strong water crowfoot growth on the riffles and the tree canopy thinned by recent cutting
