Habitat Advisory visit to the Willow
Brook, Fortheringhay,
Northamptonshire, undertaken on
behalf of Willow Brook Flyfishers by
Vaughan Lewis, Windrush AEC Ltd
December 2004

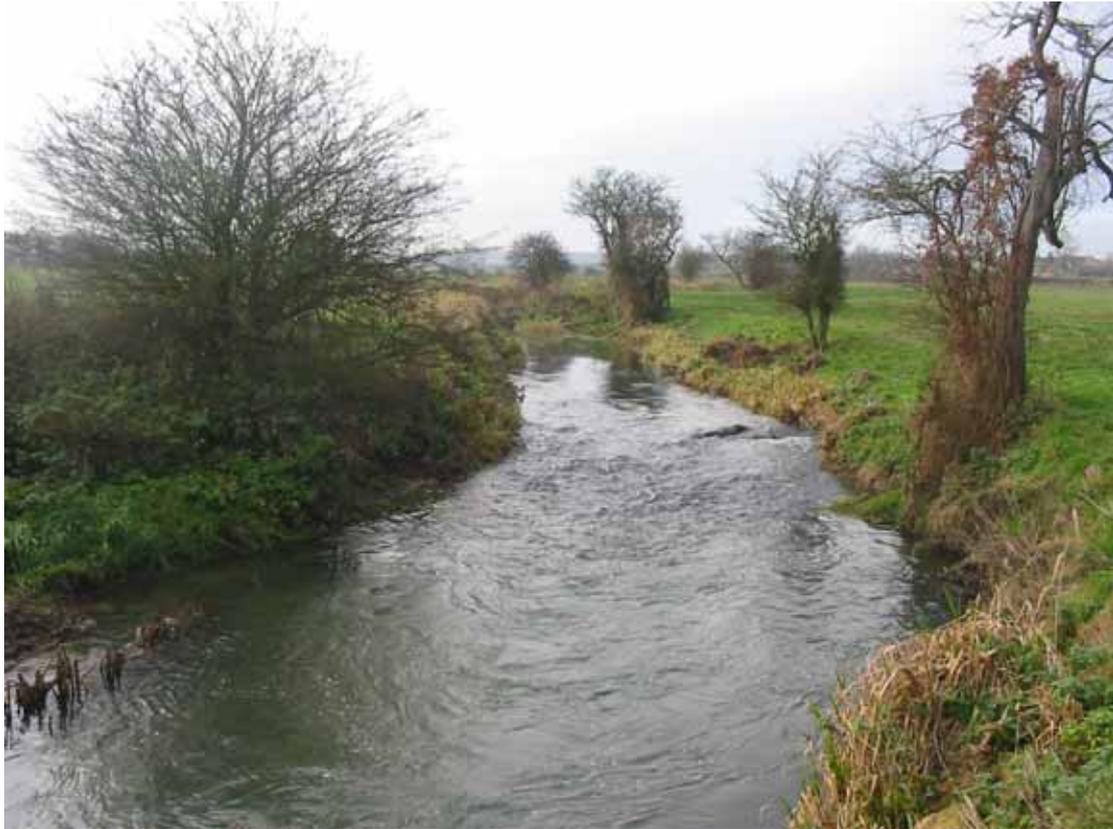
Downstream of this single field, the instream habitat was generally excellent, with a meandering planform and a well developed pool and riffle sequence. There was ample gravel dominated, shallow habitat suitable for spawning and juvenile trout. Stands of submerged water forget-me-not *Myosotis scorpioides* were present. The marginal growth of emergent vegetation was good on the semi-consolidated silt berms, with species including reed canary grass *Phalaris arundinacea*, hard rush *Juncus inflexus* and sedge *Carex spp.* present. These marginal berms narrowed the channel, creating a good variation in flow and form in the river.

Typical habitat downstream of Wood Newton Bridge

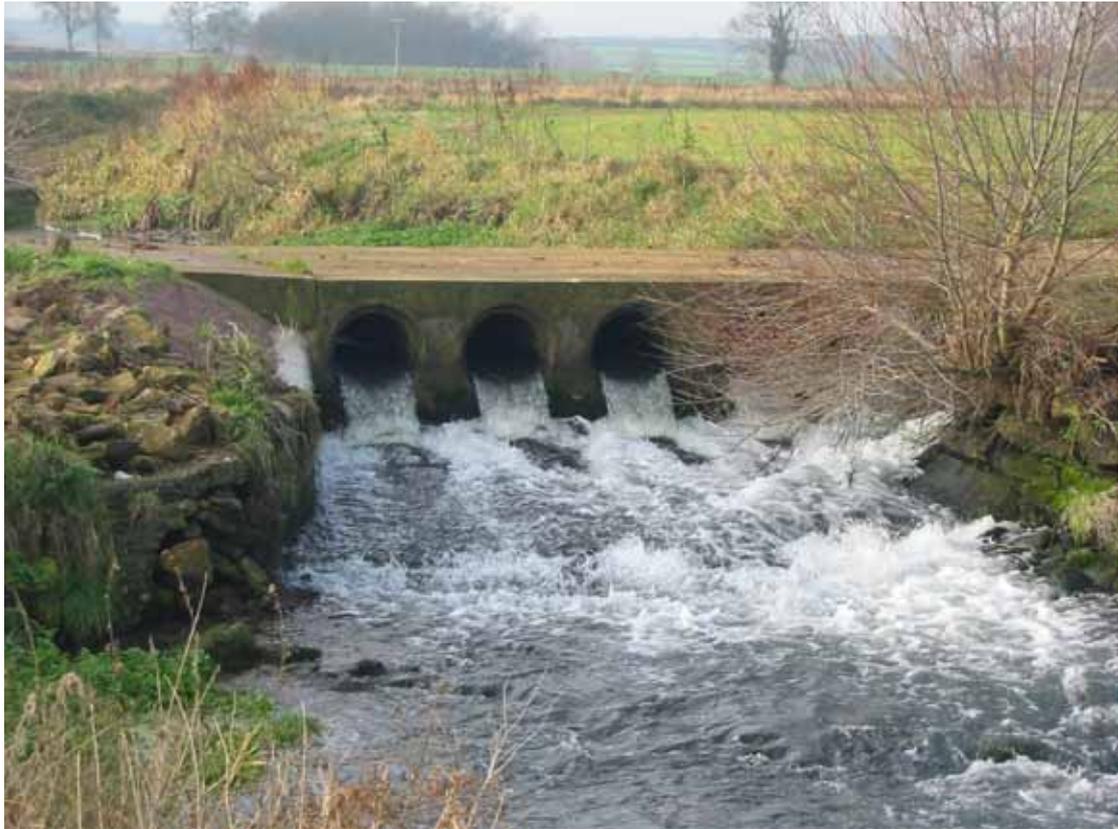
Towards the downstream end of this reach, a farm access bridge had been installed. The construction had utilised 5 round culvert sections in order to pass flow along the channel. This has created a drop of some 1m between the upstream and downstream bed levels, with the upstream level perhaps indicative of the original level prior to dredging. The pipes formed a considerable barrier to upstream migrating fish, physically separating upstream and downstream reaches, and causing fragmenting of the fish population. The backwater effect resulting from the impoundment had caused a significant length (400m+) of depositing channel upstream, with associated growth of, predominantly, reed sweet grass *Glyceria maxima*, and a silt dominated substrate. This section of the fishery has the most significant mayfly hatch but was largely un-fishable beyond mid-summer due to the growth of reeds.

Culvert bridge showing head drop over the structure and its impassable nature

Careful use of deep substrate incubation boxes could help to boost semi-natural recruitment. Basically, these are gravel filled boxes, approximately 0.6m in each dimension, that are filled with suitably sized gravel and seeded with 10,000 - 20,000 trout eggs. A water feed at the bottom of the box allows the eggs to incubate and hatch. Once they reach the swim-up fry stage, they leave the box via the overspill pipes, stocking themselves into the river or, probably more usefully, caught in a fine meshed box and distributed around the fishery. In effect, this system produces naturally reared fish without the unhelpful behavioural modifications associated with hatcheries. More details on incubation boxes can be found on the Wild Trout Trust web site www.wildtrout.org or in Volume 2 of the Trust's magazine, *Salmo trutta*. One or more could be sited in the fishery, at the mill at the fishery's upper limit or at the site of the 'Culvert Bridge', using either the head loss over the bridge or the old ram pump to drive the box.

- The presence of the 'Culvert Bridge' is without doubt a serious impediment to migrating fish. It is also responsible for significant detrimental impact on instream habitat upstream of the structure. To replace the bridge would be a major undertaking, probably beyond the means of the club. However, the Environment Agency may be able to offer assistance with this issue, either directly or via a collaborative project with other stakeholders.

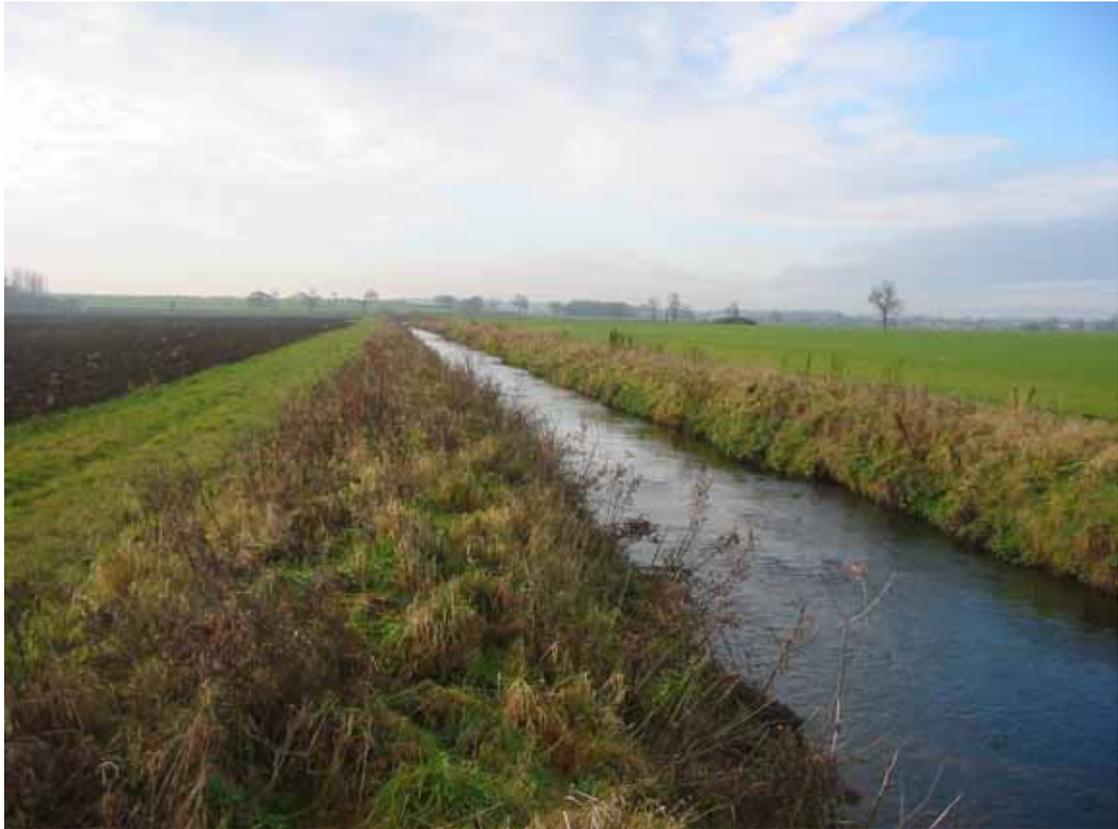
The reach upstream of the Packhorse Bridge (Martin's Farm) had been heavily modified by dredging activity in the past. The channel was heavily incised (2m), with raised banks of spoil on the RB and LB evidence of the extent of this drainage work. The incised nature of the channel rendered access for fishing difficult.

The line of the channel had been moved across the floodplain and straightened. The contemporaneous channel had a good pool and riffle sequence with extensive gravel substrate present.

Straightened line of the dredged channel upstream of the Packhorse Bridge

- Upstream of the Packhorse Bridge, wooden or stone groynes could be constructed in order to create increased variation in the bed morphology of the river, and to help sort substrate. A similar effect could be achieved by the construction of mid-channel islands constructed from faggot bundles supported by chestnut stakes, and infilled with woody brash.

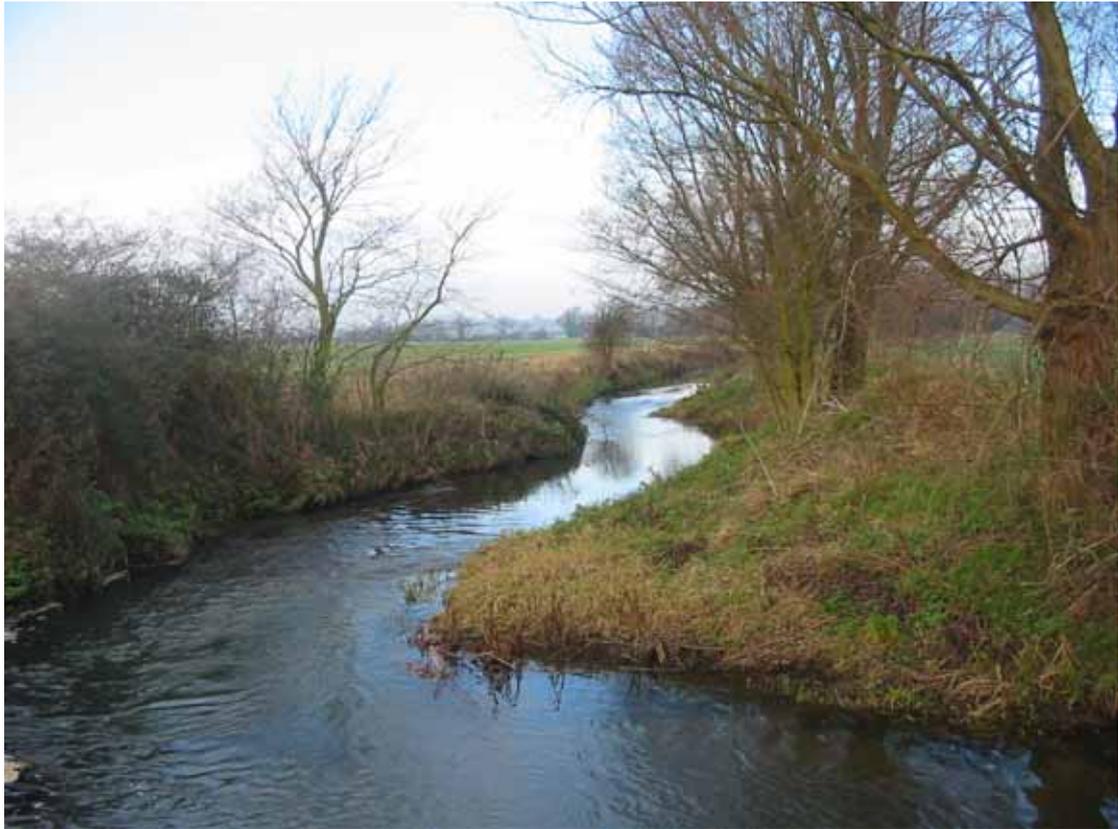
The reach downstream of the Packhorse Bridge, had a good gradient, meandering planform and significant lengths of shallow gravel dominated riffles suitable for spawning and juvenile brown trout.

Typical length of lower fishery, showing well developed pool-riffle regime and meandering planform.

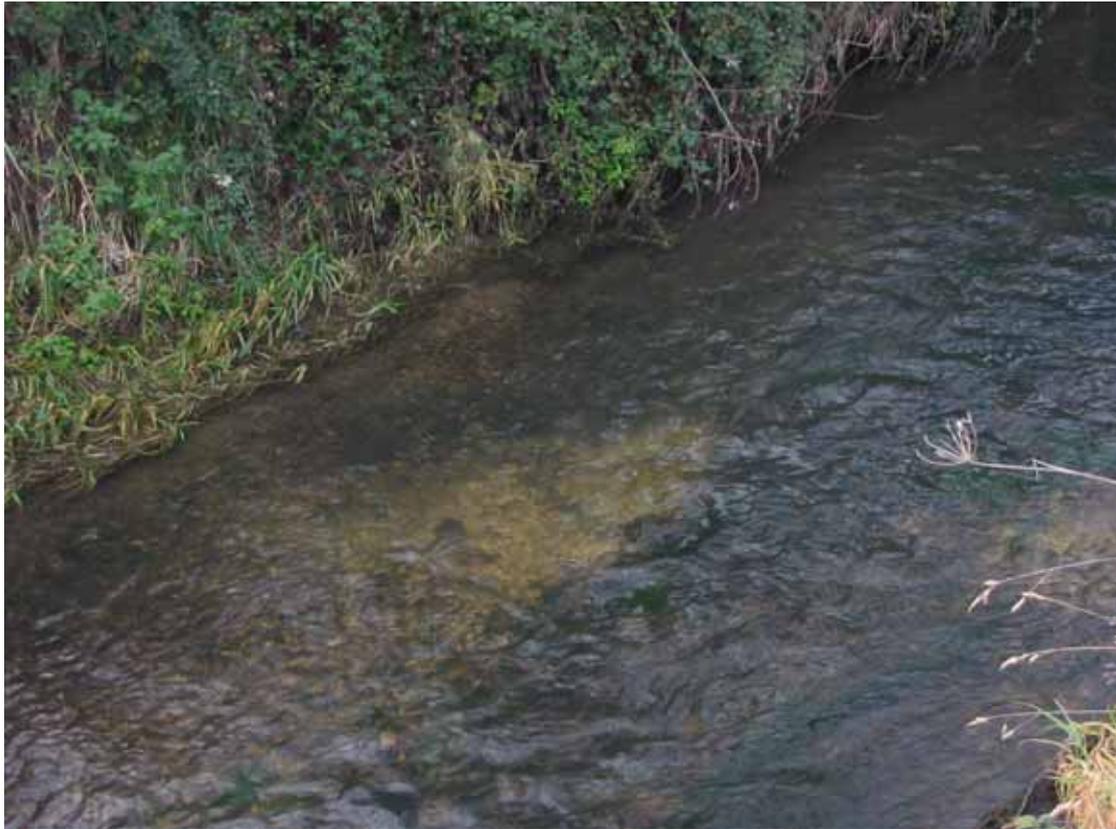
The substrate of the riffles was moderately imbedded and poorly sorted. Numbers of recently cut trout redds were clearly visible in places. There was a well developed pool and riffle regime in this reach, with abundant deeper water suitable for adult trout habitat.

Clean gravel marking the site of a recently cut trout redd

- The quality of the sections of suitable spawning gravel could be improved by establishing a regime of cleaning spawning gravels each September. This can be achieved by either manual raking, or by the use of high-pressure water jets. Care must be taken to clean riffles rotationally, with only short sections being treated annually. The EA have offered to undertake this work on behalf of the club. If their offer is not taken up, it is imported that they are contacted prior to any cleaning of gravel, due to the possible discoloration of water in the river resulting from the operation. The same concerns dictate that downstream neighbours should also be forewarned of the operation. In order to monitor the success of any gravel washing, it is further recommended that an annual count of spawning redds is undertaken by the club. Key spawning areas should be walked during November- January and observed redds logged and counted.
