Advisory Visit to the River Bulbourne,  
Berkhamstead, Herts

Undertaken on behalf of the Wild Trout  
Trust, by Vaughan Lewis, Windrush  
AEC Ltd

June 2004

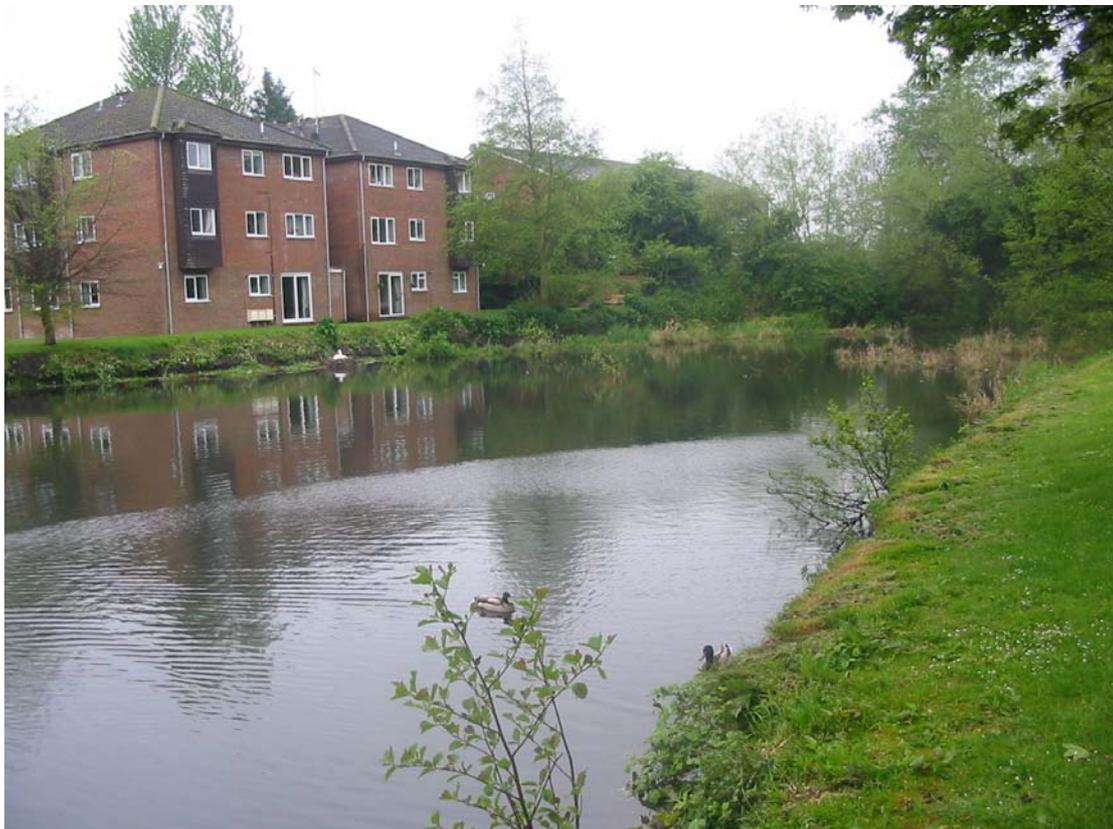
At the upstream end of the town reach, the river runs through a short section of gravel bedded, flow dependent habitat, before entering the old cress beds. The river has been impounded at this point, creating an 'on-line' pond. As a consequence, sediment and nutrient accumulation have combined to reduce the depth of the river and its value for brown trout. It does however, provide a significant and well-liked landscape feature.

**Old Cress beds, looking upstream**

- Restoration of the channel through the old cress beds can be effected by delineation of a suitably sized channel using faggot bundles, 300mm diameter coir fibre rolls or similar. The channel can then be lined using flint reject gravel. The area out-with the new channel can then be encouraged to develop as a reed-bed by selective infill with clean spoil and/or woody brash, followed by planting with reed/sedge plugs or rhizomes. It is essential that detailed plans are drawn up for this major exercise and that local residents are consulted at all stages regarding what will be a significant change to the landscape of the area.

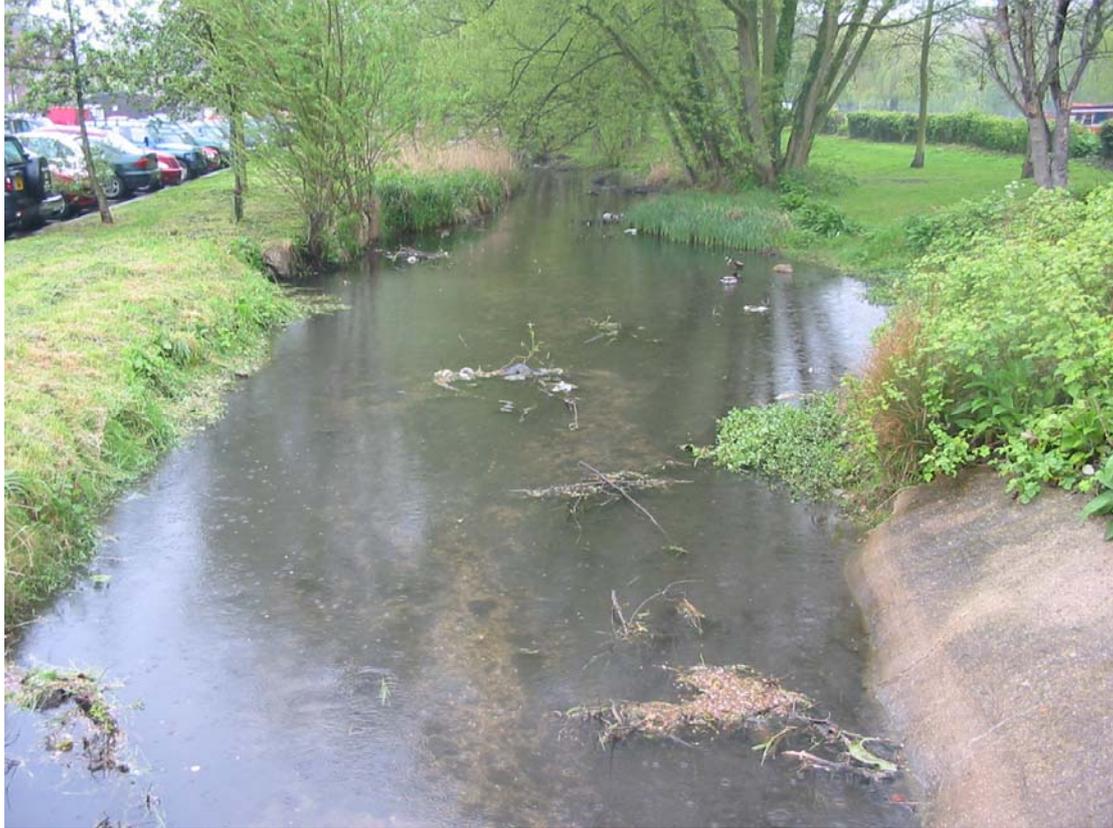
**River Bulbourne adjacent to Waitrose car park showing concrete bank to be removed and the heavily maintained RB**

The RB opposite this section of concrete was very heavily strimmed, effectively removing all fringing vegetation. This work was apparently undertaken by the Environment Agency (EA). Point source discharge of silt laden water from surface water gullies was apparent during the visit. These discharges were adding a considerable fine sediment burden to the river.

- The proposals for the river drawn up by the Chiltern chalkstreams project are broadly endorsed.
- The proposed pollarding of riparian trees, removal of section of concrete bank revetment, recreation of downstream area of wetland via the mechanism of coppicing and restoration of a channel through the old water cress beds are all positive management options.

- The current heavy maintenance of the banks of the river and canal should be reviewed with the Environment Agency and British Waterways. There is little point embarking on a river restoration programme only to have the outcome jeopardised by over-zealous bank cutting. Positive control of bank cutting could produce significant ecological and landscape benefits. For instance, the 'island' lying between the canal and river could be developed into a 'meadow' area by reducing the intensity of grass cutting. The presence of small clumps of bluebell *Endymion non-scriptus* and cowslip *Primula veris* on the day of the site visit suggests that other wild flowers may also be present that would flourish if cutting pressure was reduced. The creation of a meadow area would strengthen the link between river and canal both ecologically and in landscape terms. More closely cut paths could be maintained through the meadow to allow public access. It is likely that such a management regime would also show positive financial benefits.

- The highways authority should be lobbied to address the control of silt laden, surface water discharges in to the river. Whilst it is acknowledged that this is a potentially expensive and logistically difficult issue, the benefits to the river are significant. Recent advances in Sustainable Drainage Strategies (SUDS) have identified a range of proven, cost effective solutions to many aspects of urban surface water run-off.
