Habitat Advisory visit to Clatford Farm,  
River Kennet, undertaken by Vaughan  
Lewis, Windrush AEC Ltd on behalf of Mr  
and Mrs Johnson

March 2004

## 1.0 Introduction

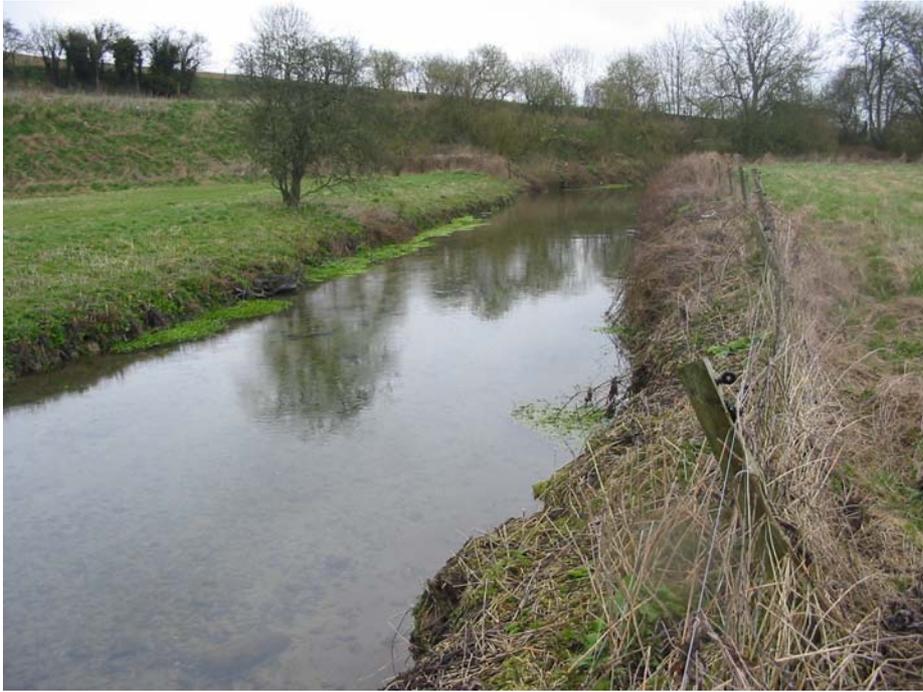
Upstream of the Old Mill, the river was slightly incised, with a berm of excavated river bed material visible on the RB. The channel was overwide and relatively shallow (0.3m) with little instream or marginal cover. Fine sediment was present over much of the bed of the river, with limited areas of clean gravel. The channel planform and bed profile were both very uniform, with little sorting of bed material or variation in depth. Some small stands of brooklime *Veronica beccabunga*, water cress *Rorippa nasturtium-aquaticum* and water forget-me-not *Myosotis scorpioides*, were noted in marginal areas. No submerged vegetation was present in the channel.

### **Upstream of the site of the Old Mill**

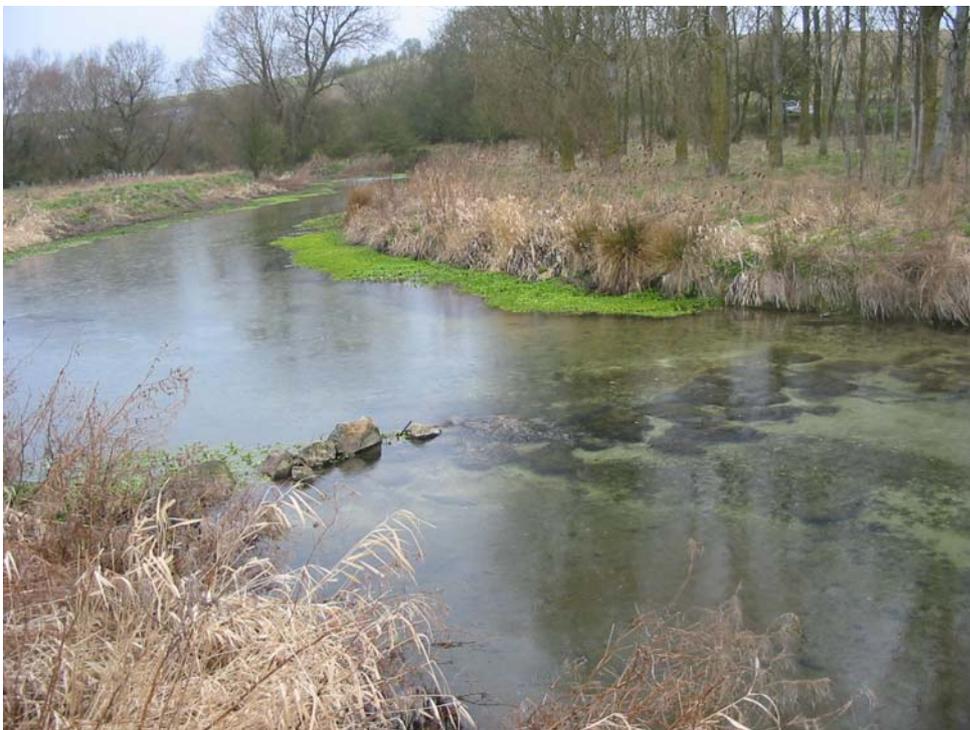
Downstream of the mill, the channel remained over-wide, with limited variation in planform or bed profile. There was abundant gravel in this reach, of suitable size for spawning and juvenile brown trout. However, there was little sorting of the substrate, with fine sediment overlying the gravel in most areas. There was again virtually no submerged vegetation or other in-channel cover. Some more extensive beds of marginal vegetation were present, including stands of reed canary grass *Phalaris arundinacea*. Low weirs had been constructed using Sarsen stones in an effort to increase flow variation, scour and sorting of bed materials.

**Overwide channel upstream of bridge, with Sarsen stones introduced to create a low level weir**

In addition to increasing the amount of LWD in the channel, the large number of Sarsen stones present along the banks should be utilised in order to create upstream facing groynes and /or low curved weirs. The latter structures should be constructed with their convex side facing upstream, and should remain submerged during normal summer flow. All groynes and weirs should be carefully keyed into the banks to prevent erosion at these vulnerable locations.

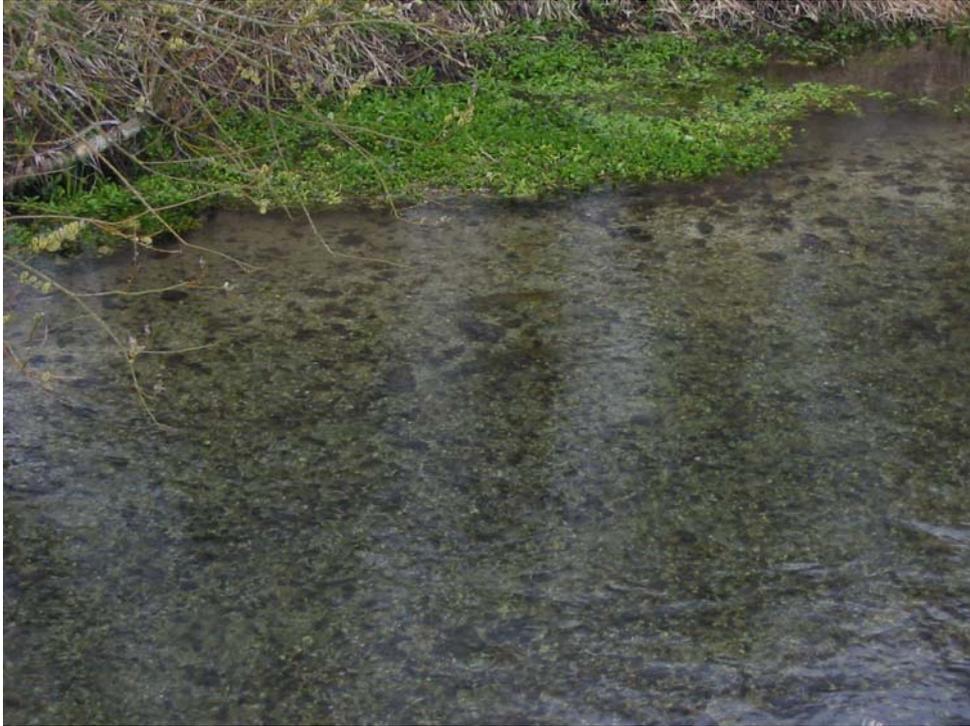
### **Two mature brown trout alongside a section of marginal vegetation**
