THE SOUTH MEDWIN WATER

Wild Trout Trust Sponsored Advisory Visit Report

Undertaken by Ron Holloway MIFM

April 7<sup>th</sup> 2004

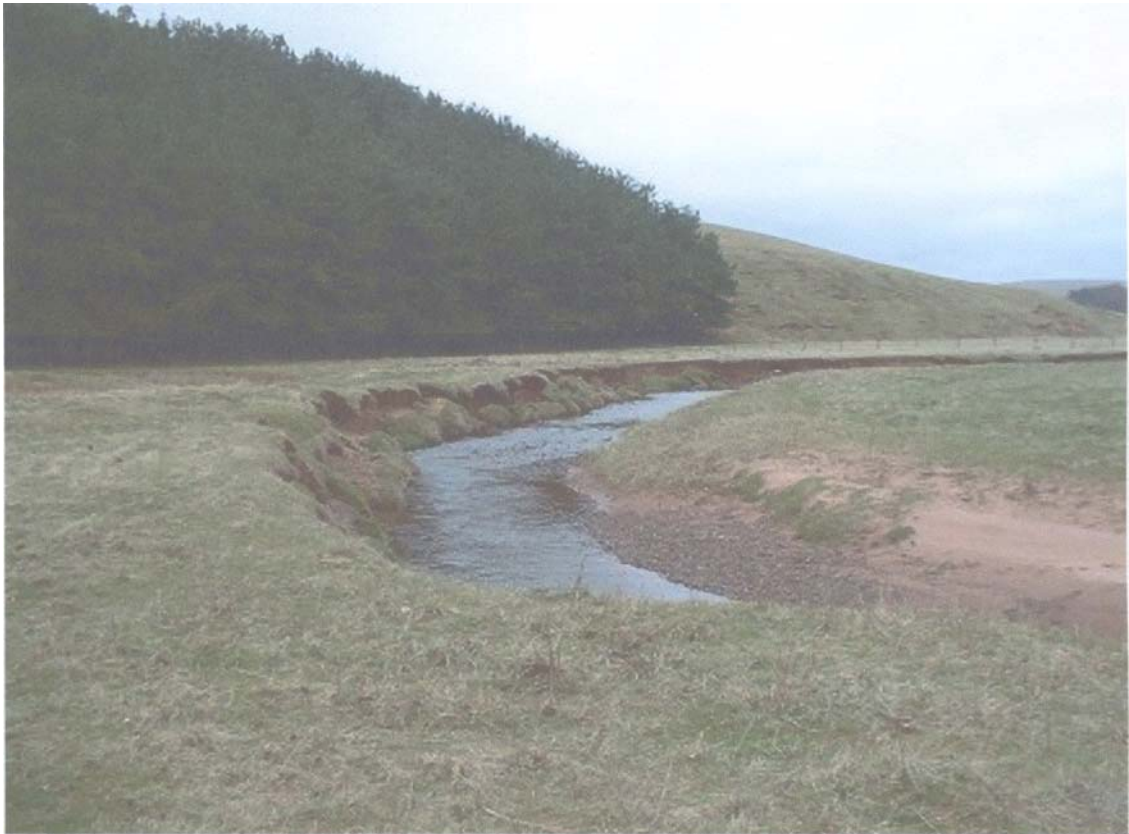
**Erosion and over grazing. Neuk Wood.**

The essential fencing would be installed after the initial survey reports have been received. It is suggested that the entire stretch between B&A be fenced off in straight line fencing where convenient. It is not practical to follow the river banks as the meanders make it difficult! Drinking points have to be planned if water access for animals is required. FWAG do have a fencing scheme that will assist farmers to fence off rivers for protection of wild life habitats. Once the area has been fenced then a program of replanting can commence. This would entail planting up all the erosion points and sediment bars along the river banks with native plants. There are excellent sources of natural plants along the site with, for example, reed mace clumps under the Neuk Wood which can be split up and planted along the banks. Also there is a good stock of Burr Reed along the river margins that can be split up and rooted shoots replanted. Any natural vegetation to the valley that can be moved and replanted should be considered. Willow cuttings are excellent. It is suggested that the trees that have already been planted should be pollarded

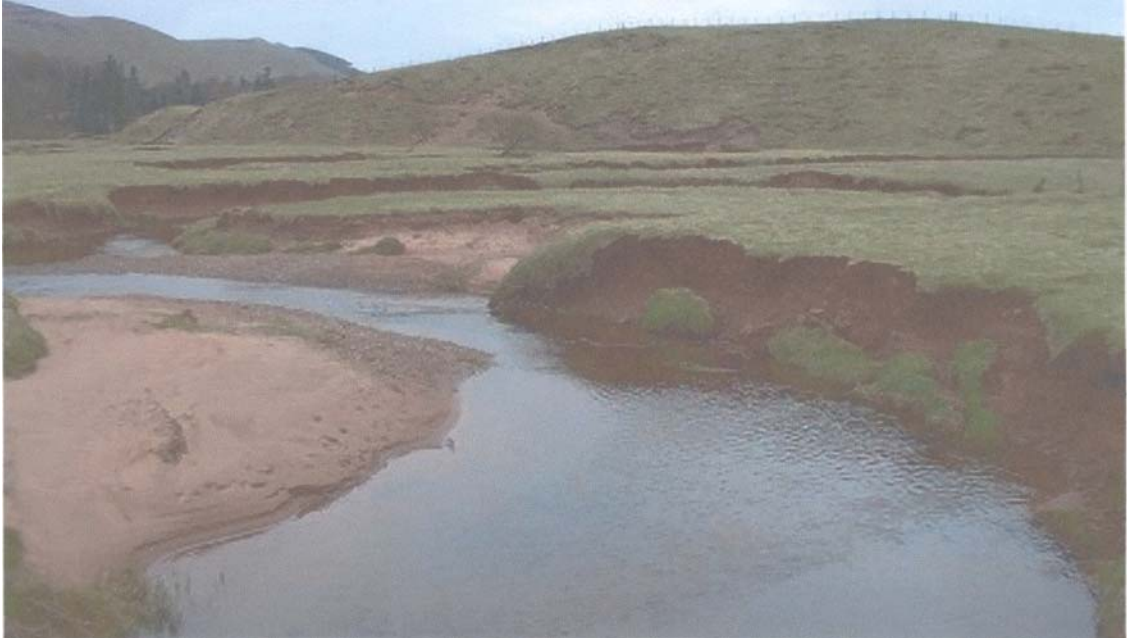
### **Erosion and sites for replanting**

to reduce spindle growth and encourage trees to bush out. Furthermore as summer goes into Autumn then seed heads from any wild field plants can be collected and randomly seeded along the river banks .
