Wild Trout Trust Advisory Visit
The Weardale Environment Trust

12th January 2004

Wild Trout Trust Advisory Visit

The Weardale Environment Trust (TWET)

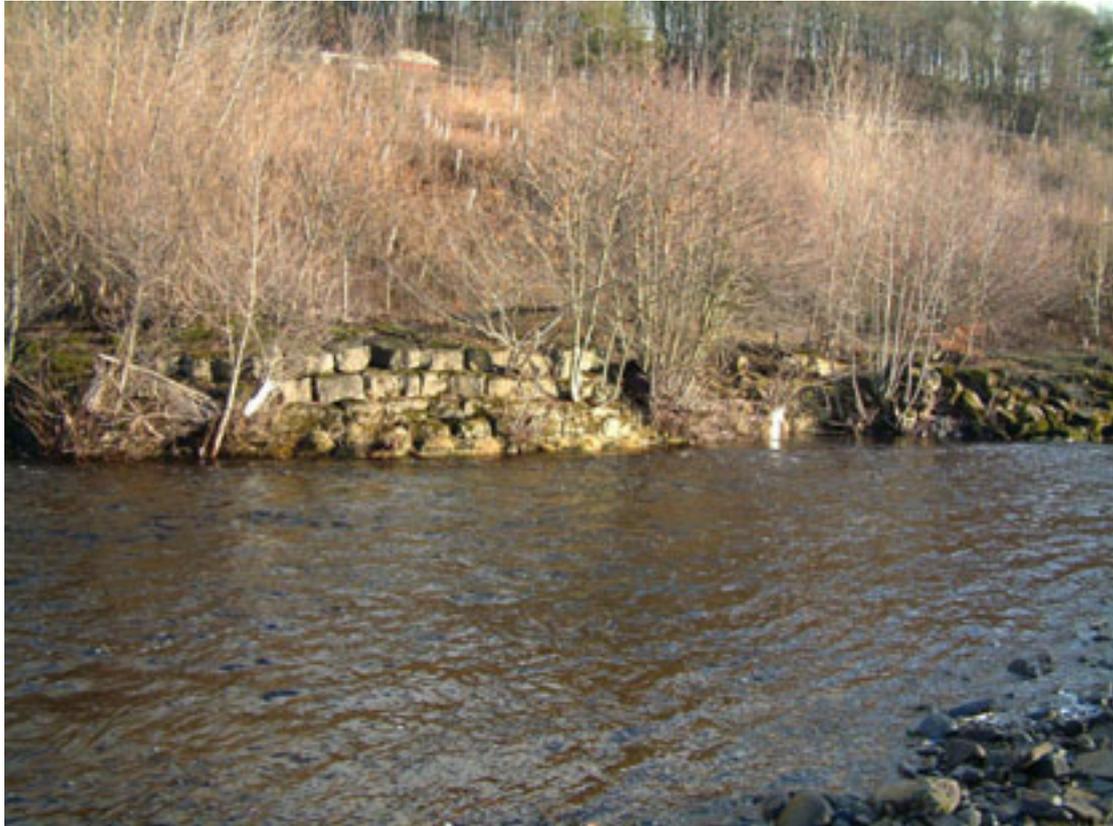
Stone revetment in the lower section.

Further upstream, the river is secured against the opposite bank by short sections of stone revetment which historically protected a pumping station for water transfer, and a steep natural bank which appears to be extremely stable. These features provide a deep run into the pool sequence and are good habitat for both migrating salmon and trout and adult non-migratory trout. Again, there is little opportunity for habitat improvements here and there is already good cover provided by overhanging trees. The right bank will remain completely fenced and this will maximise vegetation on this side of the river. It has been suggested that breaks in the fence should be used to allow drinking points for agricultural stock. This is not recommended for this site. Wherever a fence is turned at right angles to the river, it is vulnerable to flood damage. This is a particular risk for this section of the Wear. Other Trusts are now

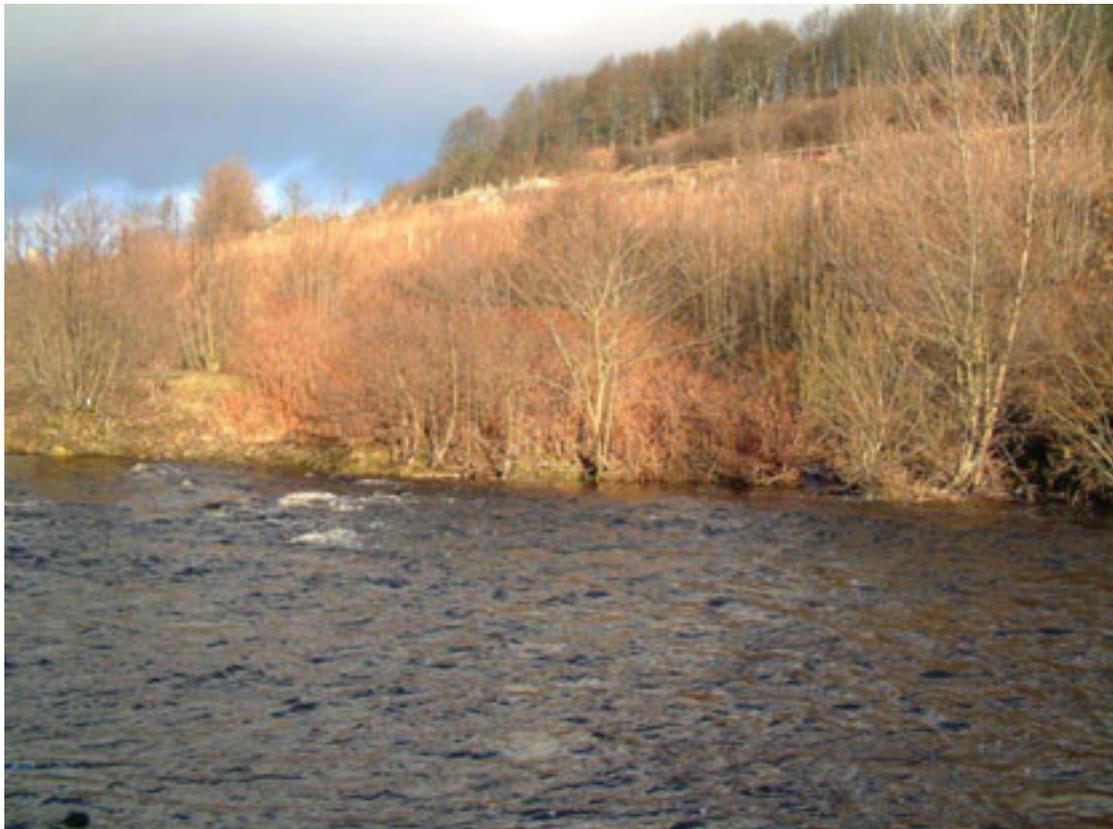
Stand of Japanese Knotweed on opposite bank.

At the top of the lower section, a stream enters the river from property controlled by Northumbrian Water. It is unknown whether this stream is subject to treated water from the sewage treatment works, and there are additional inflows further upstream. Extremely apparent at the confluence of this small stream with the river is a medium size stand of Japanese Knotweed. According to members, this could be the source of Japanese Knotweed on the Wear making it an ideal environmental problem for members to tackle. This would tie in with the land use on the opposing land with high movement of vehicles and construction work. There is a small stand

In the first instance, the small and medium stands of Japanese Knotweed are probably best treated simply with a translocated herbicide such as glyphosate (trade name RoundUp) in Spring and Autumn when growth rates are highest. This kind of treatment will still take at least three years and if it does not work specialist advice may need to be sought. Both stands are in close proximity to water and treatment of the plants must be carried out by someone holding the necessary training certificate for use of a herbicide near water, and also with a licence from the Environment Agency. This licence will not be hard to get as the problem is a recognised issue for all rivers in the UK.

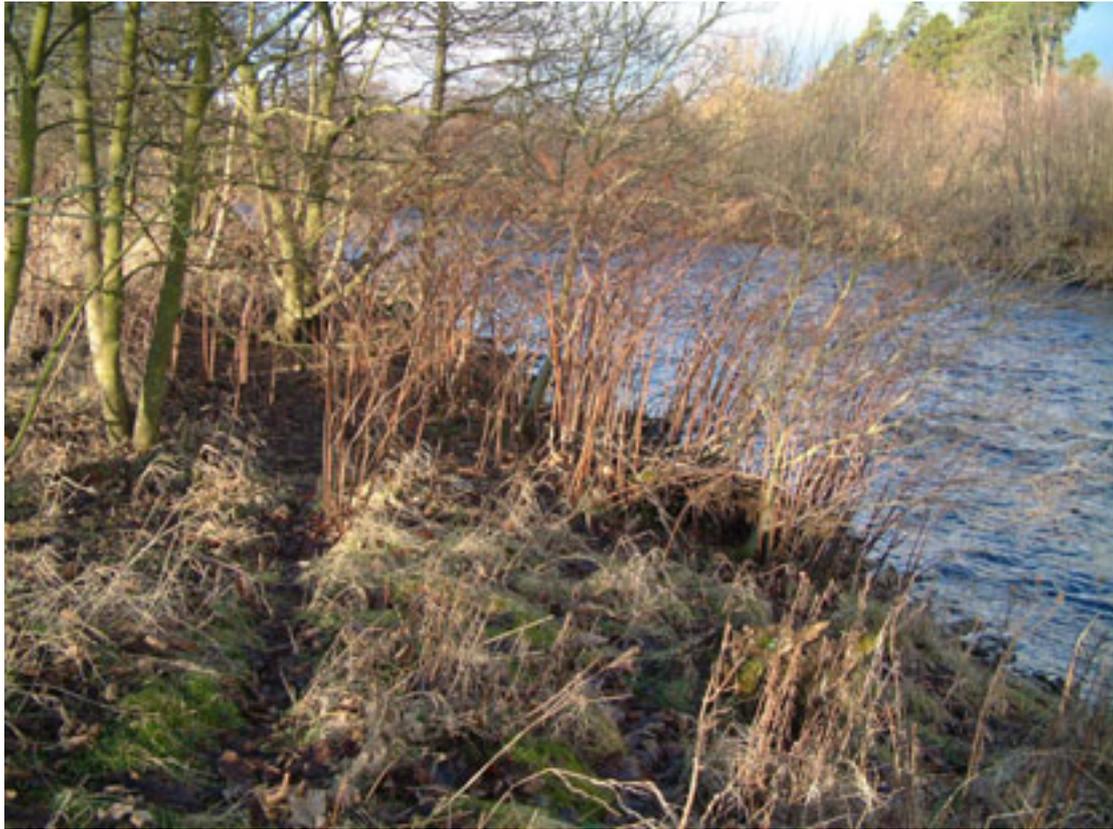
of Japanese Knotweed appearing on the right bank opposite the larger stand. It is feasible that the plant has been transported over the river, but it is also feasible that there are further stands upstream. The Wildlife & Countryside Act makes it an offence to cause or allow Japanese Knotweed to grow and steps should be taken to work with Northumbrian Water to remove both stands. As the plant is transported by water, the Trust should also take the opportunity to try and identify any occurrences of this plant upstream and tackle those also. Japanese Knotweed is an extremely invasive plant that is disastrous for riverbanks. It out-competes native vegetation, but dies back in winter to leave a bare bank vulnerable to erosion which a silt river like the Wear will immediately take advantage of. As the plant is transported by water, to eliminate it from the river, groups must start at the top of the catchment at the source of the problem and work their way downstream. Members should also be vigilant for Himalayan Balsam which was not apparent on-site but has caused similar problems elsewhere, and Giant Hogweed which can be a danger to visitors to the reserve, particularly children.

Small stand of Japanese Knotweed appearing on the right bank.

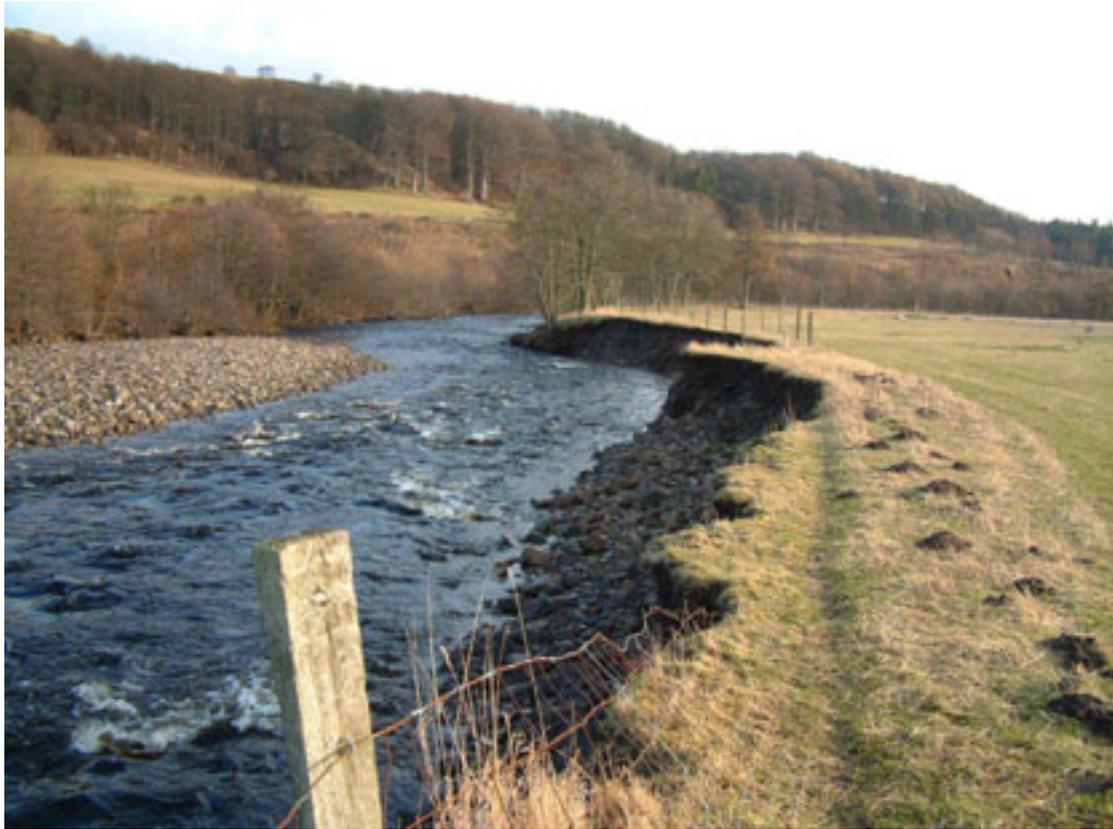
The erosion was caused by the build up of a large gravel bar on the opposite bank in the 1996 floods. This has shifted the force of the river flow onto the right bank where erosion has taken place.

Accelerated erosion on right bank.

The erosion occurring throughout this stretch appears to be related to high flow events, hence the shape of the resulting bank. There is no question that the gravel bar opposite and the direction of flow from upstream is willing the river to move in the direction it is. If allowed to continue naturally, it will create a meander of maximum bend before starting to move back in the opposite direction (pers. comm. Professor Stuart Lane). If the engineering option is taken forward, this will have to include gravel removal and possibly engineering upstream, otherwise the erosion will continue in exactly the same way, in high flows, above the level of the stone revetment. This has occurred in other rivers where revetment has been used. It should be remembered that this stretch was constrained by the gabion weirs for a number of years and this has exacerbated the problem now that they have been washed out. The river is in the process of reverting back to juvenile habitat for migratory salmonids, and indications on the Wear are that this is favouring sea trout. From a river trust perspective, the engineering solution to this problem is probably not the best way to progress. Firstly, it is very unlikely that the statutory authorities will back the engineering work and consent will be difficult if not impossible to get. Secondly, trying to fight the natural processes of the river goes against the grain of the environmental approach that TWET are taking, and past river engineering has exacerbated the river erosion in the Wear. Thirdly, the engineering will not solve the problem forever, and may not even solve the short-term problem if high flow

It is recommended that TWET explore the use of soft engineering techniques throughout this stretch both as a demonstration opportunity and to find out which techniques suit the river and TWET volunteers. It is not recommended to use live willow spilling. If the river gets behind willow spilling in a high flow location, it has a tendency to pull out in one long section and cause massive damage. It is recommended to try the following techniques, with advice and assistance from Tony Hardwick, and using the potential labour offered to TWET from BTCV:

- Regrade the bank with machinery to an ideal slope.
- Fence off in a straight line, almost continually to the stand of Japanese Knotweed on the right bank, after coppicing the lower section.
- Secure turf to bare areas (seeding may not get the desired effect between periods of flood).
- Where the toe needs protecting, try log and brushwood technique (see appendices).
- Plant single stem willow throughout the length (these have a reduced tendency to cause damage if a single stem is lost, as opposed to woven willow). This leaves the option of pleaching in the future (laying of waterside willow similar to a traditional hedgerow). Remember to coppice after first year of willow growth to increase root growth rate in the following season.

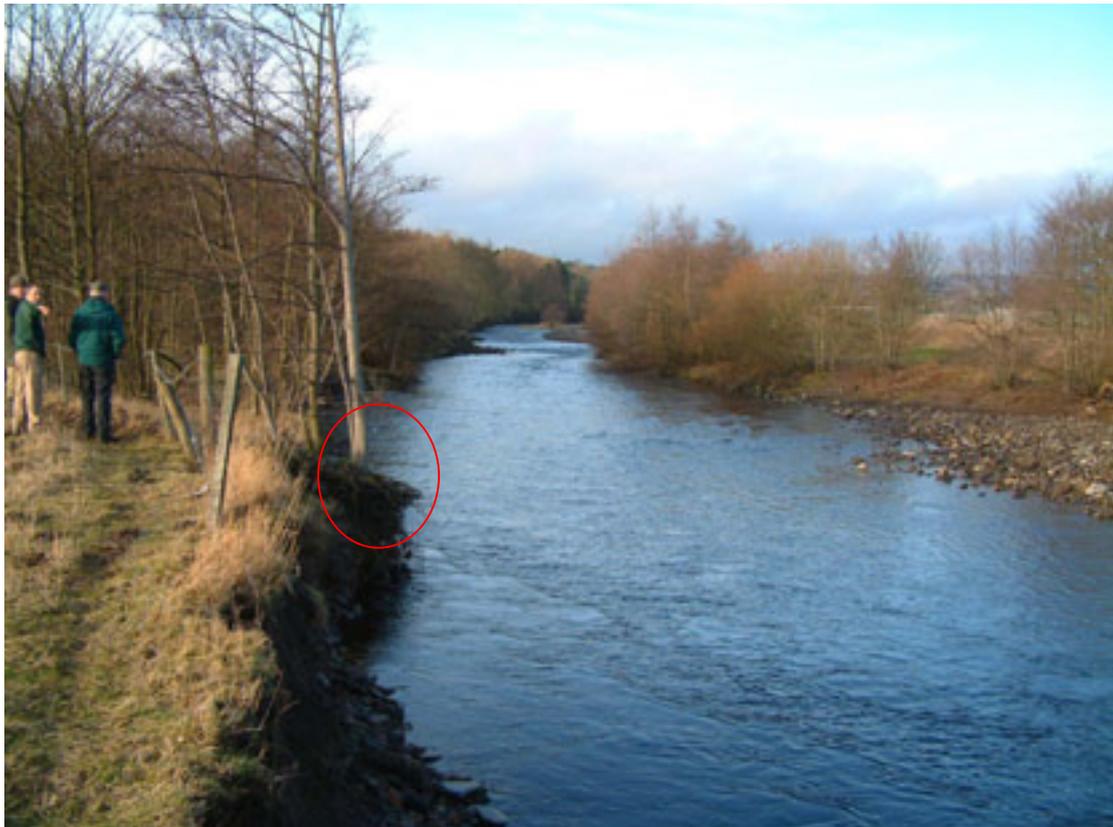
The upper section of the beat is typified by quite heavy tree cover. This has left very little bankside vegetation to bind the soil structure. This does not appear to be a problem in most flow situations, and erosion is only occurring in high flows. Any location where the weight of the tree is hanging over the river should be coppiced in order to maintain root structure without the risk of the tree collapsing.

Trees hanging over the river should be coppiced as a matter of urgency.

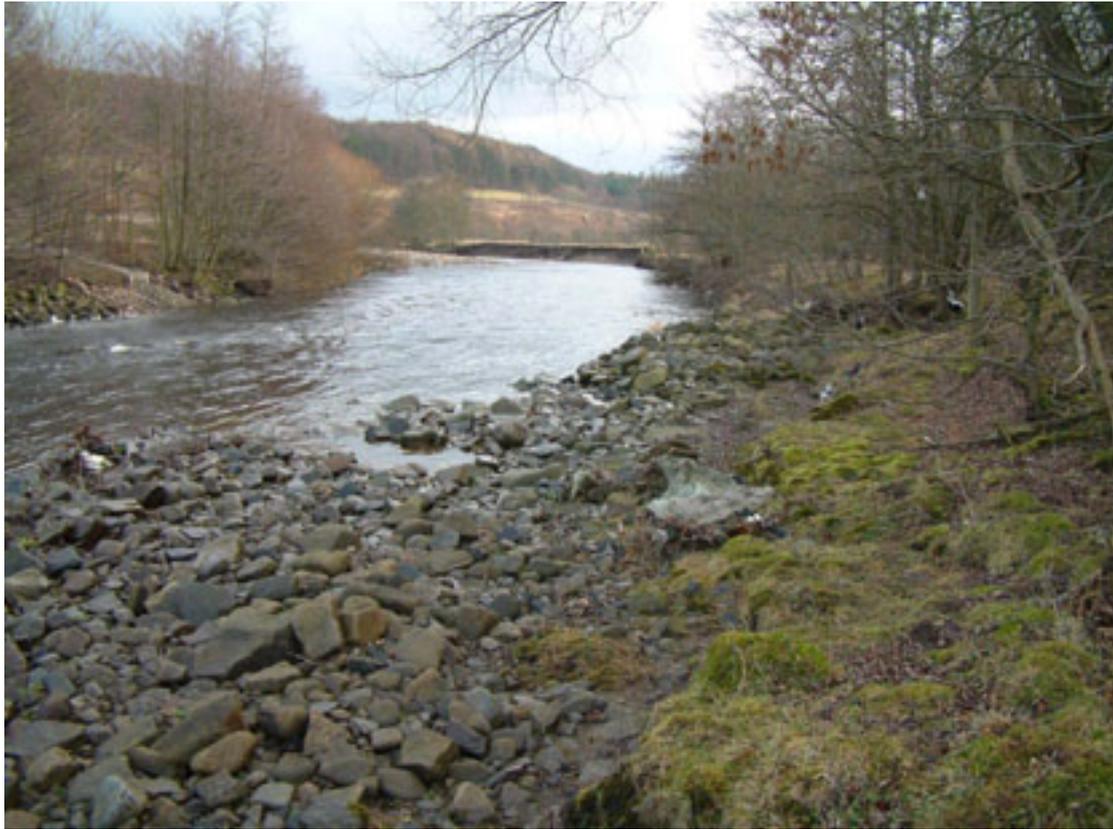
Where the river joins directly to the bank in normal flows, some soft engineering may be beneficial to slow erosion down. Unless all trees are removed from the river corridor over this stretch, it is always going to be low in bankside vegetation due to its orientation to the sun. Log and brush type reinforcements, or live willow will also help to create under-bank habitat for adult trout.

Log and brush type habitat improvements may benefit the lower section here, but further upstream, there is very little on which to secure instream deflectors etc. An increase in light through coppicing will hopefully promote bankside vegetation.

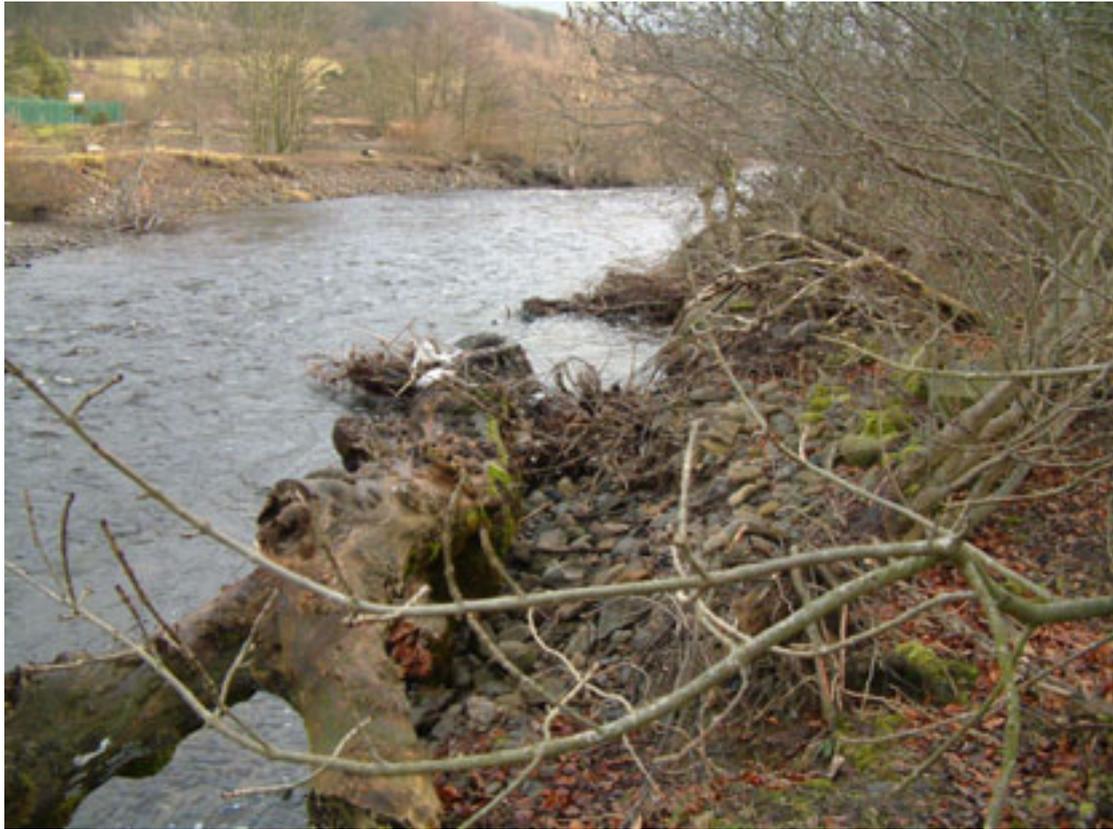
Nearing the top of the wooded section, there is a large tree that has become wedged in the bank. The eddy behind this is causing some erosion to the bank. Where this can be tolerated, it will increase both the availability of adult trout habitat in the beat and the amount of potential food. Woody debris and leaves take a very long time to decay in water, but is fed on by high numbers of invertebrates. Woody debris needs to occur to trap fallen leaves and detritus in order to store it for long enough that it is a benefit to fish. Woody debris extending into the stream creates variety in depth and flow that will be favoured by trout. In some places, it is now being reintroduced into streams to create habitat. In this instance, the erosion should be monitored and if it becomes intolerable, the tree can be removed and, or the erosion repaired with brushwood left over from the coppicing activities. Any trees that fall in or become lodged in this stretch in the future may well be a benefit, so monitor before taking any action.

Fallen trees lodged in the riverbank can provide essential habitats and foodstuff, particularly in rivers lacking other natural features. Erosion is accelerated behind this and may be slowed using brushwood left over from coppicing.

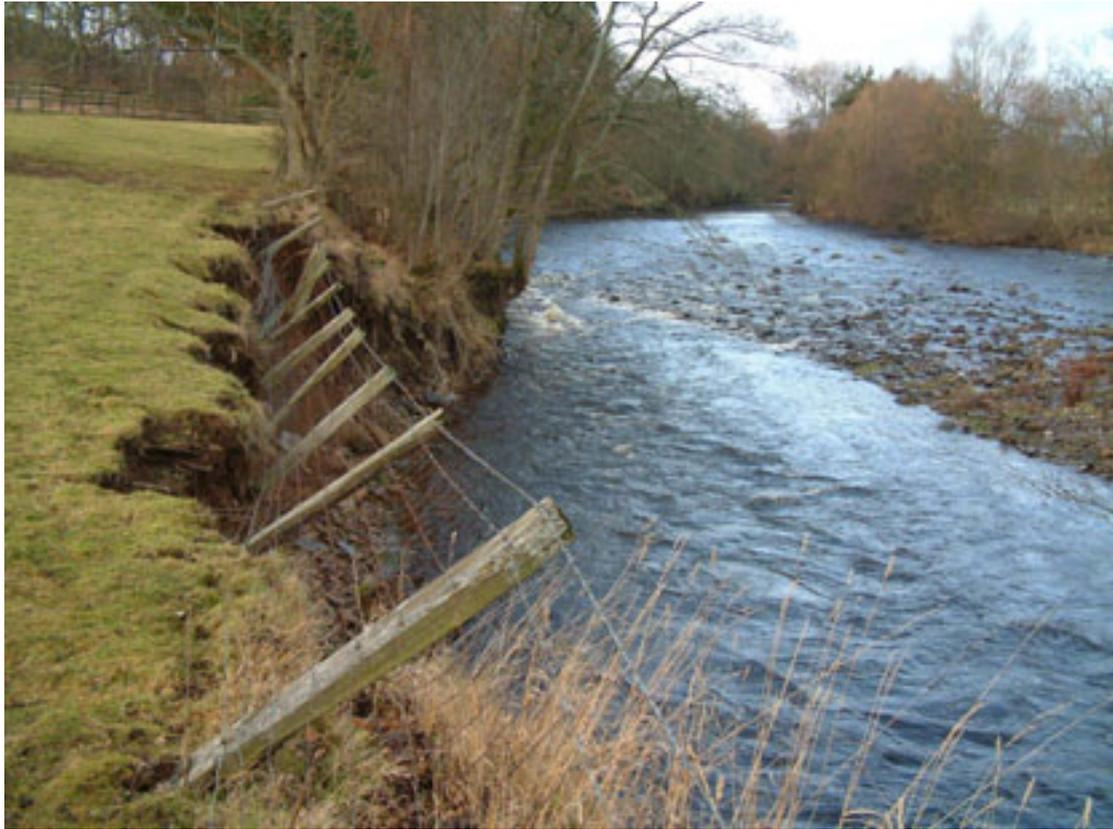
At the very top of the upper section there is further erosion associated with deposits and the change in flow following the 1996 floods. Herein lies the problem with investing large amounts of funding in hard engineering. The river is mobile along its length and very much in a state of flux at the moment. This can be seen by the river at two different heights either side of the gravel bar. The river is going to continue to move towards the right bank, right from the very top of the beat and possibly beyond. This will compromise the work downstream as they become increasingly in the wrong place for the river. The flow is forced against the riverbank at this point, even in lower flows, and it will continue to move the river in this direction.

All the overhanging trees which are putting strain on the riverbank here need to be coppiced and the landslip type erosion needs to be addressed. Agricultural stock is not a major contributory factor unlike downstream, however, a fence with a wide margin should be included to protect visitors from the unstable bank. The potential to regrade this section back is limited based on the topography and proximity to road and railway line. In summer low flows, it may be possible to reinstate a toe using either live willow, or log and post type techniques, and back fill to recreate the slope upstream. An example of a similar project is included in the appendices.

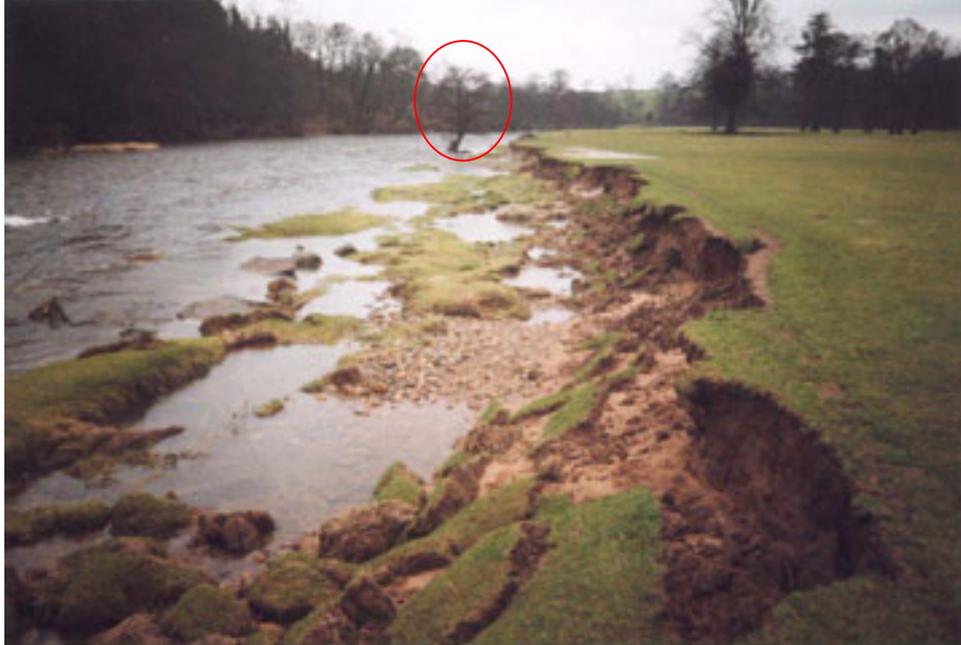
Severe erosion on mainstem of River Eden 1999.

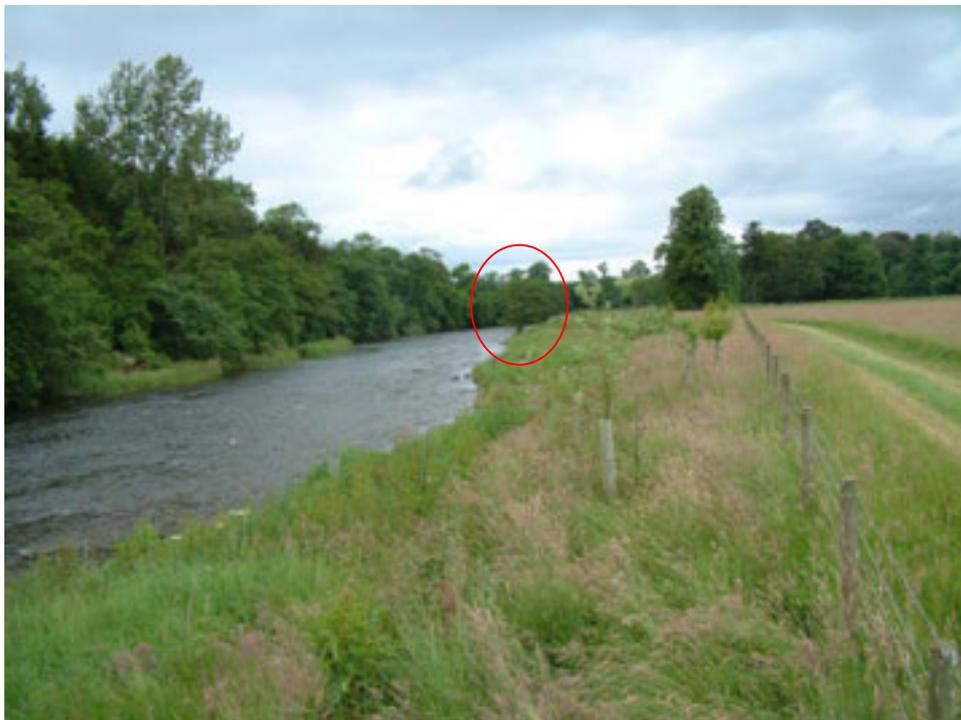
Following three years of installation of fence with very wide margin 2002.

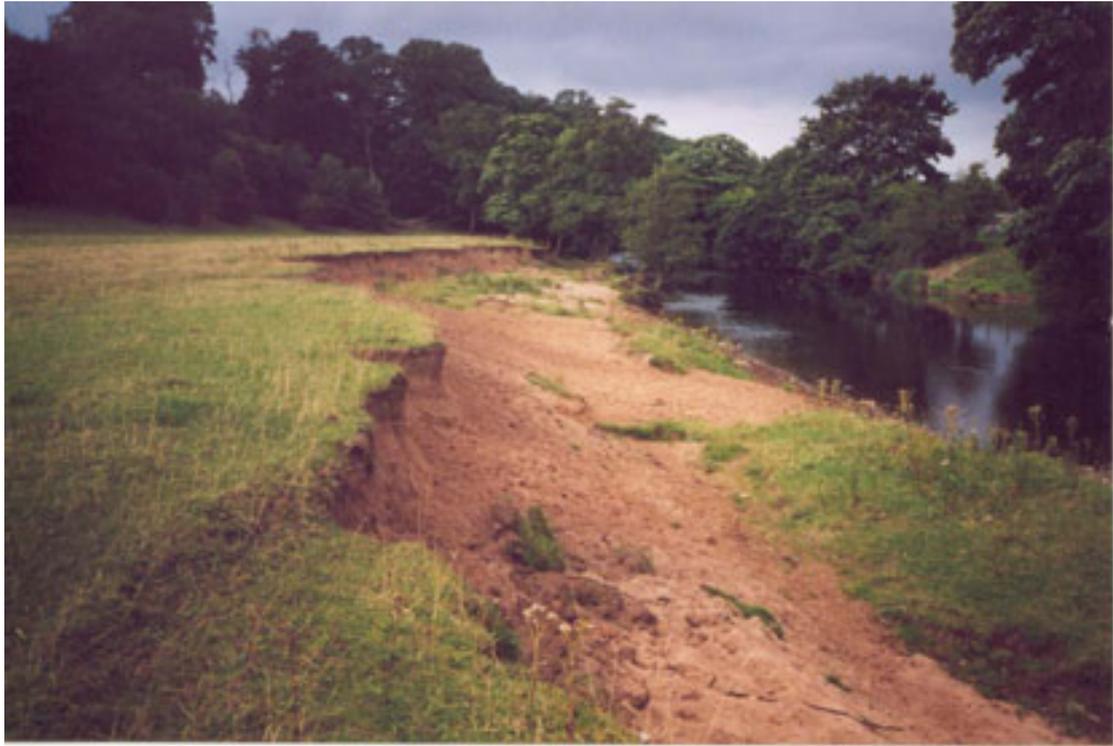
1999 severe erosion and land loss mostly due to agricultural stock access.

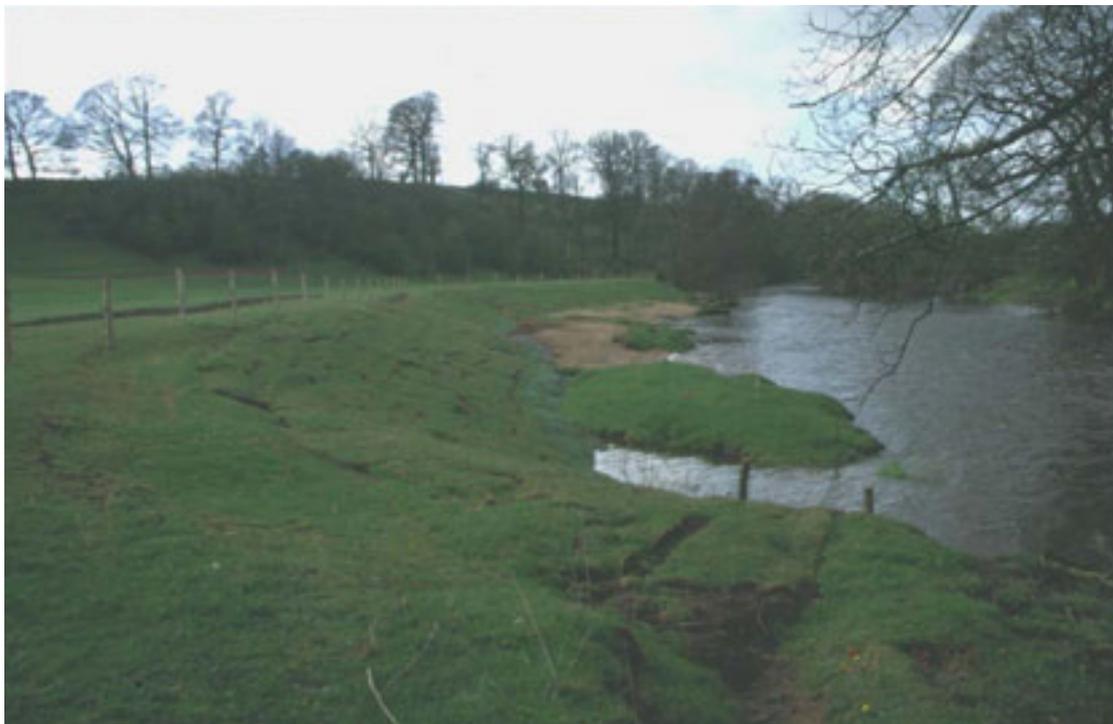
Turf harvested from the flood plain field (which was reseeded where the turf was lifted) secured to the bare patches in order to accelerate recovery.

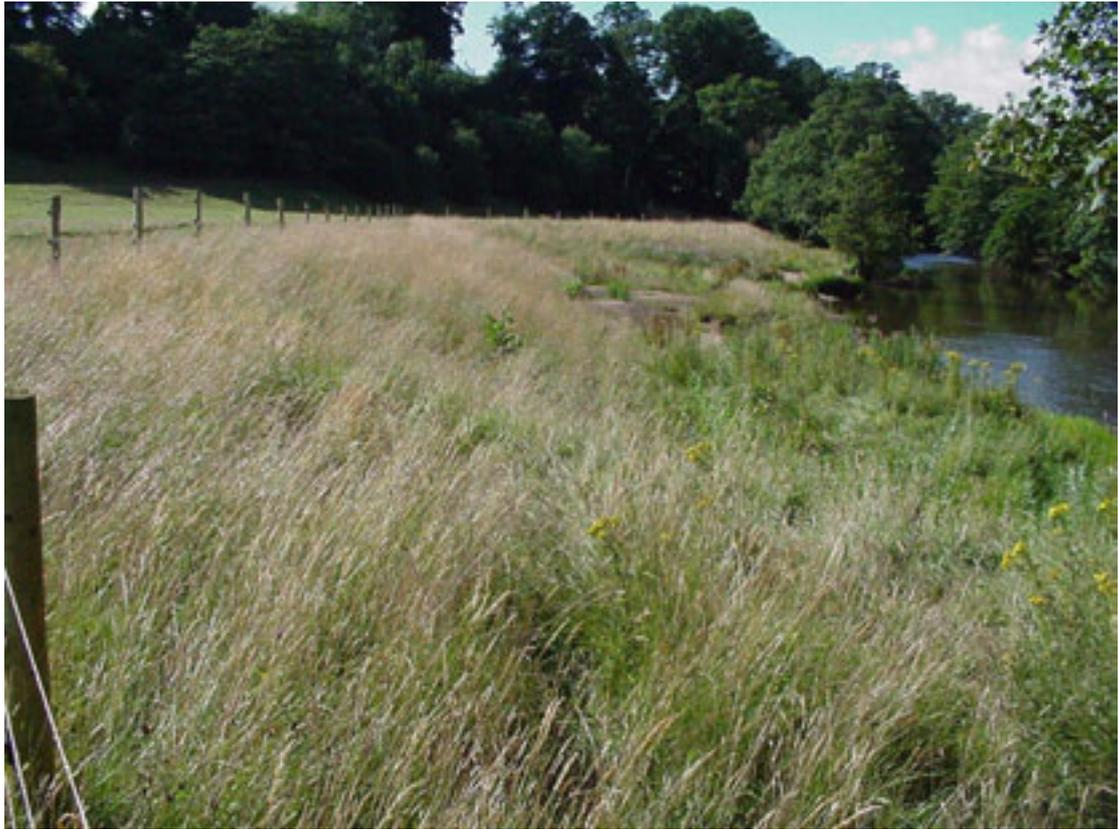
The end result one year later.

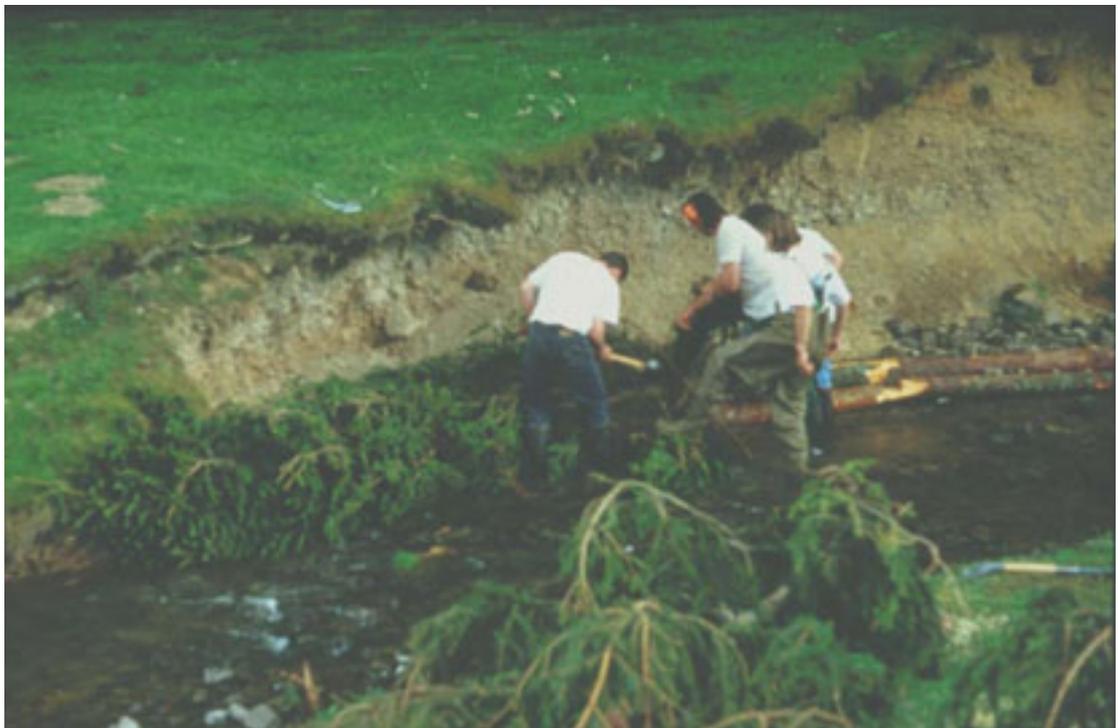
Larch poles are secured to the riverbank toe using long metal pins. Christmas trees are then nailed to the poles in a downstream facing direction. This method can be replicated using any wood and brush combination, including live willow.

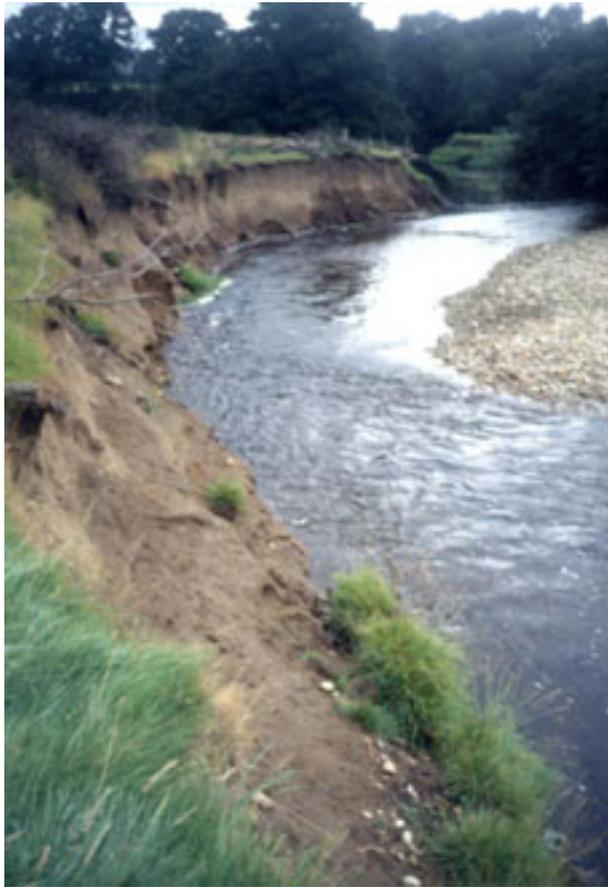
The original eroding bank.

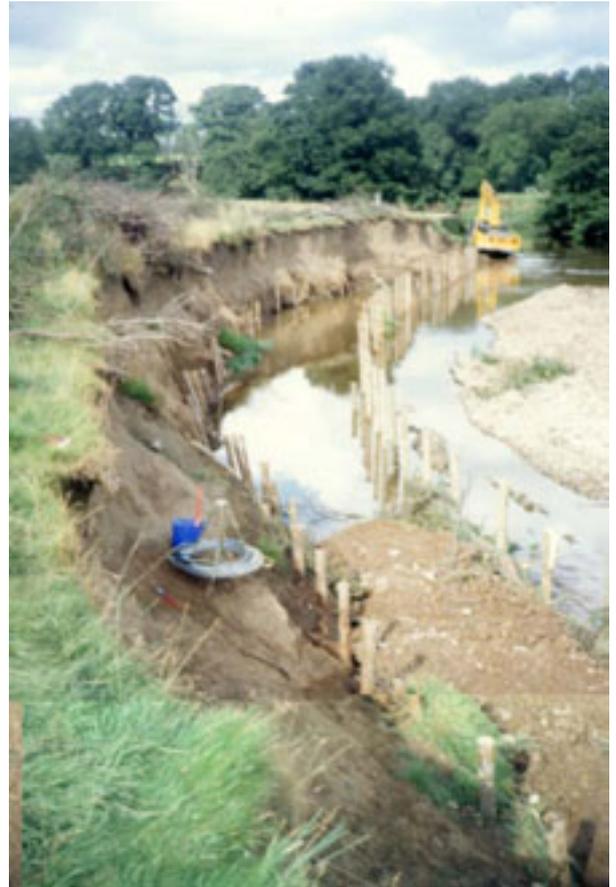
Bioengineering of the toe.

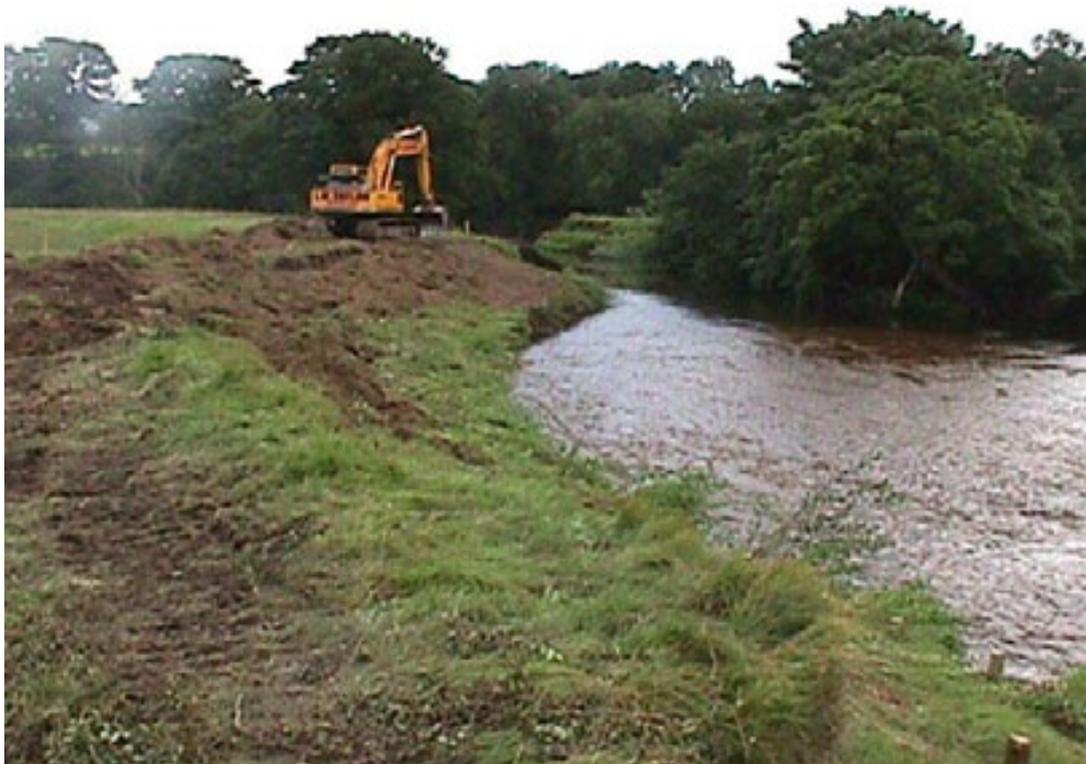
Regrading of the riverbank.

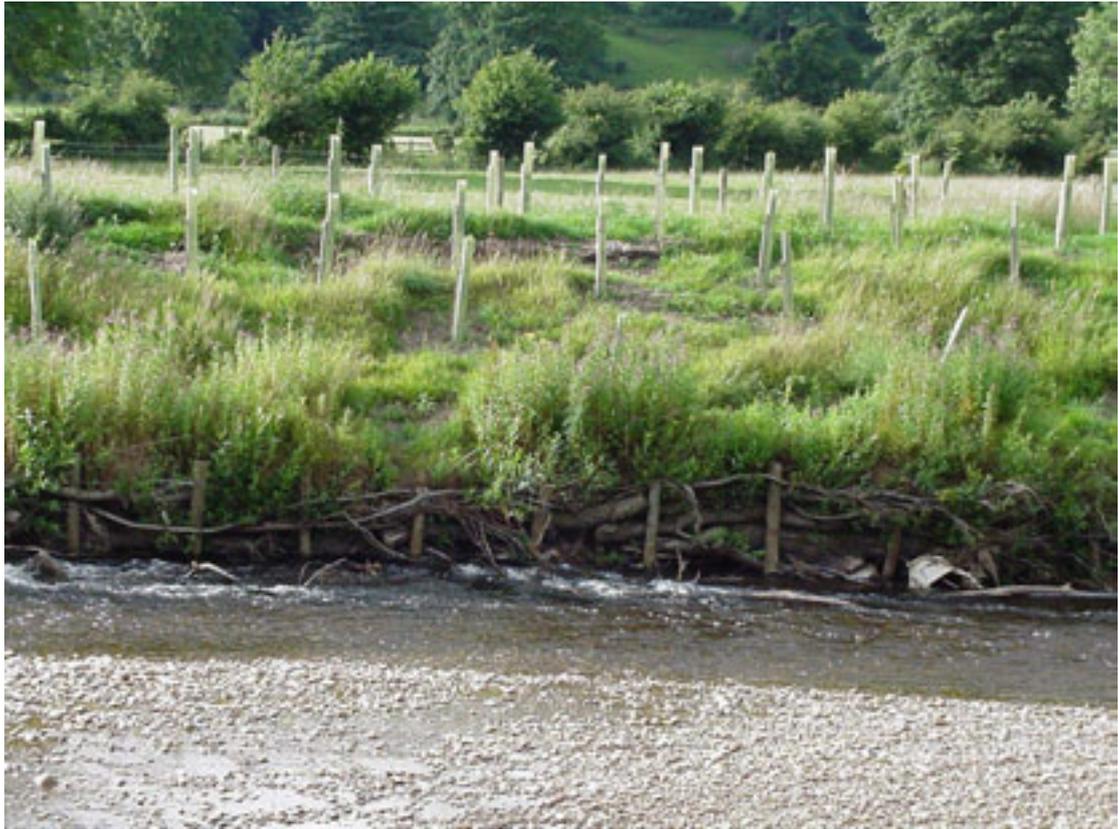
One year later. Note collapse would have serious consequences.
