Advisory Visit to the River Wampool, Cumbria

Sponsored by the Wild Trout Trust

Undertaken by Tony King for the River Eden and District Fisheries Association

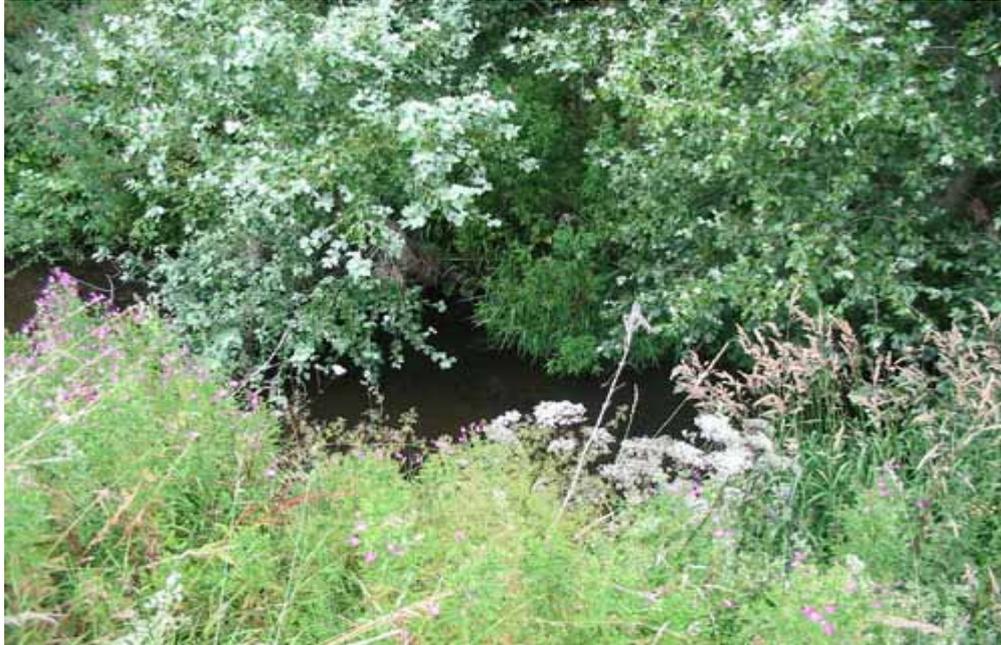
Above the road bridge on the main Carlisle to Workington road the Wampool is split into two streams - one running directly from the Cardwmiere Sand Quarry and the Shawk beck. This top section is over grown and would benefit from pollarding of some of the maturing willows and some management of the riparian zone. Small colonies of Himalayan Balsam should receive attention

Heavily shaded section of the Wampool.

before more light penetration is allowed on this section. They will spread and cause further problems as H.B. excludes more under storey growth than any shading by trees. Herbicide treatment of Himalayan balsam adjacent to a watercourse requires due attention to operator licence requirements and LERAPS. The local DEFRA office can advise.

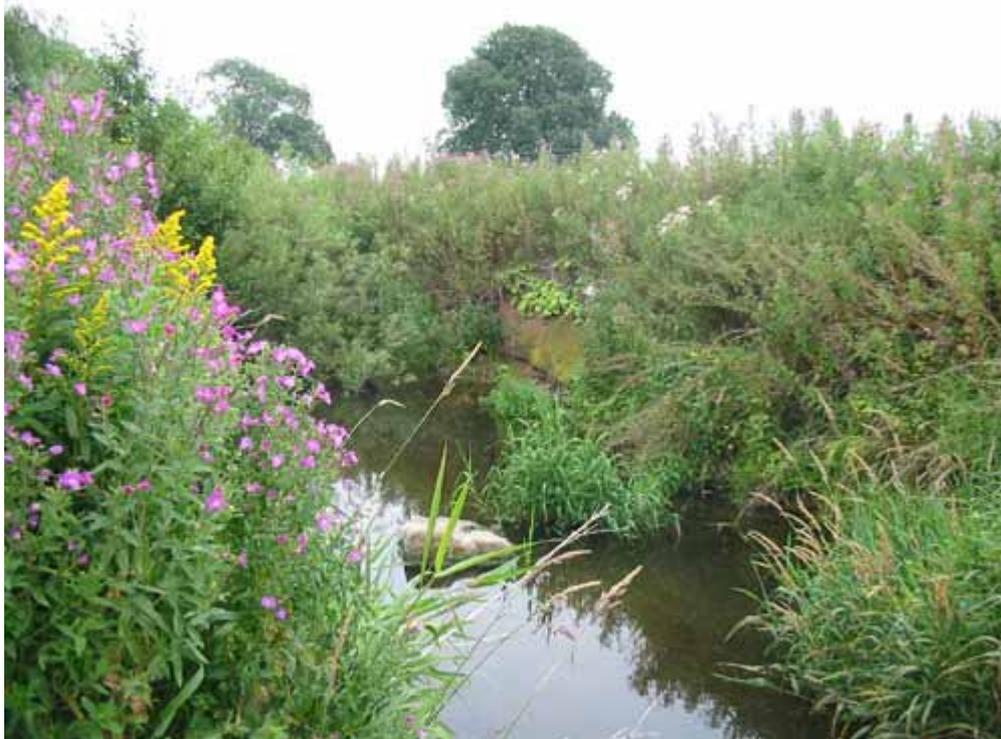
The lack of dynamism within much of the straightened stream has led to poor gravel recruitment, and the riffle and pool structure most appropriate to this type of stream is all but totally absent. Some low level soft engineering might be possible utilising the trunks of the pollarded willow to reintroduce diversity to the channel; the willow would have the added advantage of introducing large woody debris to the channel, some of which may sprout and produce new growth almost immediately.

As long as any instream or bank side feature created is of sufficiently low profile it will only affect the stream at low flows. Therefore implications for flood defence should be minimal. However, re-creating natural features may destabilise the channel and although this would solve problems such as gravel recruitment it is important to bear in mind the consequences for the riparian zone and landowners downstream of the site. Furthermore since all works within 8 metres of a river channel require land drainage consent from the Environment Agency they should be contacted at an early stage if any in-river engineering is planned.

In addition, a number of notch or vortex weirs would create deeper areas and increase the flow and diversity that is required to increase useful adult and juvenile habitat.

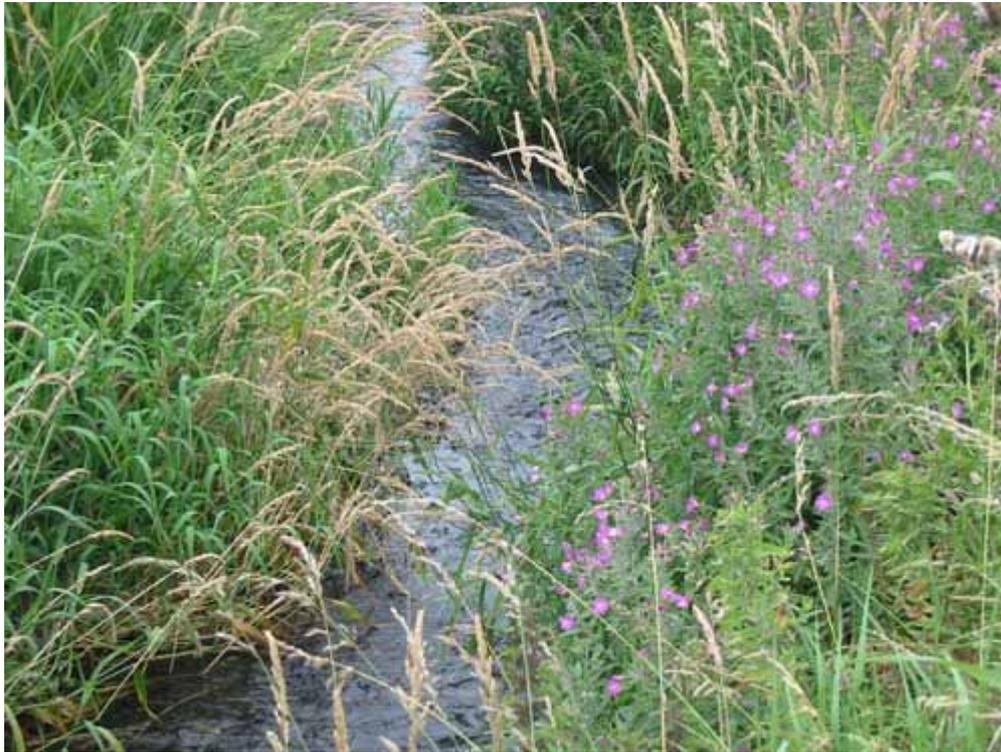
Good marginal cover

The stream is fenced for much of its length and the riparian vegetation is of high quality. Some transplanting of willow would be beneficial to provide some areas of additional shade. The shallow nature of much of the lower stream will presumably lead to rapid heating in spells of good weather and some shade would be of advantage to juvenile and adult fish alike.
