**ADVISORY VISIT TO THE DART ANGLING
ASSOCIATION FISHERY ON THE ABHAM
STREAM, RIVER DART, DEVONSHIRE,
UNDERTAKEN BY VAUGHAN LEWIS,
WINDRUSH AEC LTD, ON BEHALF OF DART
ANGLING ASSOCIATION
JULY 2005**

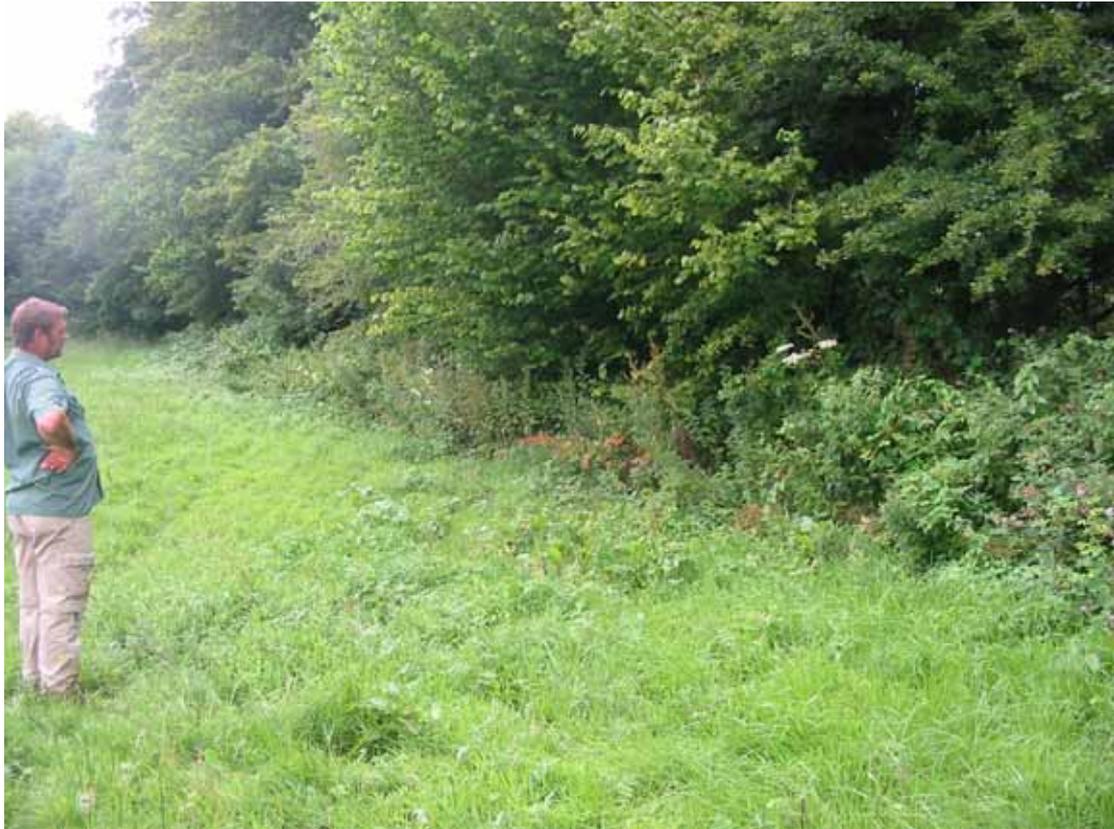
Upstream of Abham roadbridge, the stream flowed through semi-improved meadows. There was a short section of exposed soil on the LB due to excavation, apparently for a residential dwelling. However, the rest of the reach was well fenced against agricultural stock. Once again, the stream was 'tunnelled' with the riparian trees (hazel, hawthorn *Crateagus monogyna* and alder) forming almost total shade.

River upstream of Abham showing semi-improved grass field and heavy shading

- The heavy shading of the channel has reduced the growth of riparian vegetation. This is detrimental in that it increases the risk of significant bank erosion and reduces valuable fringing cover for juvenile salmonids. In order to address this issue, it would be of benefit if a regime of rotational coppicing/pollarding of the hardwood trees

could be established alongside sections of the watercourse. The aim of this should be to produce 'dappled' shading over the water's surface, allowing the growth of vegetation on the banks, whilst retaining valuable tree root systems. The ecological and landscape value of the mature trees should not be underestimated.

In addition, it will be necessary to fell some of the semi-mature/mature fir trees to further decrease shading of the channel. It is understood that the owner of the land is happy for some felling to be undertaken by the club. A felling licence may be required from the Forestry Commission for coppicing/pollarding of riparian trees.

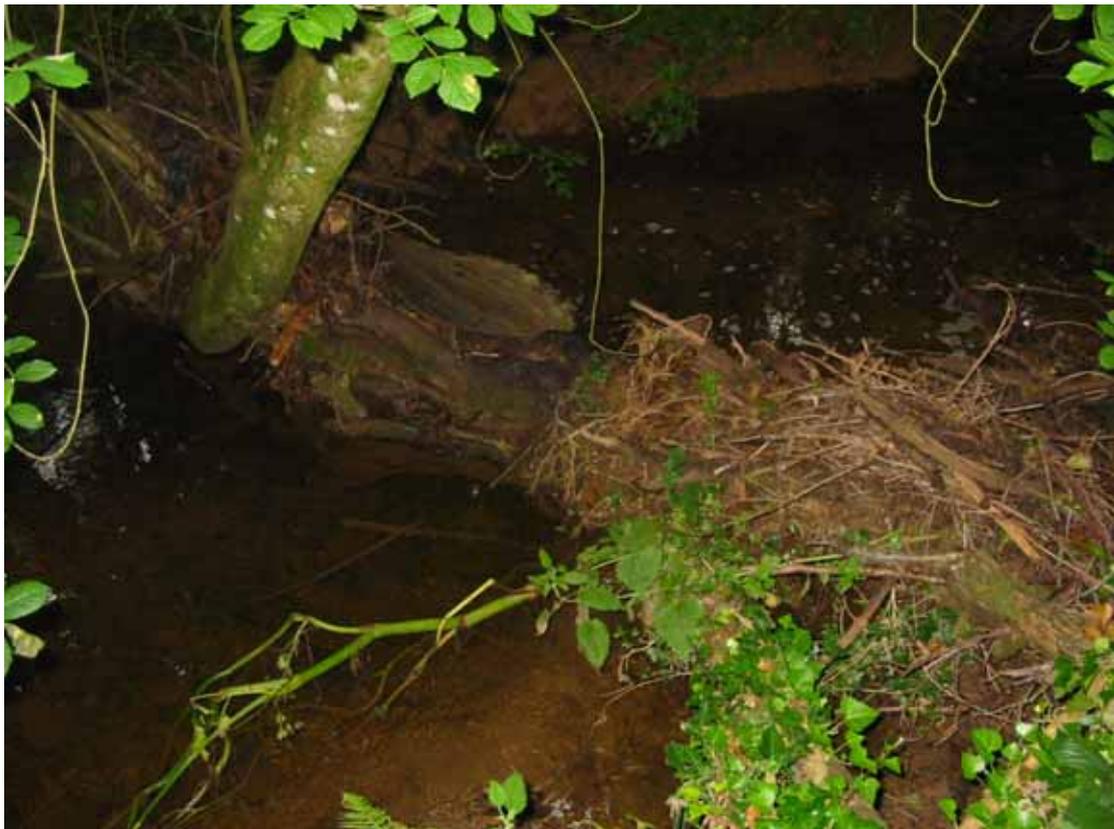
There were numbers of small woody debris dams present that had helped to form the stream morphology, scouring out pools and sorting the bed substrate.

Large woody debris dam in the Abham Stream

- The sorting of bed material and in particular spawning gravel could be improved further by strategic positioning of Large Woody Debris (LWD), in the form of tree trunks and limbs. These will from time to time naturally fall into the river. Unless flood defence or migratory fish access requirements dictate, they should not be removed. Rather, they should be stabilised and trimmed to allow angling access whilst retaining the bulk of the woody debris in the river. Several good examples of naturally fallen timber were noted during the visit. These were having a significantly beneficial impact on the river by sorting the substrate, providing variation in bed profile, providing cover for a range of invertebrates and fish, and detaining leaf litter for subsequent consumption by shredding macroinvertebrates.

LWD can actively be encouraged into the river in strategic locations (generally on riffles or shallow glide areas) by selective felling of trees. Leaving a 'hinge' at the base of the trees during felling will allow control of the placement of the timber, and

will also act to stabilise the tree by keeping the tree butt attached to the bank. Ideally, the top of the fallen tree would be angled in an upstream direction in order to reduce the risk of bankside erosion.
