**HABITAT ADVISORY VISIT TO THE
BLACKWATER RIVER, REEPHAM, NORFOLK.**

**UNDERTAKEN BY VAUGHAN LEWIS,
WINDRUSH AEC LTD ON BEHALF OF TERRY
LAWTON**

OCTOBER 2005

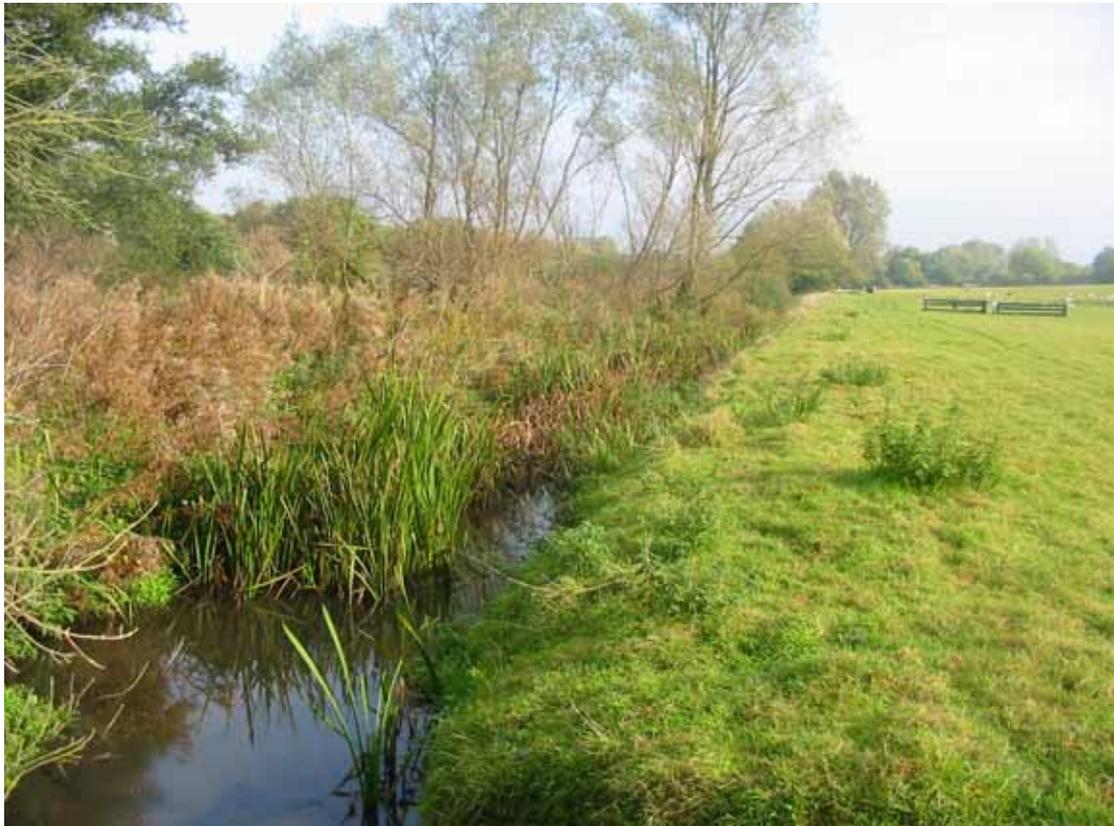
Location of raised flood bank on LB

Upstream of the old Railway line, land use comprised of wood on the RB, with significant consequent shading of the channel, with the channel totally tunnelled in places. The LB was dominated by grazing meadows. The bed of the river was incised, with largely soft sediment and sand, and a paucity of gravel due to past dredging. The RB was noticeably higher than the LB, suggesting that excavated material was deposited on this side of the river.

- A series of valuable gravel riffles could be constructed in the reach upstream of Blackwater Farm, by screening of the previously deposited dredgings on the LB of the river above. Small trial pits should be dug into the raised gravel berm on the LB to ascertain the percentage of gravel present. If adequate amounts of gravel were found, then it would be worth screening the gravel on site and using it in the riffle construction. The advantages of this approach in comparison to the use of imported gravel to construct riffles include reduced cost, fewer lorry movements, and the net neutral impact on flood plain storage. In addition, carefully planned excavation could result in the creation of a wide marginal berm at or just above summer water level, with associated benefits to a range of wildlife

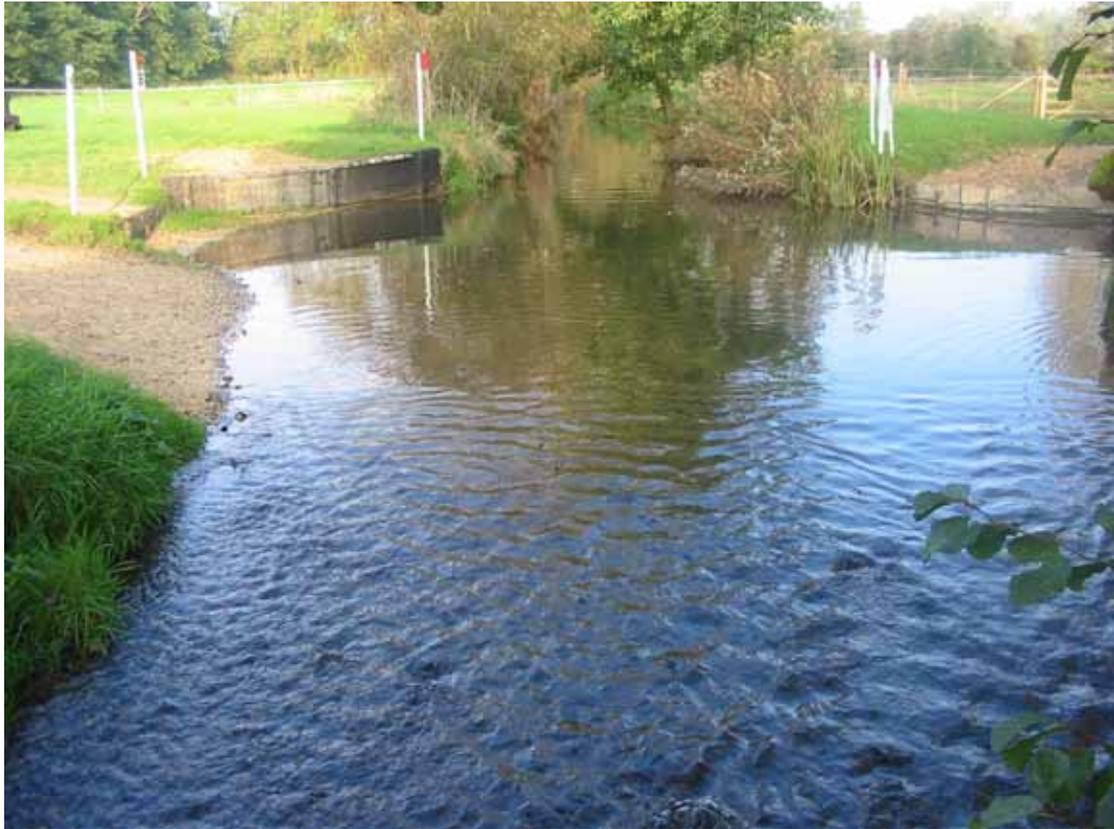
Gravel riffle at the site of a water jump for horses

The river was incorporated into design of an equestrian course, with water jumps located at the site of hard-bedded riffles. Stands of submerged weed were present, including water crowfoot *Ranunculus* spp, curled pondweed *Potamogeton crispus* and lesser water-parsnip *Berula erecta*. There were a few riparian trees in this reach casting limited shade over the channel.
