Habitat Advisory visit to the River  
Cam, Sawston, Cambridgeshire on  
behalf of Spicers Angling Club.

Undertaken by Vaughan Lewis,  
Windrush AEC Ltd  
September 2005

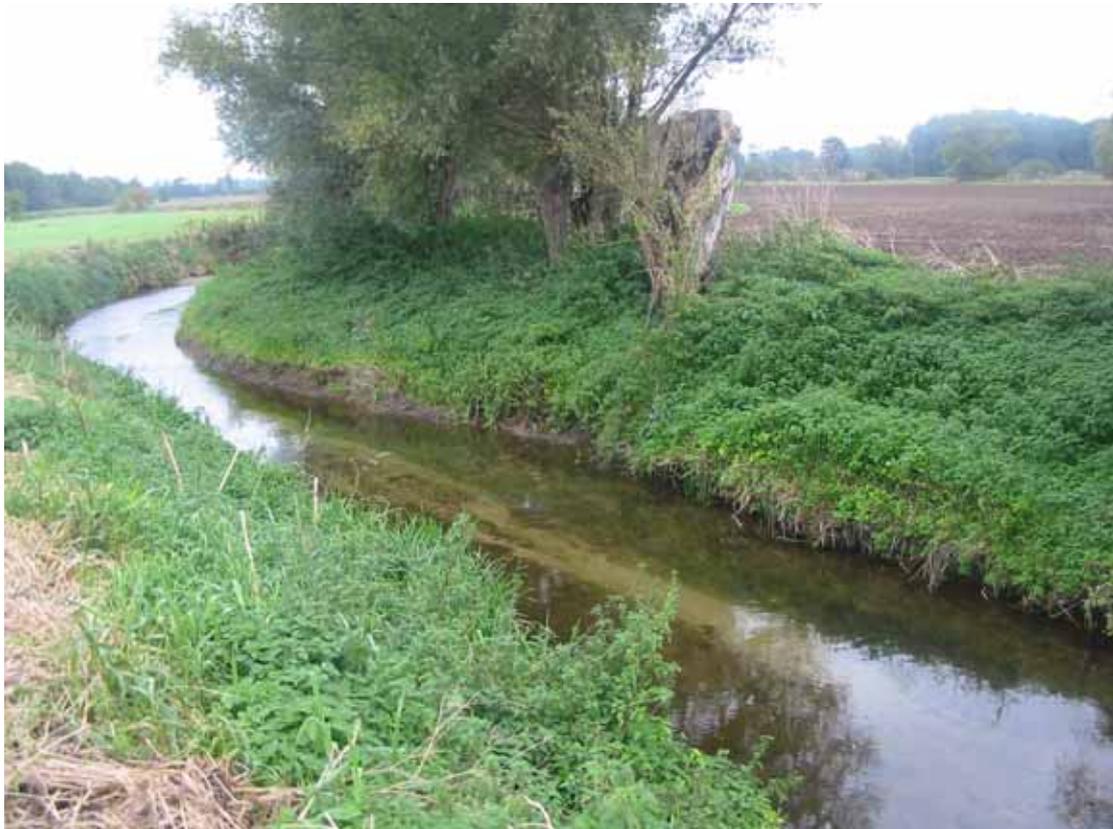
The River Cam had been subject to a 'weed raking' exercise by the EA prior to the advisory visit. This operation had effectively removed over 90% of the instream and marginal vegetation from the river, leaving the channel over-wide and lacking in any substantial vegetation cover. In addition, some silt and hard bed material had been removed and deposited on the river bank, along with the vegetation. This was apparently the first time in 9 years that this type of management had taken place in this reach of the Cam.

**River Cam showing channel devoid of vegetation following weed clearance**

The impacts of the weed removal were compounded by the low flows experienced during 2005. The channel was heavily incised (the result of previous dredging activity) and was some 6m wide, with a bed dominated by un-sorted sand and gravel, overlain in places with a layer of fine sediment. Bed profile was very homogeneous, with a generally shallow depth of water remaining. There was a shallow marginal berm on the RB, with the LB having a steeper profile.

- Control of emergent vegetation in the future could be facilitated by the use of an herbicide, rather than damaging weed raking.

The only appropriate herbicide cleared for use near to and in water is glyphosate (sold as 'Roundup', Roundup Pro Biactiv etc). It is a selective, translocated herbicide that is used to treat the actively growing plant once its leaves have emerged from the water. Glyphosate offers a cheap and environmentally sensitive option (it is inactivated on contact with water and sediment) for the treatment of emergent vegetation.

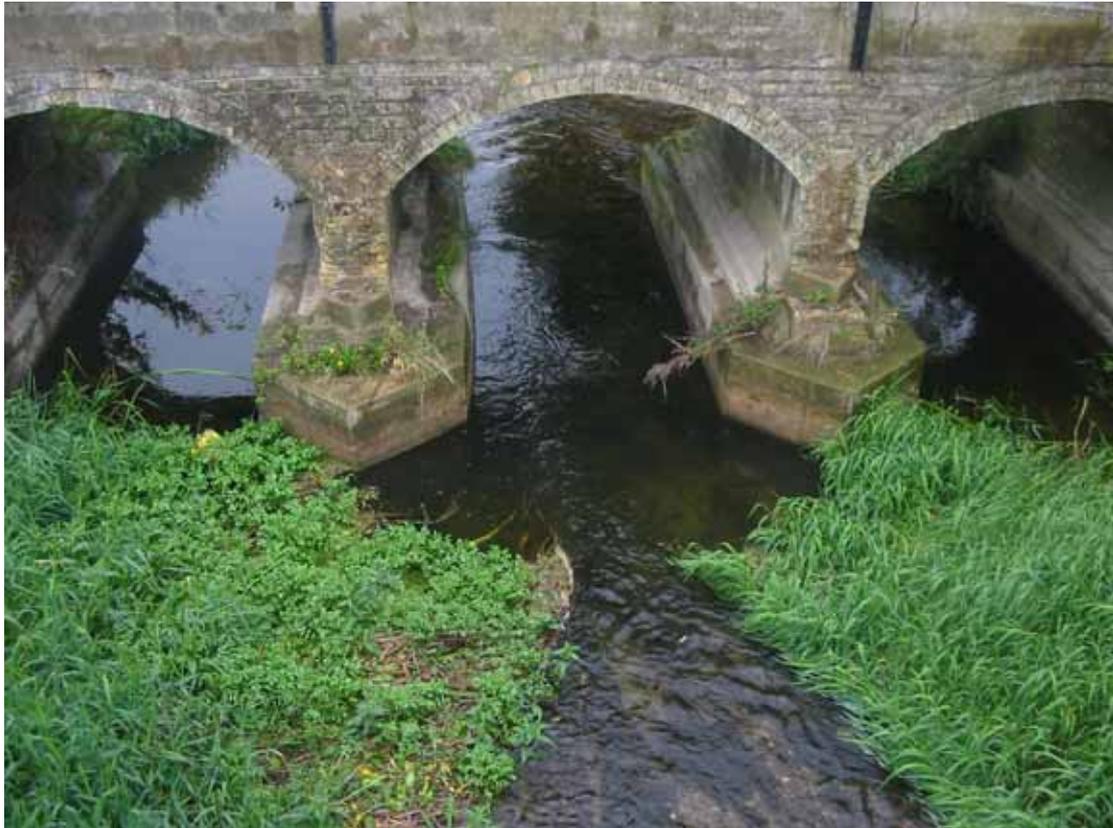
The section of river adjacent to Ley Grove Bridge had not been extensively dredged or cleared of vegetation. As a consequence, the bed was dominated by relatively well-sorted gravel, with strong marginal growth of water cress *Rorippa nasturtium-aquaticum* and reed canary grass *Phalaris arundinacea*.

**Well developed marginal growth and moderately sorted gravel associated with un-dredged bed adjacent to bridge crossing**

- The un-dredged and uncut section of the river adjacent to Ley Grove Bridge provided an exemplar of good quality habitat that should be used to inform future development of the fishery.

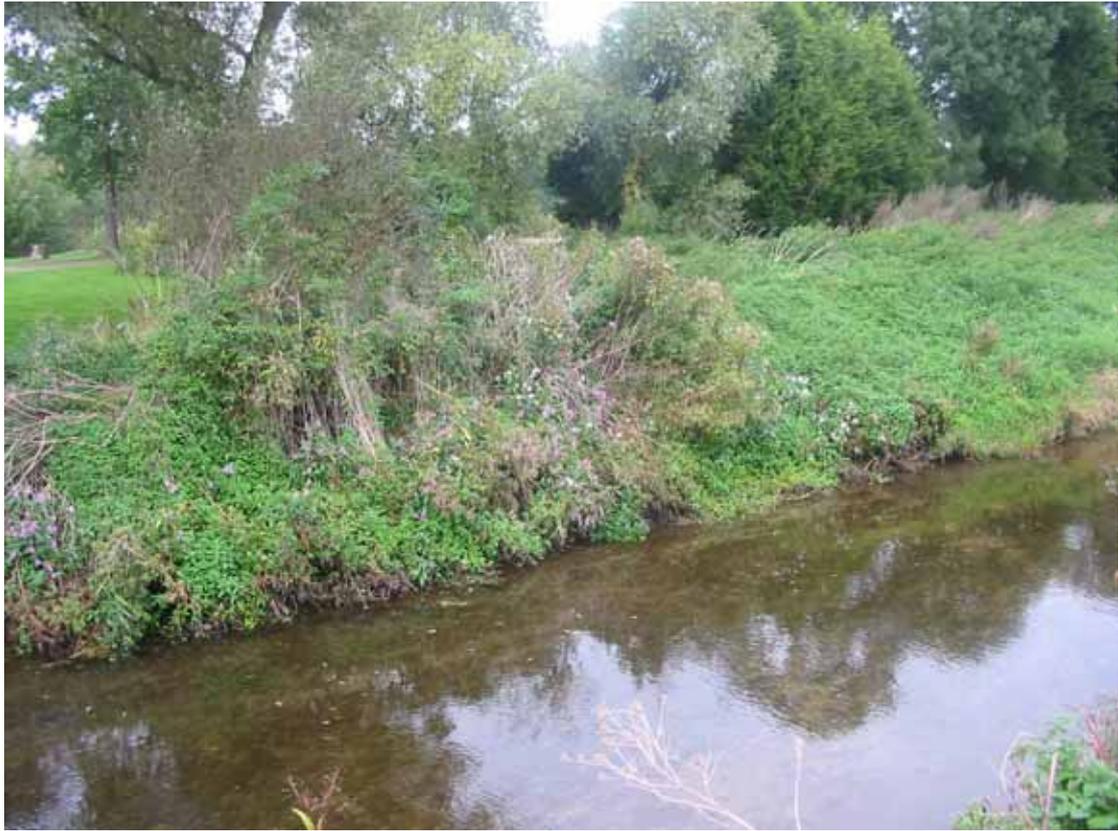
Small stands of Himalayan Balsam *Impatiens glandulifera* were present in sections of the fishery.

### **Himalayan Balsam on the margins of the river**

➤ The presence of Himalayan Balsam is undesirable. It is classified as an alien invasive weed species. It may be possible for the club to undertake limited control of the stands of balsam present in some areas of the fishery. Chemical control with the herbicide glyphosate when the plant is actively growing in early spring should be effective. Alternatively, the plants can be cut at ground level before the flowering stage (June) or they can be pulled up by the roots and disposed of by composting or burning unless seeds are present. Note that the use of glyphosate or any other herbicide on or near water requires the consent in writing of the Environment Agency.

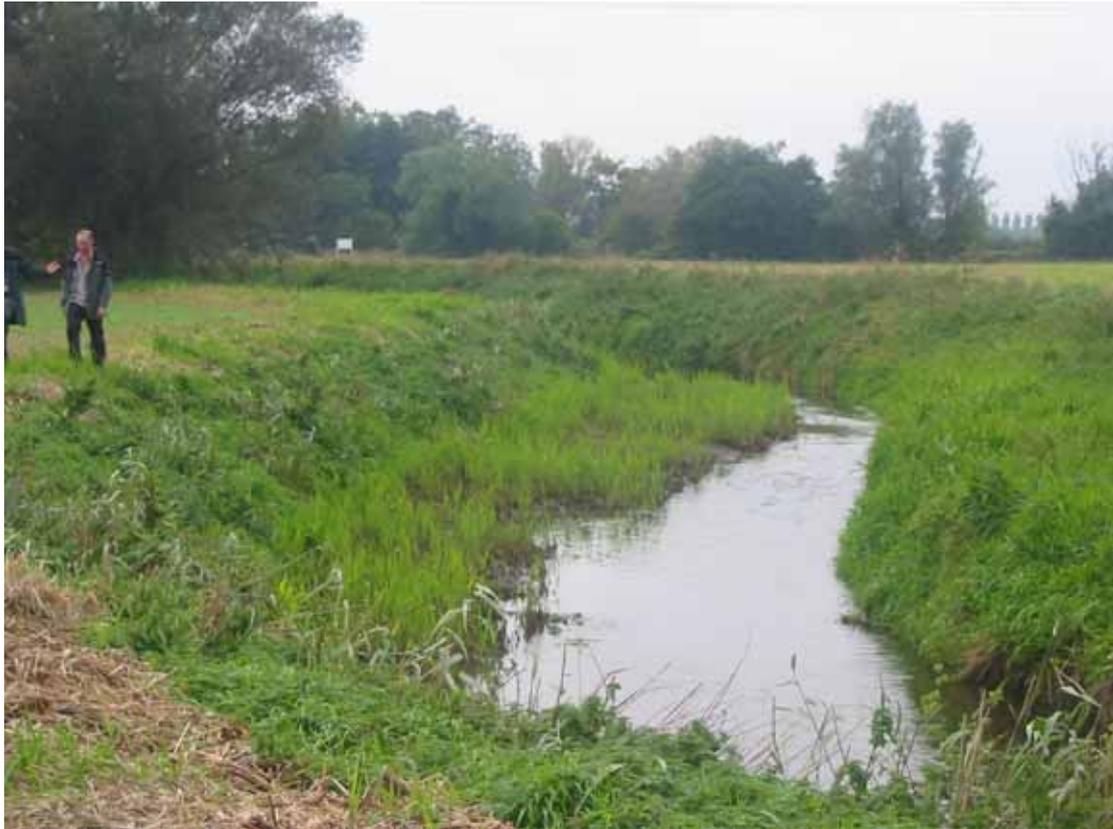
One short section of the RB had been more carefully managed, with the EA having apparently cut the vegetation in a horizontal fashion, reducing the overall height of the plants whilst retaining the consolidated structure of the silt berm. As a result, the benefits of the narrowed channel to water velocity had been retained, whilst a strong regrowth of emergent vegetation was noticeable.

### **Retained sediment berm on the RB with associated strong growth of emergent vegetation**

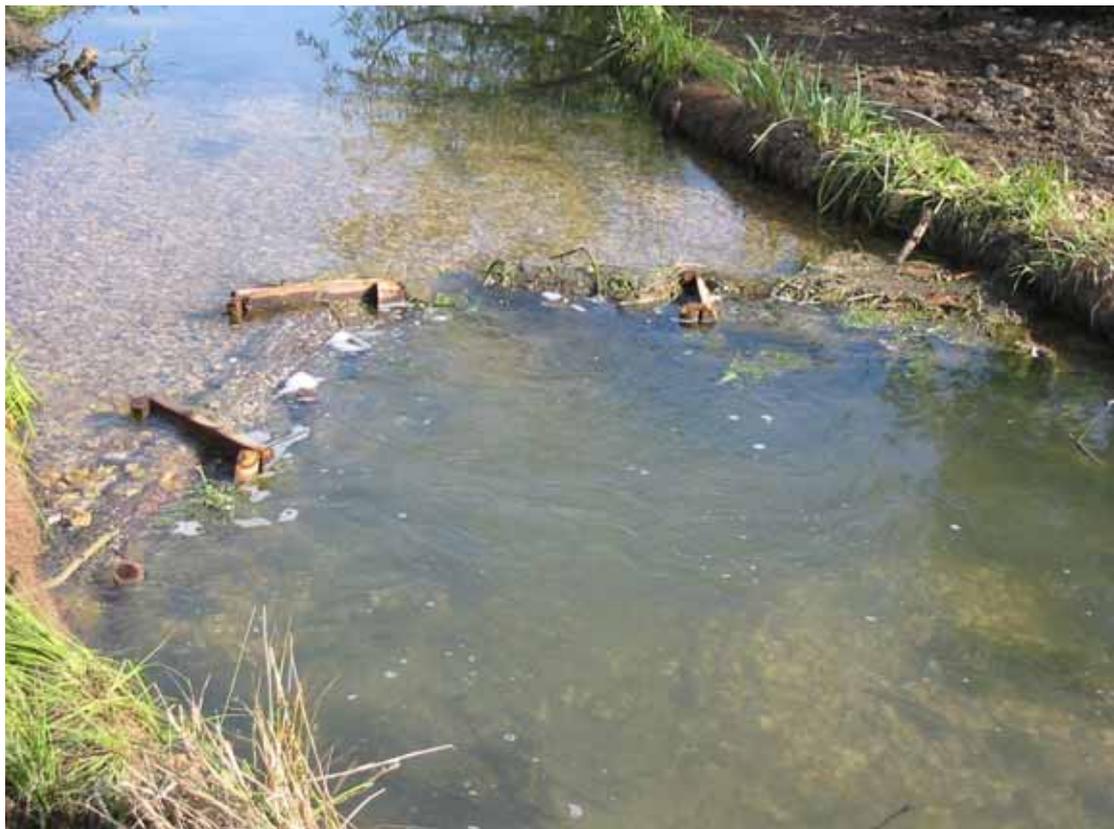
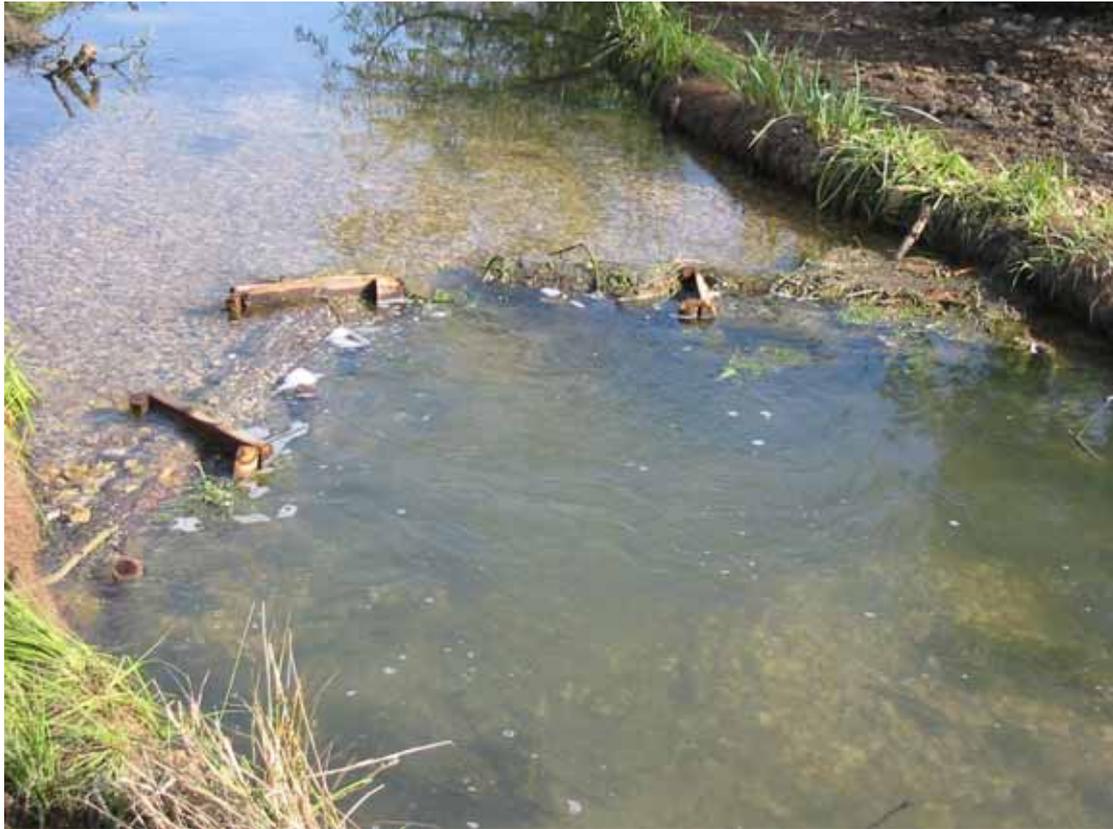
- The few areas of gravel riffle present could be improved by sorting of the substrate in order to increase bed diversity and improve spawning conditions. There are a number of ways of doing this, with perhaps the best being the use of paired 'v' shaped wooden groynes. These are simple structures that can be constructed by staking a pair of large wooden logs to the bed in a 'v' shape, in the centre of the riffle, with the apex of the 'v' facing upstream. The upstream face of the paired groynes should be filled with large stone and gravel in order to reduce flow under them; the intention is to force water over the groynes, scouring the bed downstream.

**Paired wooden groynes in a small stream. Note downstream pool excavated as a consequence of flow constriction**
