**ADVISORY VISIT TO THE RIVER CHESSE AT  
CHENIES, BUCKS  
UNDERTAKEN BY VAUGHAN LEWIS,  
WINDRUSH AEC LTD, ON BEHALF OF DAVID  
LE NEVE FOSTER**

**JANUARY 2005**

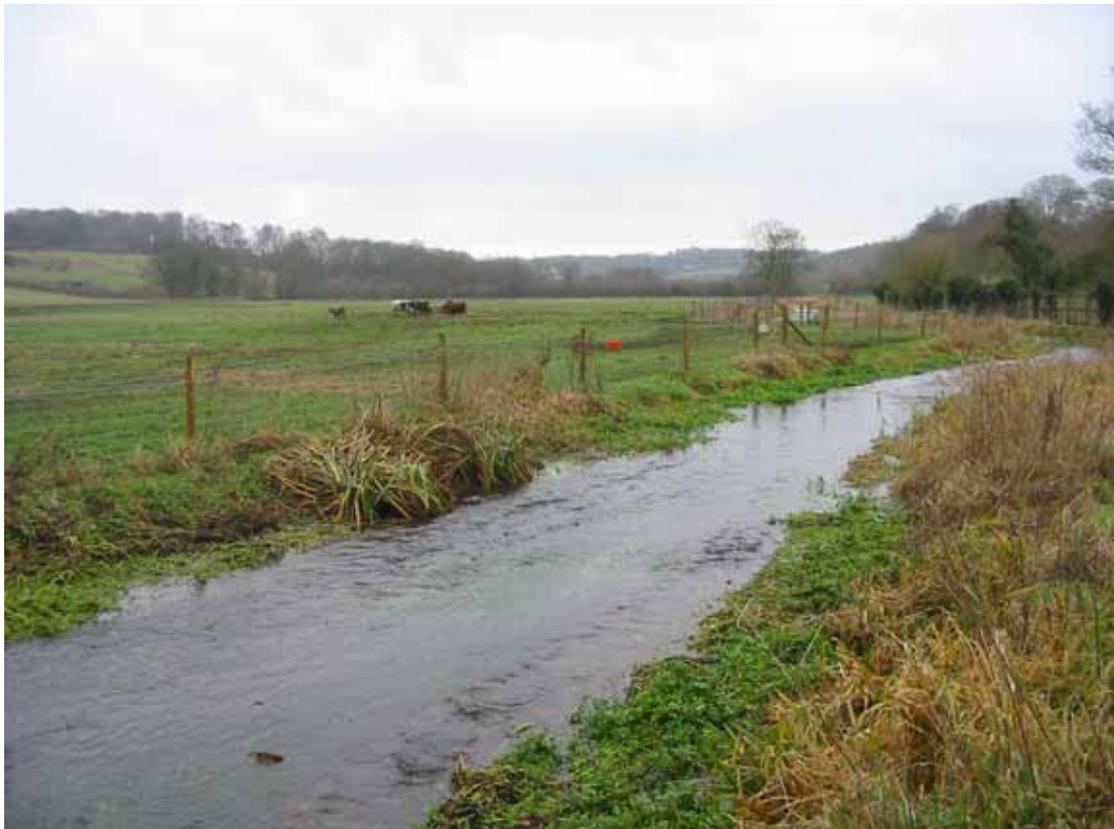
The river downstream of the mill (Fitch's Meadow) occupied two channels. Habitat in the LB channel was generally excellent. It was dominated by flow dependent habitat, with abundant gravel shallows suitable for brown trout spawning and subsequent recruitment of juvenile fish. Water crowfoot *Ranunculus* spp. was common, to the extent that regular cutting has been required during summer periods in order to allow fishing.

The river had been fenced along the LB, preventing access to agricultural stock that had previously poached the banks, causing loss of marginal habitat and mobilisation of fine sediment. A strong buffer of coarse vegetation had established within the fence line, offering protection to the banks from excessive erosion. The RB of this channel was not subject to grazing and also had a well-developed buffer strip. The wetted channel width in this reach was some 3m-4m.

### **LB channel downstream of Mill Farm**

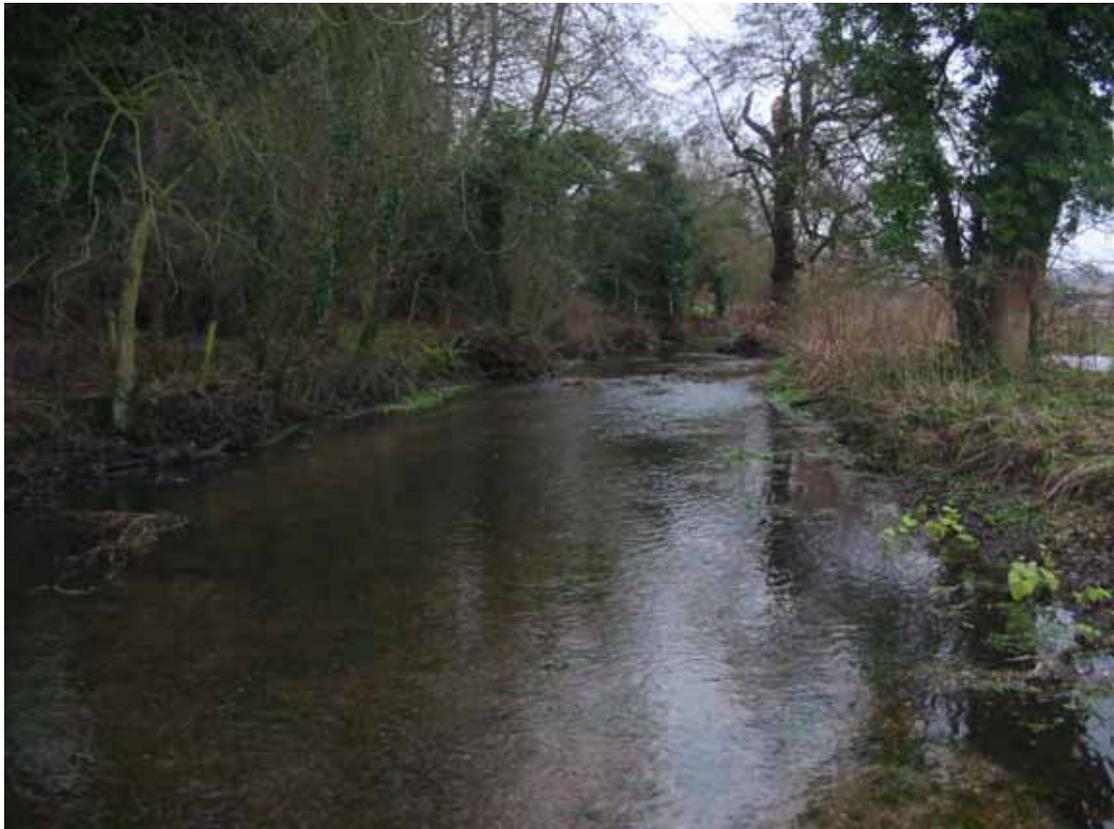
The RB was generally wider (6m+) and more shaded. Some coppicing had been undertaken on its RB in order to reduce shading and allow development of the generally poor marginal growth. Timber arisings had been placed alongside the edge of the channel in order to encourage deposition of silt and subsequent narrowing of the channel.

### **RB channel showing coppicing to reduce shading**

- The RB channel of the river was significantly shaded by riparian trees in Fitch's Meadow. Continuing the regime of limited, rotational coppicing would be of great benefit. Increasing light penetration into presently tunnelled river sections would be of benefit to instream vegetation and valuable fringing marginal vegetation. The conservation value of the existing trees should not be underestimated and great care should be exercised in the selection of trees to be cut.

The arisings from the tree trimming should be used to create faggots, roughly 2m long with a diameter of approximately 300mm. Once manufactured, the faggots can be used to locally narrow the channel. They should be pinned in place using

wooden stakes and backfilled with secured brushings. The top of the faggots should be set at approximately 100-150mm above mean summer water level. Details of faggot techniques can be found in the Wild Trout Trust guide provided to the club. Note that the installation of faggots or any other work to the bed or banks of the river or within 8m of it may require the consent of the EA.

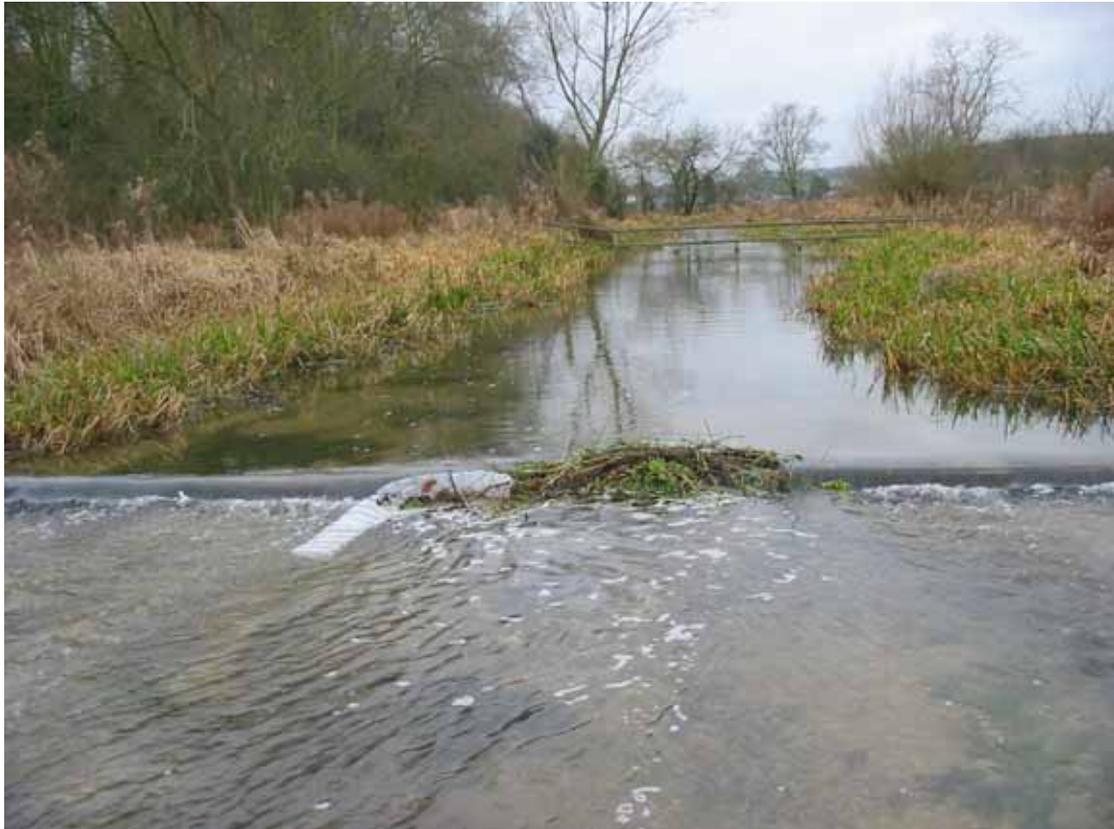
Two small weirs were present within the Broadwater reach of the fishery, separated by 80m- 100m. These had been created in the past using a combination of large

wooden poles and corrugated sheets. The head loss over each of the two structures was approximately 10cm – 15cm. Despite this relatively small head difference, there was a significantly deleterious upstream impact on habitat quality. The reduced gradient and associated slower water velocity had allowed fine sediment to accumulate behind the structures, and had further reduced sorting of the substrate, particularly above the upstream weir. The benefits of the weirs to the general habitat quality of the fishery were not immediately apparent.

### **Constructed weir showing small head loss over the structure**

- The two small weirs present in The Broadwater are on balance, having a detrimental impact on the ecology of the river and should be removed. This can easily be undertaken in late summer/early autumn, when river levels are low, birds have finished breeding and prior to the trout spawning season.

Concerns have been expressed that the removal of the weirs would adversely affect the hydrological regime of the Site of Special Scientific Interest on the LB of the Broadwater. These concerns centre on the potential for lowering of resting water levels in the river and a knock-on impact on local groundwater levels.

Notwithstanding the fact that it is not known whether the hydrology of the SSSI is primarily controlled by river water level or the influence of groundwater flow from a generally northerly direction, the very small head loss over the weirs means that any significant impact on groundwater levels is unlikely to occur following removal of the weir. Indeed, it is very likely that subsequent to their removal, the river will narrow due to increase growth of marginal vegetation, whilst the growth of water crowfoot in the channel might be expected to similarly increase. These changes are likely to more than compensate for the loss of the weirs with respect to the retention of existing water levels in the river. In order to monitor any change in water level over time, it is recommended that a simple gauge board should be installed on the footbridge upstream of the weirs.

In the very unlikely event that water level in the channel is believed to have been reduced to an unacceptable level, two sets of paired opposing triangular wooden groynes could be installed into the channel near to the site of the old weirs in order to raise water level locally. The design of these groynes would be in line with the examples shown on page 38 of the Wild Trout Trust 'Guide to Improving Trout Streams'.

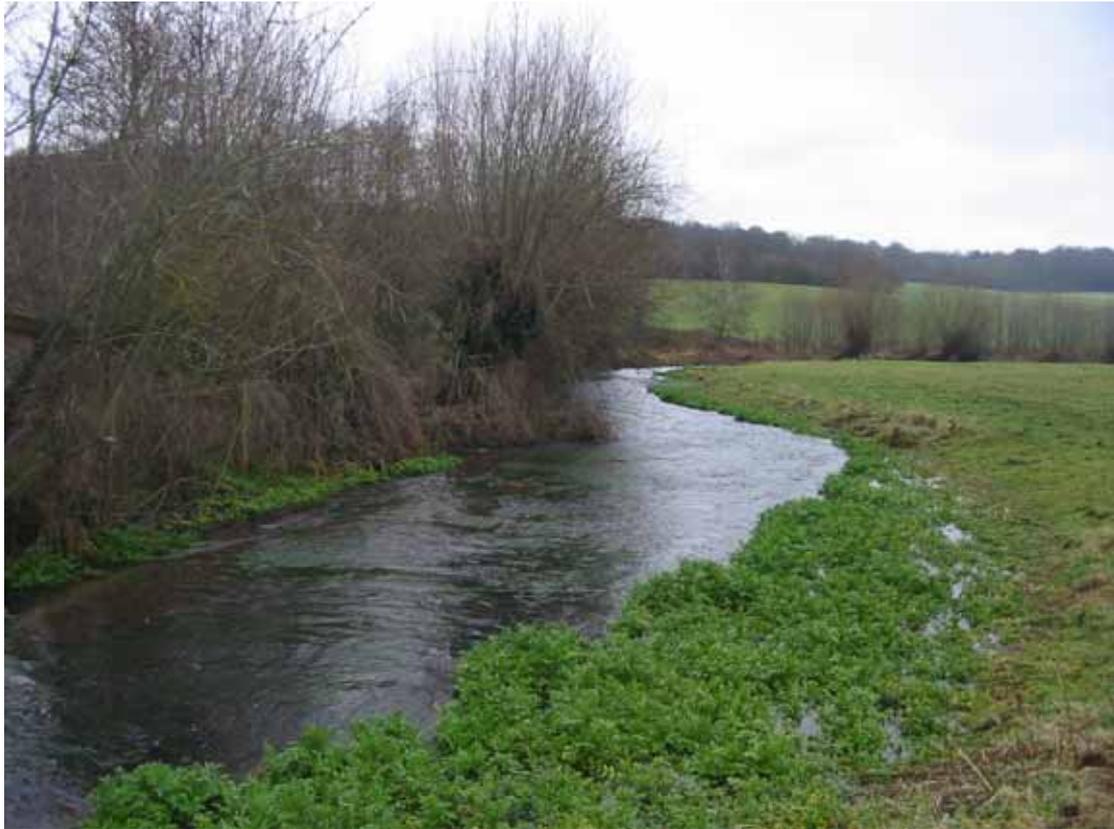
The lower reach of the river, the Willows, was characterised by poaching of the RB by horses. Damage was worst in the lower field, with most of the emergent vegetation grazed off and considerable physical erosion of the old bank line. This has resulted in the over-widening of the channel, by perhaps 50%. As a consequence, water velocity across the channel had declined, reducing scouring and sorting of the substrate. Submerged banks of unconsolidated silt, vulnerable to further erosion, had also developed in the marginal zone. The loss of the marginal vegetation has also reduced the availability and quality of riparian habitat for the nationally endangered water vole *Arvicola terrestris*. Considerable efforts have been made to protect and enhance water vole populations at Chenies, by both the fishery, and the Chilterns Chalkstream Project.

### **Loss of emergent vegetation and bank erosion due to poaching by horses in the Willows**

- The erosion of the RB of the river in The Willows by horses has resulted in an unacceptably high degree of habitat damage. It is important that this reach of the river should be fenced in order to prevent further damage and to create a well-vegetated riparian buffer strip.
