**ADVISORY VISIT TO THE BIRDSGROVE
FISHERY, RIVER DOVE, DERBYSHIRE,
UNDERTAKEN BY VAUGHAN LEWIS,
WINDRUSH AEC LTD, ON BEHALF OF
BIRDSGROVE FLYFISHERS
JULY 2005**

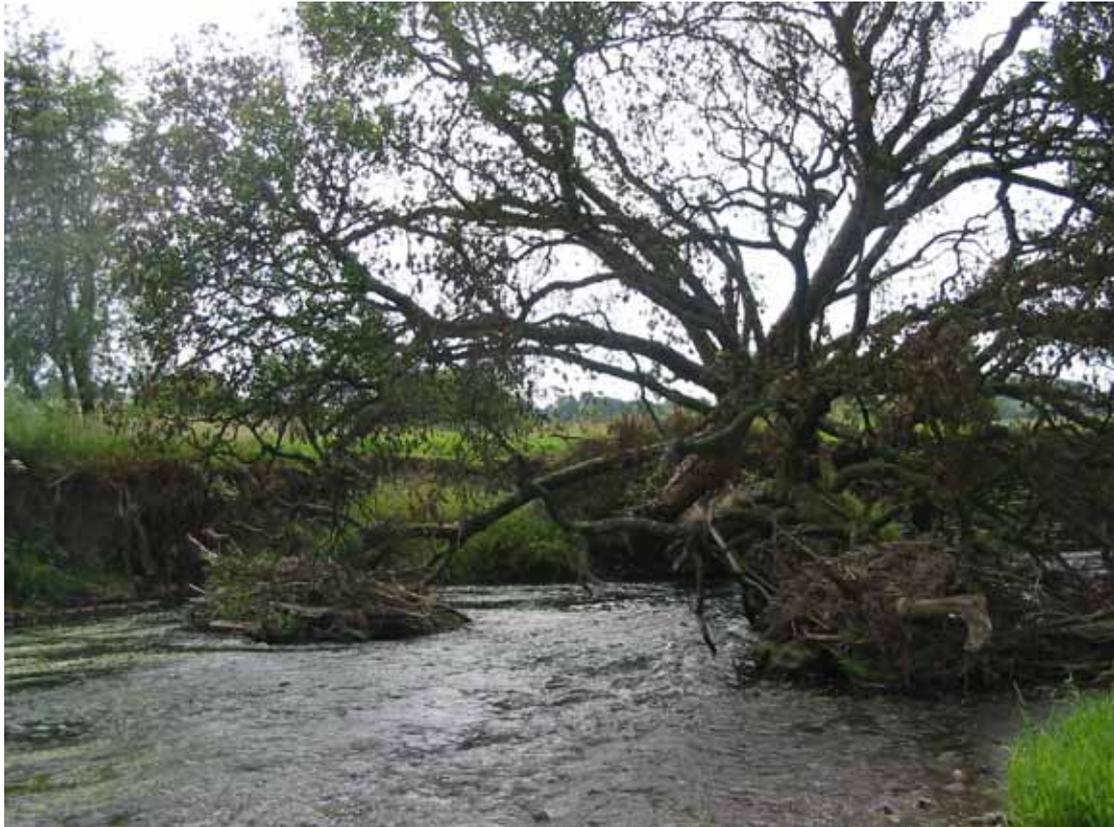
Large fallen sycamore *Acer pseudoplatanus* providing LWD to the river with beneficial impacts. Note the potential for erosion on the LB. A dipper *Cinclus cinclus* was feeding in the branches of the fallen tree, highlighting its value for a range of species

In the example of LWD shown above, there is a risk of some LB erosion. This could be addressed either by providing a degree of bank protection using rip-rap, faggot bundles or similar, or by regrading the LB to a lower, more stable batter in order to reduce the erosion risk.

LWD can actively be encouraged into the river in strategic locations (generally on riffles or shallow glide areas) by selective felling of trees. Leaving a 'hinge' at the base of the trees during felling will allow control of the placement of the timber, and will also act to stabilise the tree by keeping the tree butt attached to the bank. Ideally, the top of the fallen tree would be angled in an upstream direction in order to reduce the risk of bankside erosion.

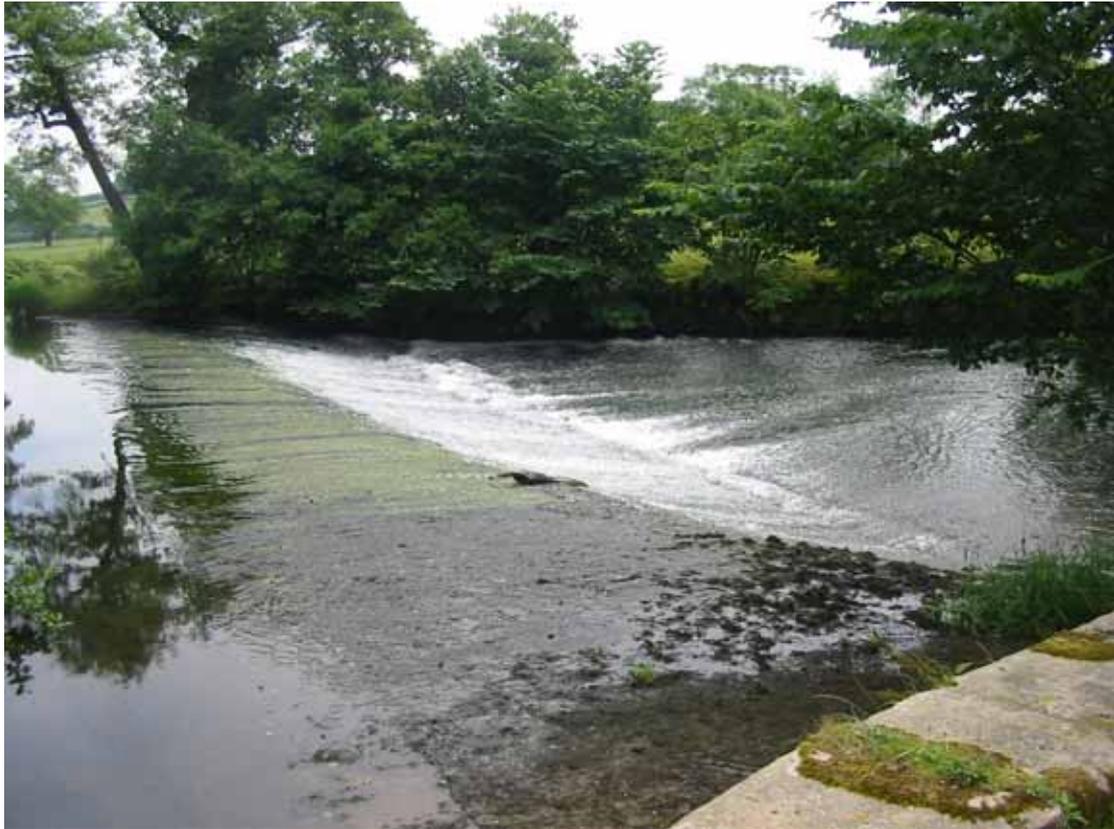
- Calwich weir forms a partial but significant barrier to migrating trout over a range of flows. There is no realistic prospect of addressing this in the short term, but its impact on the fishery should be recognised, with stocks upstream and downstream at least partially spatially isolated.

Calwich weir during low flow on the day of the advisory visit

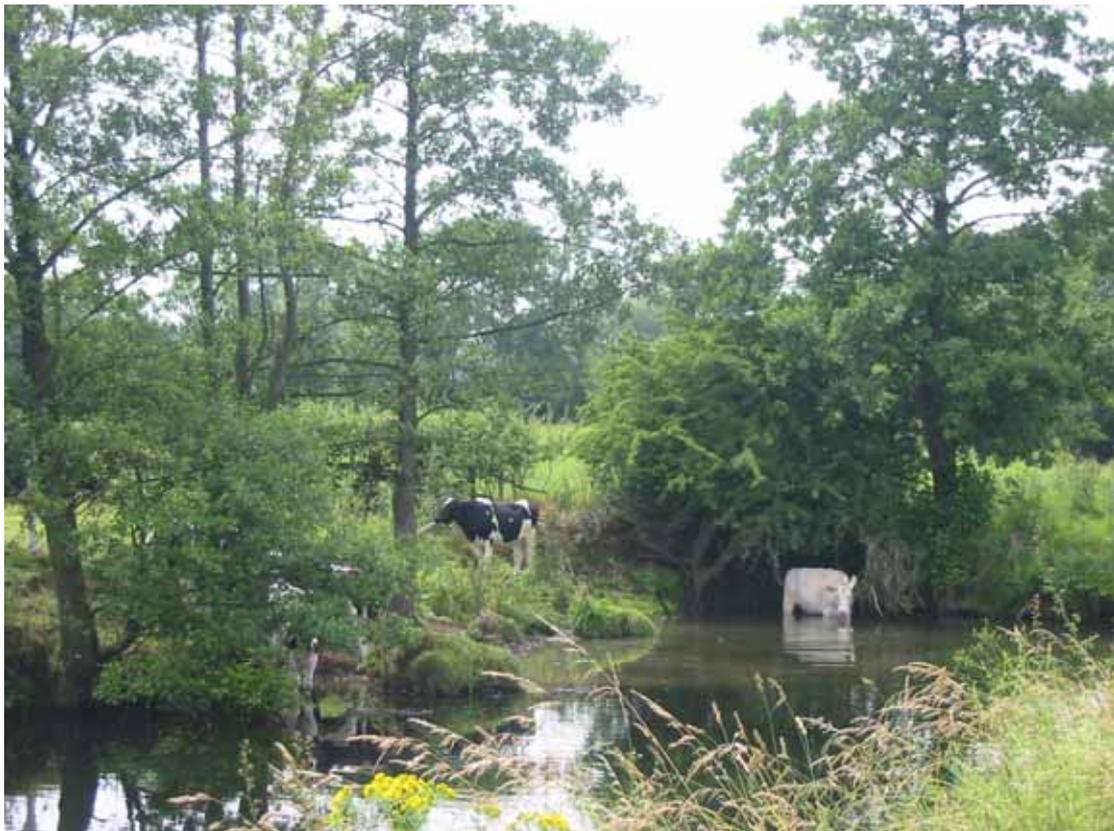
- Further upstream, there were short sections of overgrazed bank. Cattle and sheep in the field were damaging the bank of the river and were also preventing regrowth of previously coppiced trees. These fields should be fenced to prevent stock access to the river. However, it is understood that they were not under the control of the angling club.

Cattle accessing river from overgrazed field on LB

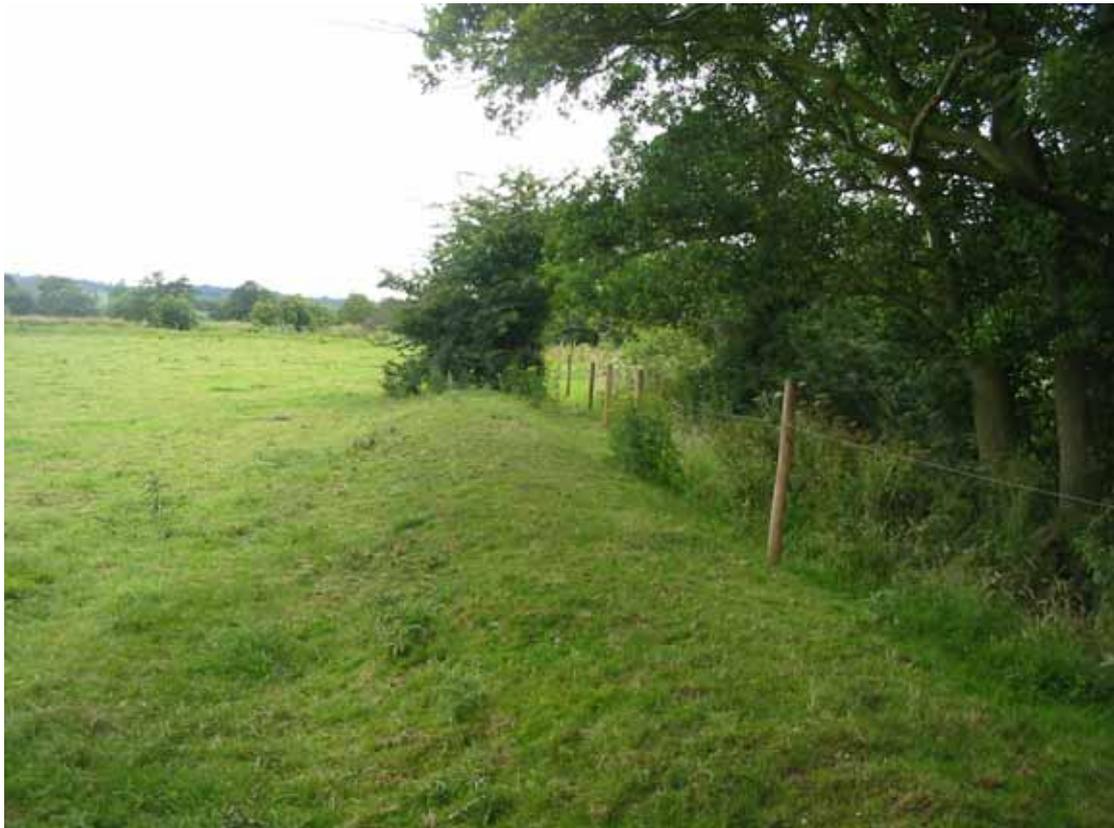
- Evidence of past dredging of the river was provided by a flood bank on the LB of the river. Ideally this should be excavated, screened on site and the resulting gravel introduced to the river. However, flood defence constraints may restrict this operation.

Bank of excavated river material on LB of the river

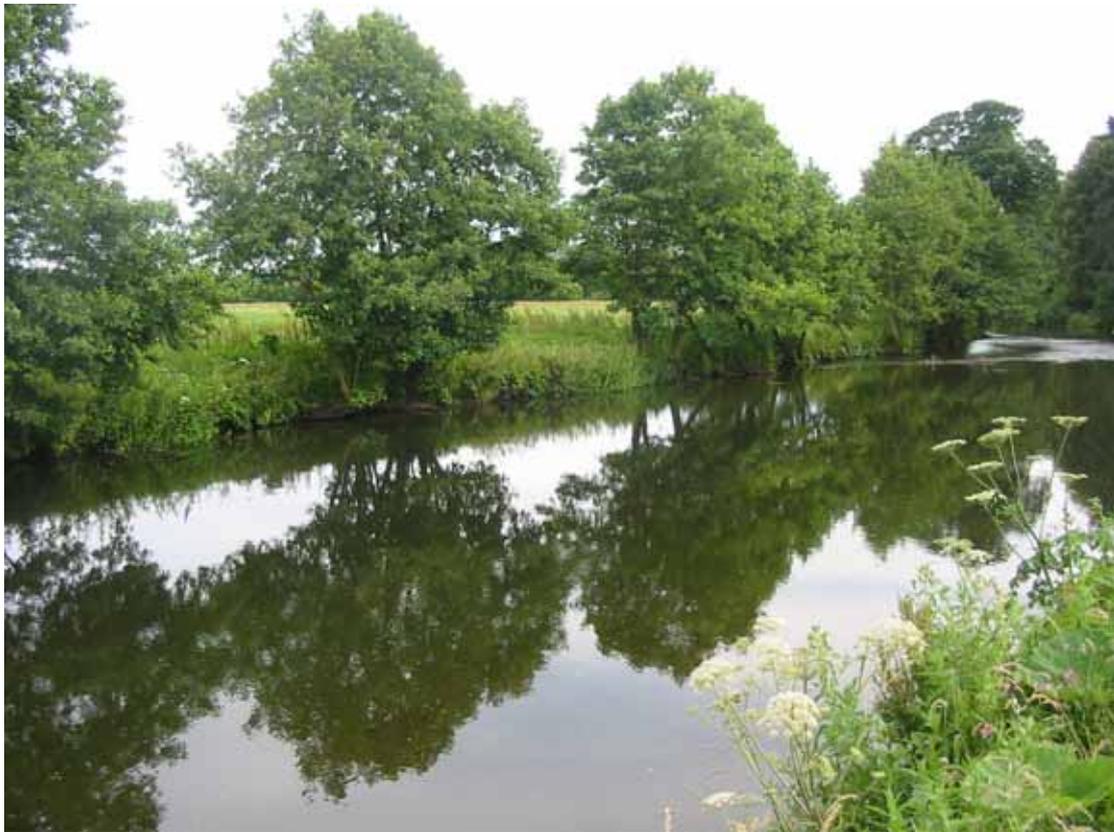
Adjacent to the confluence of the Bentley Brook, the river was over-wide, with a uniform shallow cross-section. Beneficial increases in bed heterogeneity and an increased carrying capacity of brown trout could be achieved by the introduction of a matrix of small (3-4m x 1-2m) faggot islands in this reach.

Over-wide shallow glide below the confluence of the Bentley Brook

The islands should be arranged in a staggered line down the channel, in order to create a mosaic of channels with increased velocity, optimising conditions for the growth of *Ranunculus* spp. The islands can be constructed from faggot bundles, secured to cleft chestnut stakes, driven at 600mm centres. The central core of the islands should be infilled with woody brushings, tied down in order to prevent washout by high discharge events. The upstream 'toe' of the islands can be further protected by stone rip-rap to reduce the risk of their erosion.

The top level of all islands should be set at approximately 100mm-150mm above mean summer water level (as defined on site). During high flow periods, the islands will become submerged, reducing the risk of accumulation of debris and minimising impact on flow conveyance.
