ADVISORY VISIT TO GARTMORE LOCH, ABERFOYLE, 2 OCT, 2005

**Undertaken on Behalf of the Wild Trout Trust By Dr Andy Walker,
(Ellwyn, Moulin, Pitlochry PH16 5ER Tel: 01796 472743; E-mail:
libisandy@aol.com), Windrush AEC Ltd**

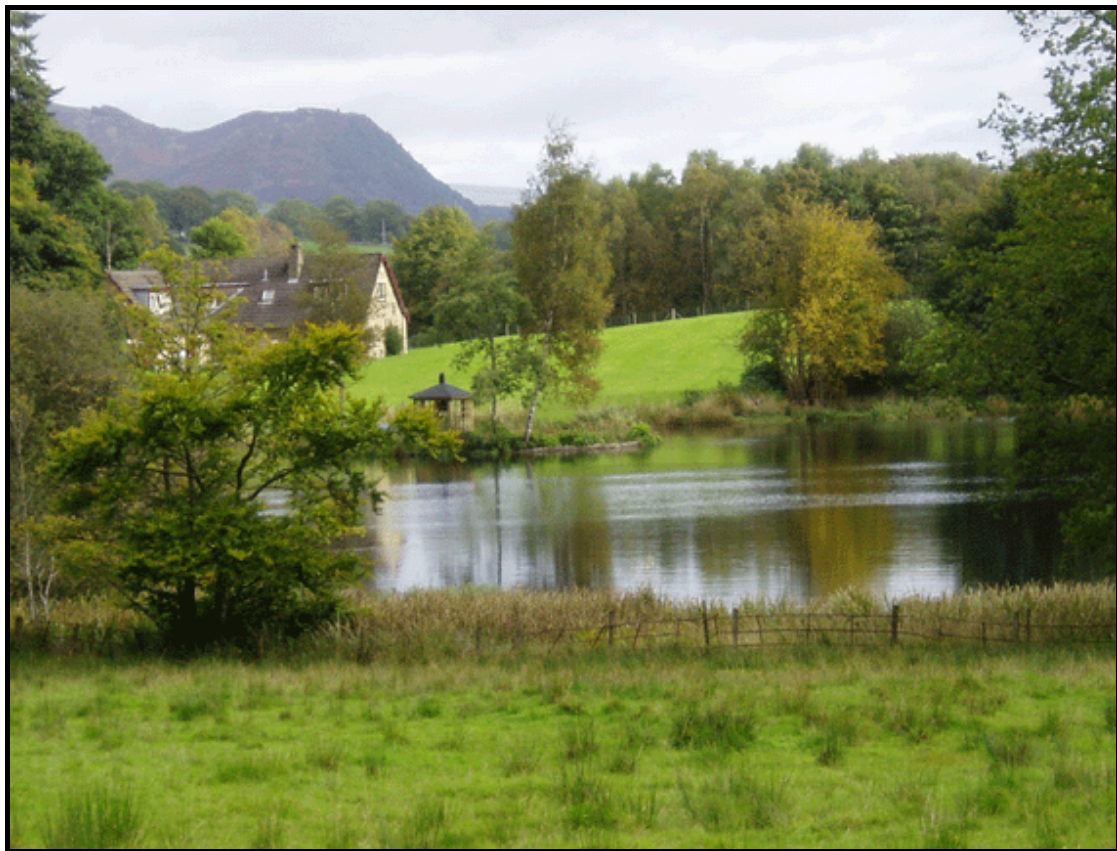
Frontispiece: Gartmore Loch

Gartmore Loch (OS Ref: NS531981) is an attractive small loch of about 6 acres adjoining a private house and on land owned by Dr Madden (Frontispiece). It contains a population of brown trout (*Salmo trutta* L.), some weighing in excess of two pounds, wholly supported by natural spawning in two small inflowing streams. The outlet flows over a dam through two functioning sluices. The loch was created from a smaller pool in Victorian times by the construction of a simple boulder, concrete and earth dam and the loch margins and inflowing streams are faced in many areas by old stonework. There are two small islands and an old boathouse. Views of the loch and its environs of woodlands and open fields are enjoyed from nearby Walks and access driveway by local people from the village of Gartmore and visitors to Gartmore House Estate. The loch is fly-fished lightly from a single boat by guests and local anglers and is visited by ospreys, herons, the occasional otter and a wide variety of wildlife.

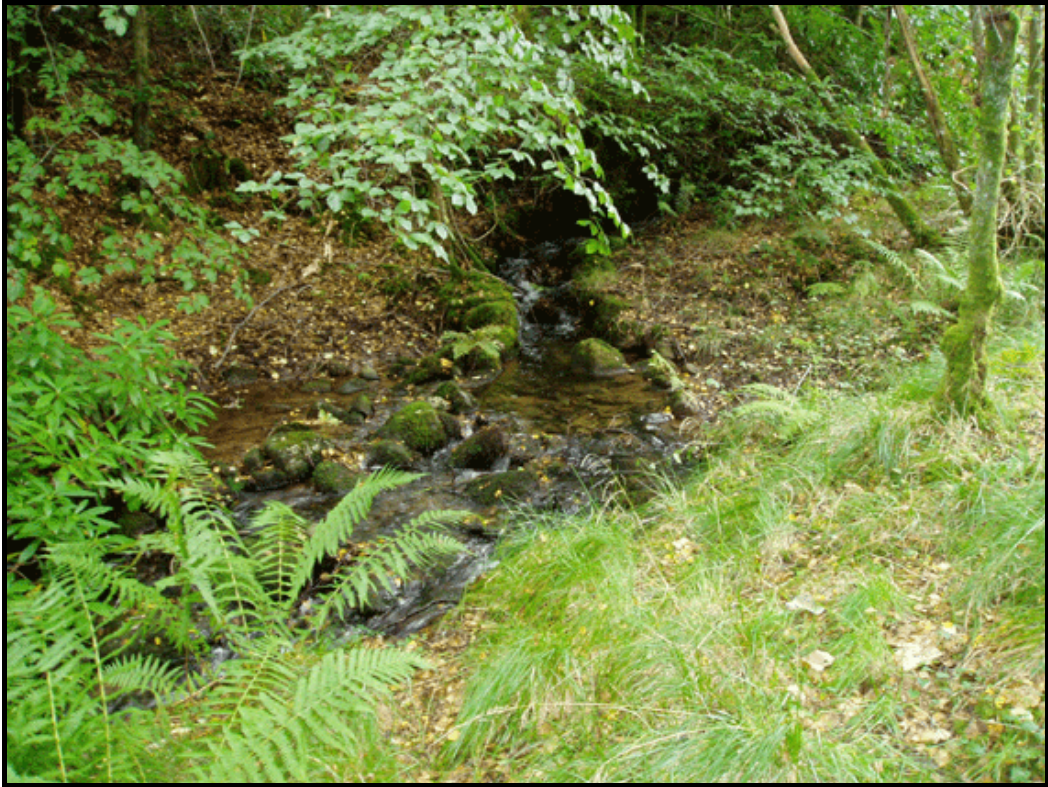
Plate III: Main stream in the wood above the road with larger pebbles and large stones, with limited gravel for spawning

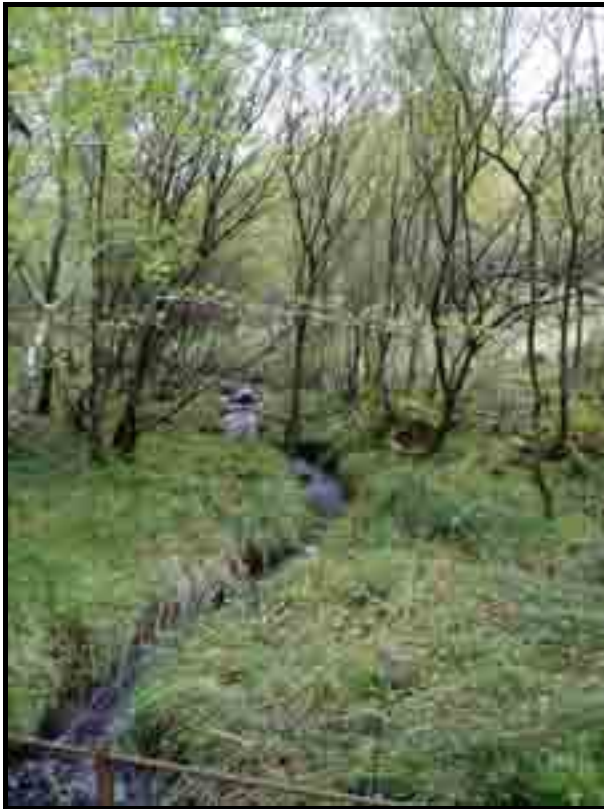
Plate IV: Better spawning gravel above the wood

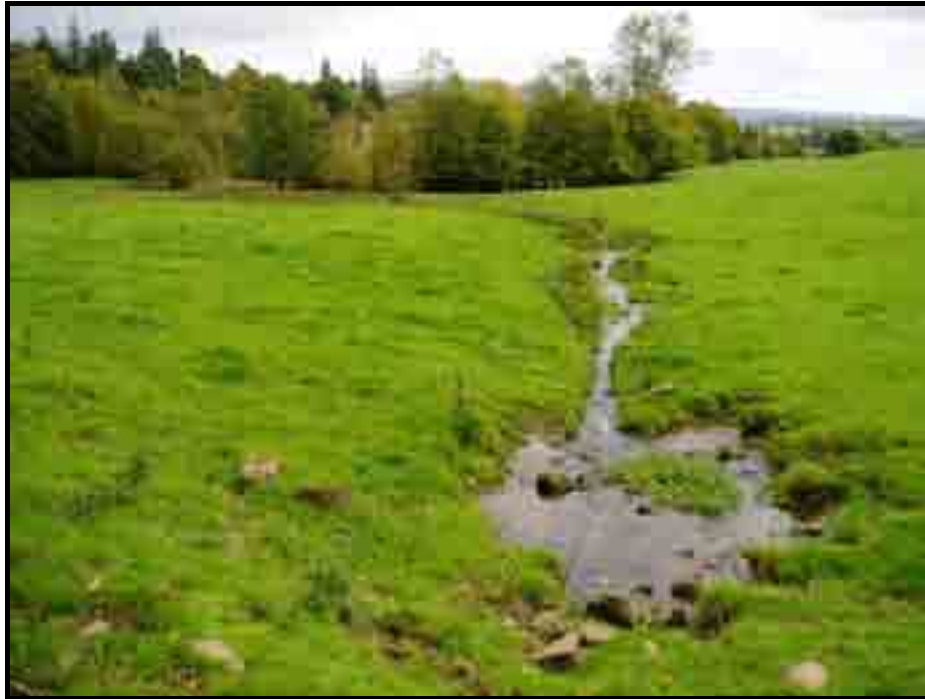
The two small inflowing burns provide limited spawning habitat for the trout population and recruitment of juvenile trout to the loch is likely to be low. Hence there is less competition within the loch for food and space and the trout can grow to a good size. The burn on the north bank flows through fields with light tree cover then steeper through well-established mixed woodland with many mature trees into the loch (Plate III). The spawning potential appears to be greater above the fence skirting the upper part of the wood (Plate IV). The plans for the equestrian development indicate that this burn would be diverted in order to create a new lochan. An exercise track for race horses would also cross the burn. In addition, some of the woodland would be cut down to create better access for the track. The other burn flowing into the loch through open fields on its western flank is very shallow (Plate V), lacking cover for adult trout making their way upstream to spawn. This burn also would be crossed by the exercise track.

Plate V: Smaller burn flowing through open pasture
