**AVISORY VISIT TO THE TICKENCOTE  
SYNDICATE AND GUASH FISHING CLUB  
WATERS, RIVER GUASH, RUTLAND  
UNDERTAKEN BY VAUGHAN LEWIS,  
WINDRUSH AEC.  
SEPTEMBER 2005**

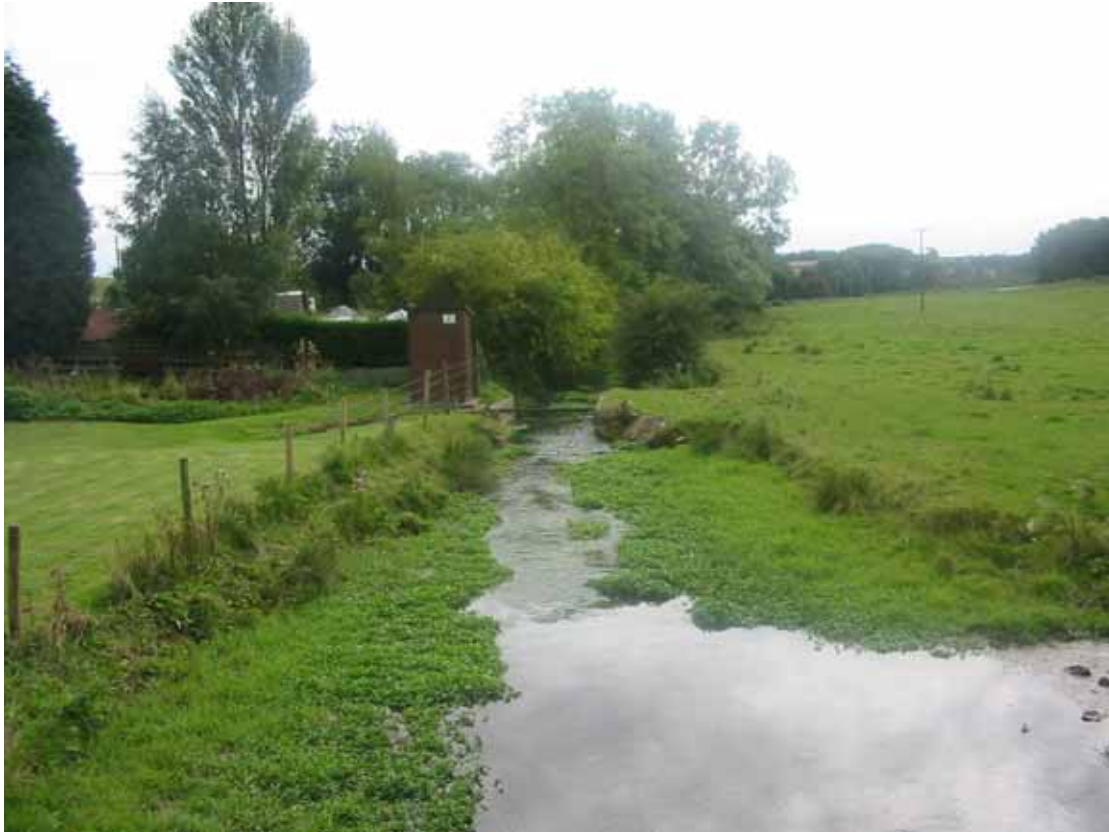
The regulating impact of Rutland Water also significantly impacts on the sediment and nutrient transport regimes to the downstream Guash. Much of the flow in the Guash downstream of the reservoir is provided by the Northbrook, a groundwater fed tributary. This stream has a self-supporting population of brown trout.

**Northbrook. Note gauging weir in the background**

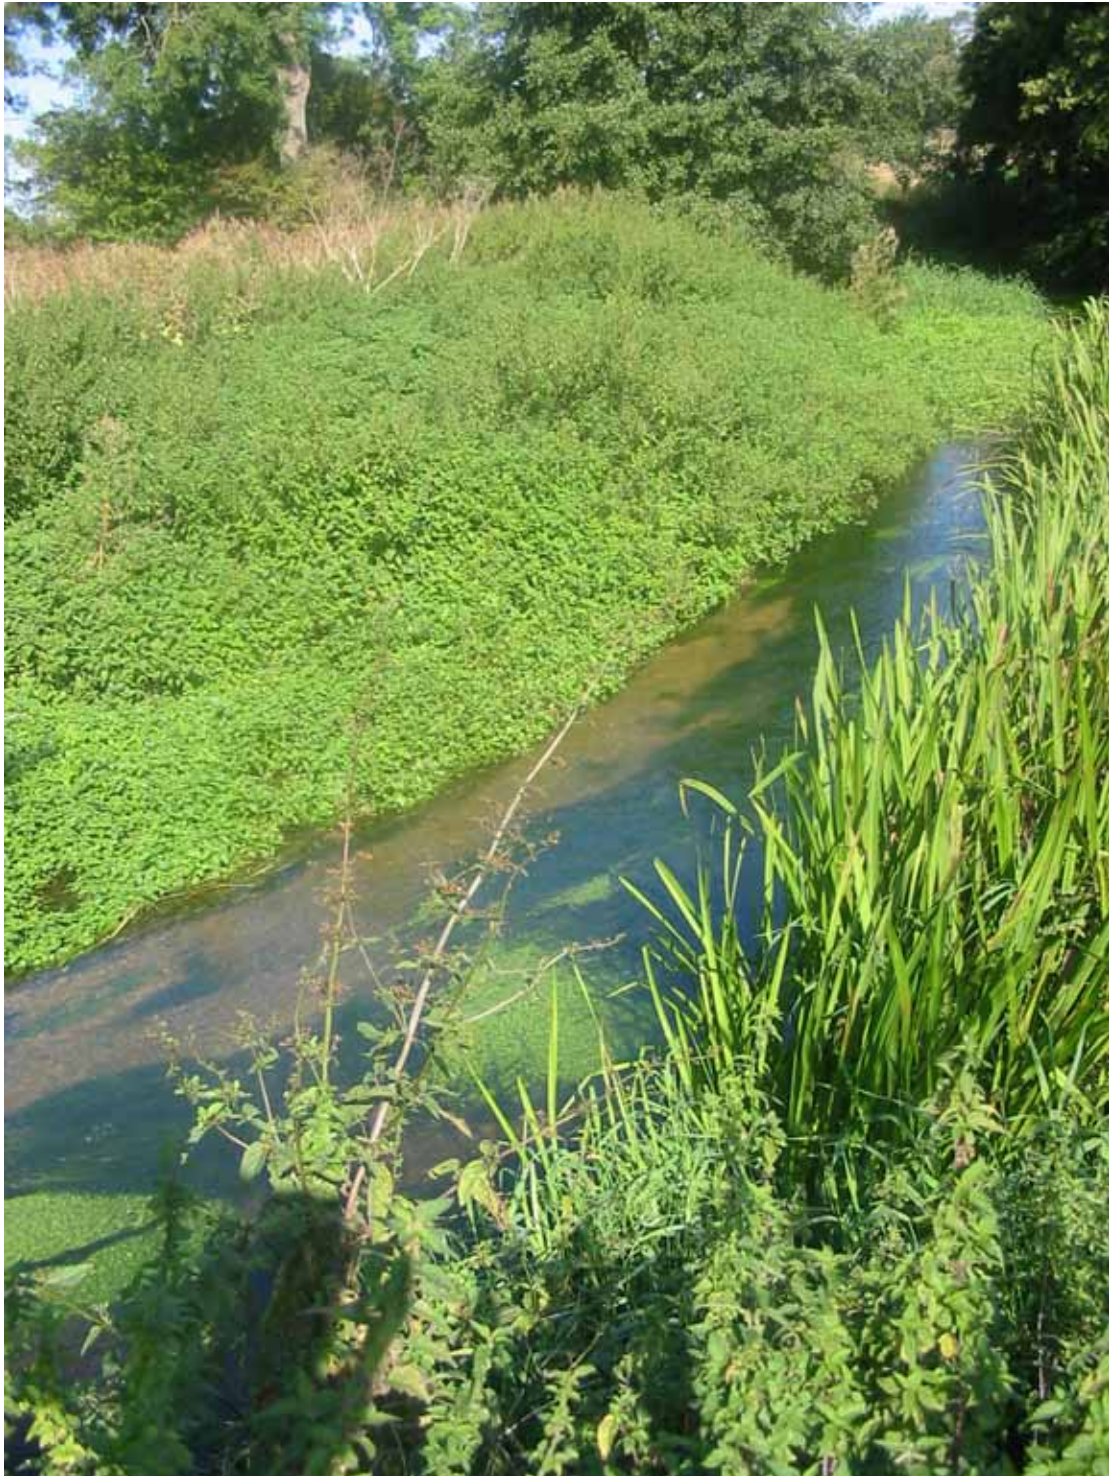
**A rare example of flow dependent, gravel bedded riffle/shallow glide habitat. Brown trout redds have been noted at this location. This habitat type is an exemplar for the proposed enhancements to this reach**

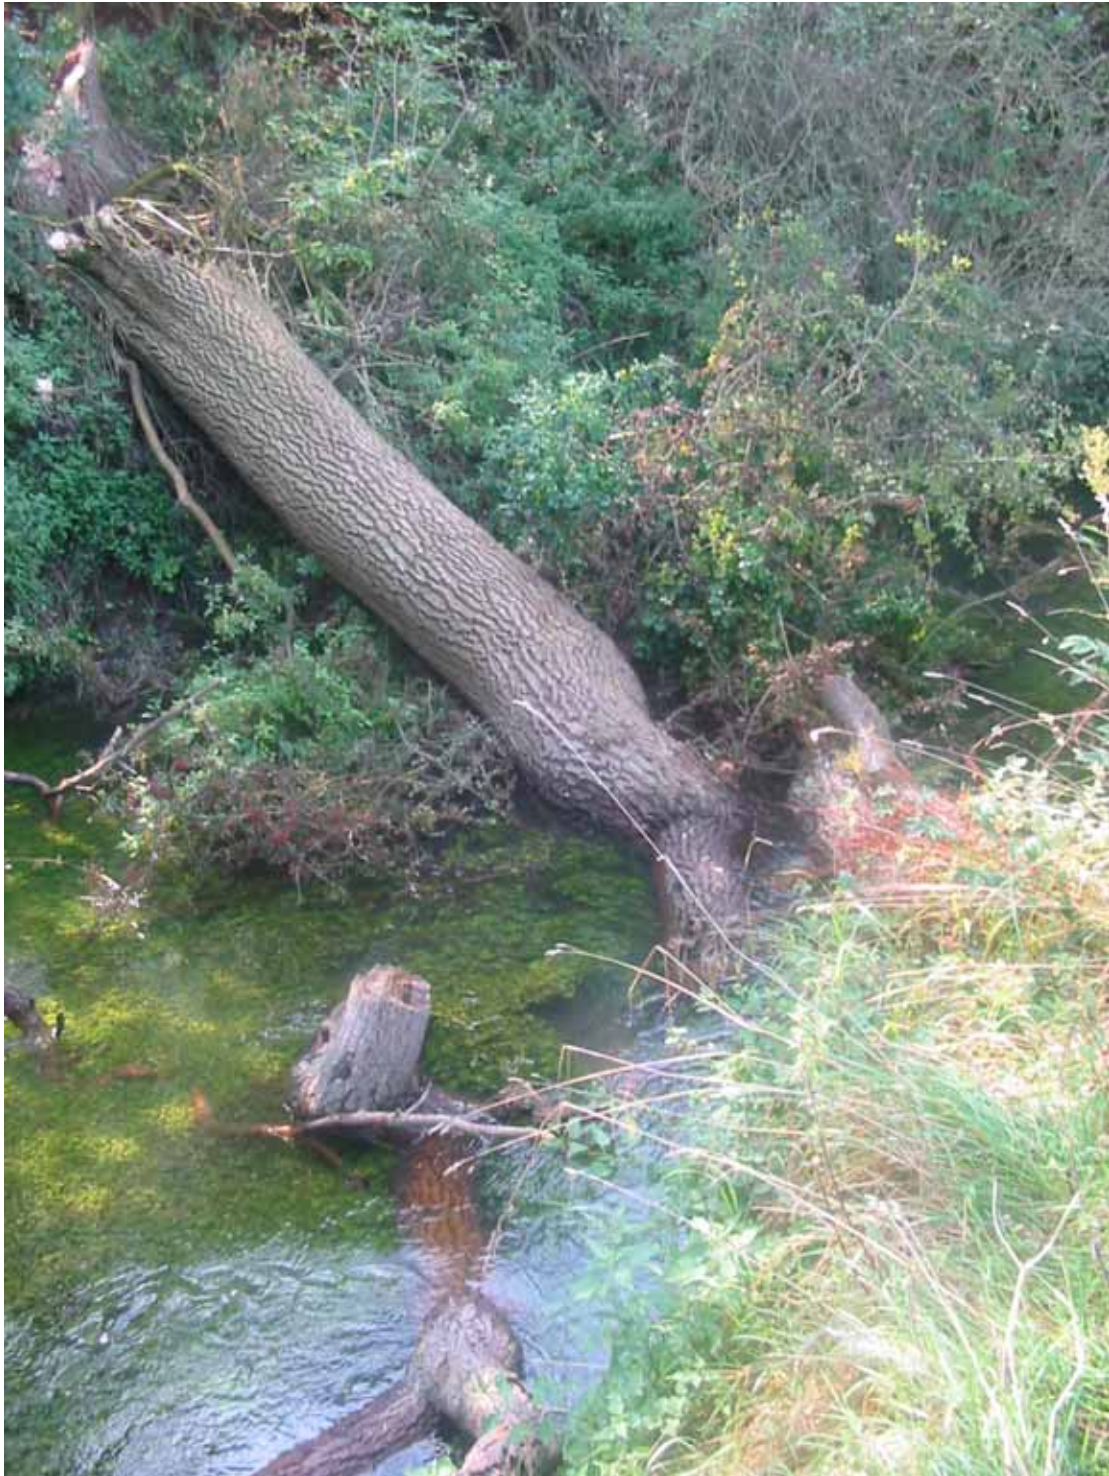
Woody debris in the channel was relatively rare. However, there were one or two good examples of fallen trees/tree limbs that were having a significantly beneficial

impact on instream habitat, with the scouring and sorting of substrate downstream clearly visible.

**Large woody debris dam created by fallen tree. Scouring and sorting of the substrate was clear downstream. Note the dense carpet of lesser water-parsnip *Berula erecta* downstream of the dam.**

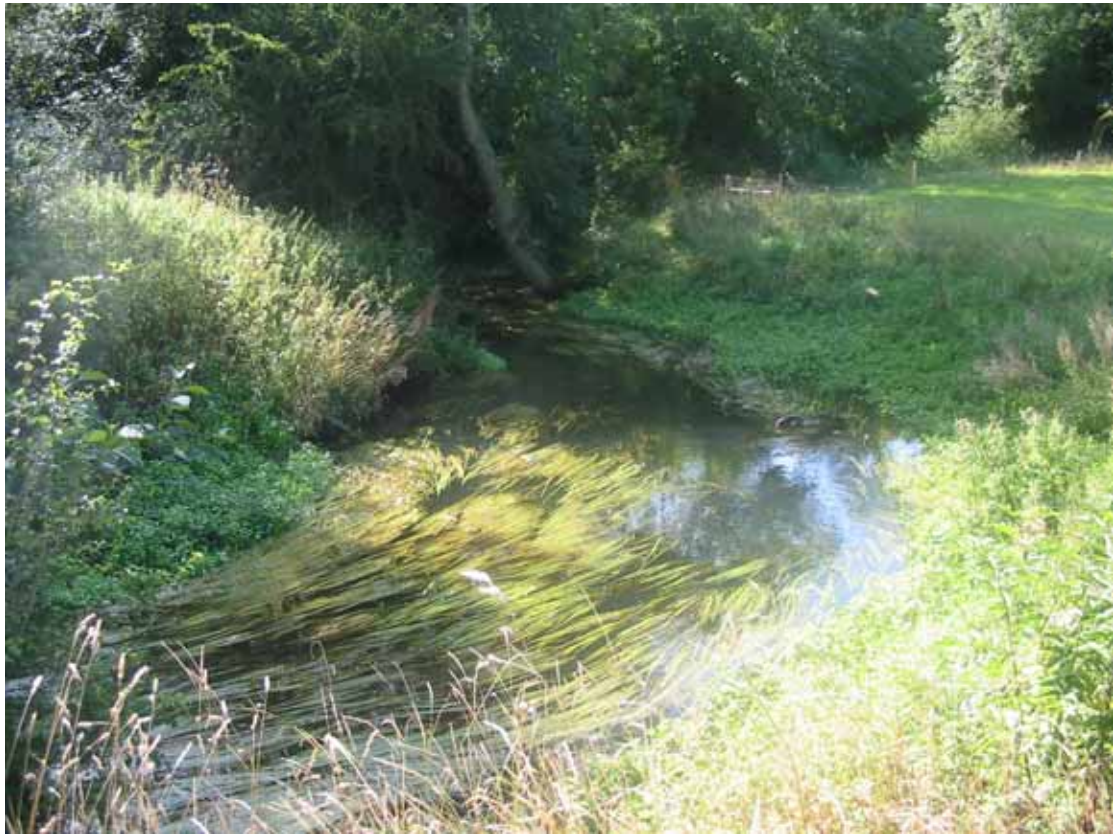
Beat 3 (the bottom beat of the fishery) had a heavy growth of branched bur-reed within the channel, with the submerged leaves of the plant covering much of the surface area of the channel over significant lengths.

**Stands of branched bur-reed on the lower reach of the fishery.**

The extensive growth of lesser water parsnip and to a lesser extent, branched bur-reed, were covering potential trout spawning areas, and retaining fine sediment. It would be prudent to selectively hand cut stands of weed on riffle areas in order to both expose gravel substrate and to 'train' flow through narrow channels, increasing water velocity, and scouring away fine sediment. Ideally, submerged weed should be cut either in a 'chequerboard pattern' or in 'bars' across the river.

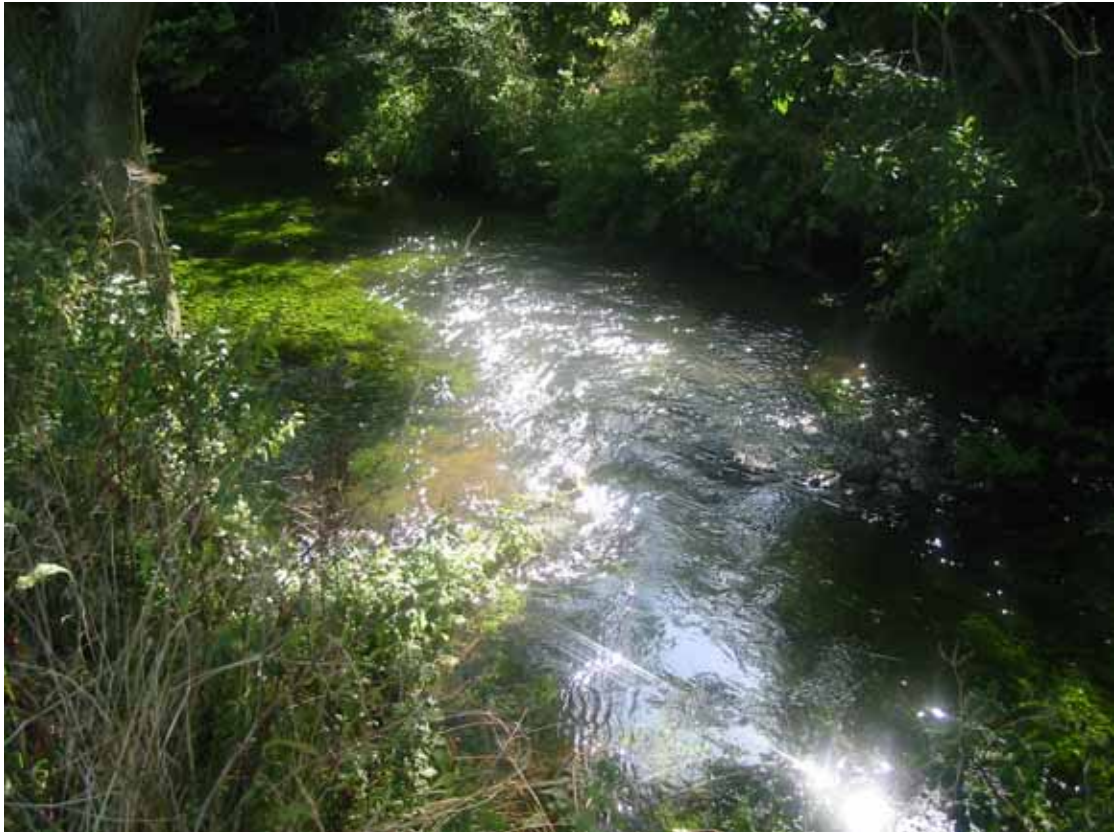
The syndicate had constructed several small stone deflectors in this reach, with the aim of increasing flow velocity locally. The structures had achieved this objective, with considerable beneficial variation in velocity created without the damaging upstream impoundment too often associated with low weirs.

### **Low stone deflector installed by the syndicate**

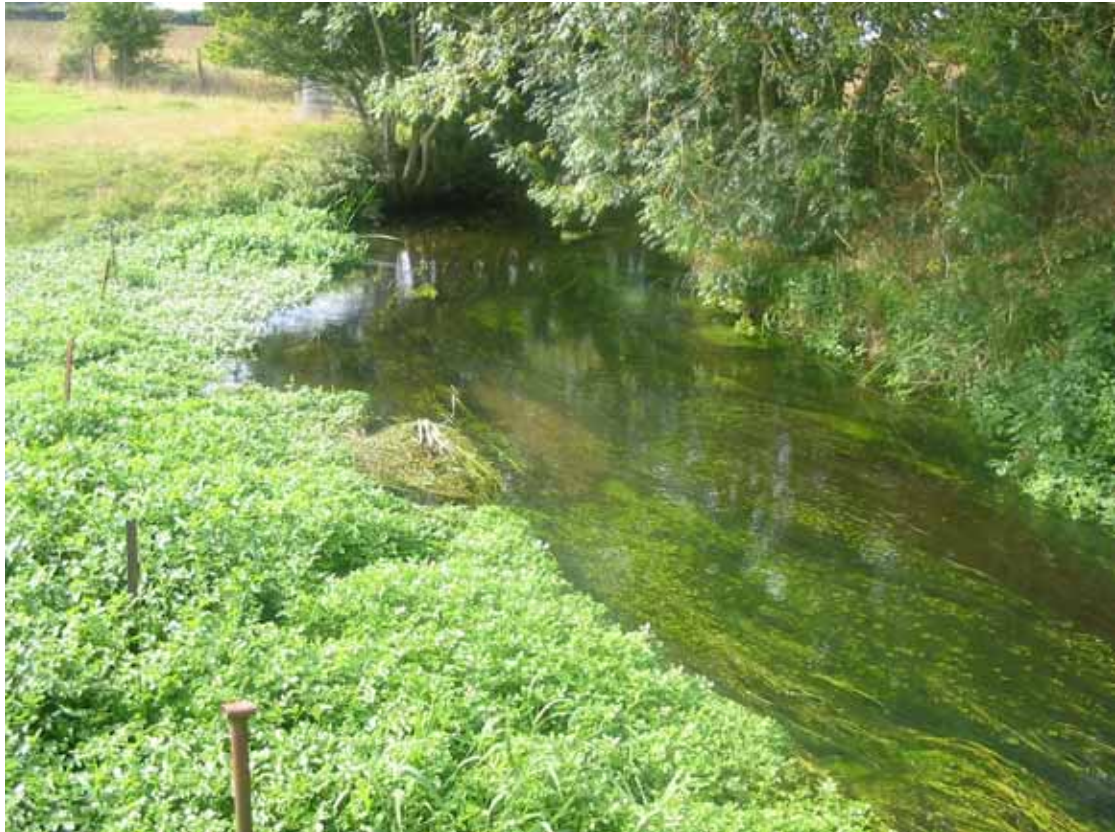
**Shallow glide showing dense growth of lesser water parsnip, starwort and water cress in the margins**

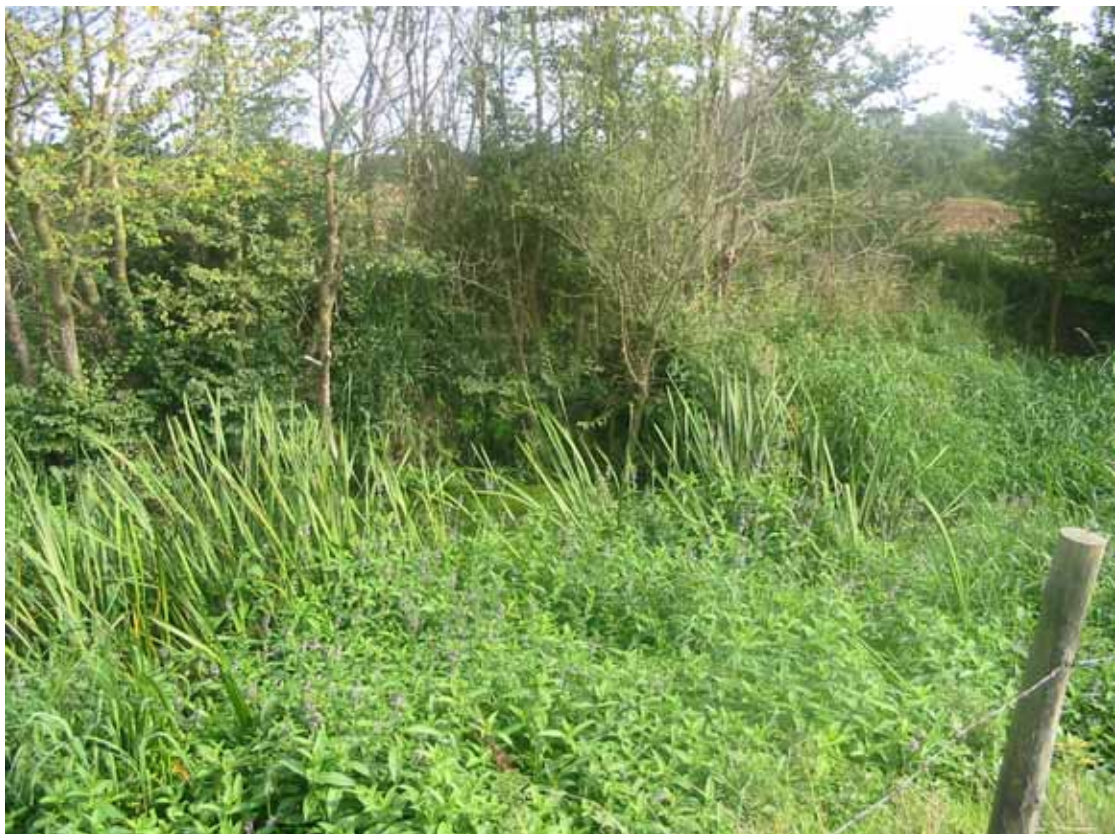
**Deeper section, heavily occluded by bur-reed, woundwort and mixed marginal species**

The growth of the emergent weed is very extensive during the summer months. Removal of all weed is not practical or desirable. However, it is possible to manage the weed in order to maintain sections of open water. This can be achieved by either manual cutting (chain scythes), mechanical cutting (hydraulic powered cutter mounted on 360 excavator) or by the use of herbicide. Of these options, the best in terms of its cost, lack of environmental disturbance and practicality is probably the herbicide.

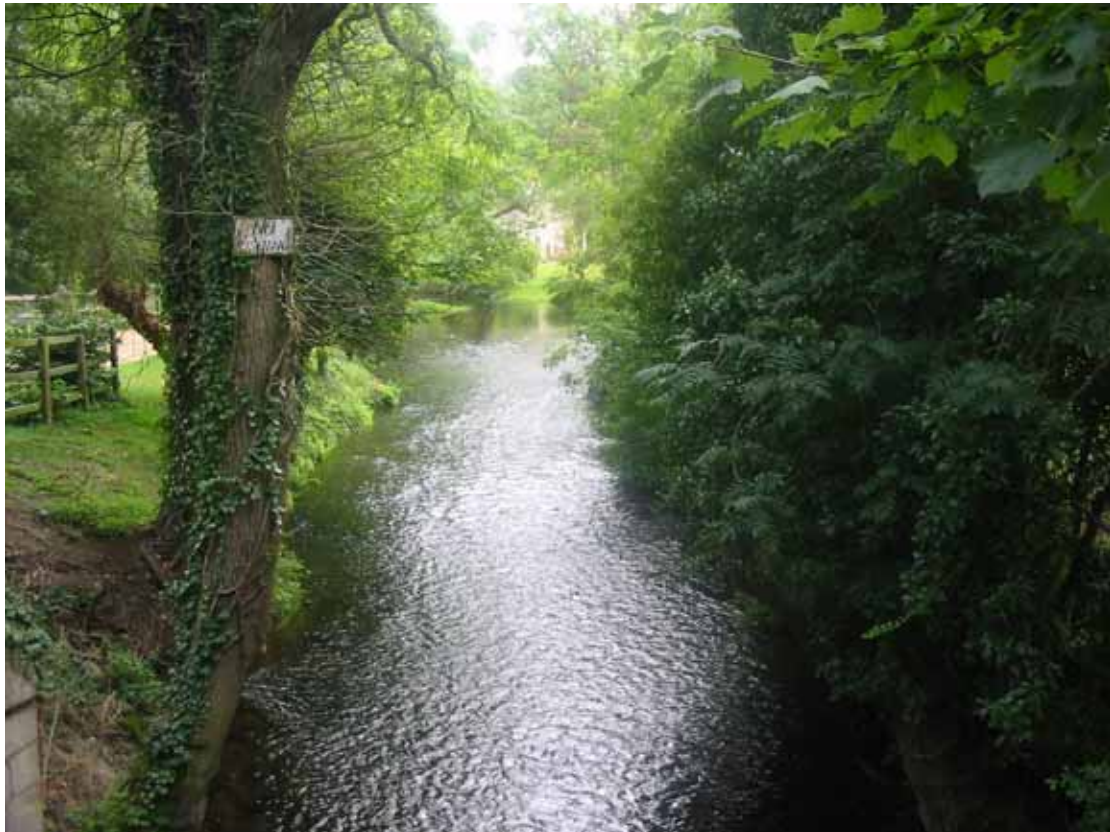
Downstream of Tolethorpe Mill, there was a section of higher gradient stream, with an extensive associated riffle, providing an indication of the likely quality of the river prior to dredging and the construction of Rutland Water. However, even at this location, the gravel remained relatively unsorted and imbedded, with a considerable volume of entrained fine sand likely to provide relatively poor hatching success for deposited trout eggs.

### **Section of shallow riffle habitat downstream of Tolethorpe Mill**

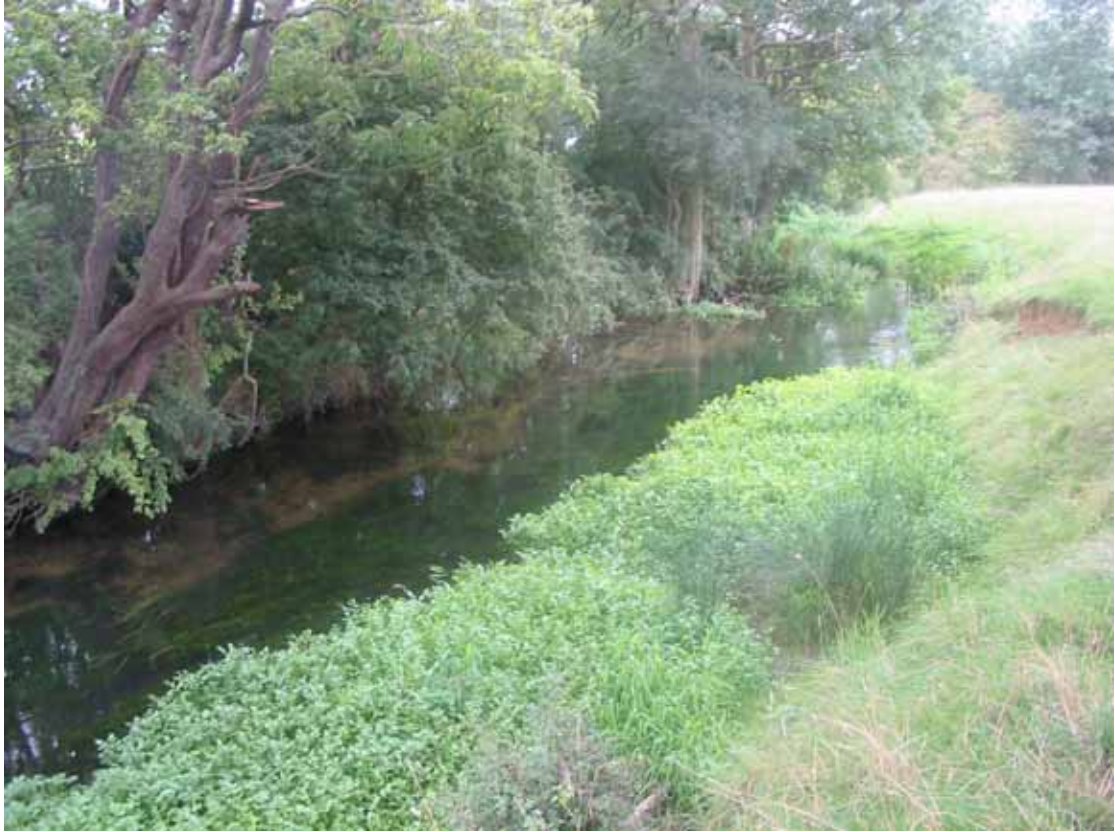
The reach below the Tolethorpe roadbridge, had a relatively steep gradient, with a wetted channel width of 6m-7m. The gravel substrate was largely covered by fine sediment, and extensive stands of lesser water-parsnip. The fishing club had installed a series of woven hurdles in order to encourage the development of the marginal vegetation and consequent narrowing of the channel. The presence of hemlock water dropwort *Oenanthe fluviatilis*, and large numbers of small brown trout were testament to the success of the work, with the former species not growing in areas of deep silt. Instream habitat within this reach of the river was probably the best of all those visited during the advisory visit.

**Dense marginal vegetation growth resulting from narrowing of the channel behind installed hurdles**

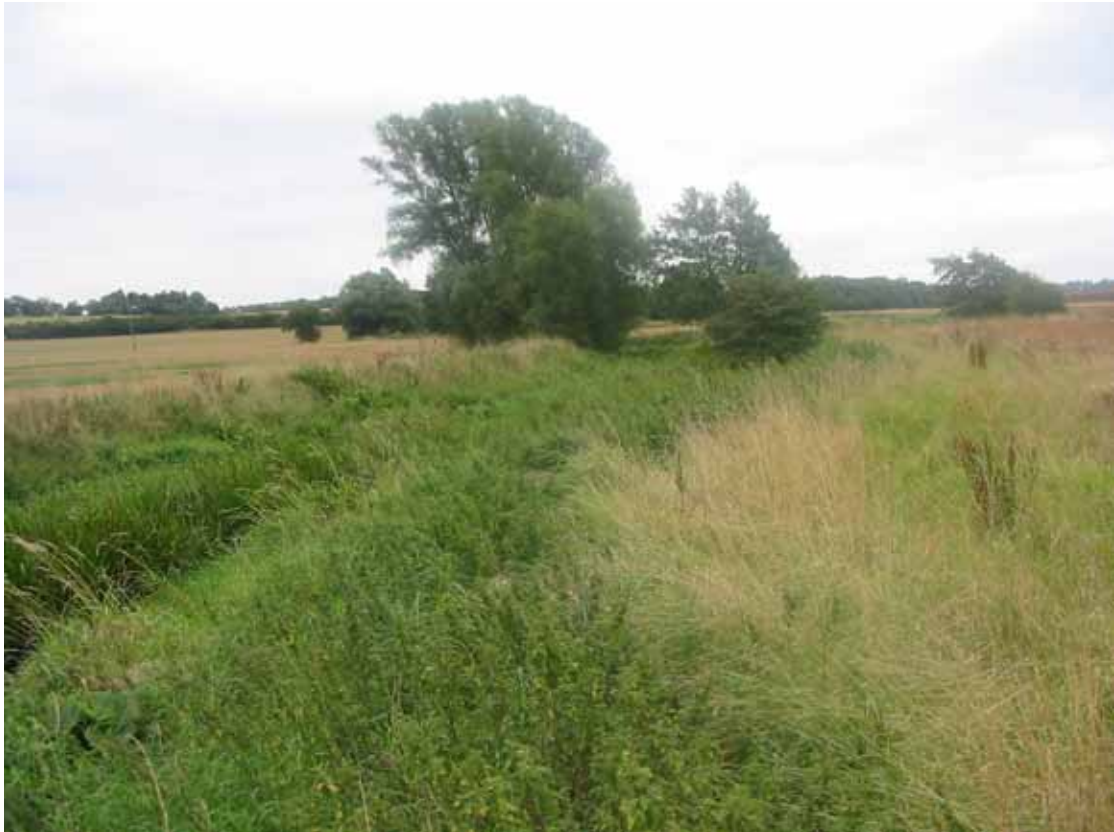
In contrast, the reach downstream of White Post Bridge was heavily incised following past dredging, with the channel occluded by emergent vegetation, to the point of being totally blocked in places. As a result the river was virtually unfishable, with an almost total absence of any shallow glide and riffle habitat that would allow recruitment of brown trout and grayling.

**Heavily vegetated channel downstream of White Post Bridge**
