**ADVISORY VISIT TO THE RIVERS LYDE AND
LODDON, HAMPSHIRE,
UNDERTAKEN BY VAUGHAN LEWIS,
WINDRUSH AEC LTD, ON BEHALF OF
GRESHAM FLYFISHERS
MAY 2005**

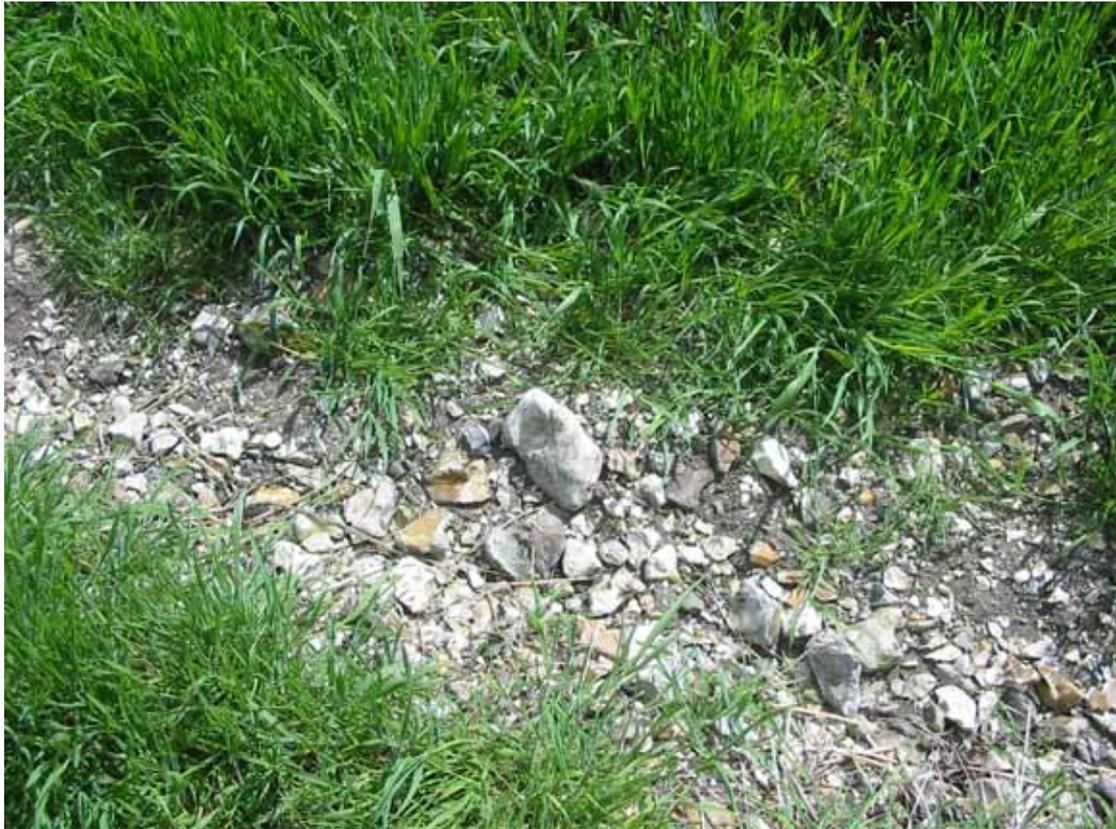
A large raised berm was present on the RB of the river. This comprised a mix of soil and coarse flint gravel and presumably originated as a result of past dredging of the river.

Flint gravel deposited on the RB of the upper fishery

- The extensive deposits of gravel on the banks of the upper Loddon could in theory be excavated, screened on site to remove the fines and the resulting clean gravel introduced to the river. This would create a significant length of good quality trout spawning habitat, along with a wide marginal shelf area, ideal for the growth of wetland plants. However, this would be a large project, probably beyond the scope of the club on its own. It may be something however that could be considered in conjunction with the Environment Agency.

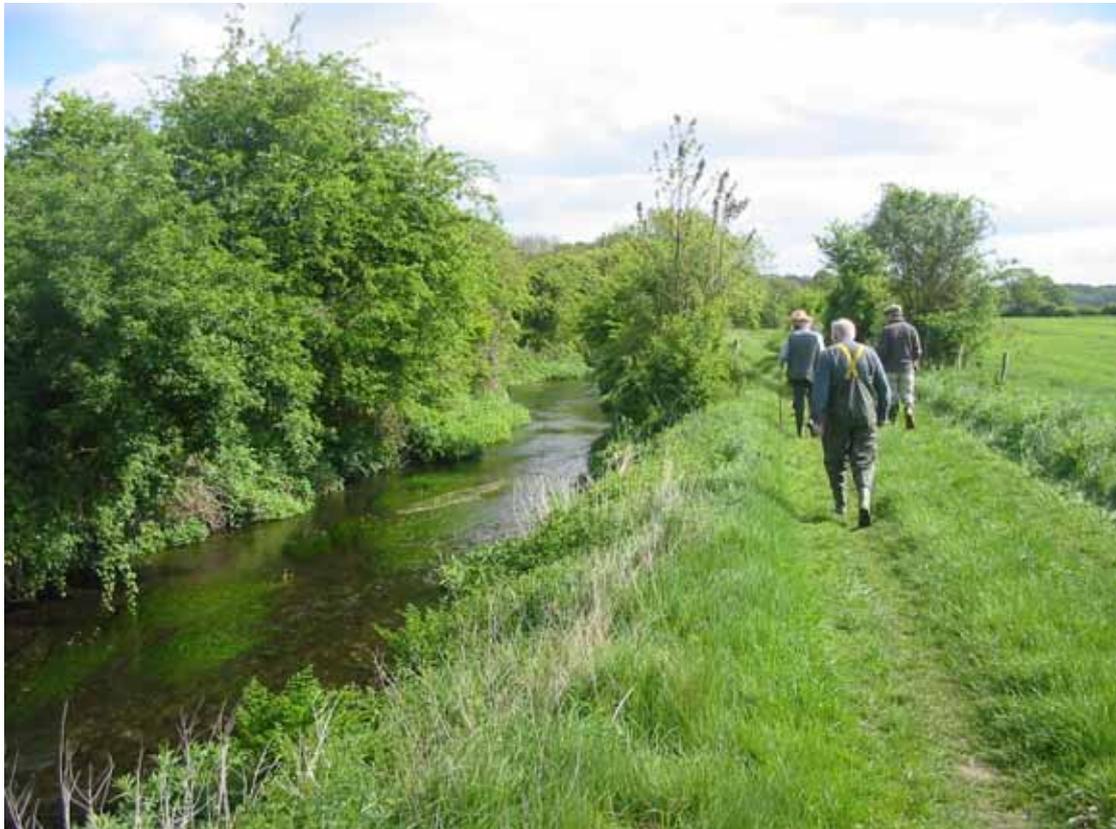
Upper Loddon, showing extensive submerged weed, gravel substrate and wide buffer strip

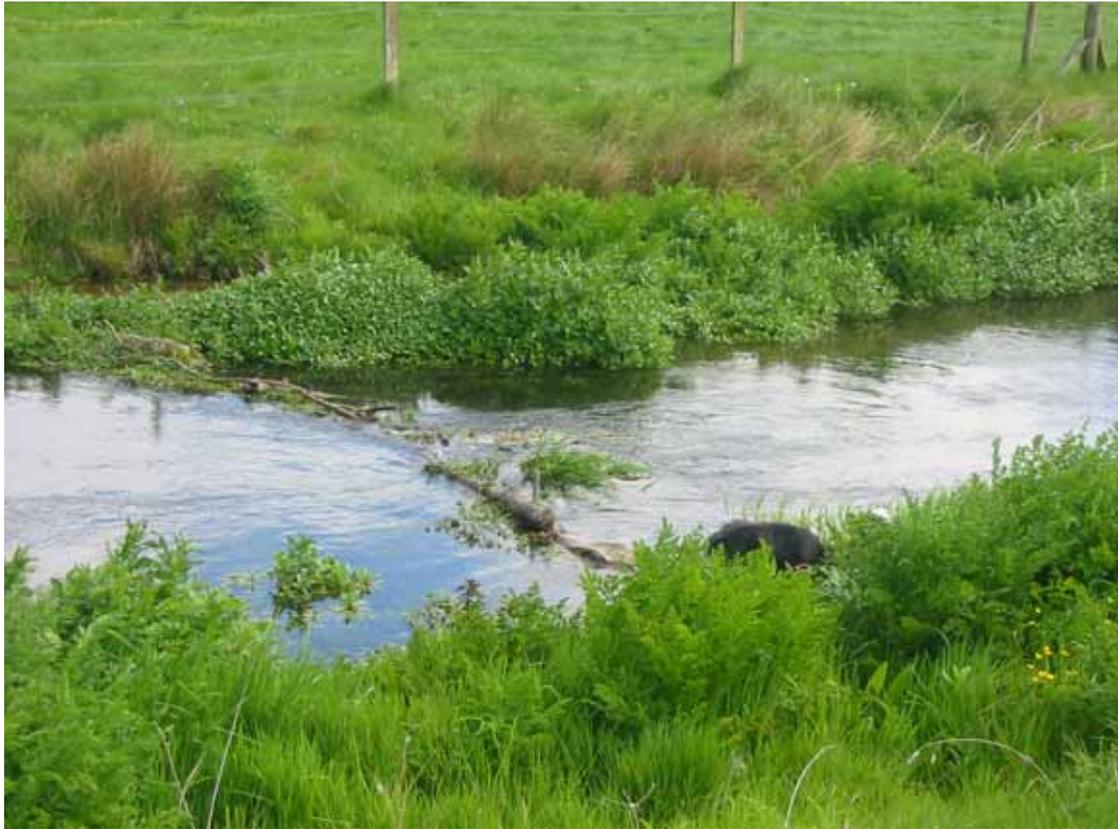
Below the confluence of the 2 streams below the decoy island, the river was more open, with fewer riparian trees present. The channel gradient remained relatively steep. A series of groyne had previously been installed by the club. These were constructed from timber held in place by reinforcing bar driven into the stream bed.

Timber and rebar constructed groyne

- The installed groynes were functionally efficient. However, similar, cheaper and more aesthetically pleasing flow deflectors could be created by using fallen or felled timber (see section on Large Woody Debris below).
- The use of Large Woody Debris (LWD) to provide feature to the channel is of fundamental importance to both fisheries. The benefits for retaining LWD are clearly laid out in the recent EA R&D document, “Large Woody Debris in British Headwater Rivers”. Key conclusions of the report include:
 - An increase in both mean flow depth and velocity and variability of both parameters.
 - The development of high physical habitat diversity both in-channel and in the floodplain. Removal of LWD reduces both habitat quality and availability for juvenile and adult brown trout.

Practical management options to increase LWD include making use of fallen timber in order to create simple flow deflectors by wiring/staking these to the bank. Timber can be used in this manner to replace the need for constructed groynes as previously installed by the club. It was interesting to note that on the Lyde in particular, there was a relatively thin layer of gravel, with soft marl present beneath this. It is very probable that scouring of the gravel layer by LWD fixed in the channel, will result in the creation of deep pools, an important and under-represented habitat type for adult brown trout.

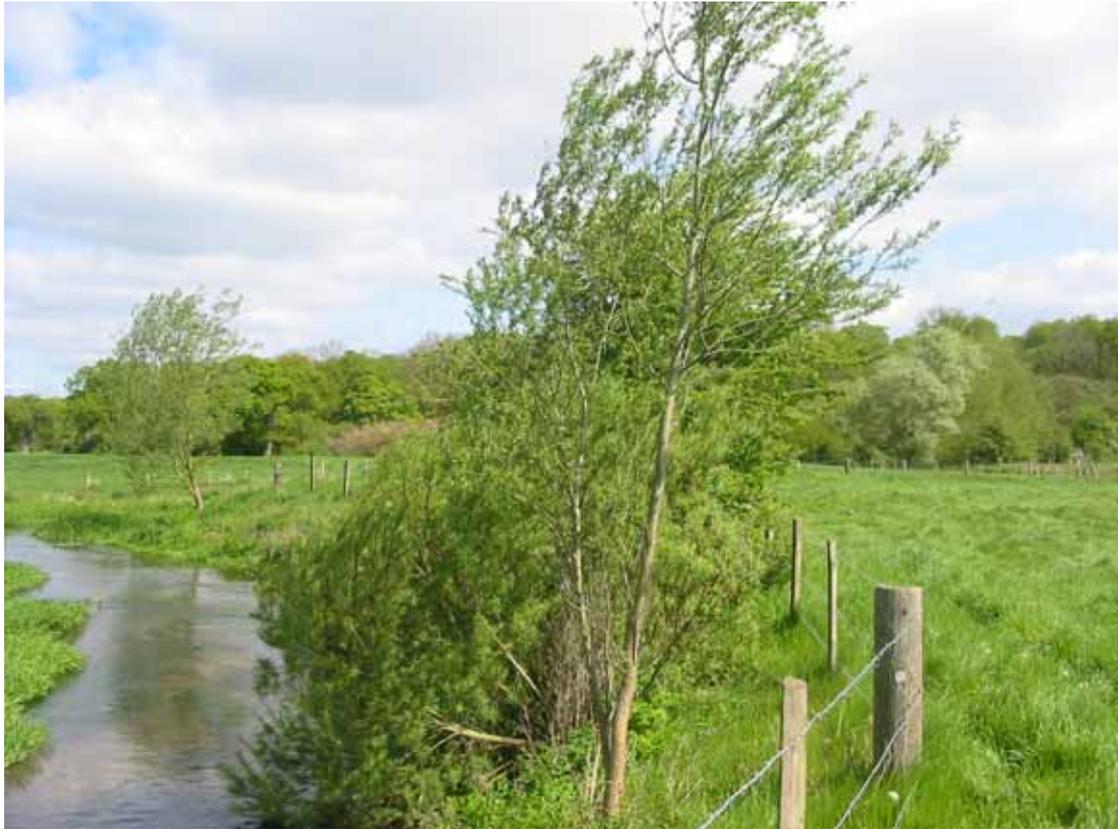
A number of willow *Salix* spp. trees had been planted along the river bank. These had established and grown well. Some of the trees had been coppiced, with the subsequent multi-stemmed regrowth providing excellent low cover, without excessive shading of the channel or banks. Alders in this reach of the river showed evidence of *Phytophthora* infection.

Single stemmed willow in the foreground, with a recently coppiced, multi-stemmed tree behind

- In sections of both rivers, particularly the Lyde, the heavy shade cast by riparian trees, particularly those growing on the south, was restricting the growth of marginal vegetation, with associated damaging impacts on the rate of erosion, the provision of marginal cover for fry, and water flow velocity. In order to address overshadowing, the extension of the already established regime of limited, rotational coppicing would be of great benefit. Increasing light penetration into presently overshadowed river sections would be of benefit to instream vegetation and valuable fringing marginal vegetation. Note that the coppicing of the planted single stem willows by the Loddon will create multi-stemmed regrowth, that is of greater benefit for marginal cover, and also provides a ready source of brushings for future bank work using live willow.

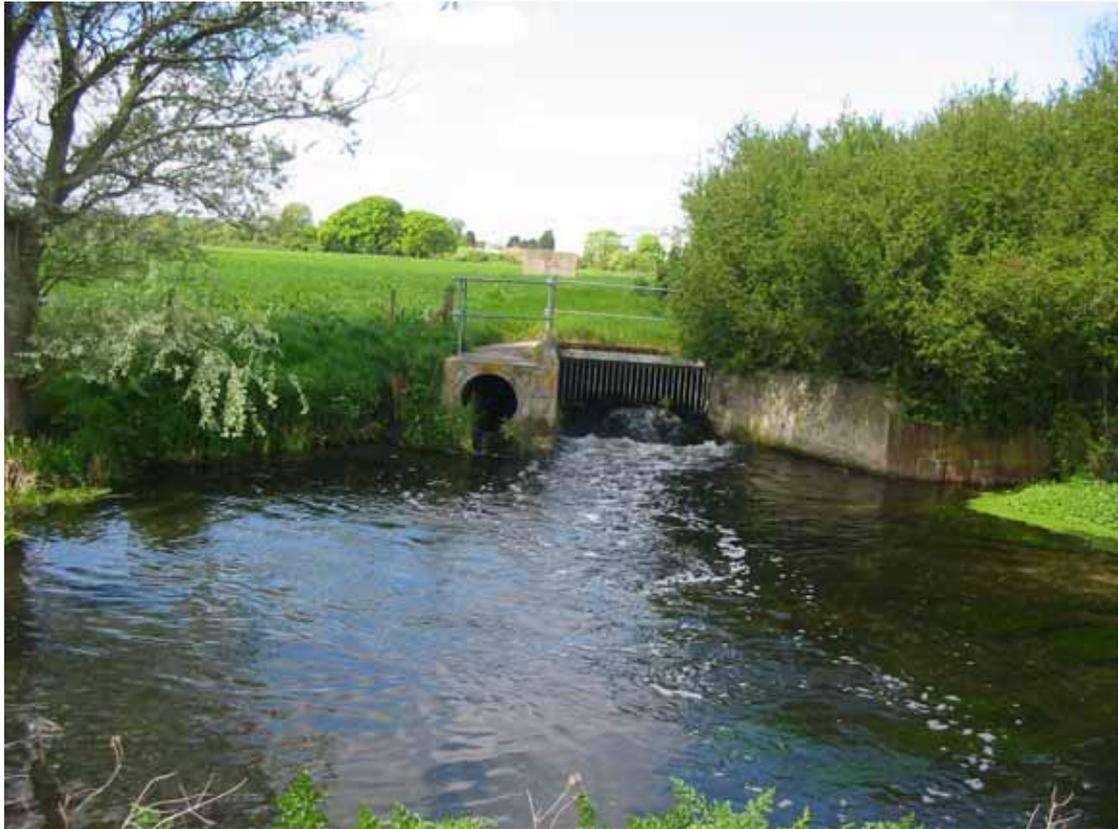
The outfall from Basingstoke STW discharged on the LB of the river. There was no evidence of discolouration or excessive foaming, with the effluent visually appearing to be of good quality. The works effluent was augmenting the flow of the river significantly. Several fish > 0.5kg in weight were present in a pool downstream of the outfall.

Discharge from Basingstoke STW

- The discharge from Basingstoke STW should be carefully monitored by the club. The works will have a statutory discharge consent standard that Thames Water is legally obliged to meet. Regular samples are taken both by the EA and the water company. The results of these samples are placed, along with the consent standard, on a publicly accessible register at the EA offices. On payment of an administrative fee, members of the public can inspect the register and obtain copies of data. I would strongly recommend that the club approach the Environment Management team at the Frimley offices of the EA, Thames Region and ask for a copy of the data from the public register. The EA should also be asked in writing whether the works has met its discharge standard over the past 5 years and if not, what action the EA are taking regarding the matter.

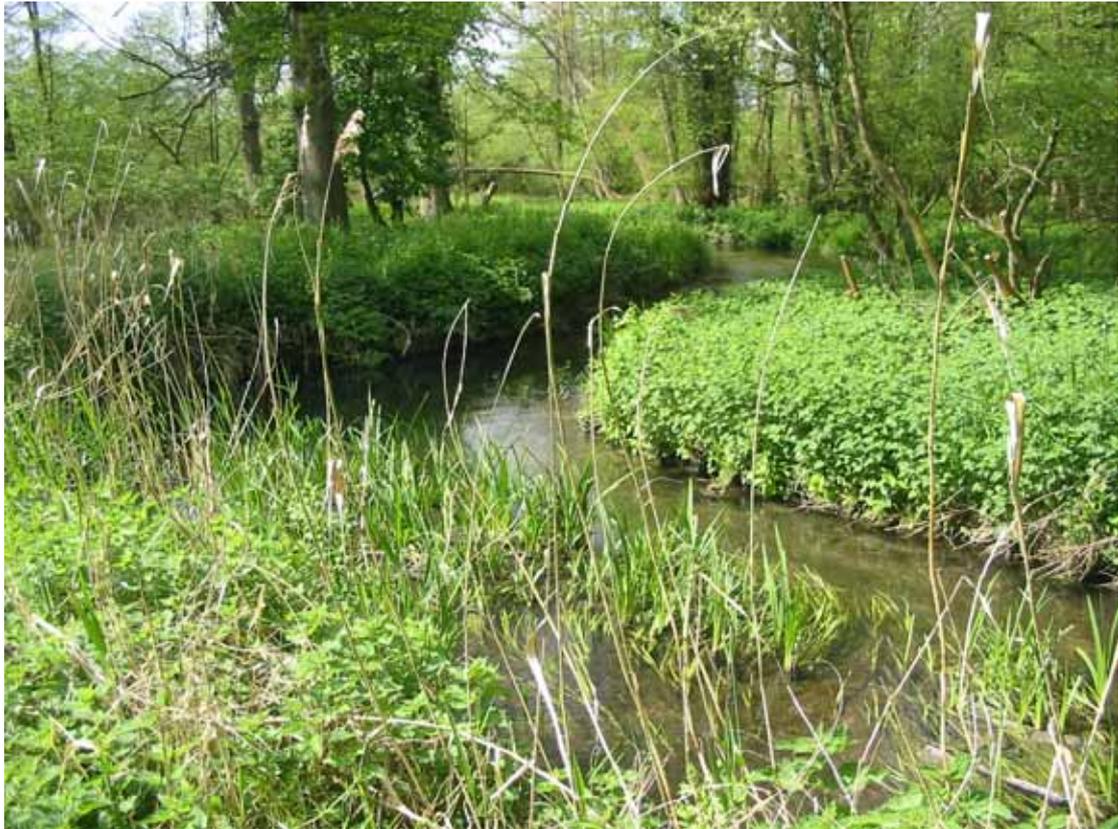
The club had undertaken a considerable amount of work on the middle reaches of their Lyde fishery. They had effectively 'sky lighted' sections of the river by selective removal of tree limbs, in the process also increasing access for rod and line fishing. Where the channel was totally unshaded, stands of bur-reed *Sparganium* spp. had become established, in some cases partially occluding the channel.

Bur-reed in un-shaded section of the Lyde

- In the event that emergent vegetation does increase and create significant difficulties for management of the fishery, then it can be controlled using either manual cutting or herbicide. The only appropriate herbicide cleared for use near to and in water is glyphosate (sold as ‘Roundup’, Roundup Pro Biactiv etc). It is a selective, translocated herbicide that is used to treat the actively growing plant once its leaves have emerged from the water. Glyphosate offers a cheap and environmentally sensitive option (it is inactivated on contact with water and sediment) for the treatment of emergent vegetation.

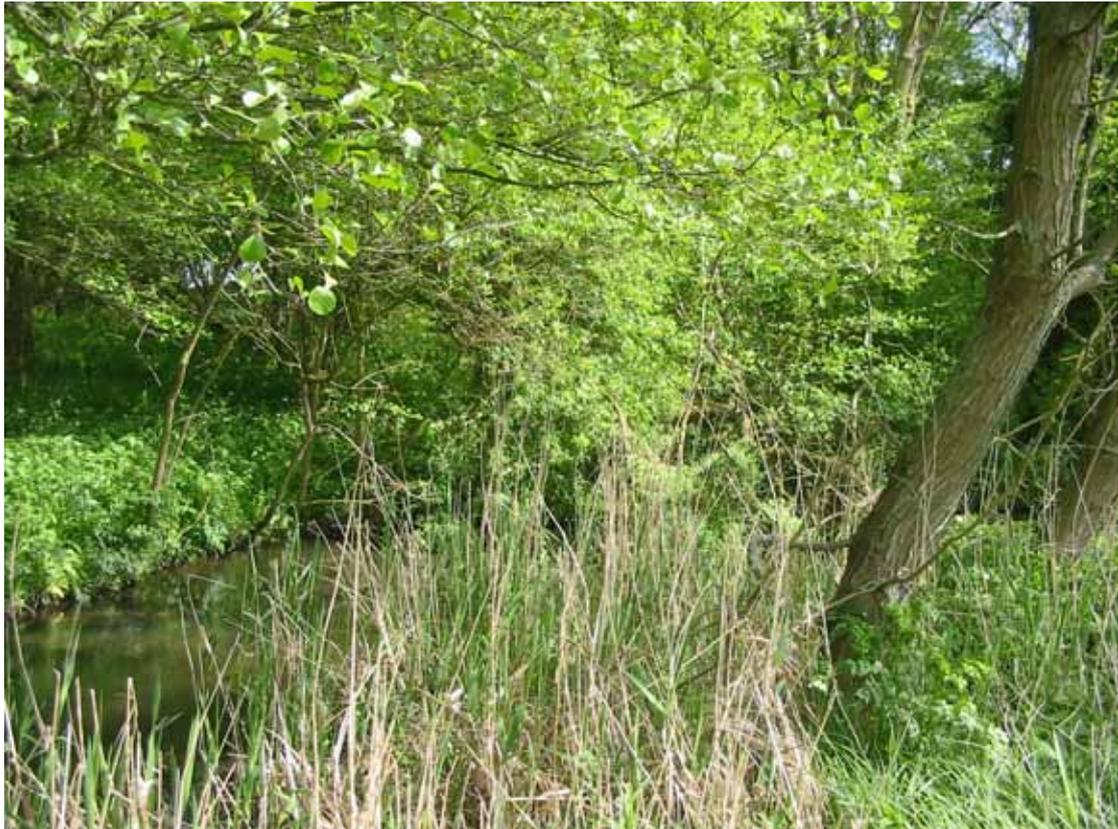
The club's River Lyde fishery was located adjacent to Deanlands Farm. The lower section of the fishery was very overgrown, with significant riparian tree growth (alder, hawthorn, crack willow) and associated shading. There was a considerable volume of LWD in the channel, which in combination with the tree growth rendered much of the river unfishable. There was a lot of fine sediment uniformly distributed on the bed of the river, with minimal growth of submerged vegetation.

Lower River Lyde showing heavy shading and fine sediment on the bed

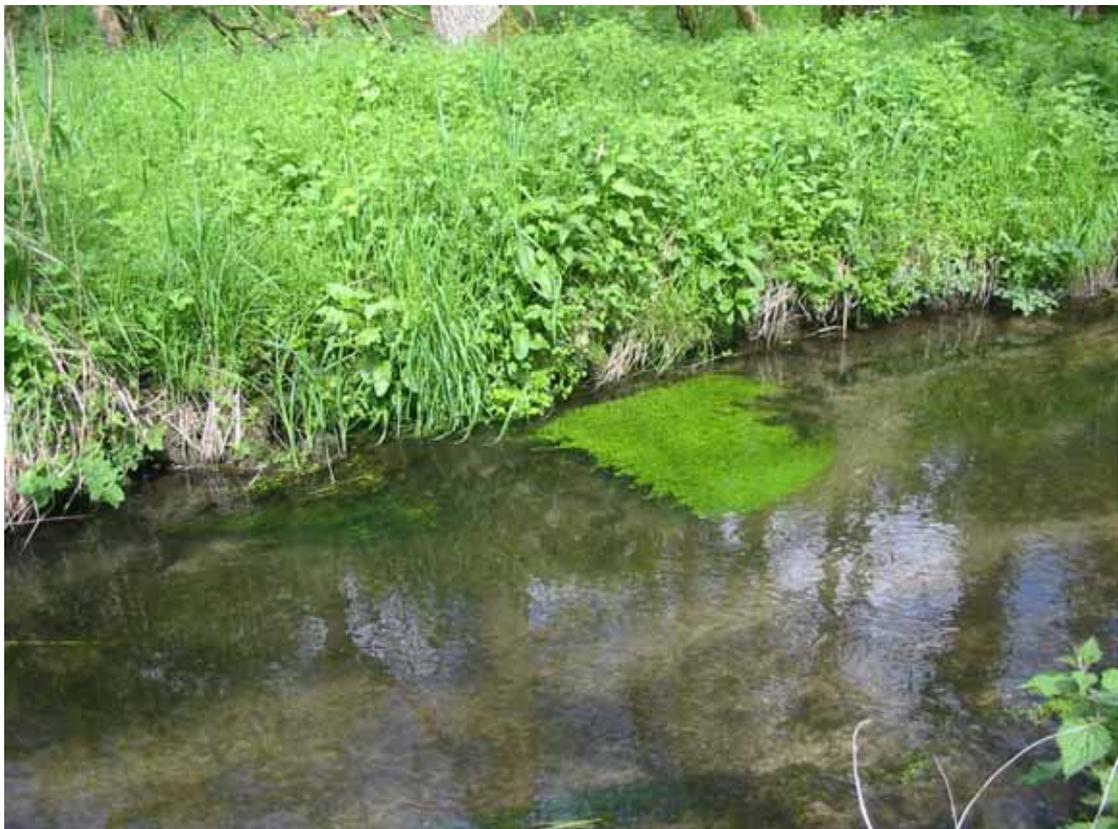
The bed substrate was poorly sorted over much of the middle reach, with a considerable percentage of fine sediment present. There were small stands of water crowfoot and starwort *Callitriche* Spp. present in the channel.

Typical section of the middle Lyde

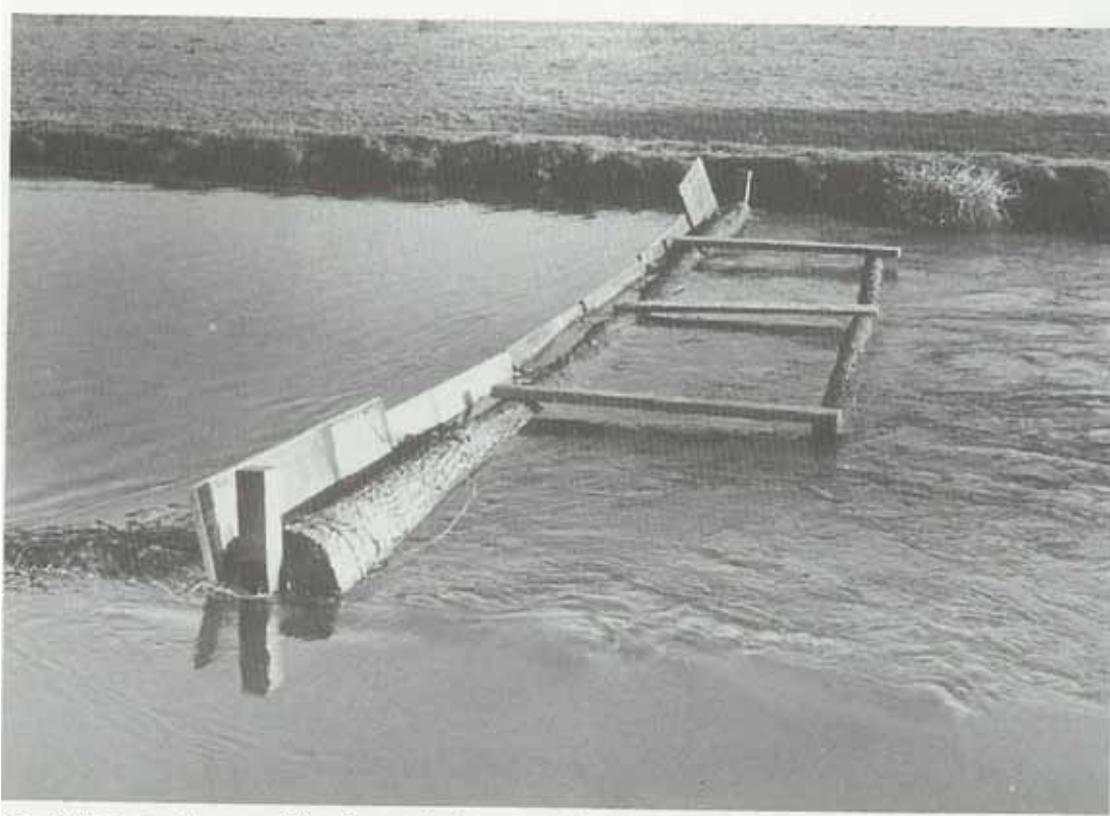
Mud engine

- The cleaning of spawning gravel and scouring of patches of sediment can be achieved by the use of a mud engine. This is a simple device (pictured below) that harnesses the rivers flow to create localised high water velocity. Operation is simple, with the engine being moved regularly in a downstream direction in order to clean short river lengths. It would be of particular use on the back channel around the Duck Decoy Island.
