Habitat Advisory visit to the River
Tanat, on behalf of Upper Tanat fishing
club undertaken by Vaughan Lewis,
Windrush AEC Ltd
June 2005

1.0 Introduction

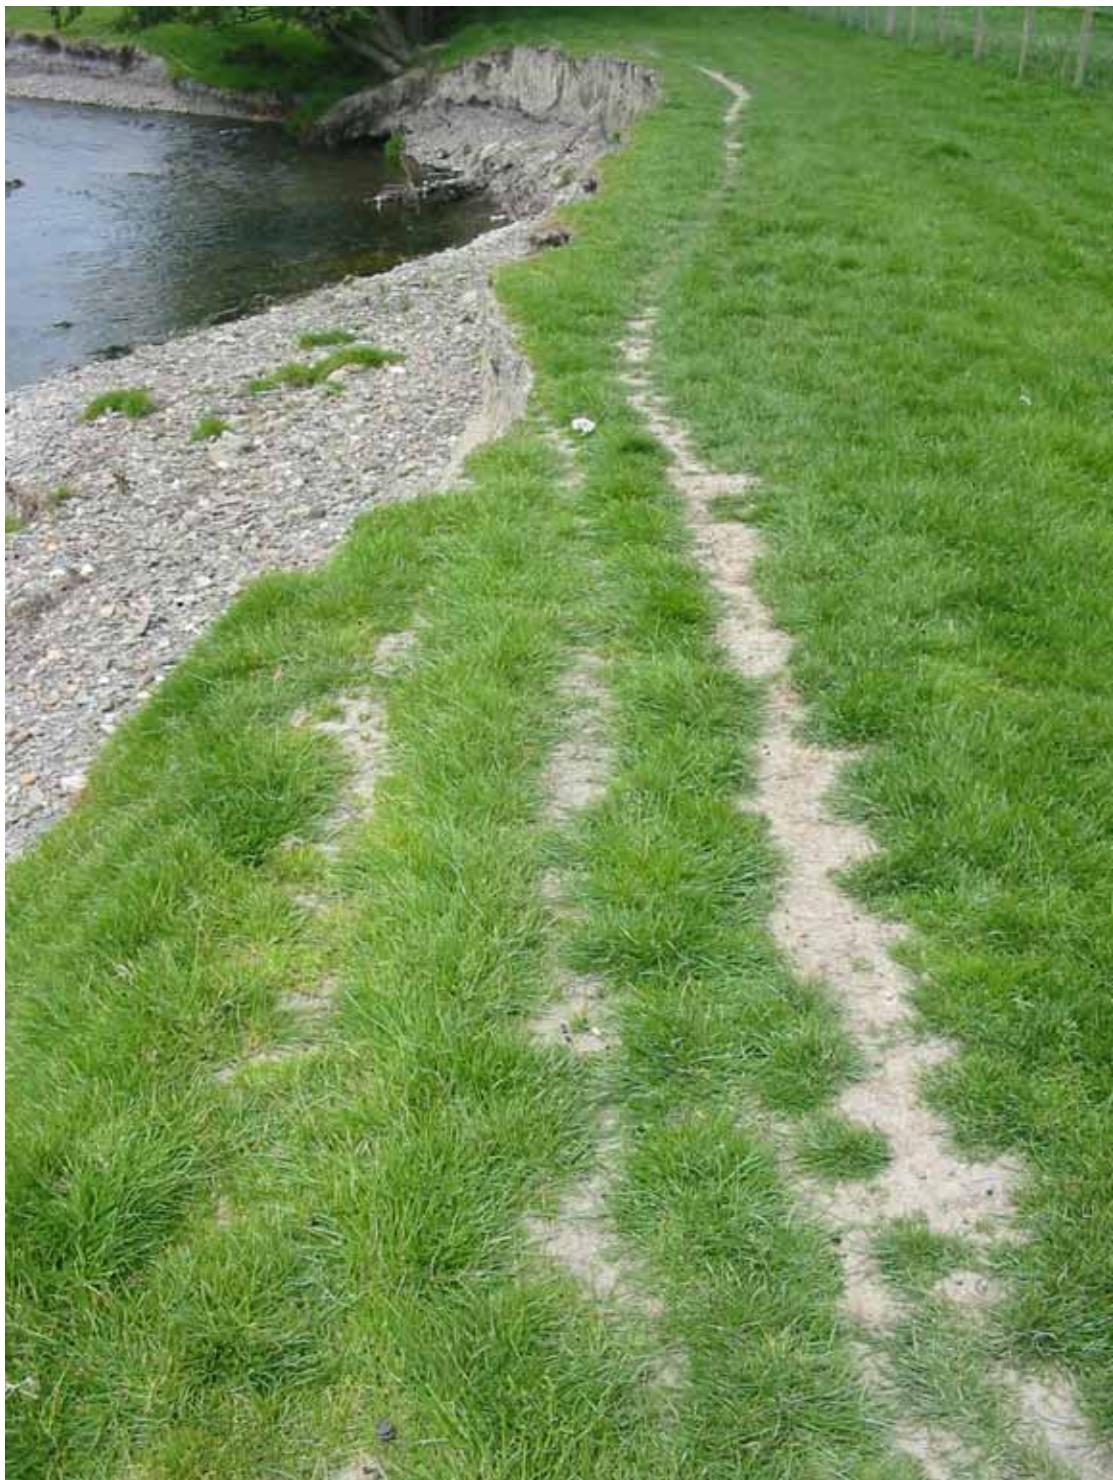
The banks over much of the reach length were relatively open, with few riparian trees or shrubs present. This was largely a consequence of the extensive grazing by sheep of the riverside meadows, and the prevalence of *Phytopthora* disease in the alder *Alnus glutinosa* trees. The grazing pressure was sufficient to have resulted not only in the loss of tree cover, but also in impoverishment of the grass and herb layer, leading to widespread and damaging erosion of the banks. As the banks had eroded, considerable volumes of fine and coarse sediment ad been release into the channel. The overgrazing of the banks had, in part, contributed to the very mobile nature of the riverbed.

Exposed gravel/fine sediment as a result of bank erosion, accelerated by sheep grazing. Note the three parallel ‘sheep path’s’, with the first two not now used as a result of the erosion they have caused

In order to reduce the rate of erosion in the Tanat catchment, it is essential that grazing pressure be reduced within the riparian zone. The recent removal of headage payments and the introduction of a Single Farm Payment under the Common Agricultural Policy may reduce the incentive for higher density sheep stocking, thus reducing grazing pressure. However, it is likely that this will not in itself prove sufficient. Additional protection could be provided by the erection of fencing to isolate an ungrazed strip, ideally, more than 10m in width. Some financial support for this and other initiatives may be available from the WTT. This ‘pump priming’ money may be sufficient to release other partnership funding from the EA.

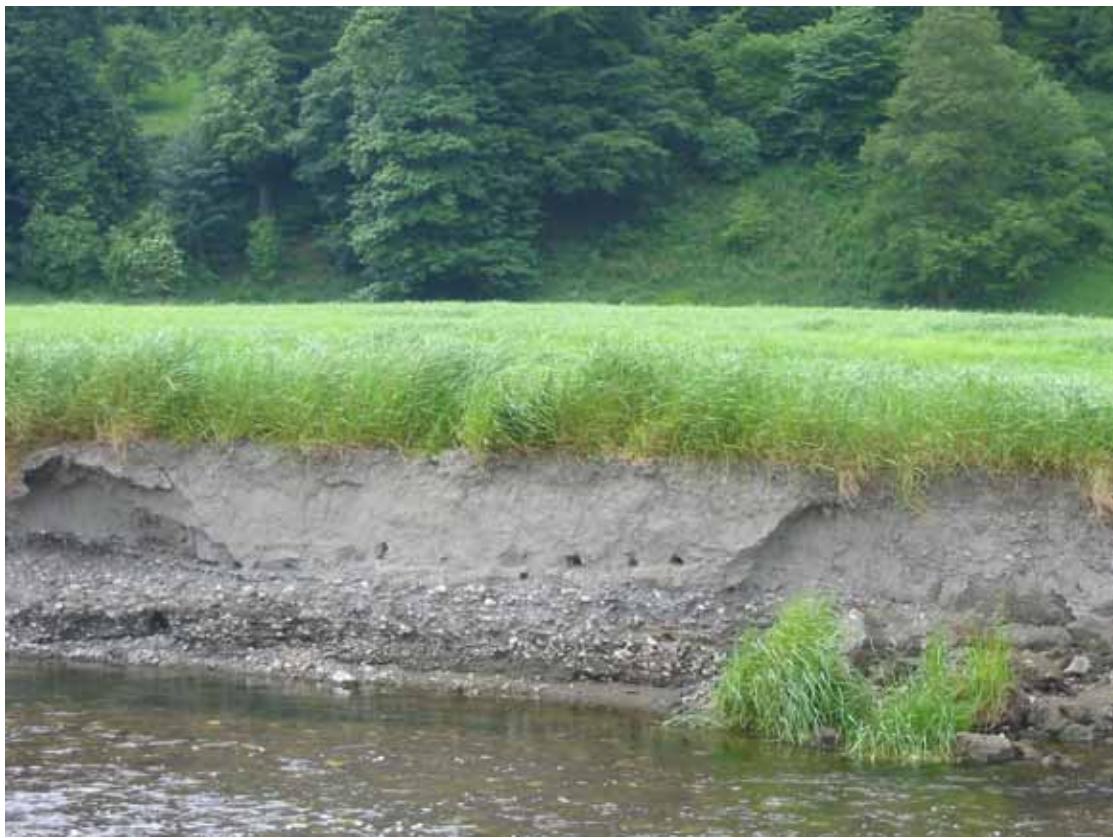
The erosive nature of the banks had provided an ample supply of suitable vertical banks for excavation of nest holes by sand martins *Riparia riparia*.

Exposed bank following erosion. Note horizon of coarse sediment and sand martin nest holes

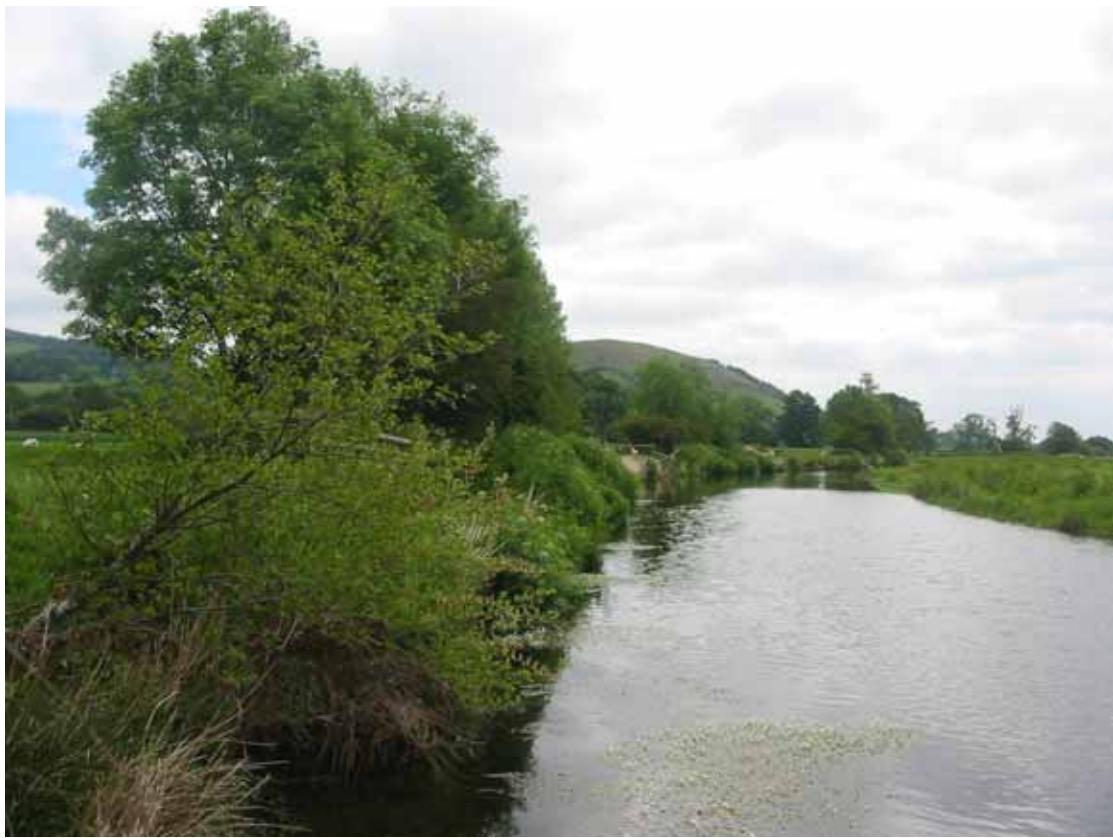
In an attempt to address issues of over-grazing and lack of riparian tree cover, the Environment Agency (EA) had fenced off small sections of the riverbank and installed overhanging wooden cover boards. The success of the former intervention can be seen in the lush tree growth, and the establishment of Water crowfoot *Ranunculus* spp, and hemlock water dropwort *Oenanthe* Spp., alongside the enclosures. Empirical observations have shown the value of the cover boards, particularly to chub *Leuciscus cephalus*.

Trees growing within fenced compound. Note the growth of water crowfoot in the foreground

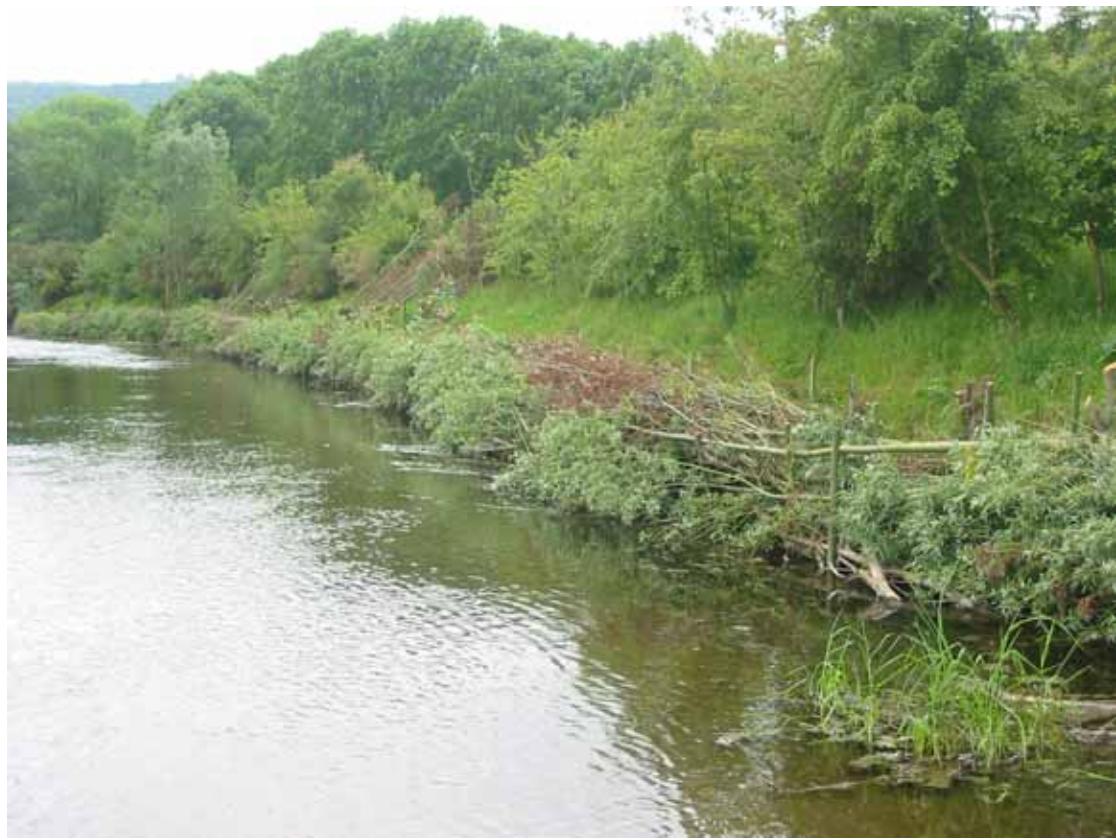
In an attempt to address excessive erosion, the EA had installed a length of some 50m of willow *Salix* Spp. spiling and mixed tree planting on the RB. Fencing had been erected to protect the new planting from stock grazing. The planting had been very successful in protecting the bank, with the overhanging fine willow shoots and roots providing valuable cover for juvenile brown trout. The spiling had recently been ‘pleached’ (laid), and the individual trees coppiced/pollarded. Woody risings from this work will be used to reinforce other sections of bank elsewhere on the fishery.

Fenced spiling and tree planting successfully protecting the river bank from excessive erosion

- Once fencing has been erected, other enhancements may be considered. These include the installation of willow spiling, and tree planting, both of which have already been shown to be successful on the Tanat. Funding for this type of work and in particular, its aftercare may be available via the Tyr Gofal scheme.

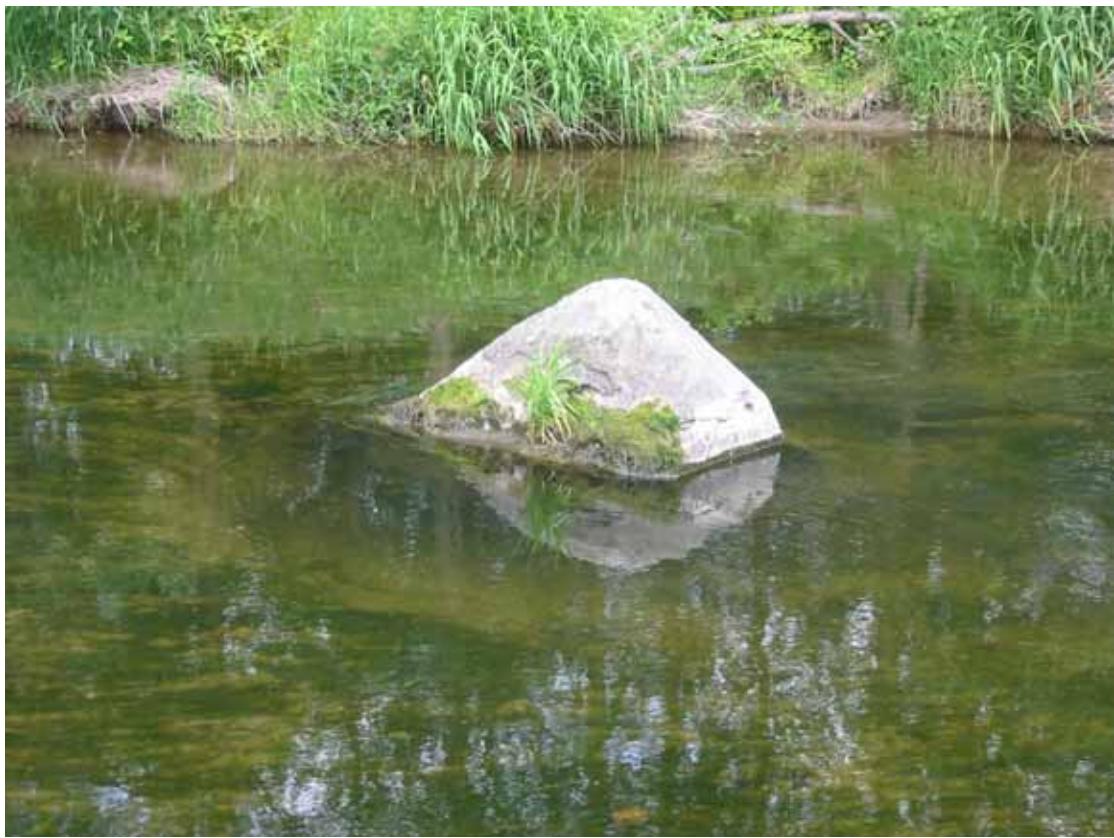
The EA had also introduced a number of individual large boulders to the downstream section of the reach. These had scoured small pools, ideal as holding areas for adult brown trout. In the same section, a medium sized tree had fallen into the river and had become stabilised due to gravel accumulating around it. Localised scour around the tree had also produced ideal holding areas for adult trout.

Individual large boulder introduced to the river by the EA

LWD is a simpler, cheaper and more ‘natural’ way to achieve the same objectives as the introduction of the large boulders by the EA.

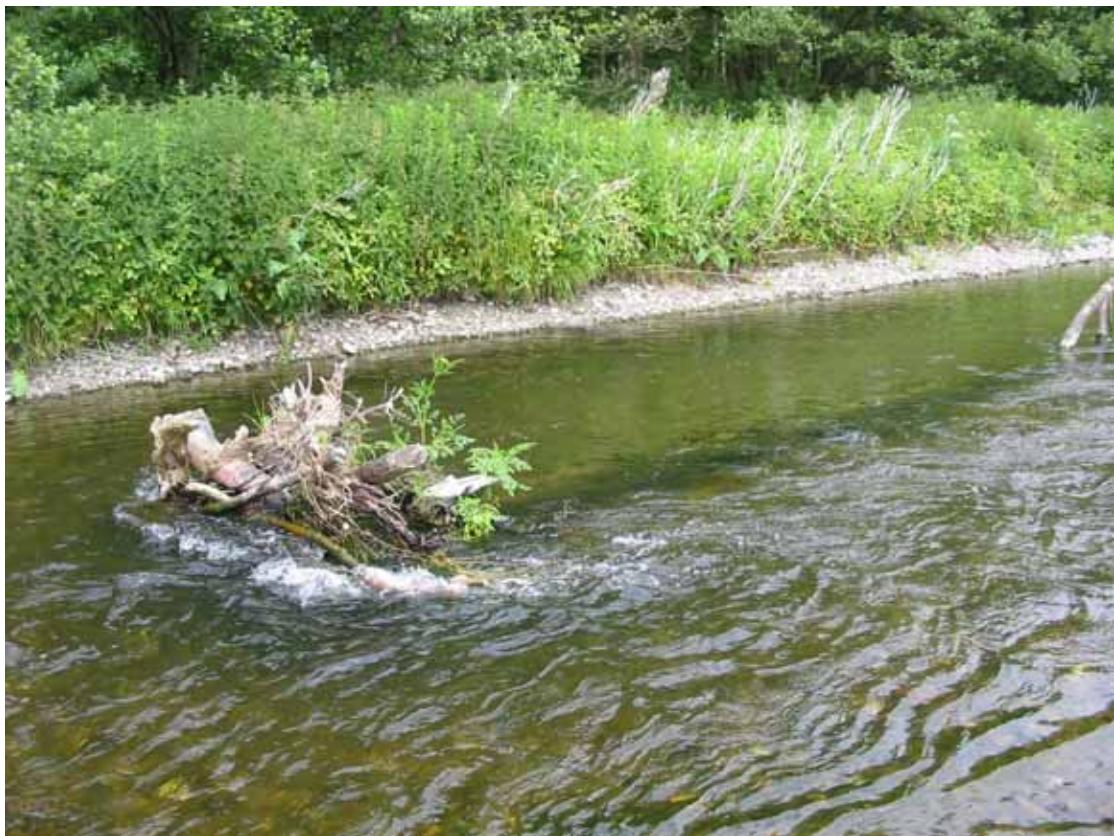
Stabilised fallen tree providing good cover for adult trout

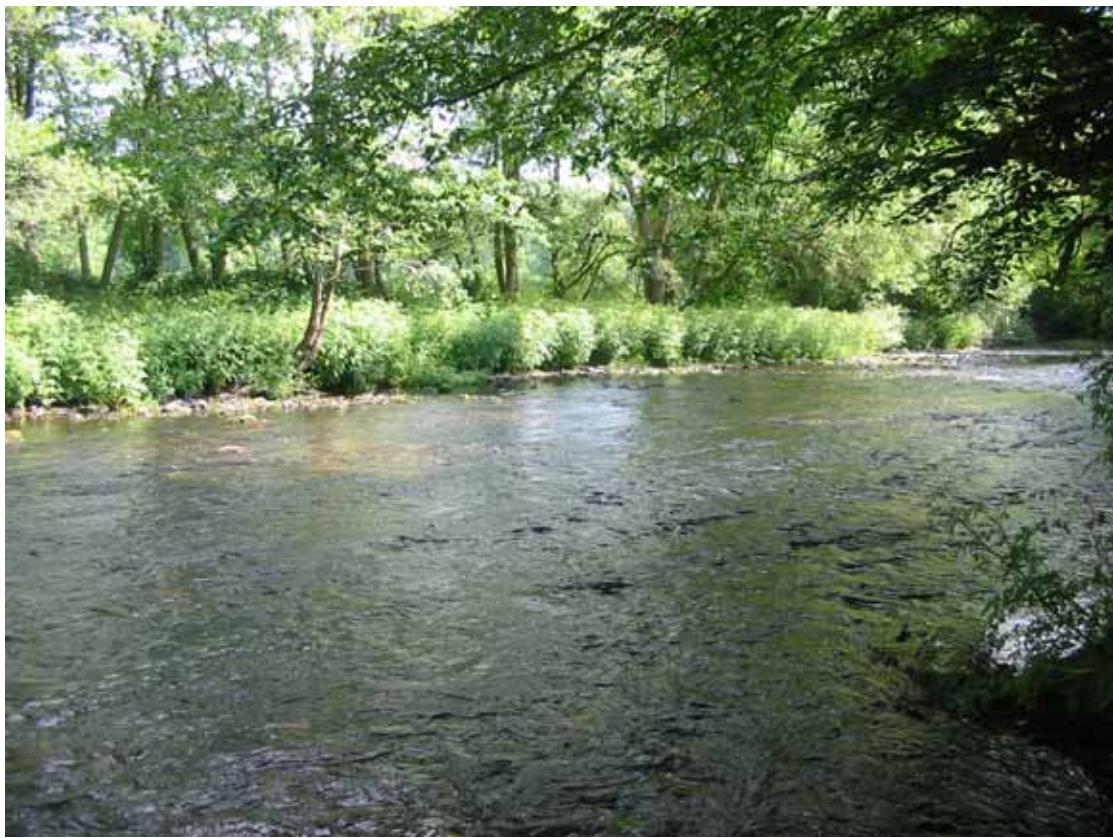
Habitat in this beat of the river was generally excellent, with a well developed pool and riffle sequence, moderate amounts of riparian shading and in contrast to Beat 8, an absence of uncontrolled/excessive erosion. Both banks were well vegetated, with stands of emergent vegetation present.

Beat 2 downstream of Llanyblodwel Bridge showing well vegetated banks and dappled shading of the channel.

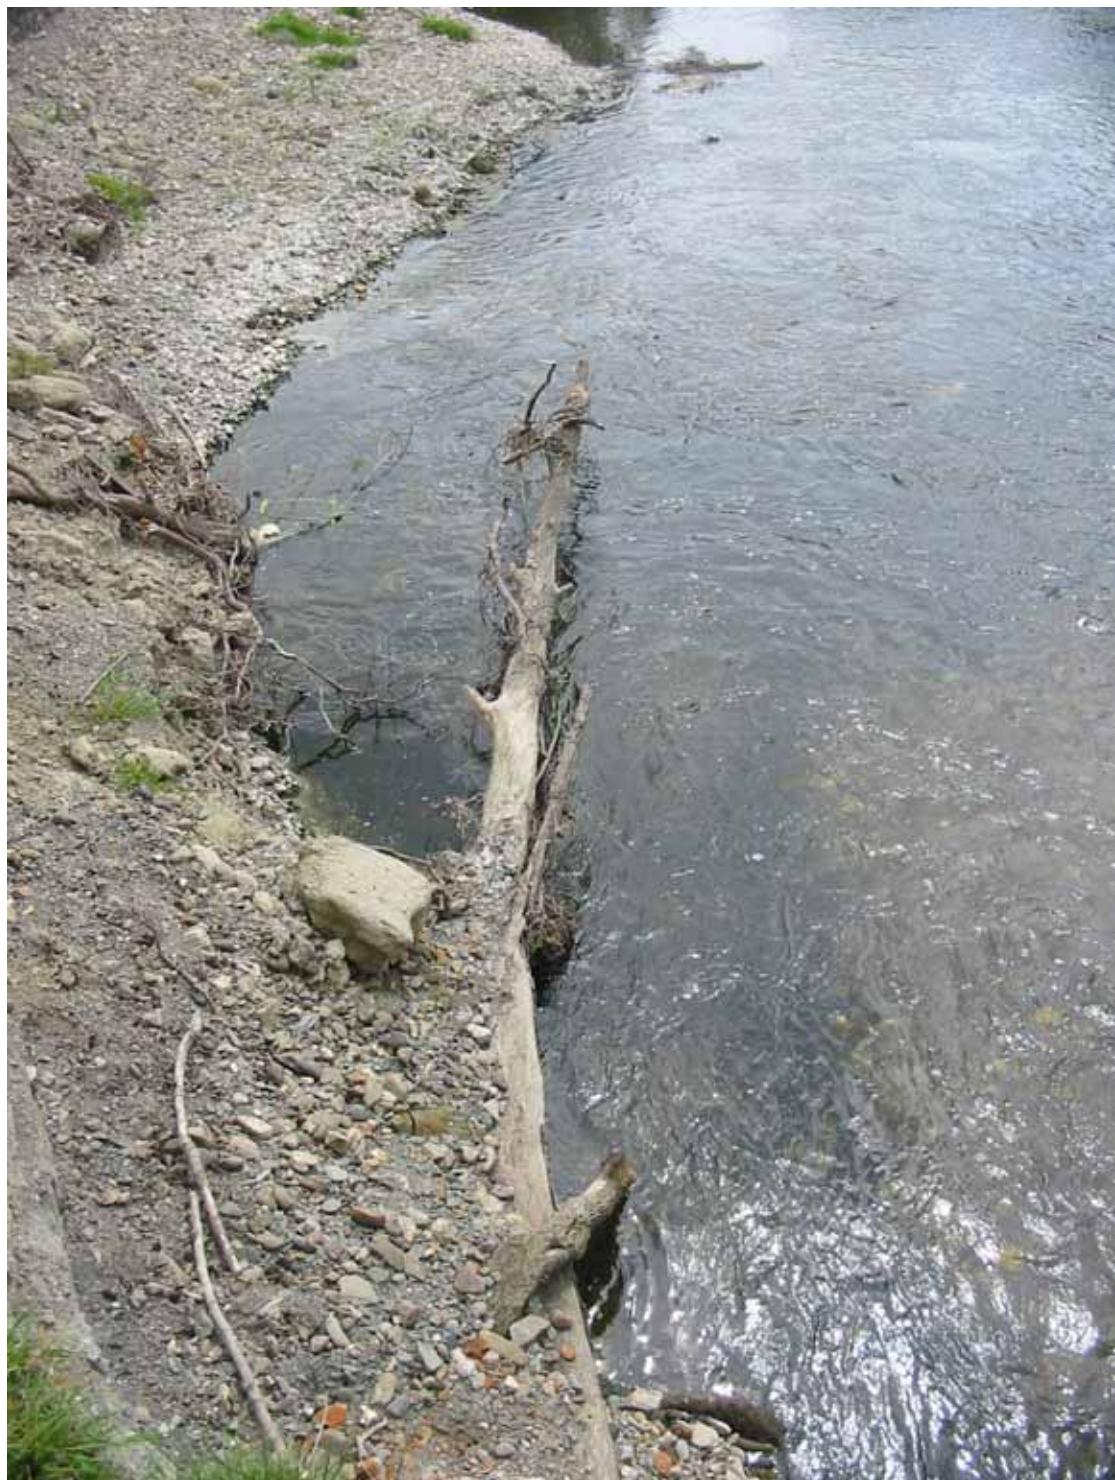
Natural woody debris stabilised in Beat 8. Note that it is not recommended that LWD should be introduced until banks have become well-vegetated following fencing to reduce stock grazing

- In areas where a good growth of vegetation has been established, it may be possible to introduce and stabilise Large Woody Debris (LWD) in order to promote controlled bed scouring. The benefits for retaining LWD are clearly laid out in the recent EA R&D document, “Large Woody Debris in British Headwater Rivers”. Key conclusions of the report include:

Practical management options to increase LWD include making use of fallen timber in order to create simple flow deflectors by wiring/staking these to the bank. These can be used to scour relatively homogeneous riffle areas in order to create deeper pools used by adult fish. These small pools can provide shelter areas adjacent to riffles during spawning periods, increasing the numbers of spawning fish.

It is important that the Environment Agency is made aware of any adopted policy to retain LWD in the channel, in order to prevent its removal during routine management
