Habitat Advisory visit to the Tolka
River, Dublin, Eire
Undertaken on behalf of the Tolka
River Environmental Alliance and
Fingal County Council by Vaughan
Lewis, Windrush AEC Ltd
November 2005

1.0 Introduction

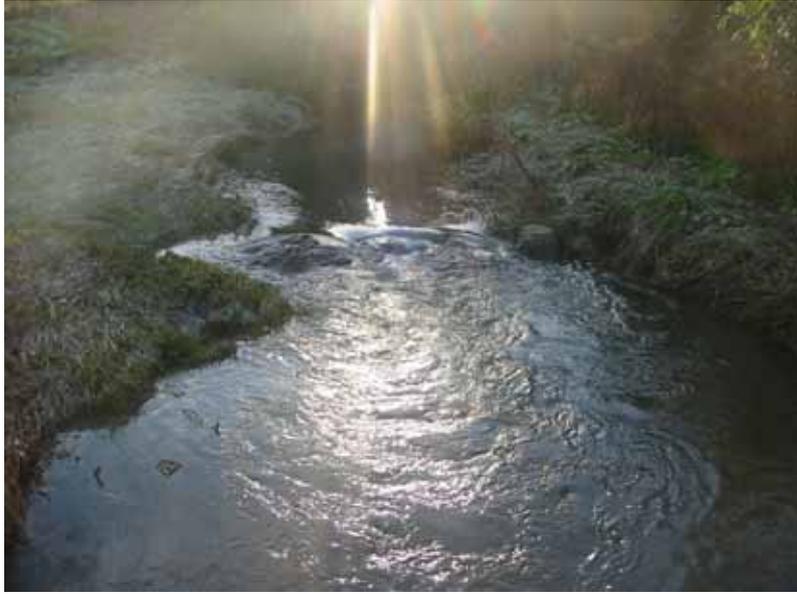
Stone weir creating pool habitat

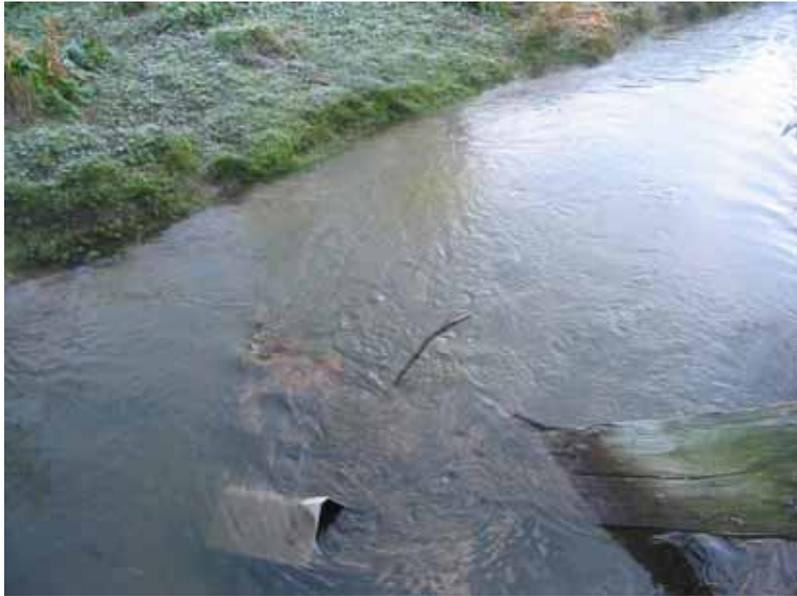
There was some Large Woody Debris (LWD) within the channel resulting from both natural and man-made sources (planks, construction timber etc). Where LWD was present, there was evidence of scouring and sorting of the substrate. However, there was a general lack of bankside trees, limiting both the amount of LWD present, and the presence of tree roots valuable for cover and for protecting the banks from erosion.

LWD derived from construction timber. Note change in flow pattern, resulting in localised bed scour

- The accumulation of stable LWD in the channel should be encouraged. Measures to increase LWD should focus on the provision of cover logs in marginal areas by the simple expedient of trimming small to medium sized trees to an acceptable size and then felling them into the river channel. They can then be pinned into position using driven wooden stakes. Simple paired upstream facing timber groynes are of great value in sorting the gravel in shallow riffle areas, improving spawning conditions for brown trout.

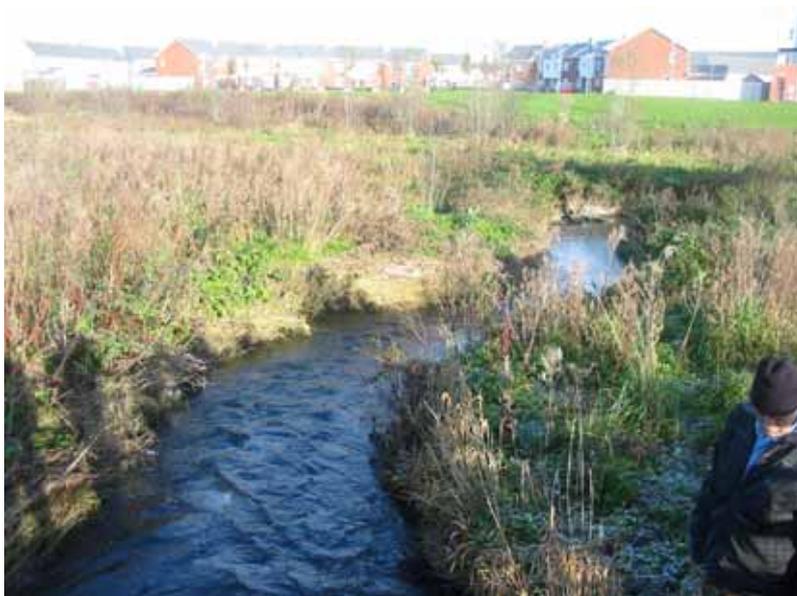
The reach of river walked was near to Blanchardstown, on the north west outskirts of Dublin. Due to flooding concerns related to the redevelopment of the surrounding area for housing, the upper section of the river had recently been realigned. A meandering low level channel had been excavated along the right hand edge of the flood plain, creating an island between itself and the original left bank channel. The new channel was some 2m-4m wide and had a relatively steep gradient, with a series of stone weirs and chutes installed to create pool habitat. Despite the good habitat and relatively strong flow, it is understood that flows during the summer period can be very low with an extensive growth of benthic algae.

Realigned channel showing steep gradient and high water velocity

- There was a general paucity of suitable sites for trout spawning throughout the river reach walked. It would thus be of great benefit to create some additional sections of gravel dominated riffle. These would provide additional lengths of habitat, not only for spawning and juvenile trout, but also for a range of species of macroinvertebrates and aquatic plants. Sites that would be particularly worth considering for riffle installation include directly downstream of the constructed weirs on the newly created river channel. The head difference resulting from these weirs could be run-out over the length of the riffle with no impact on flood risk.

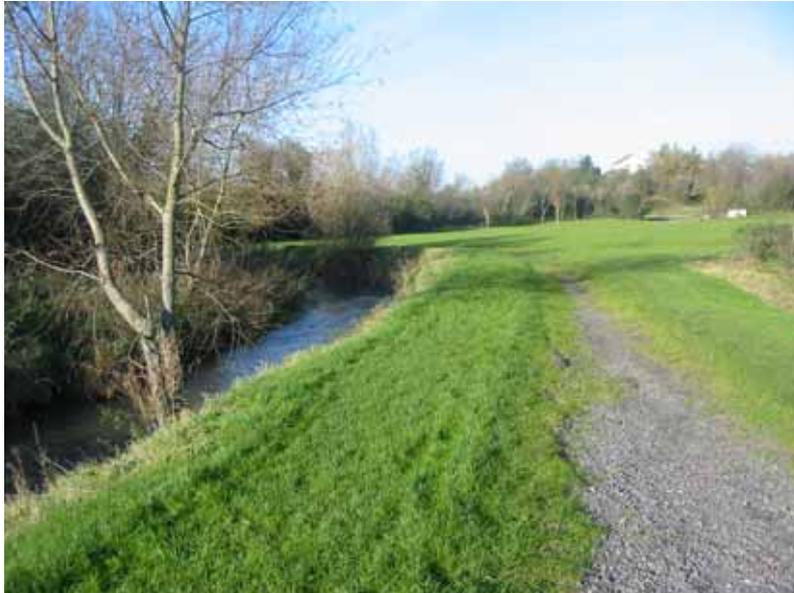
Below the main road bridge, land use on the RB was managed urban parkland. The grass was heavily cut, with a fringe of ruderal vegetation (nettles, docks etc) left

uncut. The LB was dominated by a dense fringe of deciduous trees. These were casting shade over the channel, and had resulted in an increased amount of LWD in the channel. Further downstream, parkland was present on both banks of the river with heavy grass cutting undertaken on both banks.

Managed parkland on RB, with dense tree fringe on the LB

- Management of the river banks through the urban park areas could be improved. The frequency of grass cutting should be reduced to once a year alongside the river, allowing the development of a rough grass buffer strip of >10m width alongside both banks. This would have a number of benefits including:

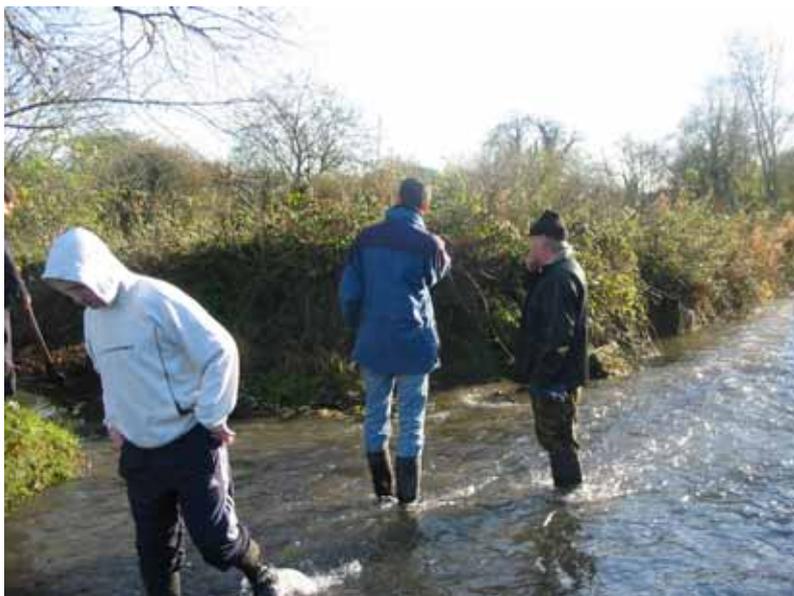
A relief channel had been cut through a wide meander loop upstream of a bridge in the park during the last 10 years, in an effort to reduce flood risk. This had deprived the existing channel of water. The alliance had an aspiration to restore flow to the original channel, which had previously provided a length of good habitat and fishing.

Newly formed cut (RB) with entrance to old meander loop visible on the LB

- The redundant meander loop could be brought back on line by a combination of the careful raising of the height of the riffle in the main channel and removal of the accumulated sediment at the mouth of the loop. This would create an additional length of valuable habitat for arrange of species, with water flow possible all year

round, or during higher flow periods only. A simple level survey would indicate the extent of the necessary modification to the bed topography to effect these changes.

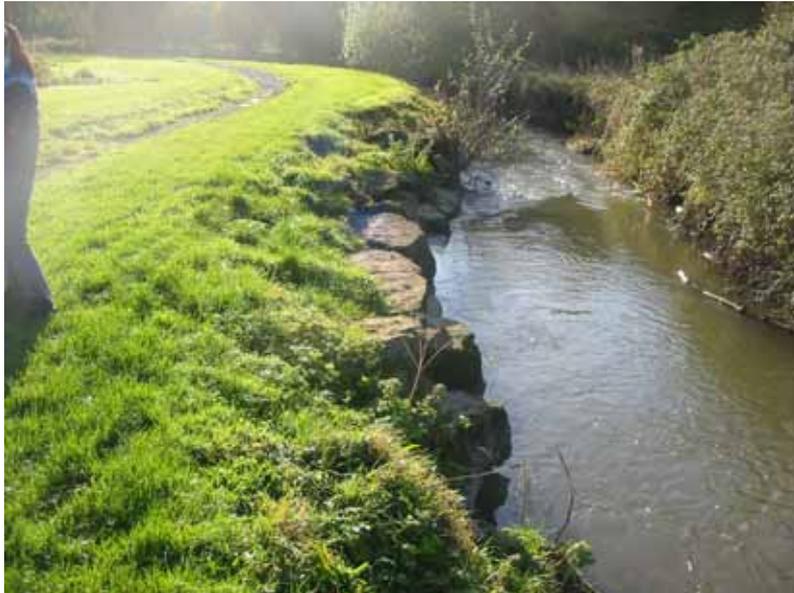
Short sections of the LB of the river within the park had been reveted with stone. This had created an ugly and unnatural profile to the bank.

Section of pitched stone revetment

- A small but significant reduction in maintenance costs for the parks
- The section of pitched stone revetment within the park could be replaced by removing the stone, and cutting a wide low level berm on the outside of the bend. The bank behind the low level berm should then be reprofiled at a shallow gradient, promoting further stability. Once vegetated, the low level shelf would provide a high degree of erosion protection to the line of the new bank behind. The stone resulting from the removal of the revetment could be used to construct small, strategically located groynes, or placed as individual boulders in shallow riffle areas, in order to increase habitat diversity.

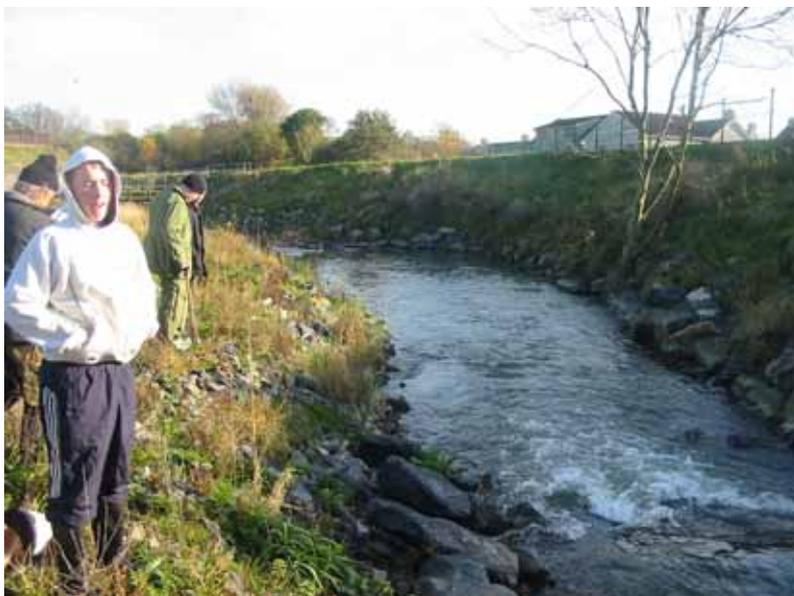
Towards Blanchardstown, there was a section of very heavily engineered channel. This was constructed to allow development of houses close to the river. The channel was heavily incised, with a steep gradient and a series of stone weirs creating cascades and chutes. The bed and banks of the channel were heavily dressed with stone and large gravel.

Engineered section of the Tolka upstream on Blanchardstown

As a consequence of the weir installation, the upstream section of the river was very flat and uniform, with a severely reduced gradient.

- A reduction in the height of the weirs installed as part of the channel modification neat to Blanchardstown would allow the development of more features in the section upstream. This river length had little gradient or variation in habitat as a result of the backwater effect exercised by the newly constructed weirs.

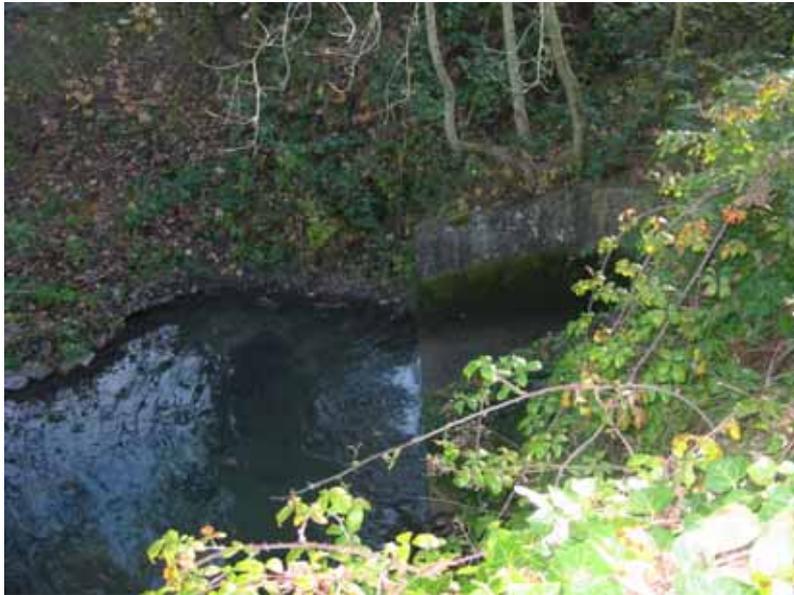
Downstream of the bridge by the hospital, a RB culvert was discharging into the river. There was evidence of sewage fungus in the river at this point, indicative of poorly treated sewage effluent.

Effluent discharging into the Tolka downstream of the hospital bridge

- The source of the effluent entering the river below the hospital bridge should be identified. Pressure should be exerted on the statutory authorities to improve the quality of the discharge. In addition, it may possible to alter the bed profile locally in order to create a shallow riffle area, improving aeration of the effluent.

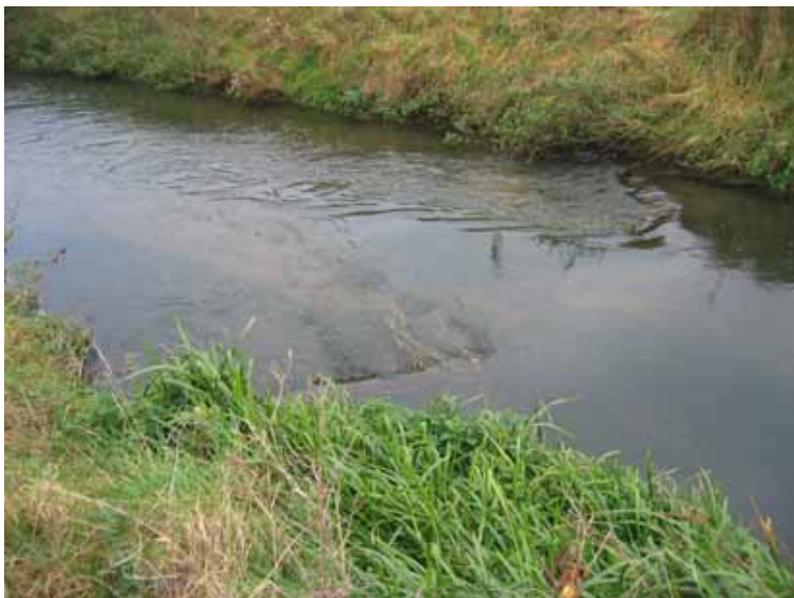
Upstream facing timber groynes showing increased downstream water velocity and scour of spawning gravel
