**ONE DAY ADVISORY VISIT ON
BEHALF OF THE UPPER TEIGN FISHING ASSOCIATION**

Report by :
Tamar Consulting
10 Exeter Street
Launceston
Cornwall
PL15 9EQ
Telephone (08707) 740687
www.tamarconsulting.co.uk

Report and visit sponsored by The Wild Trout Trust

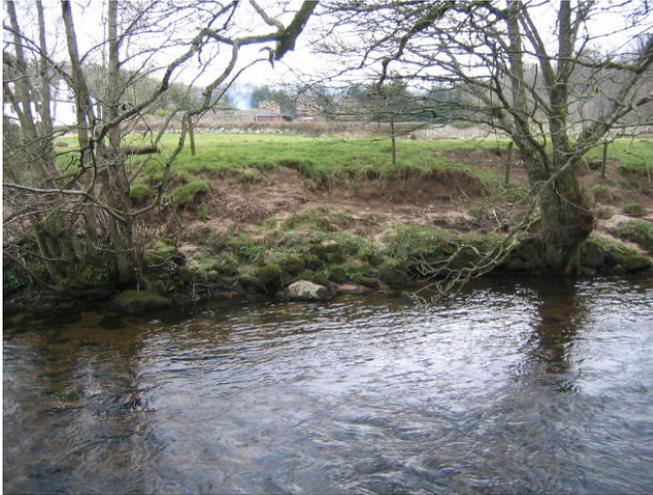
The field below Chagford Bridge (sx693878) and the field above Rushford Bridge (sx703883) on the RHB were showing signs of tight grazing and the largely redundant fences allow stock access (primarily sheep) to the riverbanks. In addition, the RHB field below Chagford Bridge was showing signs of erosion albeit limited to two areas (e.g. Plate 1). Stock access to these riverbanks has hindered the development of bankside vegetation in turn reducing marginal cover, visual isolation and food sources for trout. Parr and adult trout are extremely territorial and the size of territory is directly linked to the amount of cover and availability of food. We would recommend either improving the existing fencing or installing new fencing in order to increase the level and diversity of bankside plants and grasses, provide increased cover and increase important food sources. Bankside plants provide food through terrestrial invertebrates falling directly off the vegetation and secondly, by allowing various invertebrates to complete their life cycle. Additionally, leaves and woody material from bankside plants contribute to the detrital processing systems which supply energy to the rest of the aquatic food web.

Plate 1. New or improved fencing will encourage the growth of bankside plants and grasses, improve bank stability and enhance the riparian corridor.

As these fields are located within the floodplain, stock proof fencing should be installed ensuring there is no increased flood risk. This could be achieved by installing an electric fence however due to running costs and management implications some farmers are unwilling to use this method. Permanent fencing is often the preferred option and there are a number of measures that can be taken to minimise flood risk: use multi-strand wire instead of sheep netting and provide a large buffer, align fencing parallel with flood flow and fit running wires to reduce debris load. Fencing specifications suitable for these areas can be supplied by the Westcountry Rivers Trust (WRT). The landowners should be advised to contact the EA before any new fencing is installed in the floodplain.

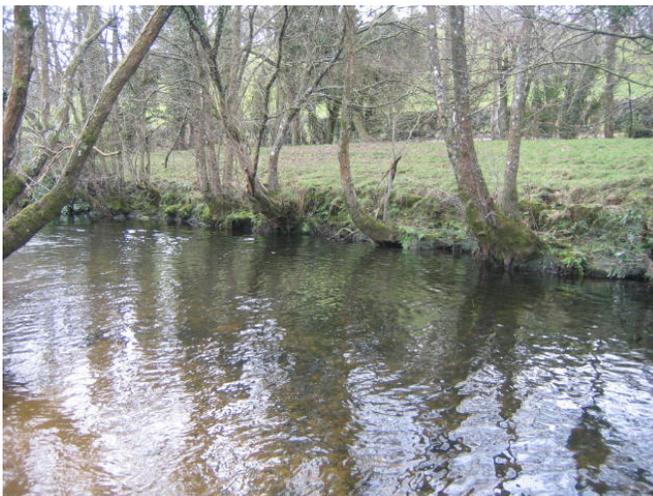
An example of where enhanced bankside cover would improve adult habitat is alongside the deep run on the RHB approx 150m below Chagford Bridge (Plate 2). Whilst there is currently sufficient overhead shade cast by the bankside trees there is little lower storey cover offered by overhanging grasses and plants. Once fencing is installed, plants will soon re-colonise the banks and in time the UTFA may even need to selectively management the banks in order maintain access for casting (from the LHB). One technique for managing land behind fences is to encourage light grazing during drier times of year although this should be restricted to the odd day and does rely on close monitoring by the farmer.

Plate 2. Increasing the level of bankside plants and grasses over deeper runs and pools will help to improve cover and refuge for larger trout.

In order to maintain stock access to watering we would recommend either installing off-stream drinking via troughs (fed by mains supply or water drawn from the river)

or provide designated drinking points at the riverbank. Plate 3 shows a drinking point in the RHB field above Rushford Bridge which indicates good farming practice (although there is scope for slight repair). Drinking points should be constructed in order to minimise flood risk, reduce the potential to catch debris and importantly have a hard standing to reduce poaching resulting from the effects of stock movement. Designs suitable for this location can be supplied by WRT. If river water is used supply troughs (and depending on the volume taken), an abstraction licence may be required from the EA

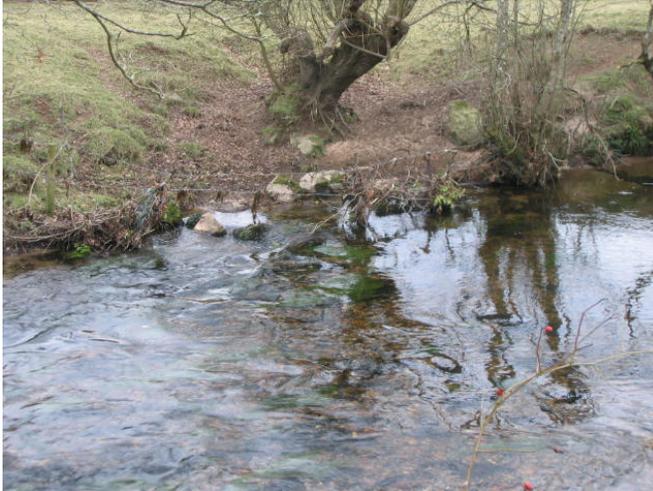
Plate 3. A stock drinking point in the field on the RHB above Rushford Bridge.

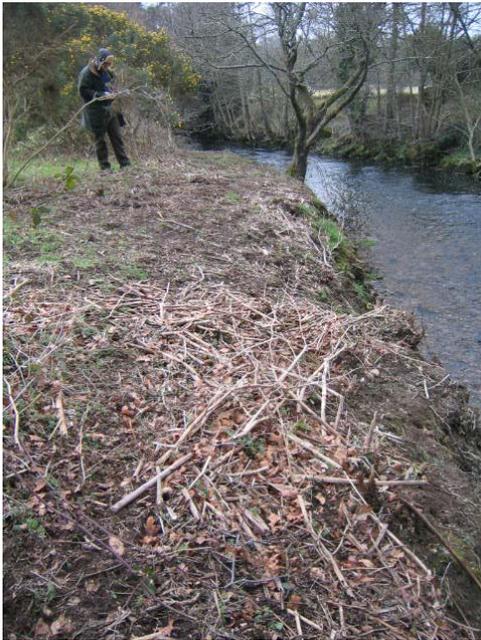
The stand of Japanese Knotweed at sx702892 (LHB field below Chagford Weir) has been partially treated and whilst it is encouraging to see this plant being controlled there are several ways in which the methods employed could be improved. Firstly, it is advisable *NOT* to dig up the rhizomes as it is highly unlikely that all will be removed and this can result in increased rhizome growth thus exacerbating the problem. Secondly, we observed that whilst efforts had been made to burn the uncovered rhizomes many were only scorched resulting in new growth (Plate 5). We would advise early treatment of both stands and in particular aim to treat the uncovered rhizomes as this could create a new stand on grazing land. We would also recommend the UTFA contact the DNPA and Devon County Council (Knotweed Forum) to discuss a catchment approach to controlling this plant. The most effective way to rid a catchment is through a co-ordinated approach starting at the uppermost reaches and working downstream. Guidelines on controlling Japanese Knotweed can be found in Appendix 2.

Plate 4. An area where Japanese Knotweed rhizomes (and dead stems) have been removed. Note the lack of vegetation and bare soils which are subsequently at risk of erosion during spate conditions.

- Growths of Japanese Knotweed should, in general, be treated as soon as possible according to guidelines set out in Appendix 2. However we would advise the UTFA to contact DNPA and Devon County Council to see if a catchment wide programme for removing Knotweed is planned for the river Teign. The UTFA can play an important role in controlling the spread of this plant along the river.

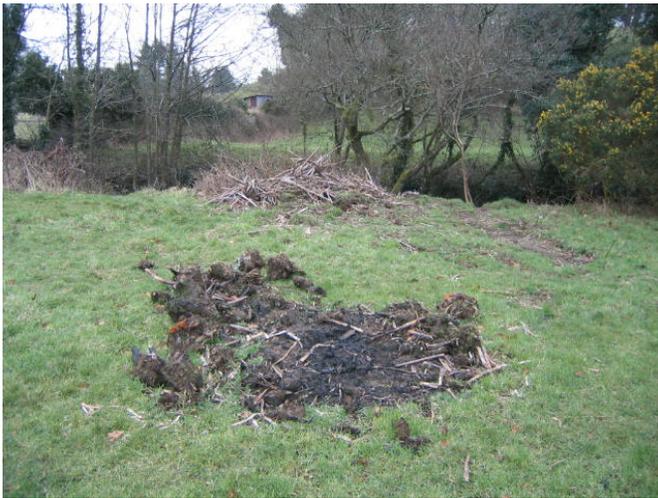
Plate 5. A pile of partially burnt Japanese Knotweed rhizomes.

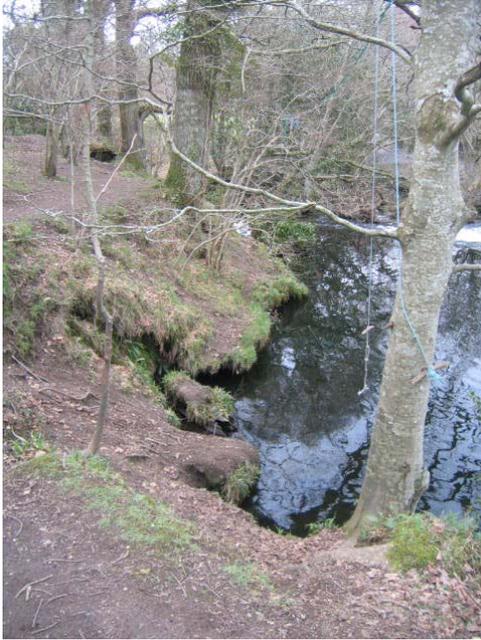
The Two Moors Way, a public footpath, extends for the whole of the survey reach (on the LHB) and whilst we observed few direct impacts to the fishery, an area of bank above Chagford Weir has become eroded (Plate 6). This would seem to largely stem from the use of the footpath and nearby rope swing and whilst unlikely to cause any lasting impact to salmonid habitat, increased activity in this area may cause problems for anglers wishing to fish the Weir pool.

Plate 6. Localised bank erosion caused by use of the footpath and nearby rope swing.

If public access and use of the footpath were deemed to be causing conflict between other river users or tourism interests were a priority, the area between Chagford Bridge and Chagford Weir LHB would make good location for an 'interpretation

point'. This could be used to explain local wildlife and associated habitat requirements, current management of the river and any other features of interest. Promoting a wider understanding and appreciation of the local environment will help to reduce potential areas of conflict.

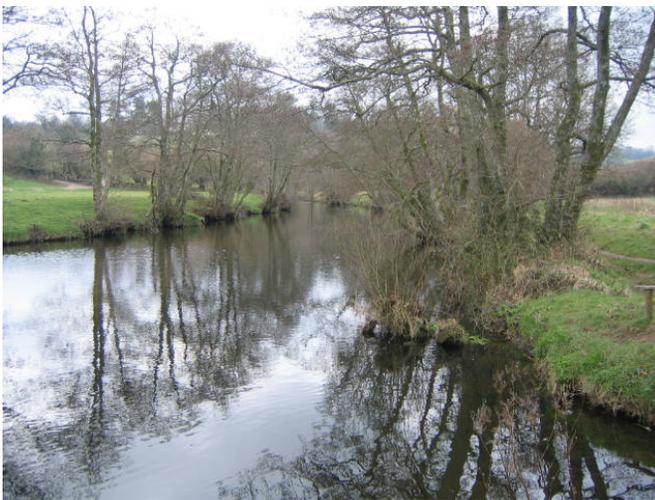
The LHB and RHB above Chagford Weir appear to be regularly cleared with mown grass banks and limited bankside diversity. Although access to the river needs to be maintained it is possible that over zealous management of the banks could be reducing valuable cover (Plate 7). We would recommend therefore that for improving habitat, sections of bank should remain untouched and only selected areas should be routinely cleared (for access, views etc). The growth of overhanging bushes and shrubs will significantly increase bankside cover and encourage trout to move away from the deeper parts of the river and take up station across the whole channel.

Plate 7. A section of deep water above Chagford Weir with 'mown' banks and little lower level cover.

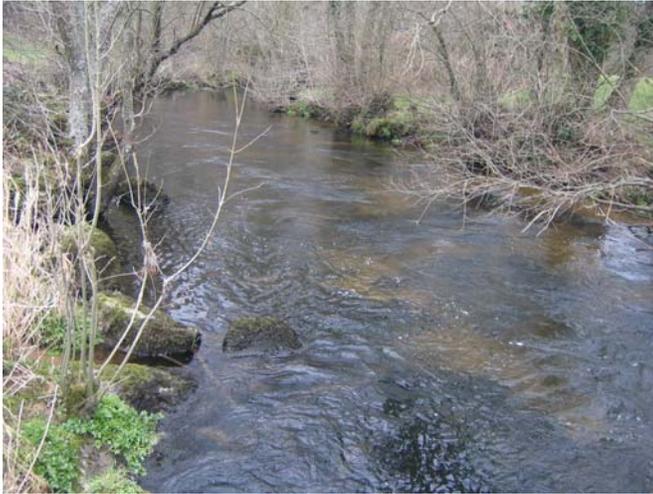
Plate 8. Good trout habitat with high levels of instream and bankside cover below Rushford Mill Farm

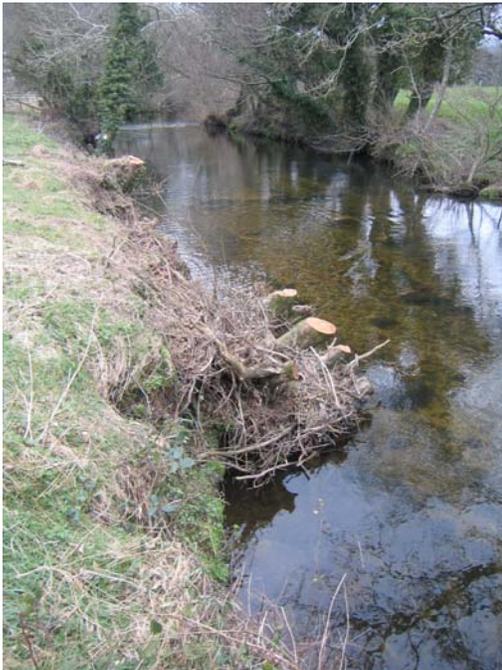
The UTFA organise bank clearance days with the aim of improving access and this shows a responsibility to the needs of its members. For example, an area of LHB has been cleared below Rushford Bridge at sx706883 in order to improve access to a pool that would likely hold both resident and migratory trout. It is important however to target works in order to minimise knock on impacts to habitat. The removal of trees over pools and deeper glide will affect the level of shading, cover and therefore refuge provided in the area. Also, shade is very important for regulating water temperature and will help to keep areas cooler in summer thus allowing for higher concentrations of dissolved oxygen as needed by adult salmonids.

Plate 9. A section of cleared riverbank. Aim to retain a dappled shade over deeper runs and pools in order to provide cover and refuge.

In the future it is recommended the UTFA target the removal of bankside trees so that a balanced approach is taken and importantly aim to retain dappled shade over pools and deeper water which is preferred by adult trout. A good option is to try and roll the

programme of bank clearance over a number of years so that only a portion of the bank gets tackled in any one year. Although this is not always practical it will essentially help to steadily improve the riparian strip whilst retaining greater bankside diversity. If access to pools cannot be resolved without clearing long sections of bankside vegetation the UTFA may consider providing access into the river (steps, ladders) and encourage anglers to fish from within the river.

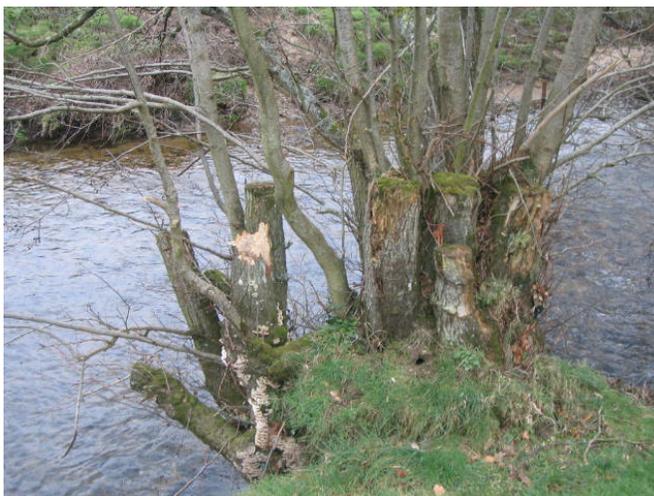
There is evidence of previous coppicing along several sections of the river indicated by the development of multi-stem tree growth. Whilst we observed no significant overshadowing of the river and banks (and associated erosion problems) there may be scope, in the future, for light trimming or singling in order to improve light levels onto the banks and encourage the growth of bankside plants and grasses. There may also be a need for selective coppicing in order to limit the potential for excessive shading over riffle areas which are suitable for fry production. Increasing light onto shallow riffles will result in an increase in primary production with knock-on benefits to juvenile salmonids. For example, this could include areas such as approx 100m below Chagford Bridge where we observed good salmon spawning and fry habitat.

Plate 10. Previous coppicing and new growth of multi stem stool in field below Chagford Bridge LHB.

We would generally recommend assessing multi-stem trees to ensure that the weight of the stems are not destabilising the root ball and excessive baying is not occurring. As mentioned, it may be appropriate to carry out selective singling of multi stems and we would advise initially focussing on areas where new fencing is to be installed (i.e before access is reduced). In the RHB field below Chagford Bridge for example, several smaller multi stem trees could be trimmed back improving bankside growth with no impact on the overhead canopy. In addition, the method of ‘hinge-cutting’ trees can be used where baying occurs or marginal cover needs enhancing. This method involves partially cutting the tree stems approx 2ft above the ground and laying the stem alongside the bank (in a downstream direction). The horizontal stem should be secured back to bank. The stem will help to protect the bank, gathering sediment and other debris and provide valuable habitat for salmonids and other wildlife. Before carrying out any such works please read the EA Code of Good Practice for Bankside Coppicing in Appendix 1.

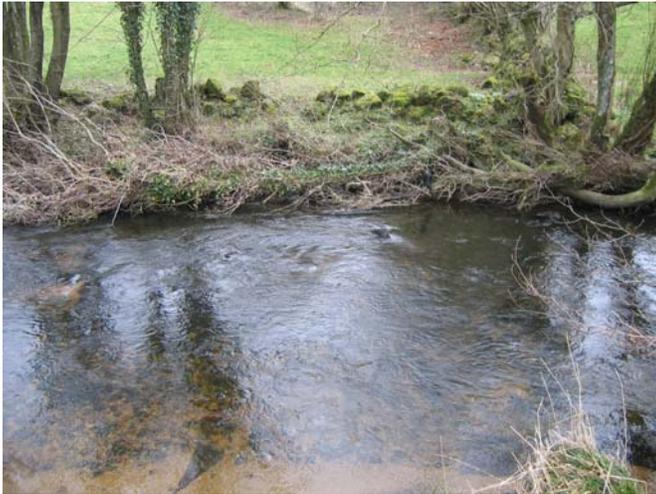
Salmonids of all ages will benefit from the presence of woody debris along the banks and in the river as it provides good cover and refuge. For example, the Trust has seen a strong correlation between adult brown trout abundance and the incidence of coarse

woody debris (CWD). In addition, woody debris can deflect currents which scour out new pools and form riffles in the river essentially creating new habitat. Wood itself is of poor nutritional value although a huge variety of organisms within the river are associated with it. CWD retains leaf litter which acts as an energy reservoir for the river section as well as providing a substrate for unique invertebrate communities. In general we observed little instream woody debris over the survey reach and this could be contributing to under-utilisation of otherwise suitable habitat by adult trout. It follows that as a general recommendation, we would encourage the UTFA to leave as much CWD in the river as possible. Whilst it is naturally important to retain access to pools and deeper runs, the benefits from increased cover and instream diversity are extensive.

Plate 10. Coarse woody debris offering bank protection and providing increased habitat diversity

- In general, we would advocate leaving as much in-stream coarse woody debris as possible. The benefits to increasing habitat for salmonids, improving bank stability and enhancing the overall diversity of the river is extensive.

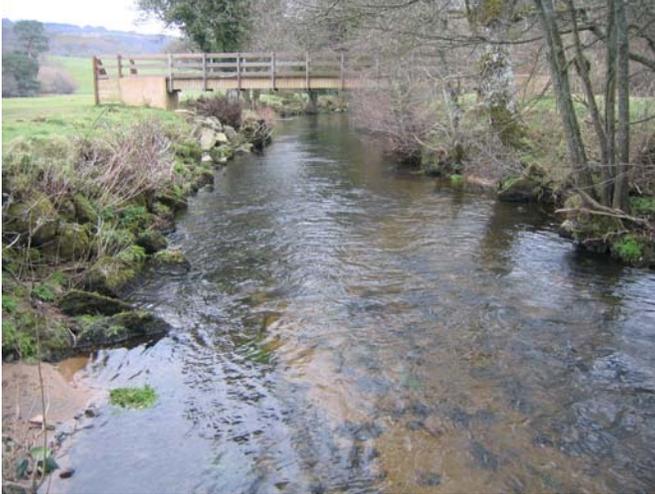
This section consists of a stretch of deep glide running from Dogmarsh Bridge downstream for approx 450m which offers suitable adult habitat with reasonable to good levels of instream cover. There follows a section of shallow riffle/run before the river opens out into Drogo Weir pool, an approx 150m section of deep water offering good adult salmonid habitat and prime fishing potential. Overall, there is little scope for habitat works along this section of water although as a general recommendation, retaining high levels of bankside cover on the LHB (from Dogmarsh Bridge to below the footbridge) would be beneficial to larger salmonids. This has to be balanced with the need to retain access for fishing and views of the river from the footpath running on the LHB.

Plate 11. A long section of glide below Dogmarsh Bridge

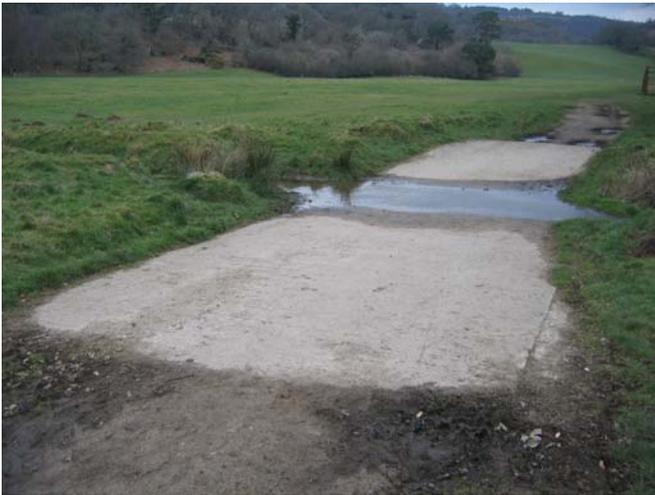
Plate 12. Hardening stream crossing points is good practice and will reduce poaching and sediment inputs into the river.

Several small stands of Japanese Knotweed were found at the inlet of the tributary LHB (sx717894) and just below the footbridge on .LHB. We would recommend treating these growths before further development and in order to reduce potential impact from human or stock activity in this field. Good agricultural practice can be seen as the National Trust has hardened the crossing point on the LHB stream flowing into the main river. This will reduce poaching of the stream and surrounding land thereby lowering sediment inputs into the main river.
