**AVISORY VISIT TO THE GRANTHAM ANGLING
ASSOCIATION FISHERY AT BELTON HOUSE,
RIVER WITHAM, LINCOLNSHIRE
UNDERTAKEN BY VAUGHAN LEWIS,
WINDRUSH AEC.
SEPTEMBER 2005**

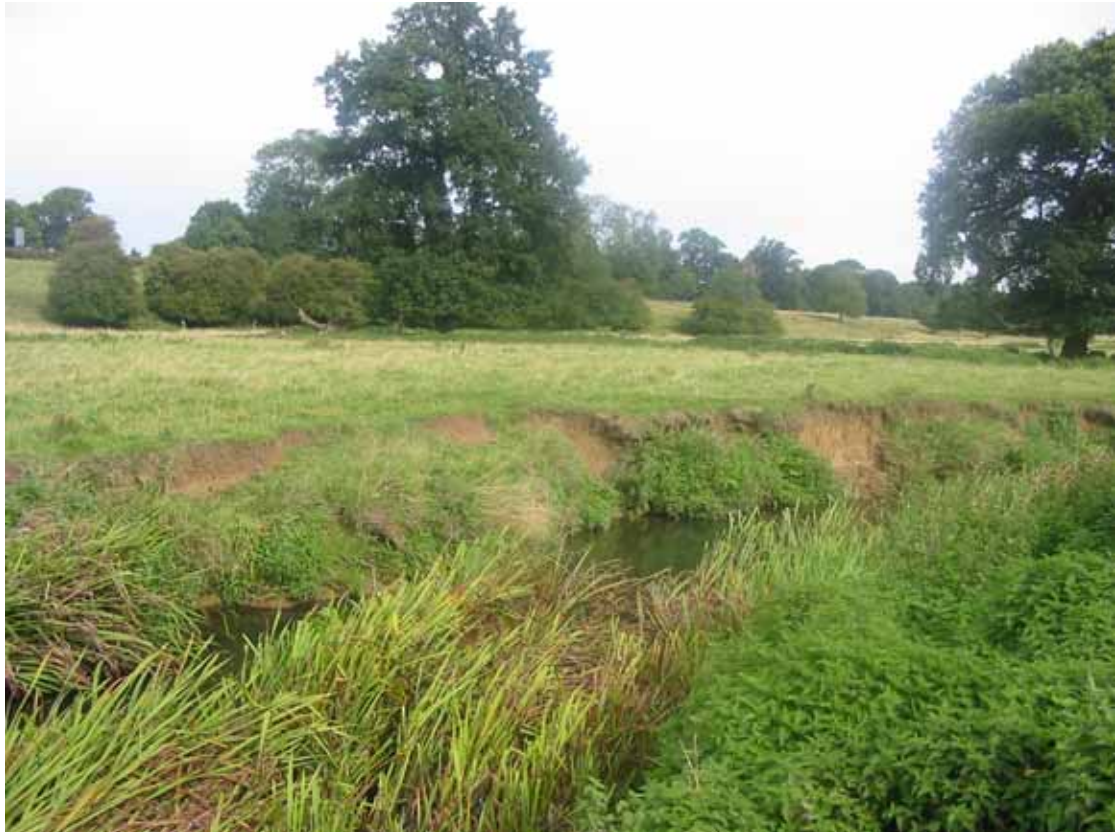
Section of extensive bank slippage, largely attributable to overgrazing by sheep. Note also extensive growth of emergent vegetation

- Of prime importance for both the general improvement of habitat quality, and for the provision of optimum conditions for the success of proposed enhancements, is the reduction in over-grazing of the riverbanks by sheep. Whilst *controlled* erosion is an important feature of natural geomorphological processes, the erosion noted at Belton was both excessive and ecologically damaging. The present grazing regime should be modified, either by a significant reduction in stock density, or more likely, by fencing of the riparian zone. This could be facilitated using either permanent fencing or temporary electric fencing. Ideally, the latter system should be employed, not only preventing damage to the river margins, but also allowing controlled grazing of the water meadows, promoting their botanical interest.

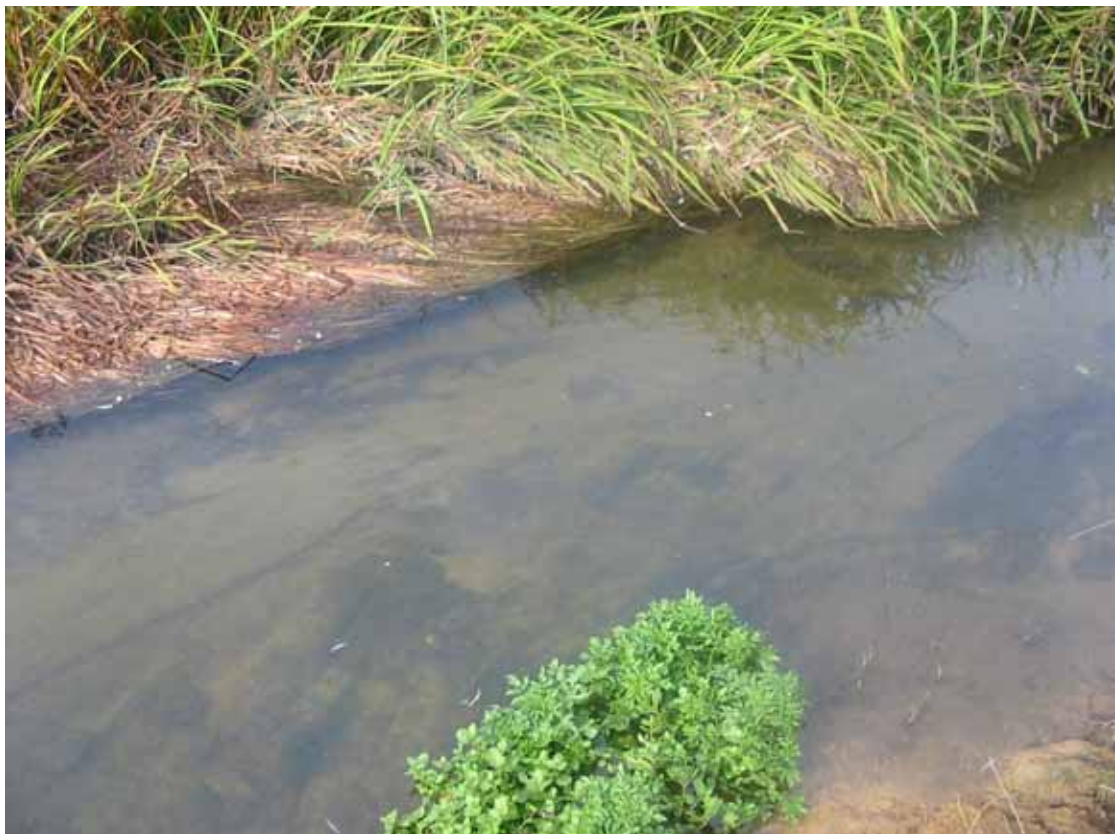
Fine sediment coating the bed of the river

Land use on both sides of the channel was unimproved/semi-improved grassland. Comments from Phil Smith (EA biodiversity officer) confirm the significant botanical value of this grassland. The meadows were being managed by intensive sheep grazing. It was not clear whether this was a suitable regime to optimise the conservation value of the fields. What was apparent however, was the very significant damage that sheep grazing was causing to the riverbanks. Impoverishment of the riparian vegetation has caused weakening of the banks, with consequent significant bank slippages common. Large blocks of clay were noted in the river, with fine sediment coating much of the riverbed.

- In combination with channel narrowing, bed raising should be used strategically in order to reduce the cross-sectional area of the channel, thus increasing water velocity. The creation of gravel-dominated riffles would also increase the availability of this valuable and under-represented habitat type. A range of species is associated with gravel riffles, including spawning/juvenile brown trout and white-clawed crayfish.

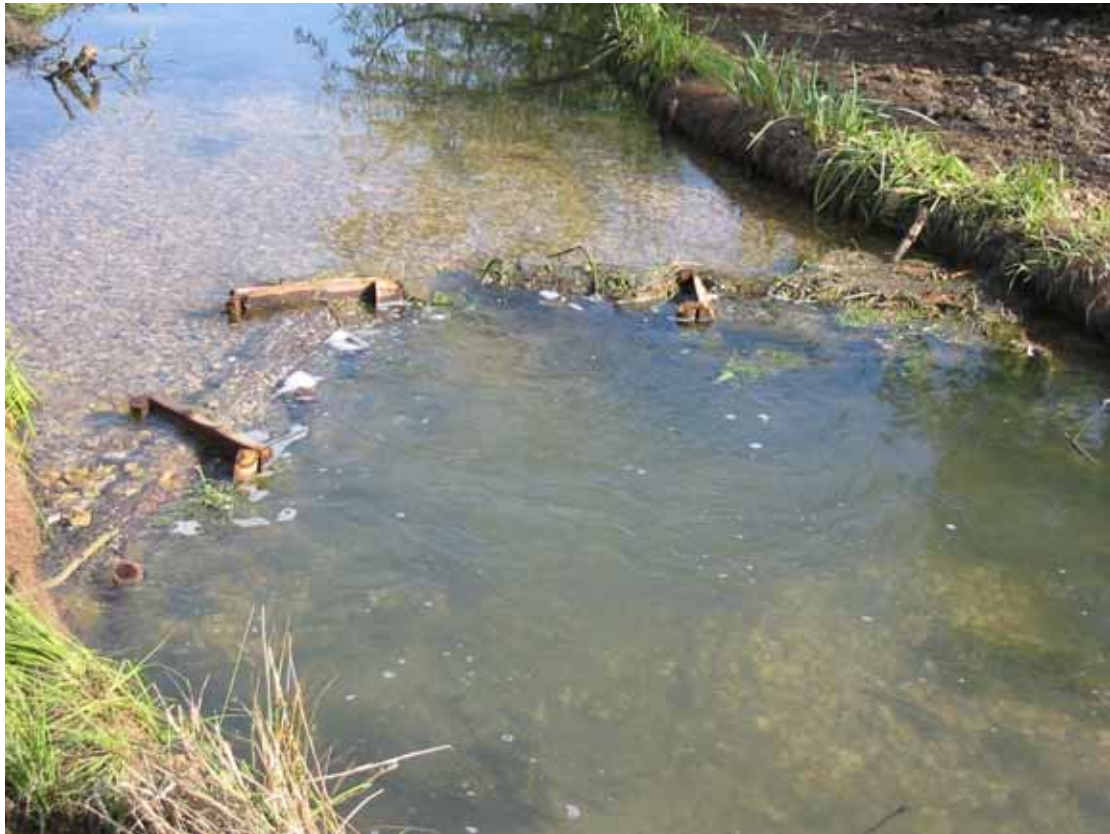
Wooden ‘v’ shaped groyne installed on gravel riffle. Note gravel backfill upstream of groyne and pool scoured downstream

- The few areas of gravel riffle present could be improved by sorting of the substrate in order to increase bed diversity and improve spawning conditions. There are a number of ways of doing this, with perhaps the best being the use of paired 'v' shaped wooden groynes. These are simple structures that can be constructed by staking a pair of large wooden logs to the bed in a 'v' shape, in the centre of the riffle, with the apex of the 'v' facing upstream. The upstream face of the paired groynes should be filled with large stone and gravel in order to reduce flow under them; the intention is to force water over the groynes, scouring the bed downstream.
