Overview of habitat enhancement
opportunities on the River Wandle,
London

Undertaken on behalf of The Wandle Trust
by Vaughan Lewis, Windrush AEC Ltd

November 2005

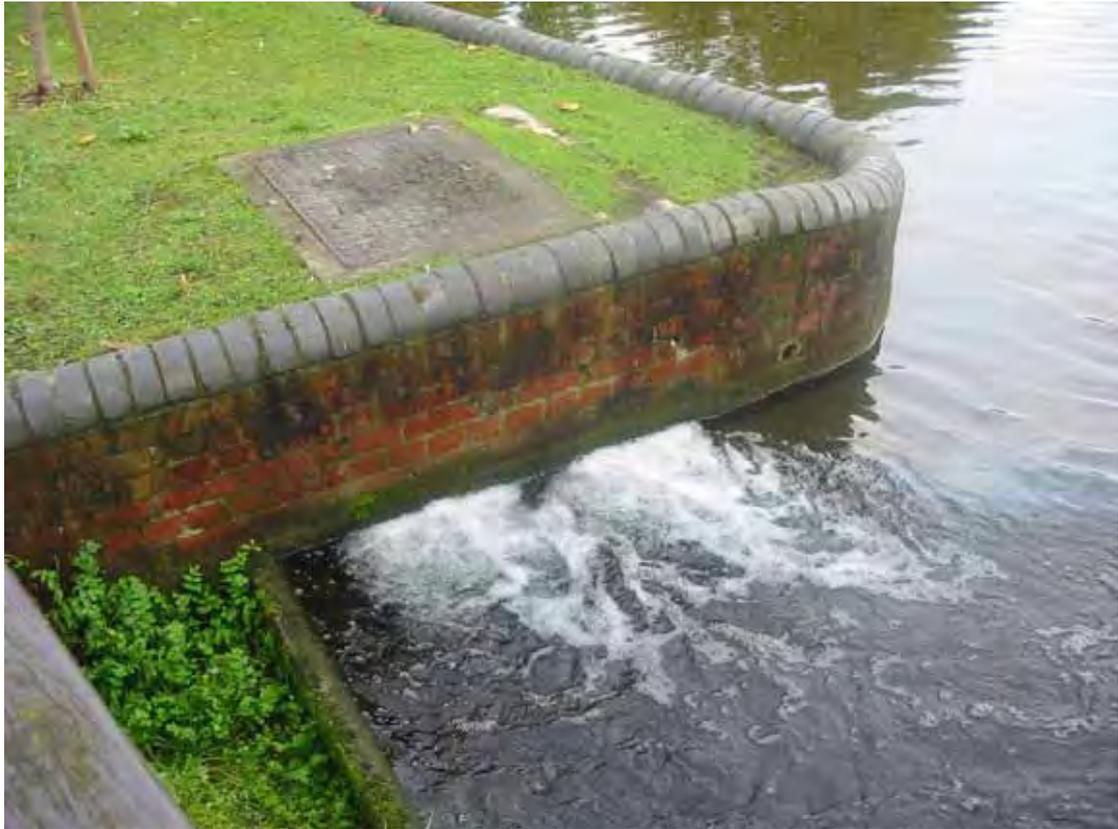
The effective source of the River Wandle was immediately upstream of Carshalton Ponds. Groundwater recharge to the pond had been significantly affected by abstraction. As a consequence, augmentation flow was provided by Sutton and East Surrey Water Company, using a recirculation system. Water was abstracted from the Wandle immediately upstream of the discharge of the Beddington STW outfall, with water subsequently being discharged into a channel feeding the upper pond in Grove Park. It is understood that under the abstraction licence held by Sutton and East Surrey Water Company, the augmentation should provide a guaranteed minimum flow of 4.5 Ml/d. Contemporaneous records from JetSet (reported to the Environment Agency) show that this condition of the abstraction licence has been breached on a number of occasions, with augmentation flow reduced to zero.

Augmentation flow discharging into upper Carshalton Pond

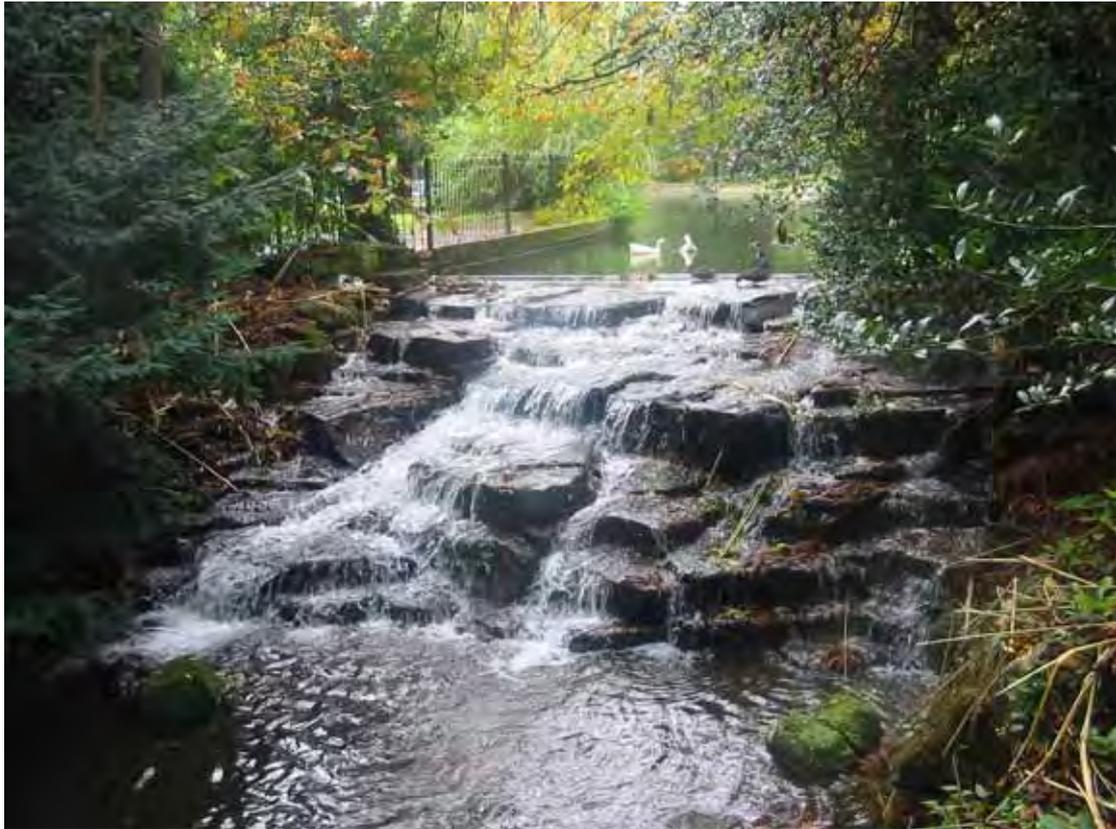
Ornamental cascade preventing upstream migration of fish

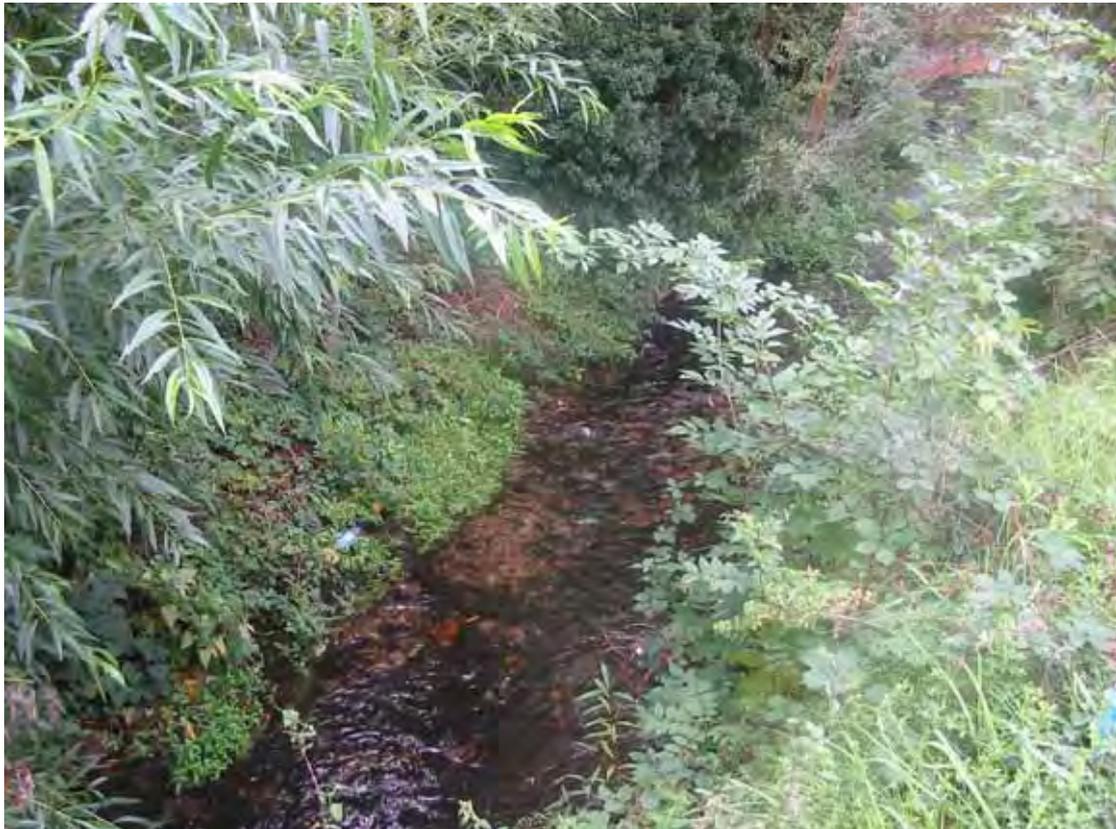
Channel downstream of pedestrian footbridge

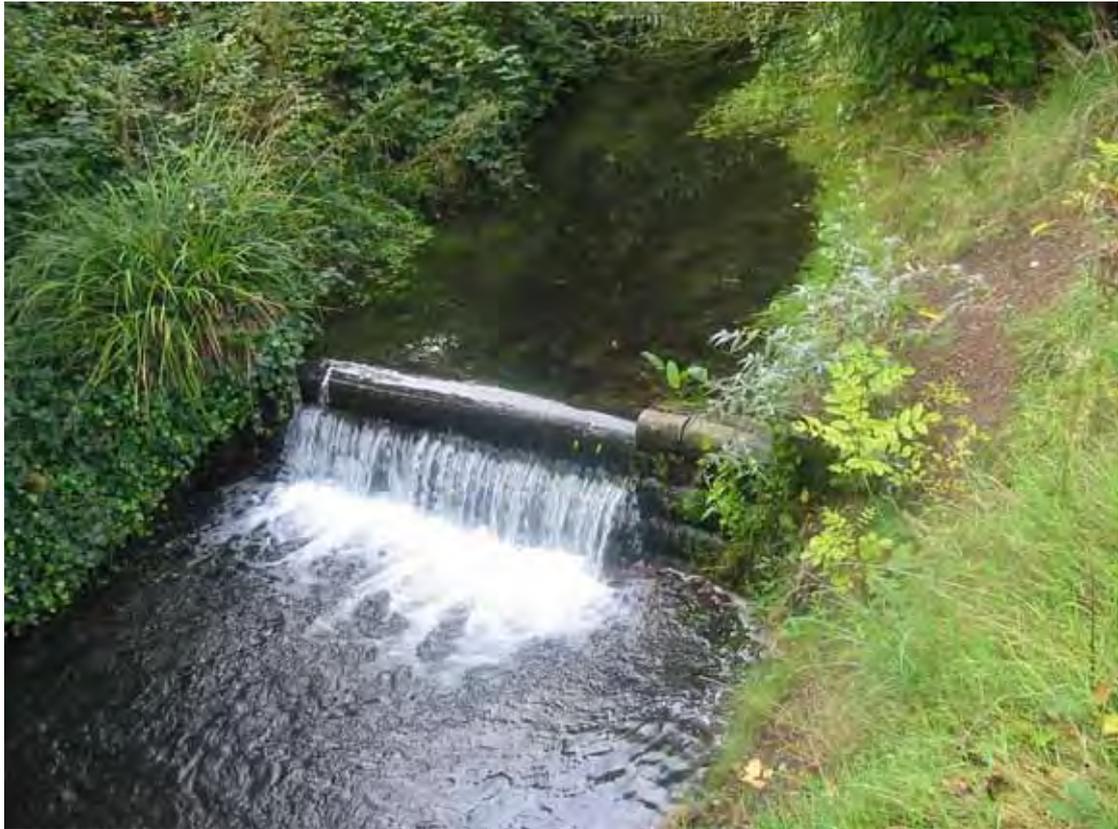
A small impoundment with a head loss of some 0.5m was present adjacent to Paper Mill Close Bridge. This was constructed from engineering bricks and blocks. Its purpose was unclear. Over a range of discharges, it would affect upstream migration of fish adversely.

Impoundment at Paper Mill Close Bridge

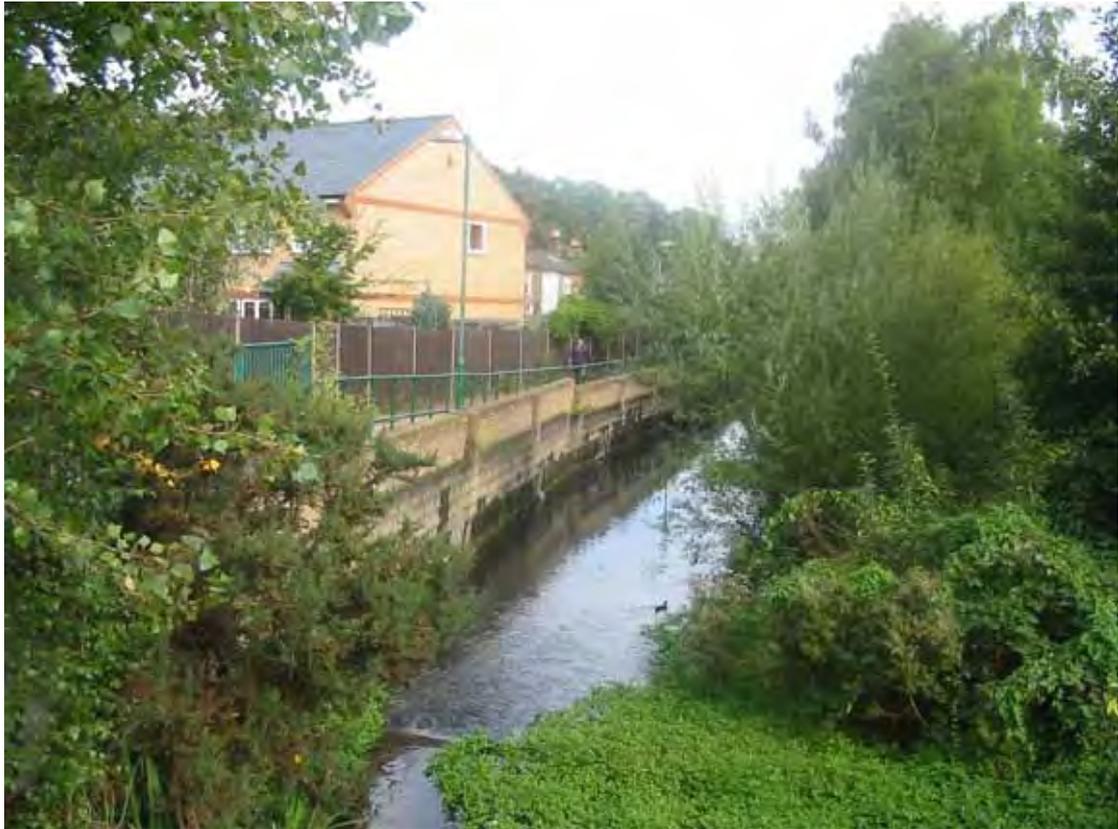
Downstream of the wooden footbridge at Butter Hill, the LB was reveted by vertical concrete walls, with a drop of some three metres from the footpath to the water. There was extensive shading cast by the dense riparian tree fringe on the RB.

Downstream of Butter Hill Footbridge showing vertical concrete revetment and small impounding weir

As a consequence of the concrete wall and tree shading, marginal vegetation growth was restricted.

- Downstream of Butter Hill Bridge, the combination of RB tree shading and vertical concrete revetment had combined to limit the growth of marginal vegetation. Rotational coppicing (as described above) would reduce shading in this section of channel. In addition, it is recommended that a two-stage channel should be constructed along the LB of the existing channel. This should vary between 0.5m and 2m in width in order to create an element of sinuosity within the river and should be constructed from chestnut stakes and coir fibre rolls/faggots as described for Reach 1.

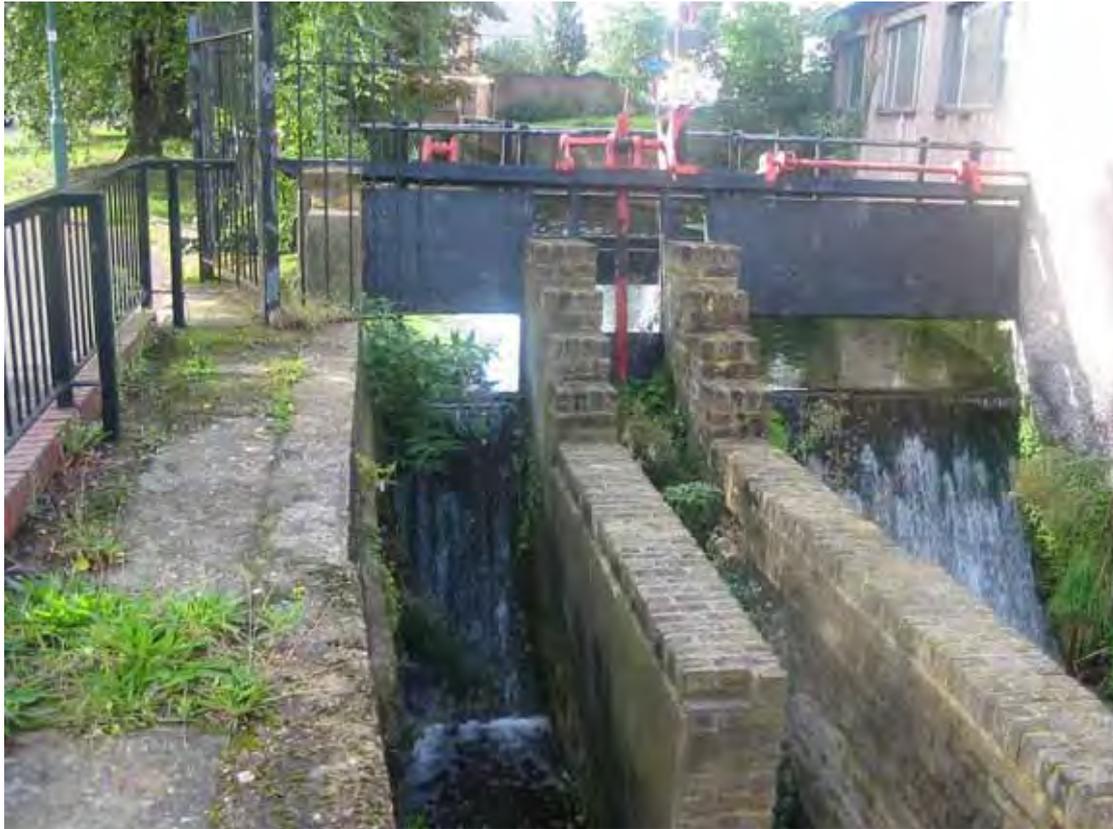
The downstream limit of Reach 2 was marked by the presence of an old mill impoundment, retaining a head of water of approximately 2m. The backwater effect of this mill was expressed upstream to the small weir at Butter Hill Footbridge. As a consequence, instream habitat was deep/shallow glide, with a substrate dominated by a deep layer of fine sediment. The impoundment comprised of two fixed outer weirs, with a central variable sluice structure. The presence of the mill structure prevented any upstream migration of fish, effectively isolating fish populations in the two adjoining reaches. The construction of a fish pass in the mill would be of great benefit to re-establishing spatial connectivity of these populations.

Old Mill impoundment at Butter Hill

- The old mill impoundment at Butter Hill isolated fish populations in adjacent reaches, effectively preventing any upstream migration. It is recommended that consideration should be given to the retrofitting of a modular fish pass within the structure in order to afford passage to fish. It is likely that either a Denil or Larinier pass could be fitted within the brick wing walls downstream of the central sluice. Prioritisation of flow through this channel would allow passage of fish over a large range of discharges. Detailed design of such a pass is a specialist undertaking, and beyond the scope of this report. It is recommended that Greg Armstrong, the EA national fish pass officer should be consulted via the local EA fisheries team for further professional input into any project aimed at providing fish passage over this obstruction.

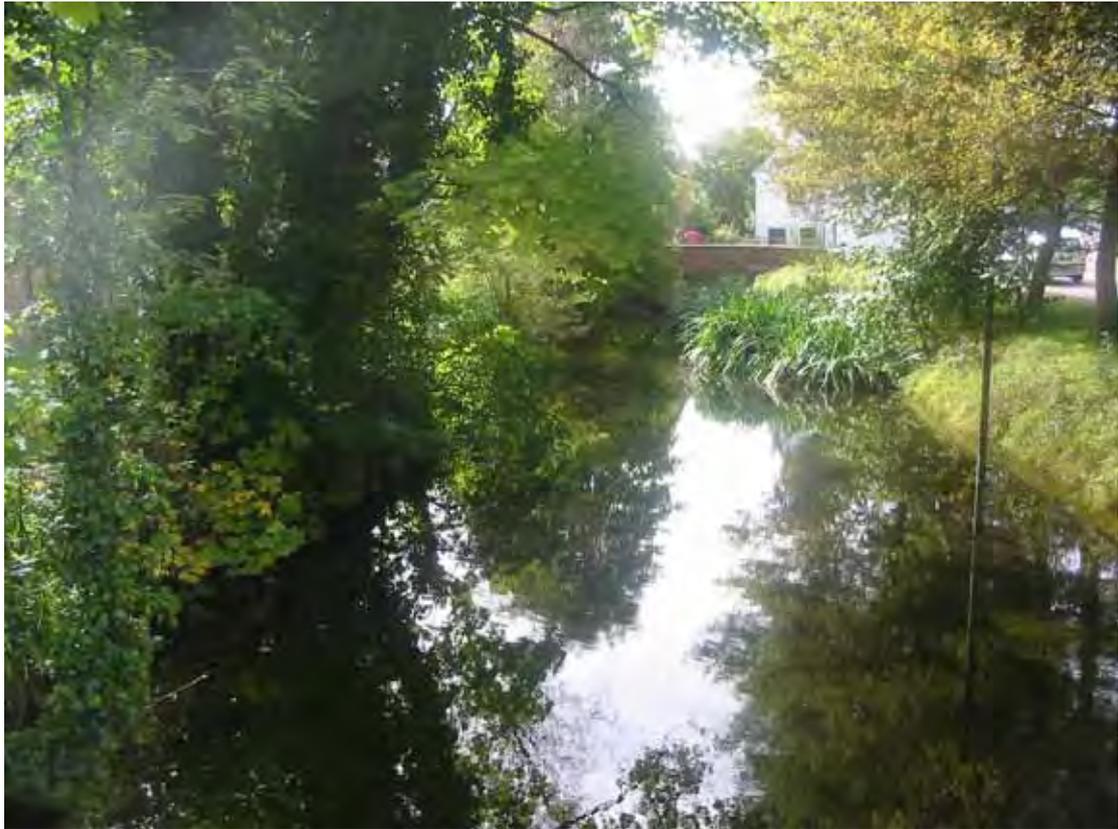
Downstream of the mill, the river was considerably overwide, with a wetted width of some 8m-10m. This was a consequence of the construction of a wide, shallow retaining weir at Mill Pond Place bridge. Head difference across the weir was some 300mm. As a consequence of its presence, the bed of the river was coated in a thick layer of accumulated fine sediment. Instream vegetation was restricted to some strong stands of starwort. The weir also restricted access of fish migrating upstream during low flow periods.

There was a well-developed fringe of branched bur-reed *Sparganium erectum* on the LB of the channel where tree shading was light. Elsewhere in this section, the riparian tree canopy on both banks was moderately dense, creating enough shade to restrict the growth of marginal vegetation.

Overshaded and overwide channel downstream of Butterhill Mill

- Much of the reach downstream of Butter Hill Mill was overshadowed by riparian tree growth. A programme of rotational coppicing should be instigated in order to reduce this shading, promoting the development of a marginal fringe of aquatic vegetation and consequent narrowing of the channel.
- The small retaining weir at Mill Pond Place bridge was detrimentally affecting upstream habitat. Its backwater effect had resulted in an overwide channel and ongoing and damaging deposition of fine sediment on the river bed. It is strongly recommended that it is modified, ideally by its total removal, or alternatively, by the removal of a wide central notch, reducing the retained head and damaging upstream impacts, and allowing passage of fish across the structure at all times.

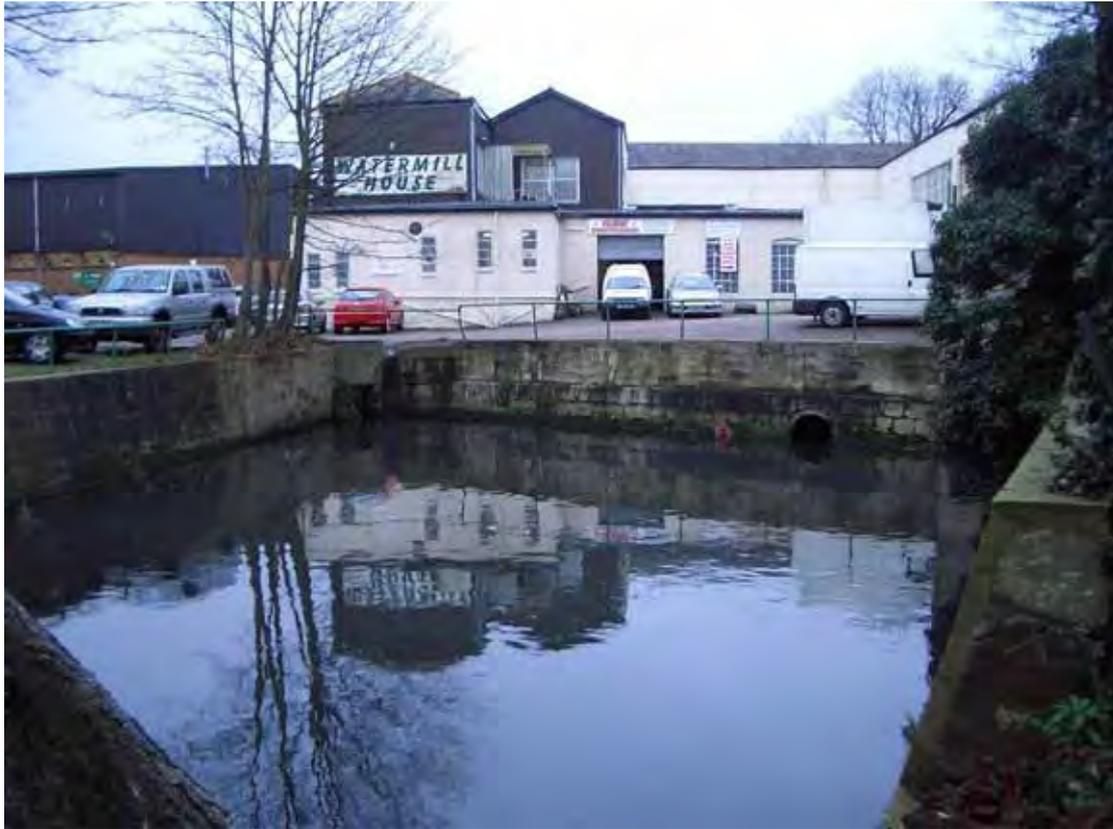
The Carshalton and Croydon arms of the river joined upstream of an impoundment at the old Shepley Mill site. The weir had a head loss of approximately 2m across it, with the river downstream then flowing through a culvert some 50m in length before exiting into a large mill pool.

Shepley Mill Pool

The combination of the large head loss over the weir, the concrete culvert and associated trash grids effectively prevented upstream and downstream migration through this site, spatially isolating fish populations in the adjoining reaches.

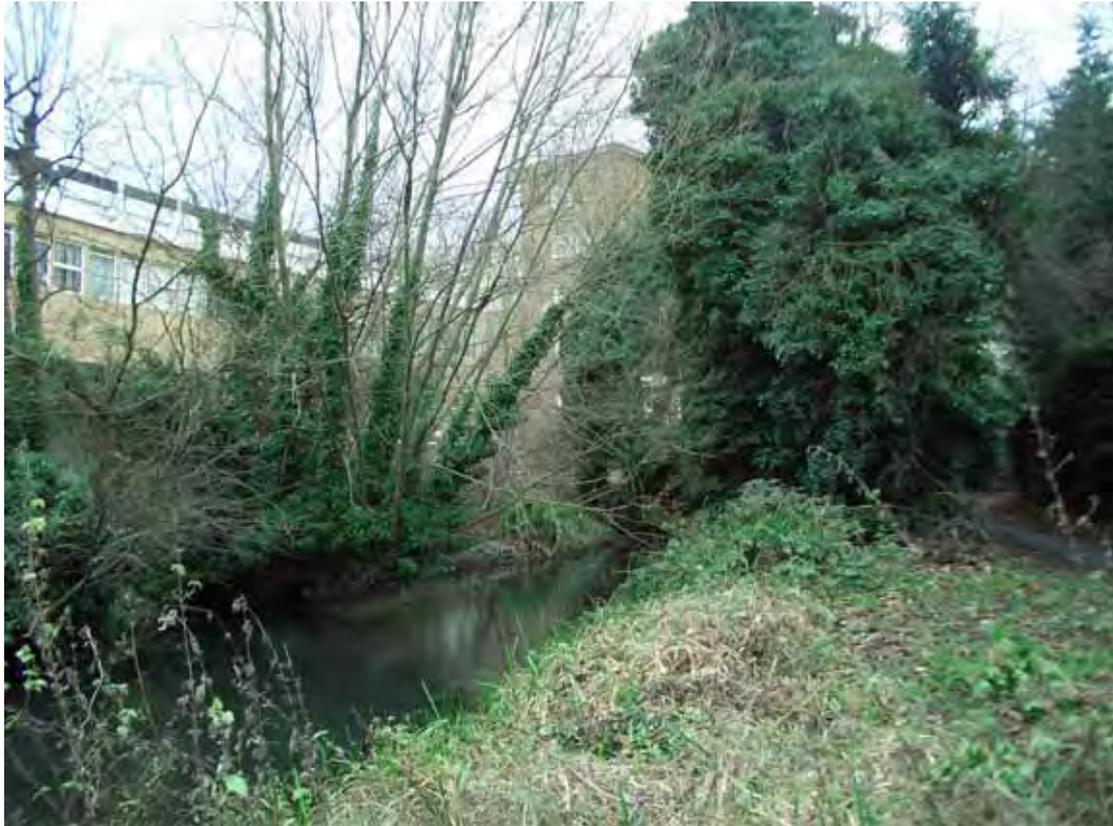
The channel was generally straight and relatively uniform, with limited variation in bed profile. Water depth was between 0.5m - 1m, with an unsorted hard substrate, covered with a layer of fine sediment for much of the reach length. The downstream length of the reach towards Hackbridge had a generally reduced water velocity, as a result of small impoundments downstream of the bridge and the overwide nature of the channel. There was a strong marginal growth of emergent vegetation, with the bed of the river heavily coated with fine sediment.

Overshading of the channel in the middle/lower section of the reach

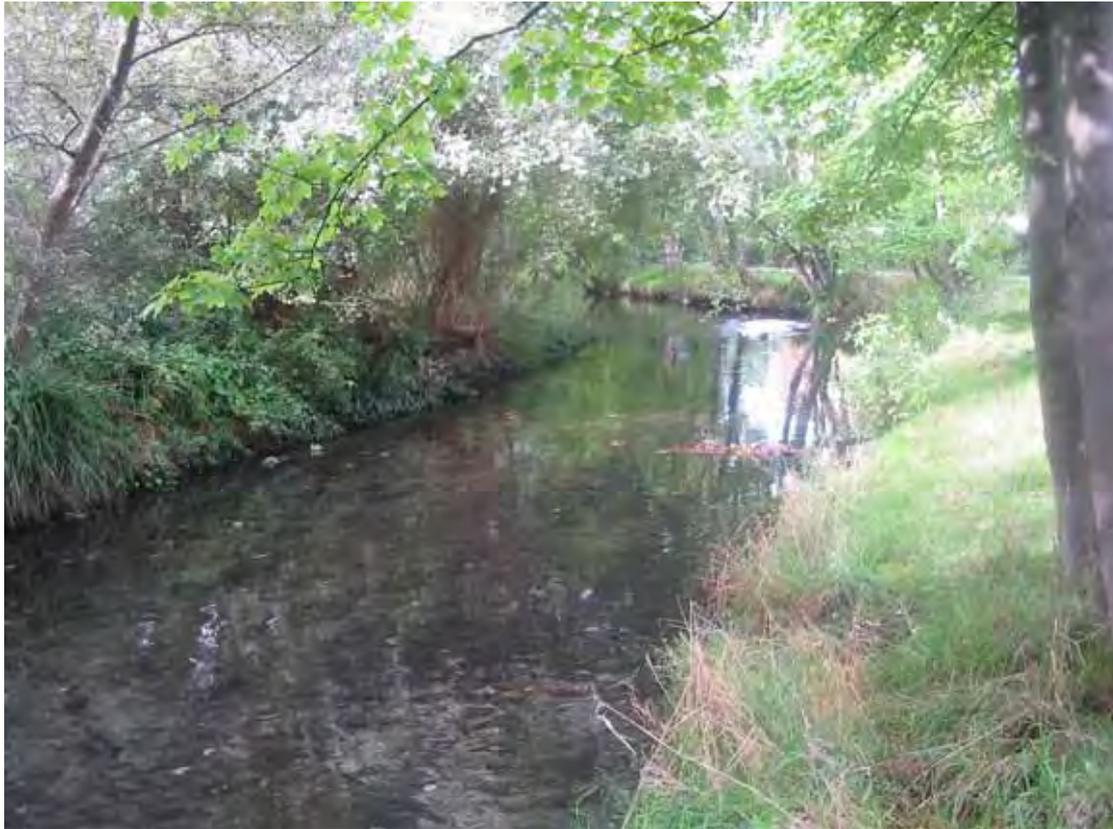
The upstream limit of Reach 5 was alongside Culver's Island. The river was overshadowed by riparian trees including sycamore, horse chestnut *Aesculus hippocastanum* and ash growing along both banks. As a consequence, there was virtually no instream or marginal vegetation present under the tree canopy. The channel was some 6m-8m in width, with a relatively steep gradient, and an unsorted gravel and cobble dominated substrate. The gravel was relatively silt free, although the uniformity of the bed profile was likely to be limiting fish population abundance, with the lack of deeper glide and pool habitat particularly apparent.

Downstream of Culver's Island. Note the overshadowed and overwide channel, with virtually no instream vegetation. Note also the uniform, undifferentiated bed profile

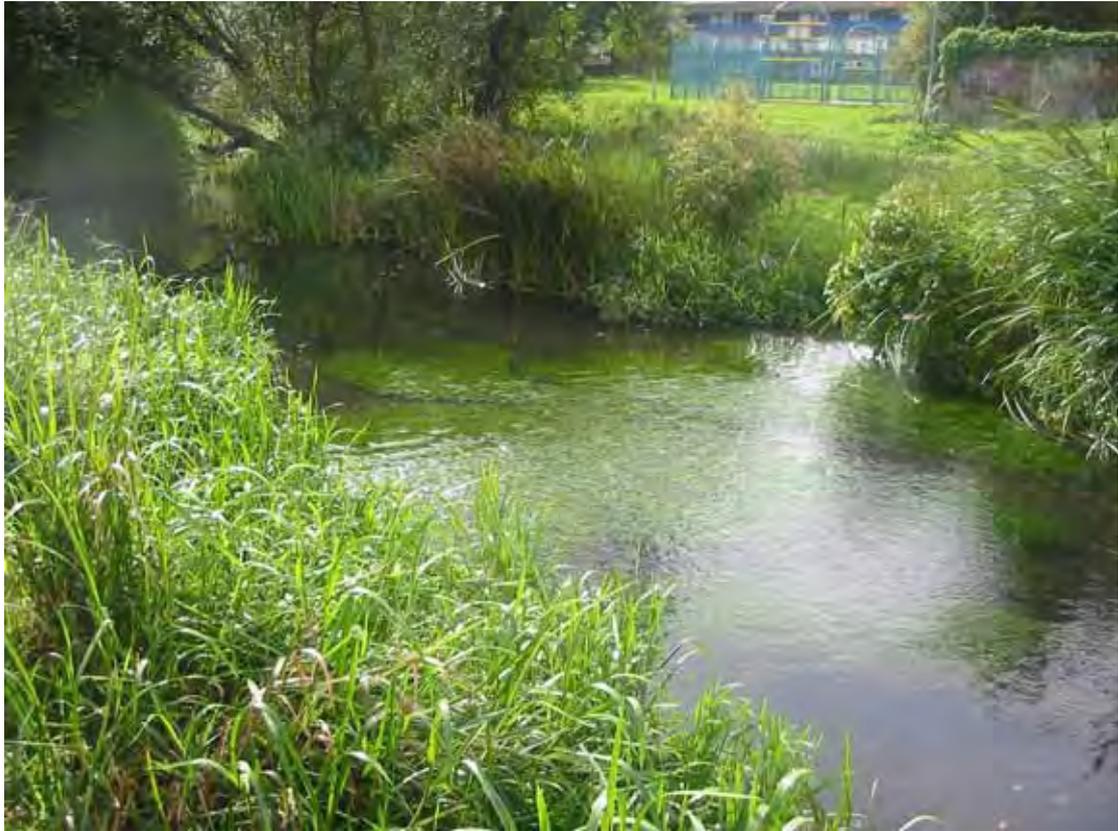
Open section of the river with well-developed margins, high water velocity and extensive instream weed growth.

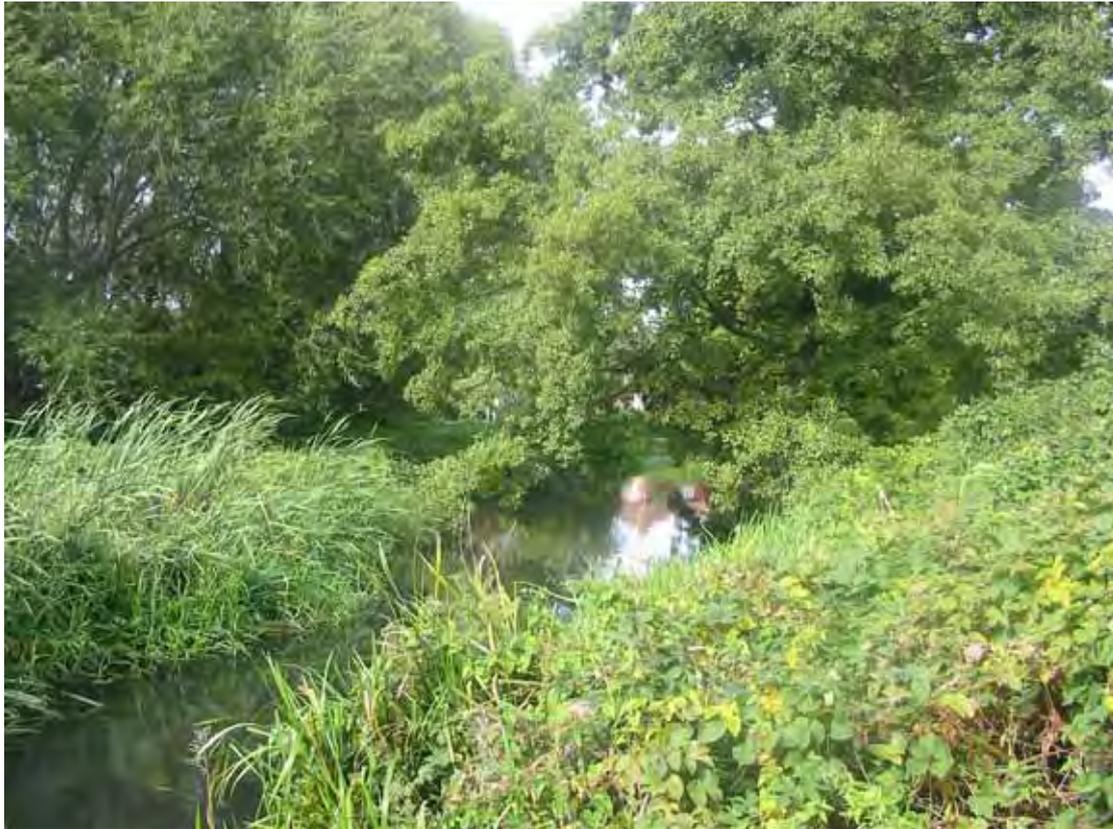
There was no clearer example of the damaging impact of heavy shade on any reach of the river.

The impact of shading. Note the suppression of marginal growth and the resultant widened channel at the downstream end of the section

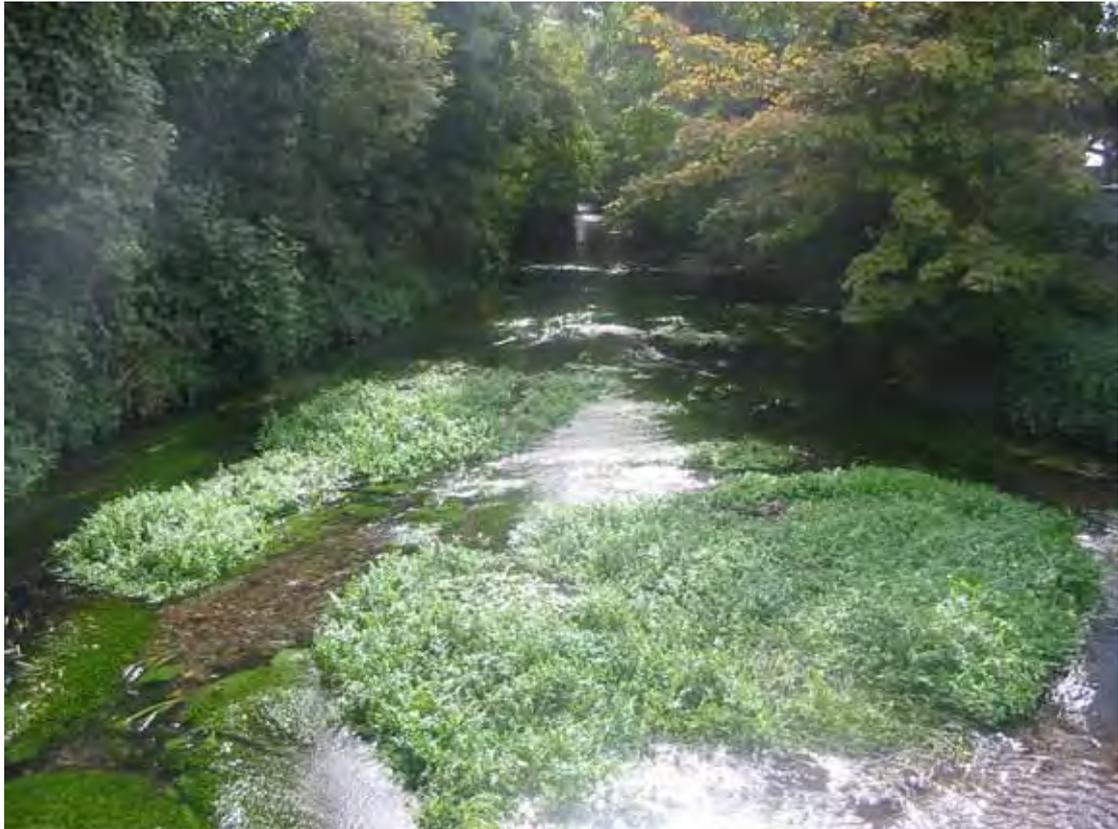
At the downstream limit of the reach, there was abundant habitat suitable for juvenile trout. Riffles and shallow glides braided by extensive stands of water cress and fool's cress, with submerged weeds dominated by starwort and water crowfoot, provided abundant cover for fry. The weir at McRae's Mill formed a significant barrier to ascending fish, effectively isolating upstream and downstream fish populations.

High quality trout fry habitat downstream of McRae's Mill

- The old weir at McRae's Mill presented an impassable barrier for upstream migrating fish. Ideally it would be removed and replaced with a series of constructed riffles. In the event that this is not possible, then the provision of a fish pass should be considered at the site, in order to re-establish the connectivity of upstream and

downstream fish populations. It is recommended that Greg Armstrong, the EA national fish pass specialist should be consulted via the local EA fisheries team for further professional input to any project aimed at providing fish passage over this obstruction.

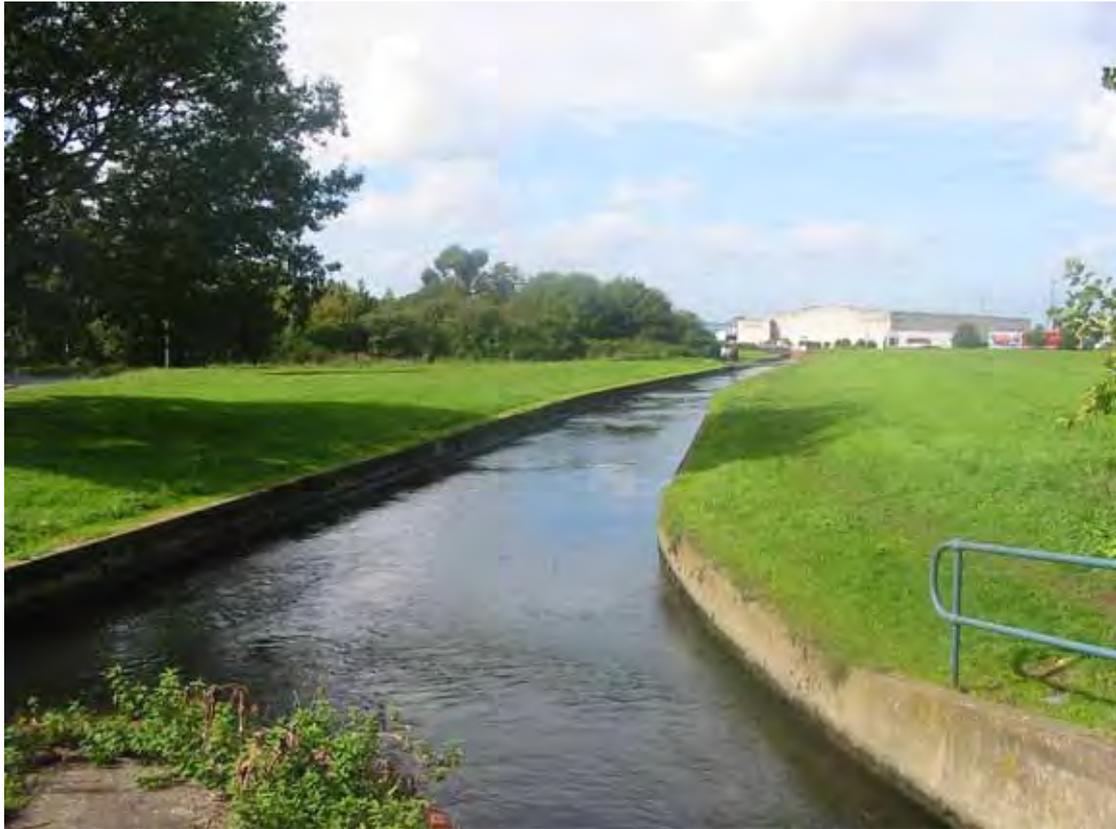
Due to the concrete nature of the channel sides, there was no growth of marginal vegetation within the channel. This was likely to have reduced the habitat quality within the channel for juvenile fish and a range of macroinvertebrate species. Large chub, dace *Leuciscus leuciscus* and barbel were seen within the channel.

Effluent channel carrying discharge from Beddington Sewage Treatment works

- The lack of marginal vegetation was very noticeable in the Beddington STW effluent channel and was likely to be limiting the value of the channel for juvenile fish and a range of macroinvertebrate species. It is recommended that a shallow marginal berm should be constructed within the channel to address this habitat shortfall. 300mm diameter pre-planted coir fibre rolls should be bedded onto proprietary 300mm diameter rock rolls or stone filled gabion mattresses, in order to create a shelf with a width of between 0.5m and 2m. The coir rolls should be fixed to the rock rolls or gabions using wire or plastic ties, in order to create a firm and stable revetment.

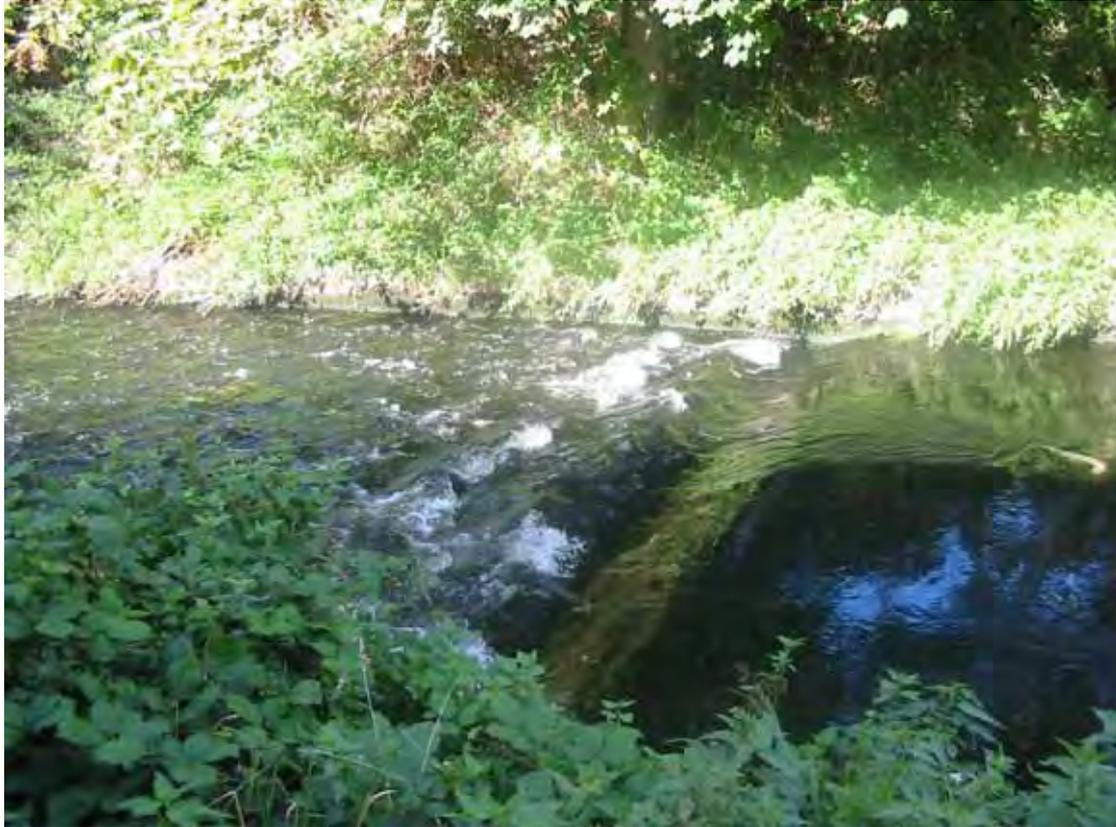
A small impoundment was present in this reach, with a head loss across it of some 300mm. It had no obvious contemporaneous purpose. Downstream of the weir, the depth of the channel increased to around 1.0m-1.5m, with a width of 10m+ and heavy shading due to the presence of riparian trees.

Impounding weir – purpose unknown

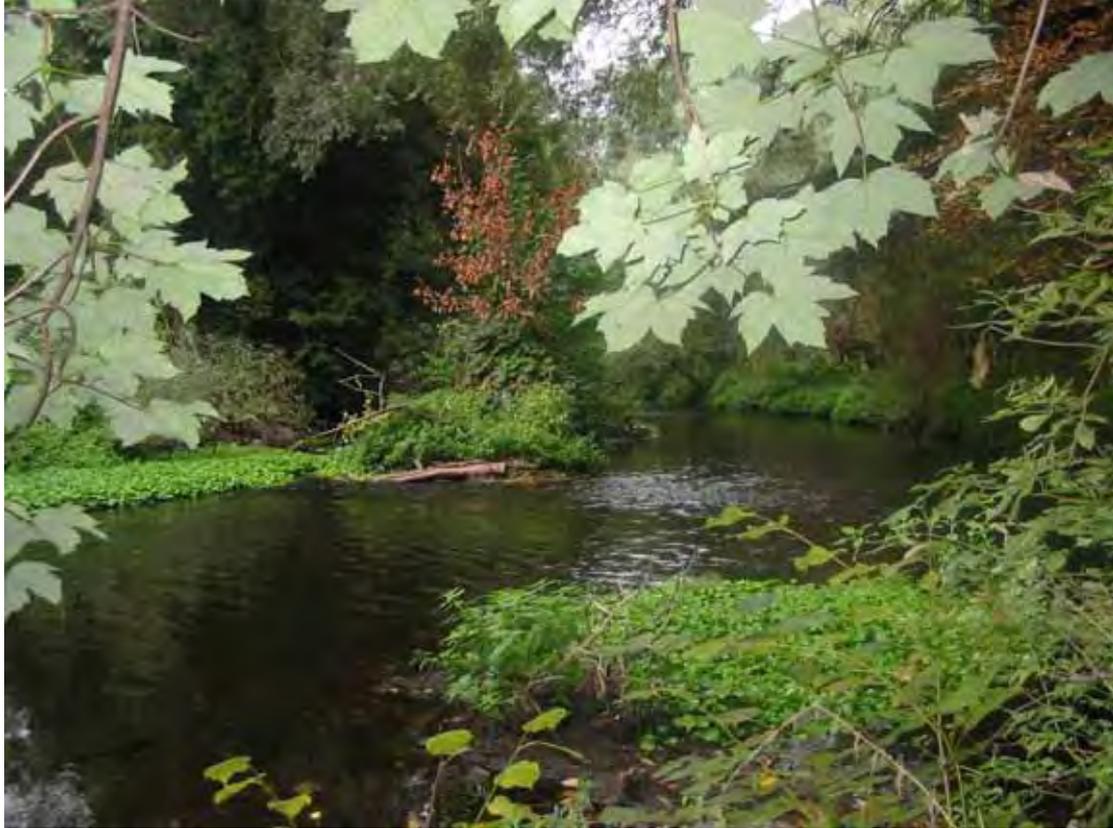
Further downstream, there were abundant stands of floating pennywort present in marginal areas, with the relatively high water velocity probably preventing its establishment in the centre of the channel. Some small LWD dams were present. Their impact on habitat was apparent, with locally increased flow velocity resulting in substrate scouring.

LWD covered with floating pennywort on the LB of the river. Note locally increased water velocity

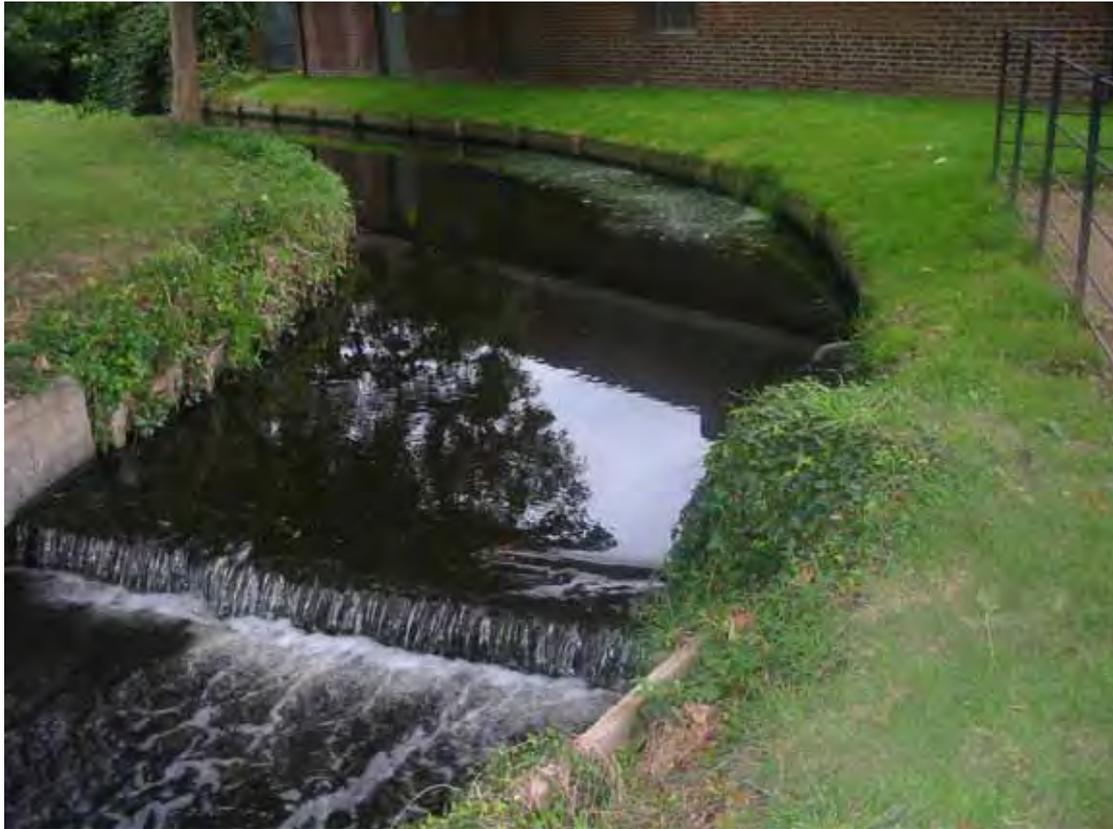
Sections of the main channel and tributary streams had been reveted using wooden toe boarding. Whilst this treatment of the channel may aesthetically appeal to some, its presence was significantly reducing instream habitat quality by suppressing marginal vegetation growth.

Small channel within the grounds of Mordon Hall. Note heavily cut banks, wooden toe boarding and small impounding weir

- The small impoundments located in several of the channels within the Hall’s grounds should be removed and replaced by constructed riffles of appropriate dimensions and gradient. This will reduce the accumulation of fine sediment in the channel, whilst increasing the quality and availability of spawning habitat for rheophilic fish species that is currently under-represented in this reach. In the event that removal of these impoundments is not possible, then gravel riffles could be constructed downstream of each impoundment increasing the length of good quality spawning habitat present for trout and rheophilic coarse fish within the reach.

- The toe boarding present over lengths of the distributary streams and main channel should be removed and replaced with 300mm diameter coir fibre rolls,

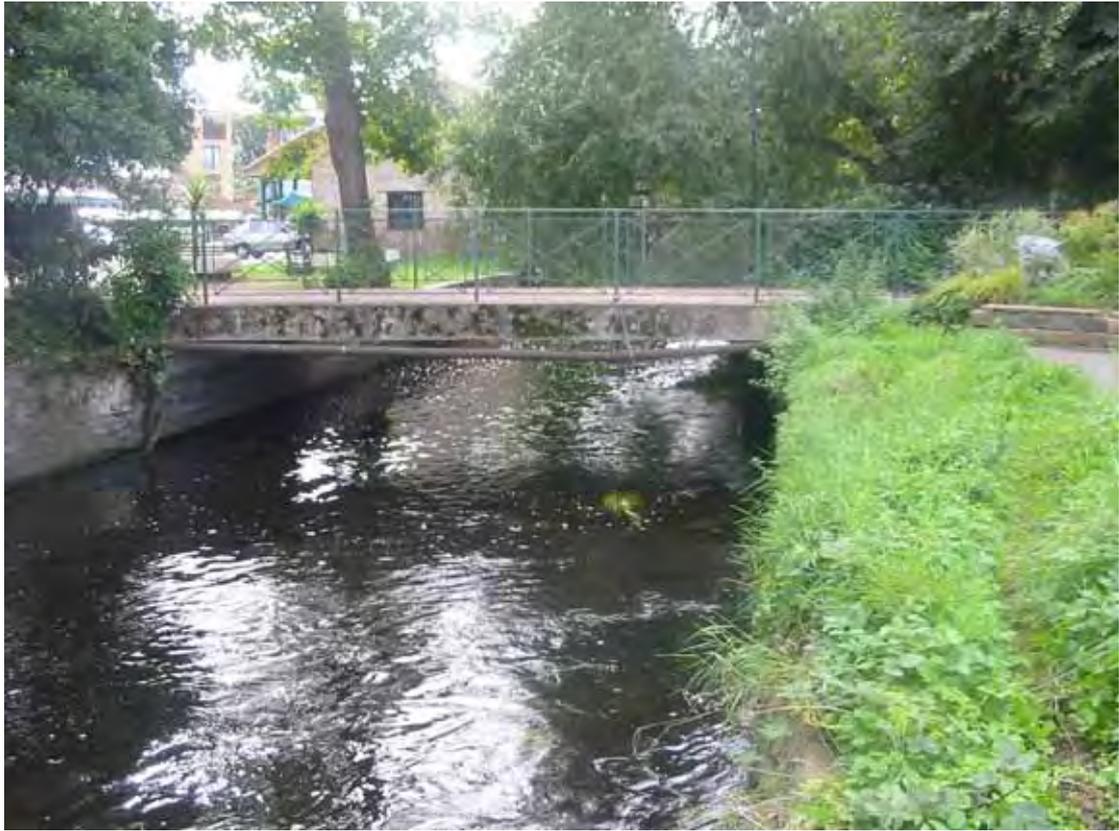
This section was heavily shaded by riparian trees. Japanese knotweed and Himalayan Balsam were abundant on the banks.

Channel adjacent to Merton Abbey Mill

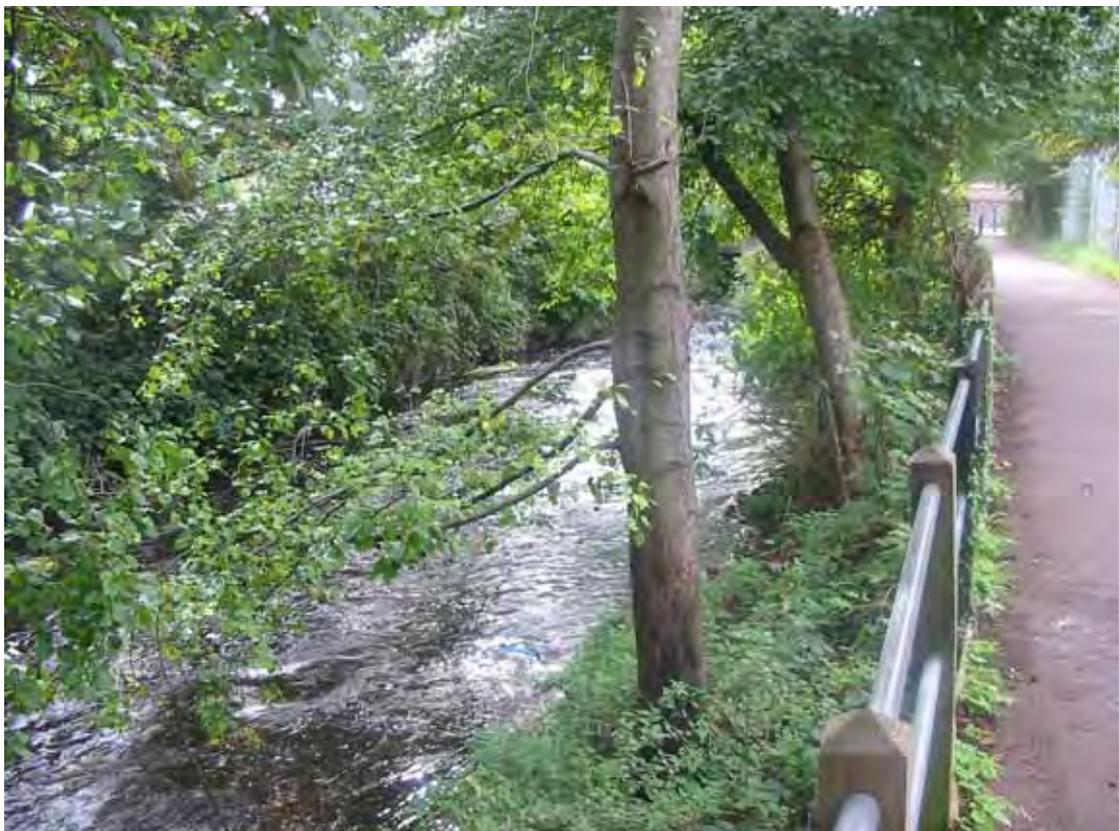
Downstream of Merton Abbey Mill roadbridge, showing torrential flow

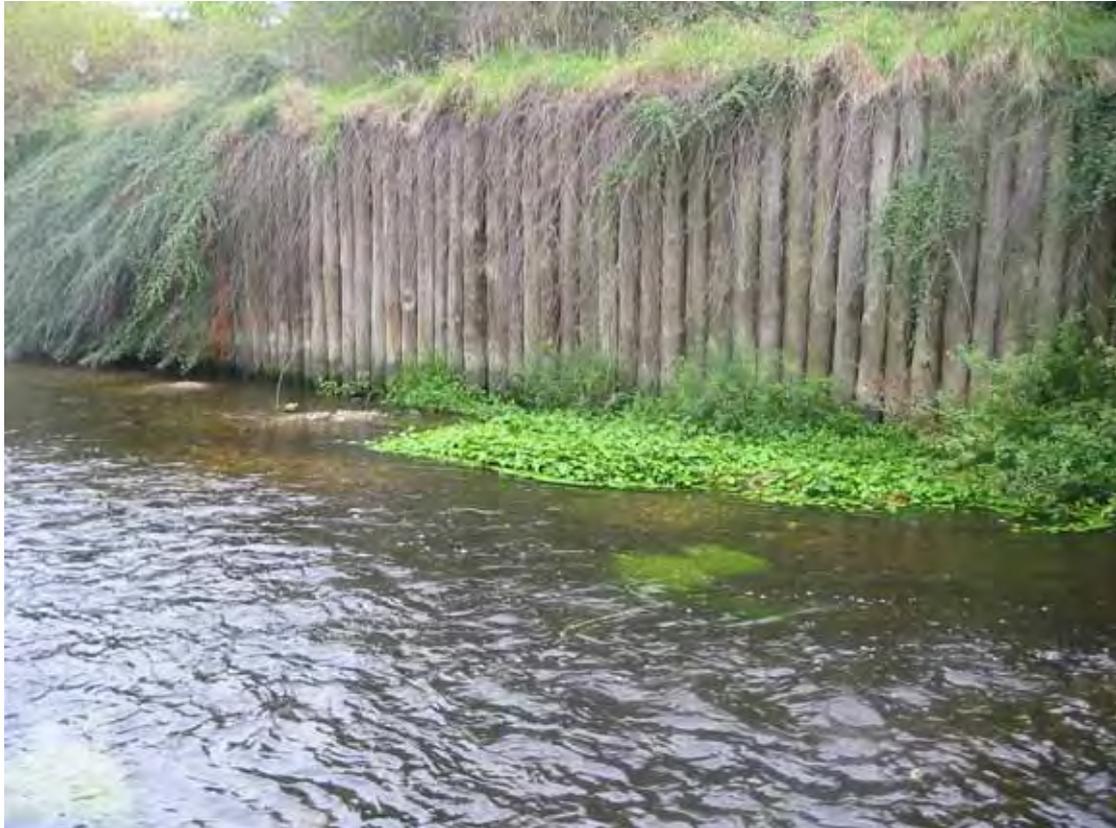
Approximately 200m downstream, the RB of the river was reveted by a 3m+ high palisade of tannalised wooden stakes. There was very little emergent vegetation along this bank, although floating pennywort had begun to form a marginal shelf. Instream weed remained abundant, with starwort and water crowfoot present.

Wooden revetment along RB with floating pennywort in the margins
