Overview of habitat enhancement
opportunities on the River Wandle,
London

Undertaken on behalf of The Wandle Trust
by Vaughan Lewis, Windrush AEC Ltd

November 2005

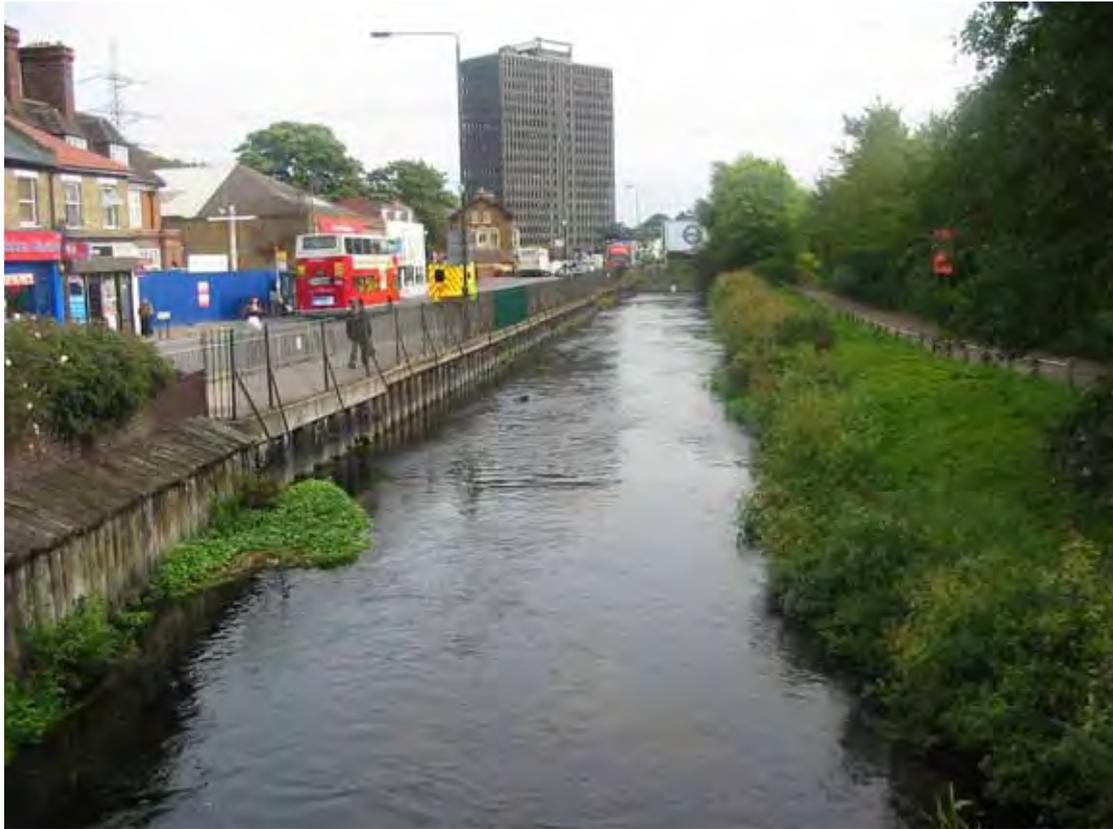
The lack of marginal vegetation continued further downstream on the LB adjacent to Merton High Street, with vertical concrete revetment preventing its development in this location. Despite this, the instream habitat was good with a gravel dominated bed, with stands of starwort and water crowfoot abundant.

Lack of marginal vegetation at the base of a section of vertical concrete revetment

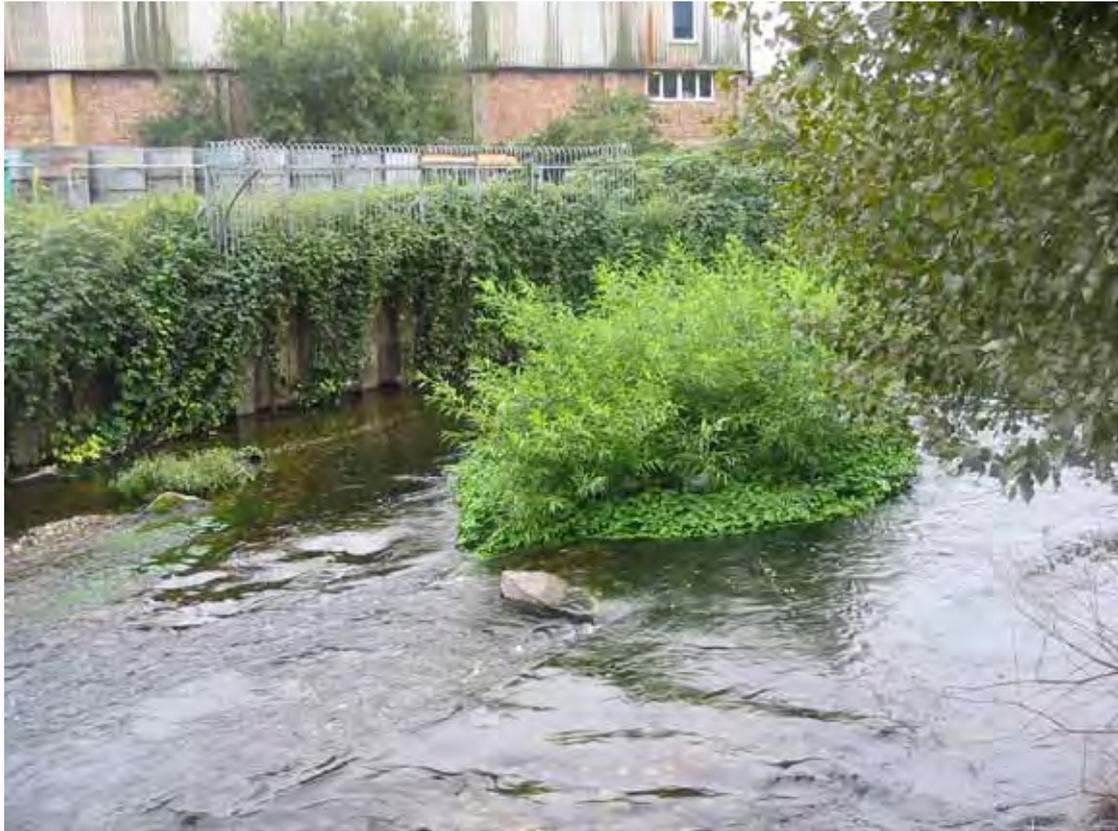
The EA had undertaken a major habitat enhancement about 1 km south of Trewint Street. A redundant weir had been removed, with the head difference dissipated by constructing a section of steep, boulder strewn, gravel riffle. The resulting habitat was excellent, with the fast water velocity over the gravel bed and stands of water crowfoot, ideal for spawning fish and a range of macroinvertebrate species. Islands had subsequently formed in the channel due to the establishment of willow and floating pennywort around the boulders. These not only braided the channel, but also provided an element of valuable fringing cover.

Mid-stream island at Trewints Lane

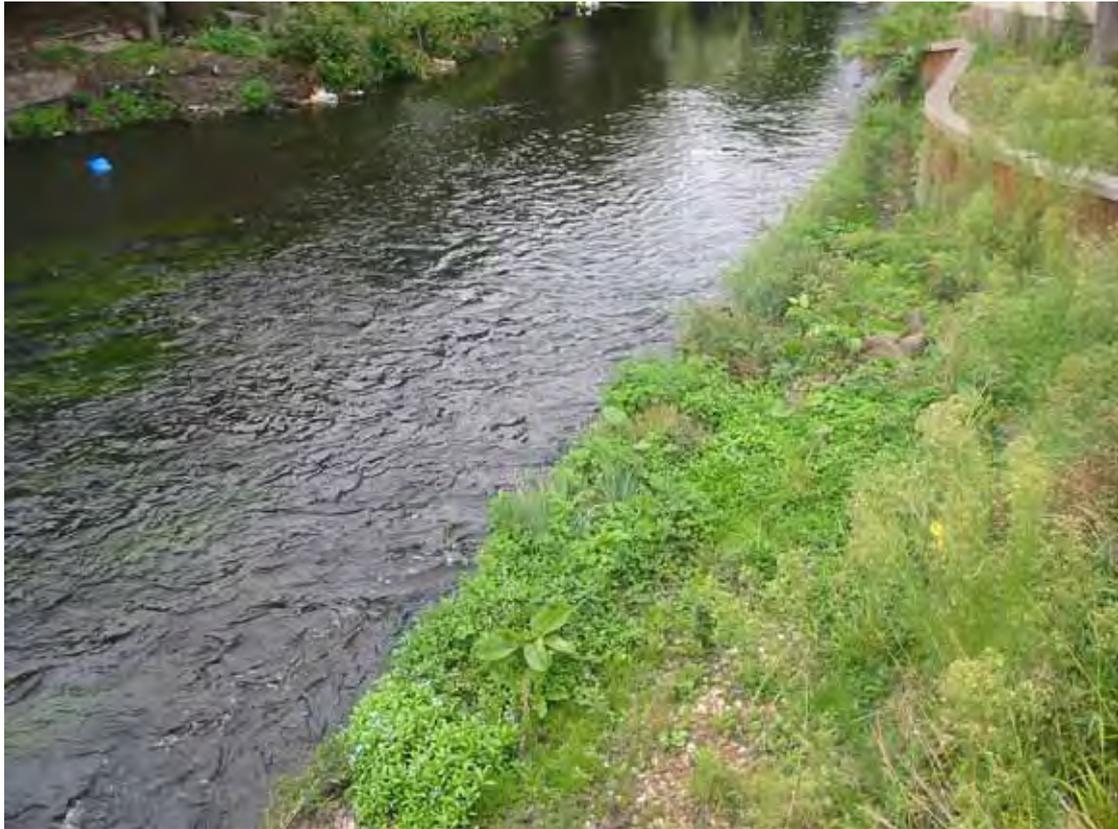
Much of the bank length had vertical hard revetment. However, low marginal shelves had been established in some sections as planning gain during recent development adjacent to the river. A particularly good example was present on the RB with strongly growing stands of water forget me not *Myosotis scorpioides*, sedge and water cress. This was an exemplar of the aspirations for creation of this habitat type elsewhere along the river.

Low-level shelf created on RB upstream of the Arndale centre. Note strong growth of water forget me not

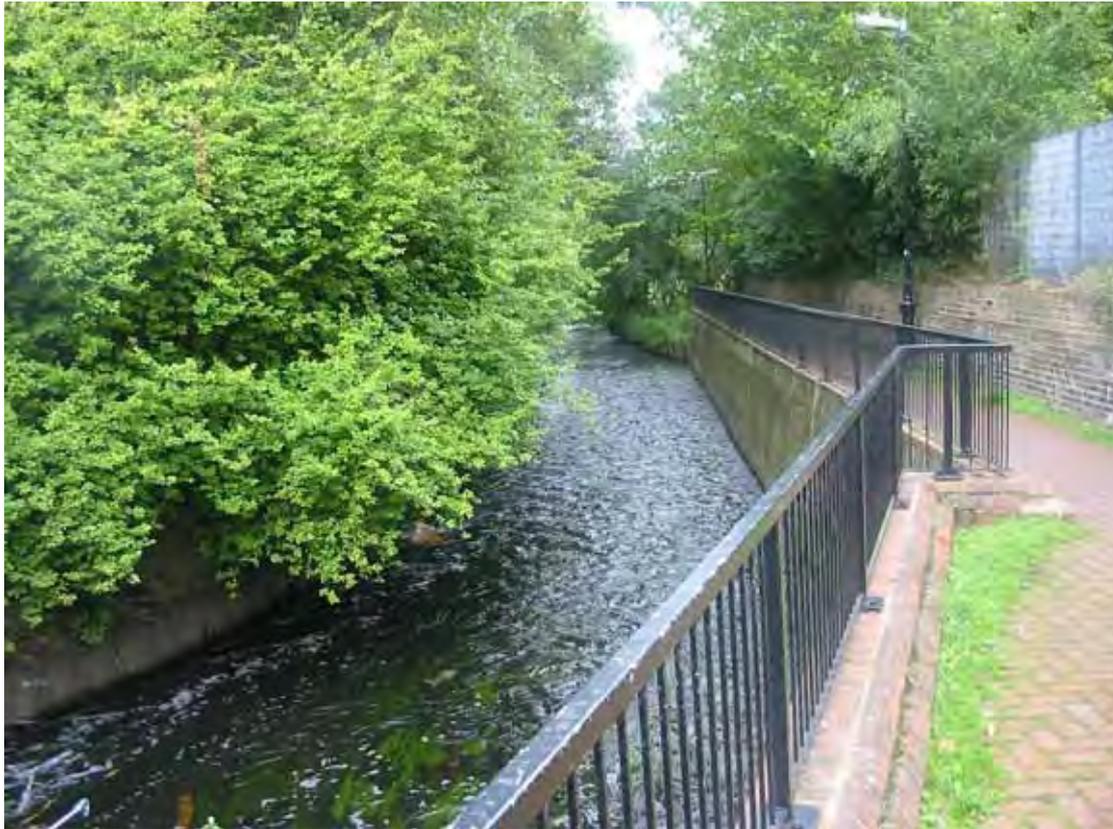
Similar comments apply to the split concrete channel behind the stores alongside Upper Mapleton Road.

Hard vertical revetment preventing establishment of marginal vegetation

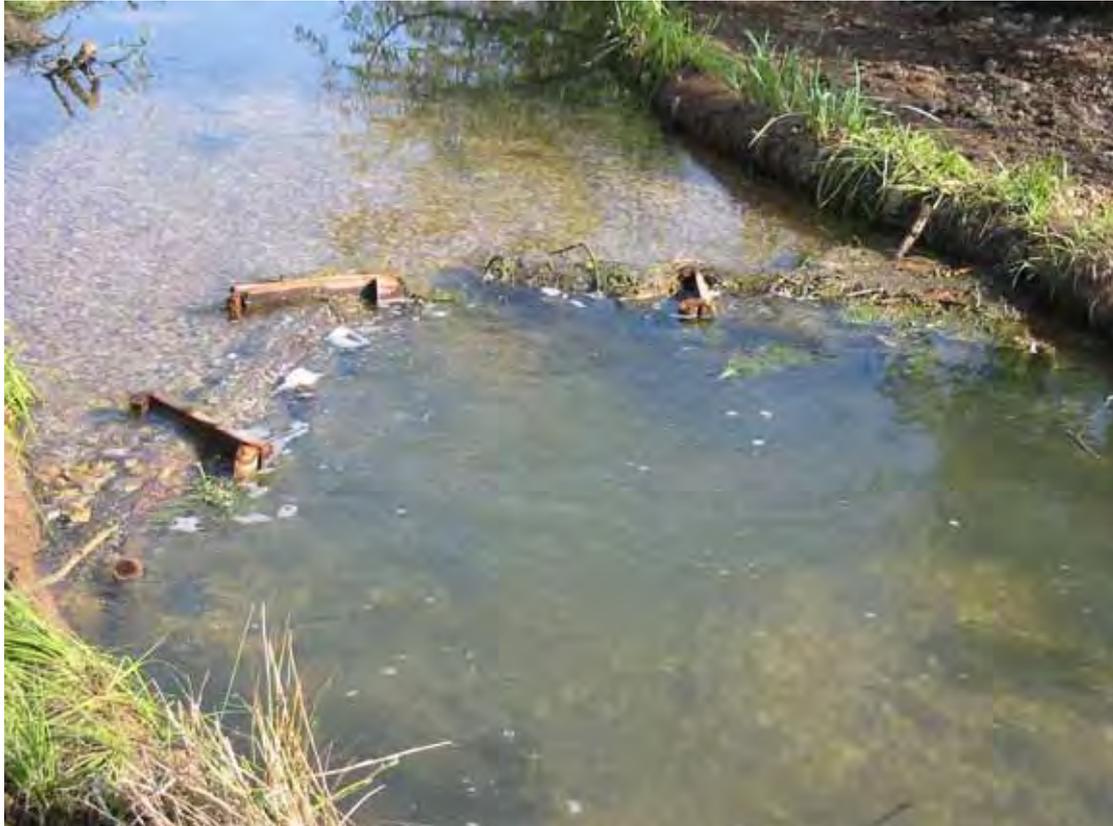
- In order to encourage sorting of the substrate and heterogeneity of the bed profile in this section of the channel, a number of measures are recommended. A series (say 5 no.) of small, upstream facing 'v' groynes should be installed near to the centre of the channel, in order to scour deeper pools, important as refuge areas for brown trout and other fish. These are simple to construct from timber derived from localised coppicing.

Wooden 'v' groyne. Note deeper hole scoured downstream of the structure

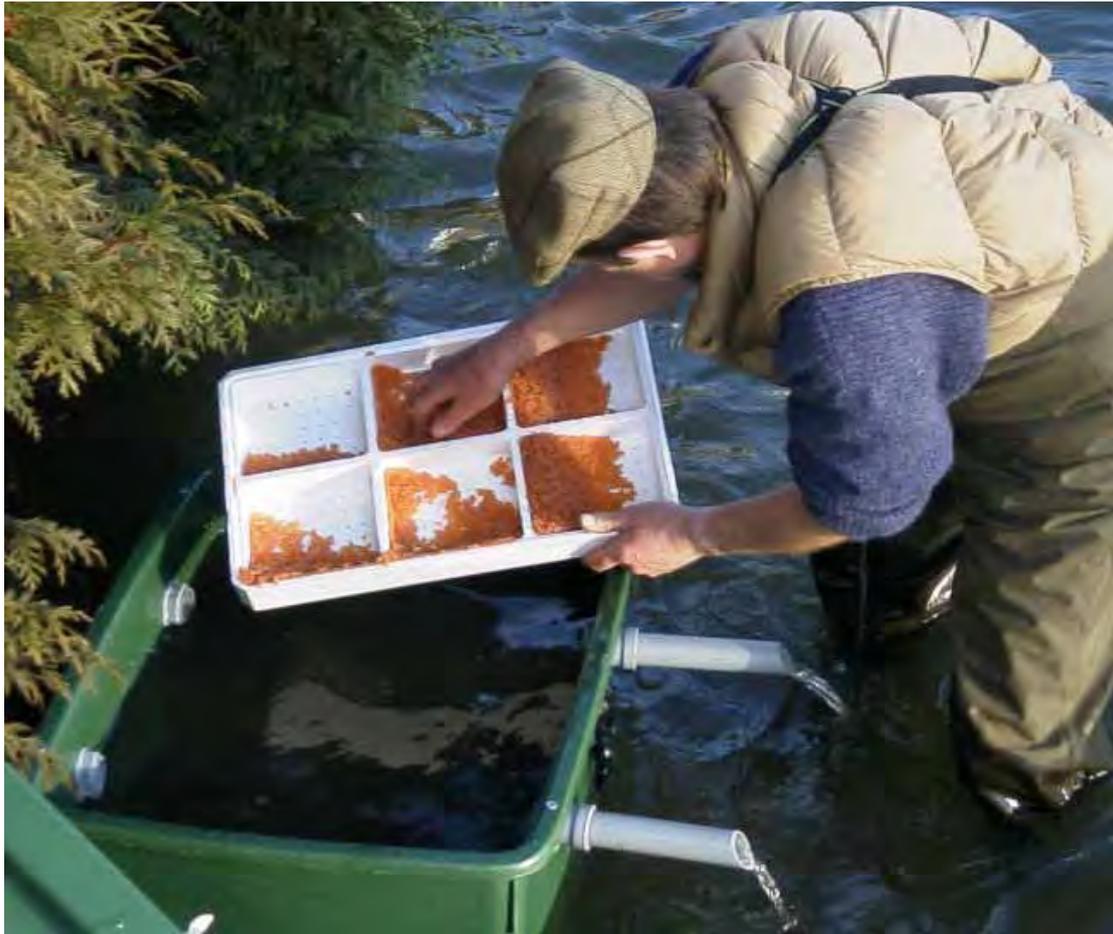
Placing eyed ova into a deep substrate incubation box

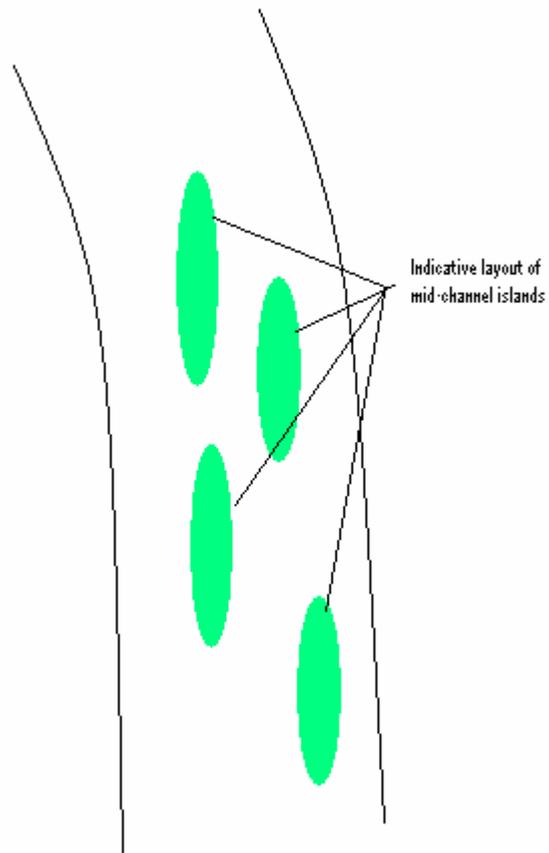
Drawing 1: Layout of mid-channel islands

A total of 10 islands are recommended, with overall dimensions of 2m (w) by 4m (long). The islands should be arranged in a staggered line down the channel, in order to create a mosaic of channels with increased velocity, and optimising conditions for the growth of water crowfoot. The islands should be constructed from deadwood faggot bundles, secured to cleft chestnut stakes, driven at 0.6m centres.

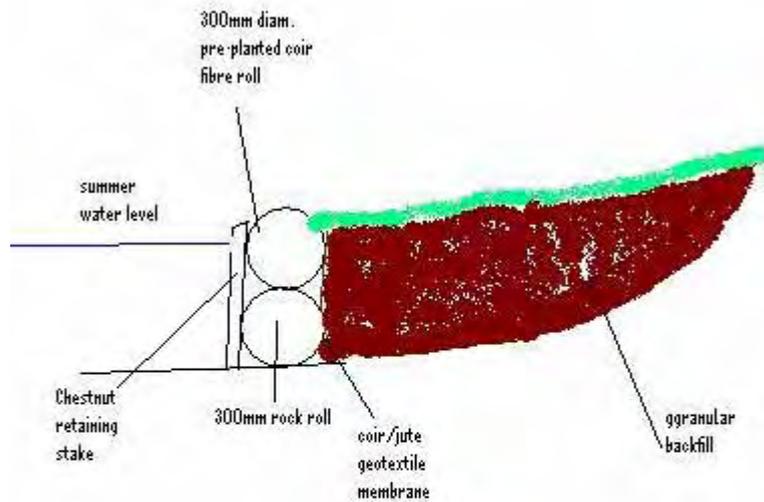
Drawing 2: Cross section of bank narrowing using rock roll and coir fibre (alternative narrowing uses faggot bundles to replace rock roll)

- i) Narrow 300m of the effluent channel using pre-planted coir fibre rolls set on gabion mattresses or proprietary rock rolls. Backfill with locally derived sub-soil or timber brushings in order to create low-level marginal berm.
- ii) Narrow 200m of the main river channel using pre-planted coir fibre rolls set on gabion mattresses or proprietary rock rolls. Backfill with locally derived sub-soil or timber brushings in order to create low-level marginal berm.
- iii) Construct 30 no. midstream faggot islands
- iv) Remove small weir and replace with a 30m length of constructed riffle
- v) Introduce LWD elements into marginal areas of the channel
