**HABITAT ADVISORY VISIT TO THE ABBOT'S
HALL FISHERY, RIVER BURE, NORFOLK**

**UNDERTAKEN BY VAUGHAN LEWIS,
WINDRUSH AEC LTD ON BEHALF OF ABBOT'S
HALL FISHERY, MARCH 2006**

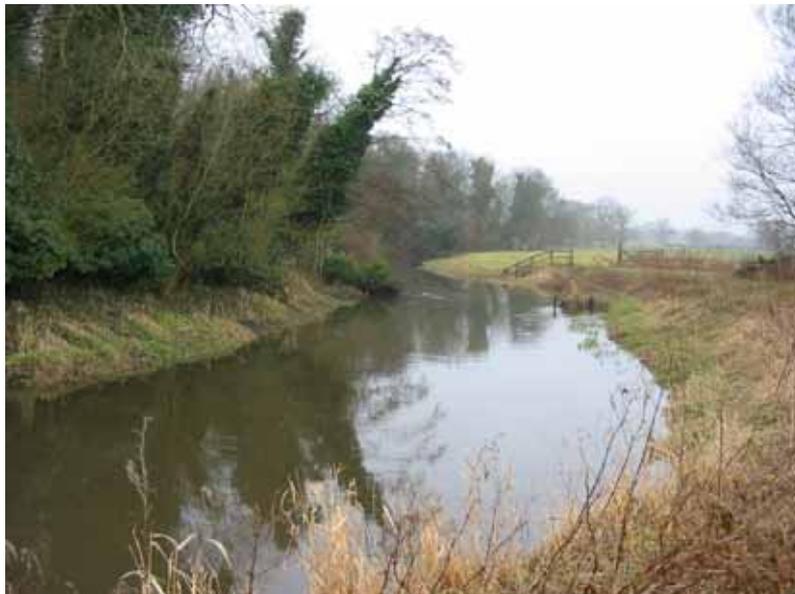
Downstream reach of the river

The river had been significantly modified by past drainage works, with the channel over-widened (to a width of 6m-10m) and over-deepened. Although poor water clarity resulting from recent rainfall prevented detailed observation of the substrate, it was apparent that sections of shallow, gravel-dominated riffles were limited throughout the fishery. Large banks of excavated gravel were present along the banks over the length of much of the fishery, evidence of past dredging.

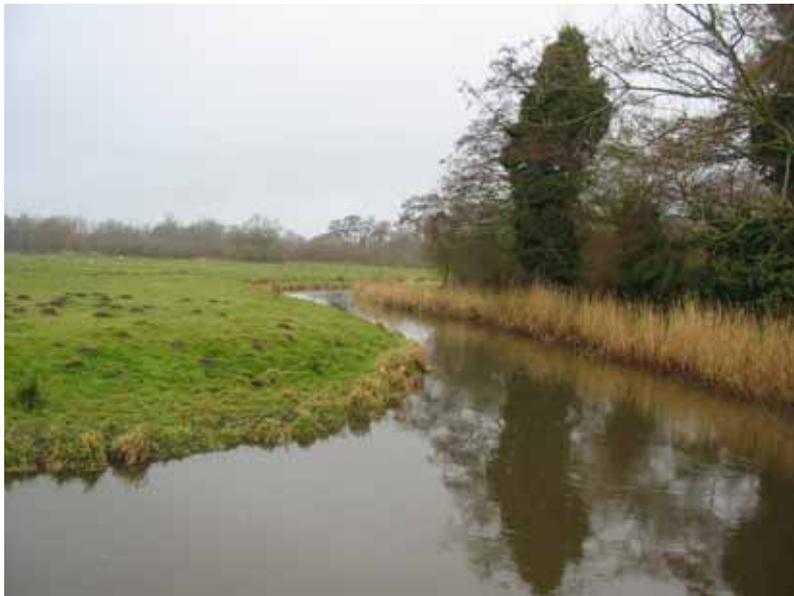
Land use was dominated by heavily grassed wet grassland on the RB, with a mix of woodland and more lightly grazed reed bed and wet grassland on the LB. The more intensive grazing pressure on the RB had caused noticeable damage, with the reduction in stands of coarse vegetation increasing the vulnerability of the very friable bank to erosion. The loss of overhanging vegetation resulting from grazing of the RB in some sections had reduced habitat quality for juvenile brown trout *Salmo trutta*. In addition, grazing pressure had resulted in virtually no trees on the RB.

Heavily grazed RB and tree fringed LB. Note absence of trees on RB

- Uncontrolled access by grazing stock to the riverbank, largely on the RB, had a significant damaging impact on the fishery. It is important that either the banks are fenced to prevent access to stock or that the agricultural stock density is reduced. Fencing could be permanent post and wire, or temporary electric if more acceptable.

- Assuming that the fishery become adequately protected against agricultural stock grazing, it would be of great value to plant trees along both banks of the river. Suitable trees including goat willow, hawthorn, ash *Fraxinus excelsior* and hazel *Corylus avellana* could be planted in small blocks.

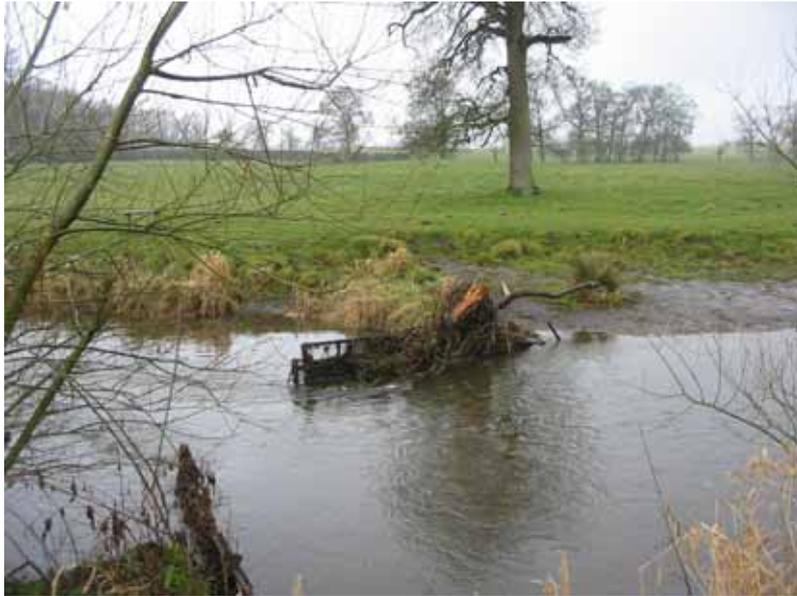
A number of groynes have been introduced into the fishery at a variety of locations over the past 25 years, for instance on the outside of a sweeping bend upstream of Holy Grove. These had been constructed from a variety of materials, including wood, metal mesh and, more latterly by the Environment Agency, from stone. Some of these groynes were installed facing upstream, encouraging erosion of the banks. Others had become detached from the bank, allowing the flow to erode around the bank end of groynes, further isolating them. Large Woody Debris (LWD) had accumulated against some of the groynes.

Metal groyne with accumulated LWD on its upstream face

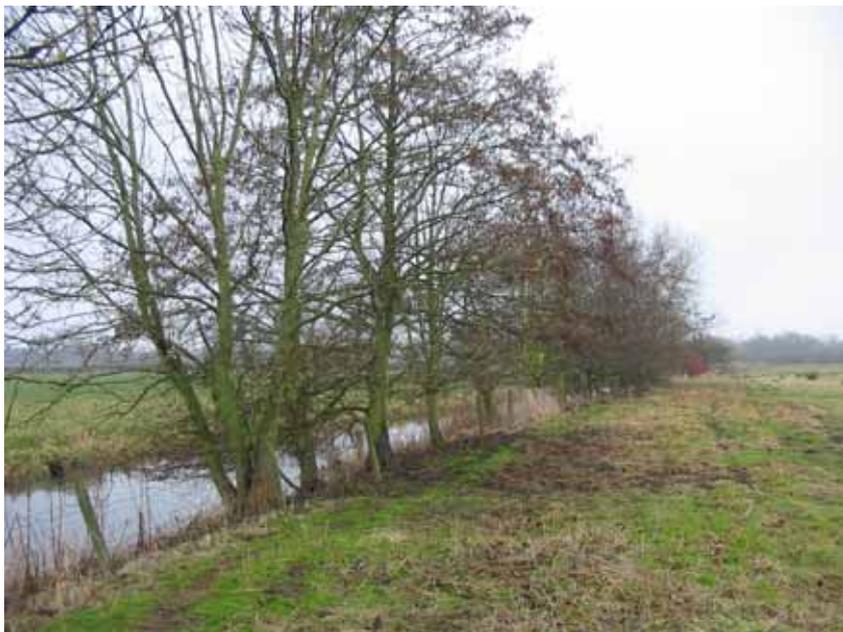
On the LB downstream of Goff's Bridge there was a line of trees adjacent to the bank that were planted within the past 30 years. These included horse chestnut *Aesculus hippocastanum*, alder *Alnus glutinosa*, crack willow *Salix fragilis* and goat willow *Salix caprea*. These were shading this section of the bank, restricting the growth of emergent vegetation.

Line of trees on RB below Goff's Bridge

- The existing tree stock should be managed by the establishment of a regime of limited, rotational coppicing. This would increase light penetration into some river sections and would be of benefit to instream vegetation and valuable fringing marginal vegetation. The conservation value of the existing trees should not be under-estimated and great care should be exercised in the selection of trees to be cut. Timber arising from coppicing/pollarding could be added to the river as LWD, with brush wood converted into fagots and used to consolidate areas where sediment was already depositing, for instance on the inside of bends. A felling licence may be required from the Forestry Authority for significant felling.

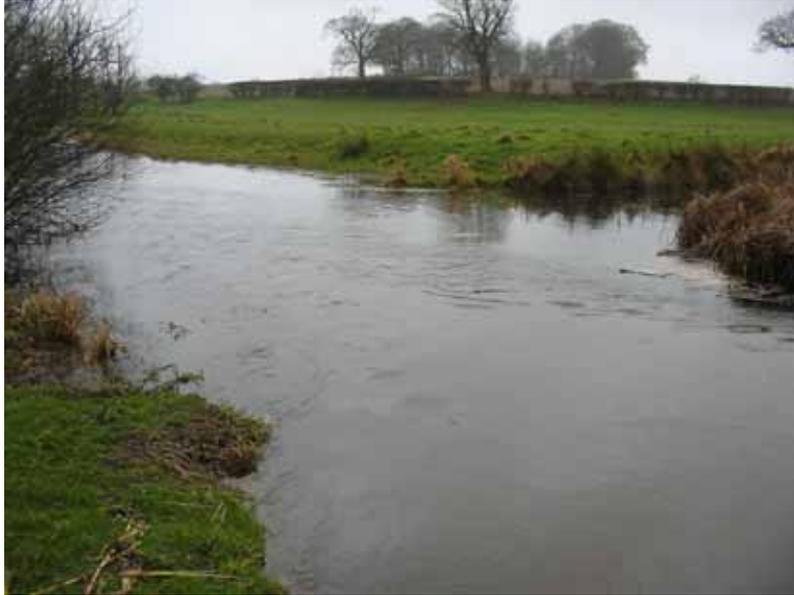
In the upper reach of the fishery the EA had installed two sets of stone groynes/riffles. These were functioning well, increasing diversity in flow, encouraging bed scour and sorting of the substrate.

Stone groyne installed by EA fisheries team

- The introduction of further gravel groynes and riffles into the river would be a welcome and positive management option. There is little doubt that past dredging of the river has significantly damaged instream habitat quality, with few shallow gravel riffles areas remaining. The lack of these areas is likely to be restricting spawning of brown trout and survival of juvenile trout. Gravel for the creation of riffles could either be imported to site from nearby mineral extraction sites, or more productively, obtained by the excavation and screening of the dredged piles of spoil deposited on the bank. There is likely to be a substantial volume of riverbed gravel within these piles. Cutting and screening of the spoil would not only potentially help create more gravel riffles, but would also increase flooding of the valuable wet grassland either side of the river, promoting not only the wildlife interest of the site, but also providing a limited but valuable amount of flood attenuation.

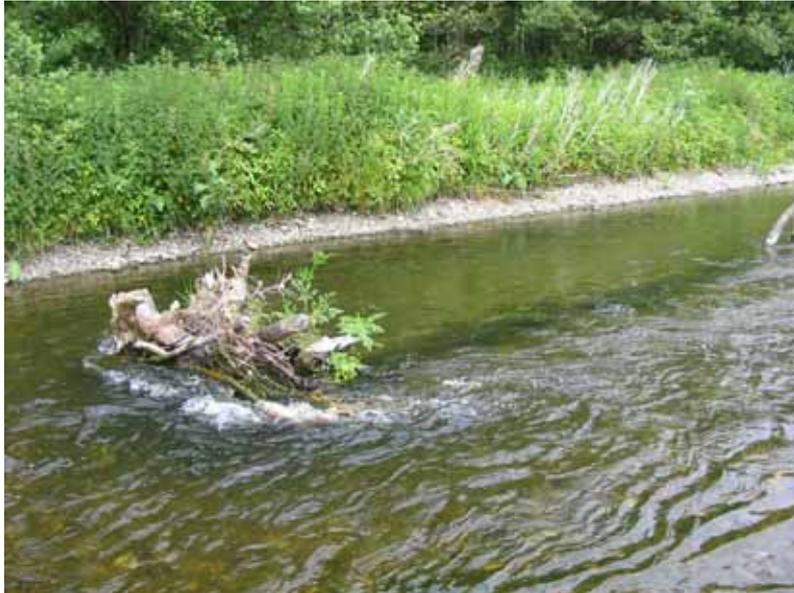
- The lack of any LWD in the fishery reduced the habitat quality significantly. In low energy lowland streams, the presence of LWD is one of the few habitat features that can increase local flow velocity enough to cause scouring and sorting of the bed. Without LWD in the channel, instream habitat will remain relatively homogeneous, with a uniform layer of fine sediment present over much of the bed.

Stabilised tree root system causing localised scour in a river

Practical management options to increase LWD include making use of fallen timber in order to create simple flow deflectors by wiring/staking these to the bank. These can be used to scour relatively homogeneous riffle areas in order to create deeper pools used by adult fish. These small pools can provide shelter areas adjacent to riffles during spawning periods, increasing the numbers of spawning fish. Provided that the LWD is adequately secured in the channel there is very little risk of it posing an unacceptable local flood risk, particularly as land use either side of the fishery is managed as wet grassland.

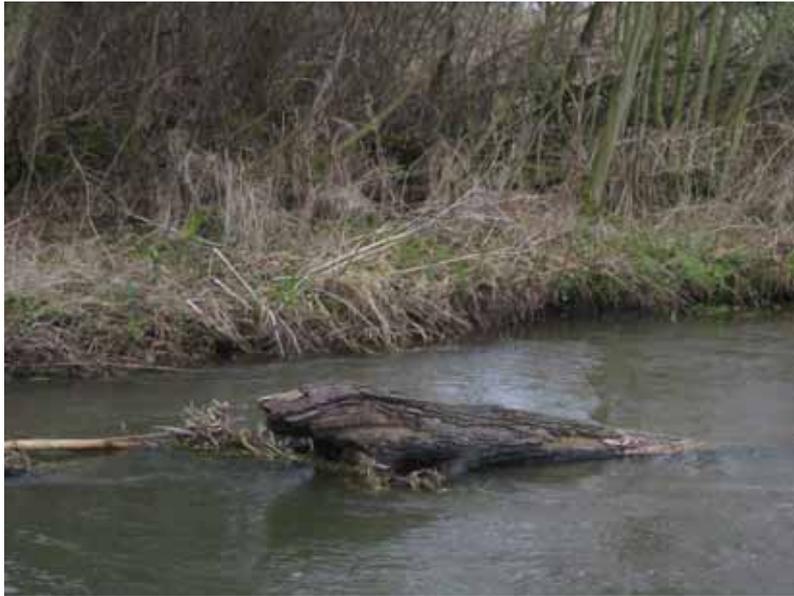
An example of LWD in the fishery

It is important that the EA is made aware of any adopted policy to retain LWD in the channel, in order to prevent its removal during routine management operations undertaken by the Agency. It is understood that one of the drivers for removal of LWD in the past has been to allow access for the EA weed cutting boat (see below). Whilst there may be some need from time to time to undertake weed cutting in the river, access for the weed cutting boat should not be used as justification for removal of such an important ecological component as LWD from the fishery.
