**HABITAT ADVISORY VISIT TO THE  
BLICKLING FISHERY, RIVER BURE, NORFOLK**

**UNDERTAKEN BY VAUGHAN LEWIS,  
WINDRUSH AEC LTD ON BEHALF OF THE  
BLICKLING FISHING CLUB, MARCH 2006**

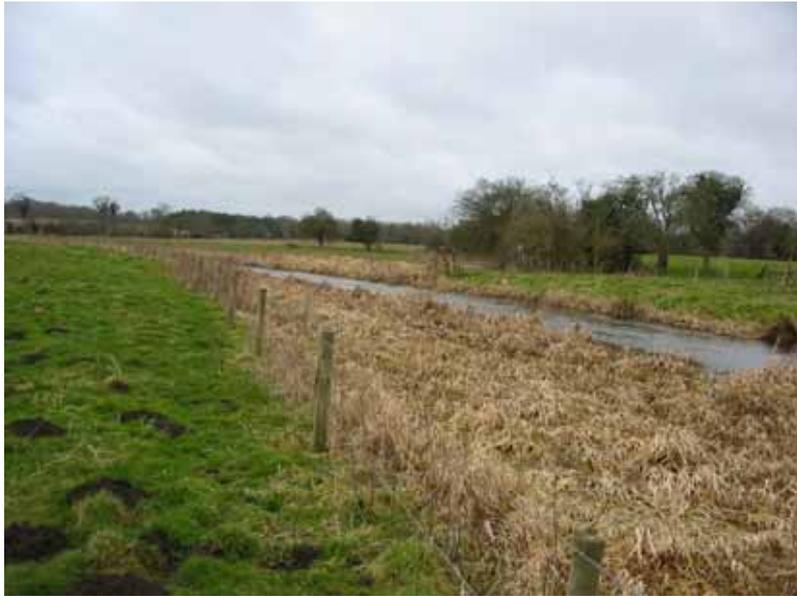
Upstream of Ingworth, the river was constrained by high banks of spoil deposited largely on the RB, following historic dredging operations. As a consequence, the hydrological connectivity between the river and its floodplain had been significantly. Some sections of the raised bank appeared to be comprised largely of finer sediment, with other sections clearly having a larger percentage of flint gravel.

The river had an artificially straightened channel form. The RB was fenced against agricultural stock, with a well-developed marginal fringe of emergent vegetation, largely branched bur-reed *Sparganium erectum*, reed canary grass *Phalaris arundinacea*, reed sweet grass *Glyceria maxima* and sedge *Carex* spp. The LB fringe was substantial but less well developed.

The channel was overdeep as a result of the dredging, with a substrate largely comprised of fine sediment. There was little evidence of gravel bedded shallow riffles within this section.

### **Downstream reach of the Blickling fishery**

- The old meander loop at the downstream limit of the fishery could be excavated and reconnected to the main river, restoring some sinuosity in this otherwise relatively

straight reach. Partial infilling of the present channel would be necessary in order to force water down the restored channel. The present river could be retained as a flood relief channel, with the infill used to create an overspill at an agreed level. Alternatively, if flood defence constraints permit, the present channel could be infilled with the spoil excavated during the restoration of the meander.

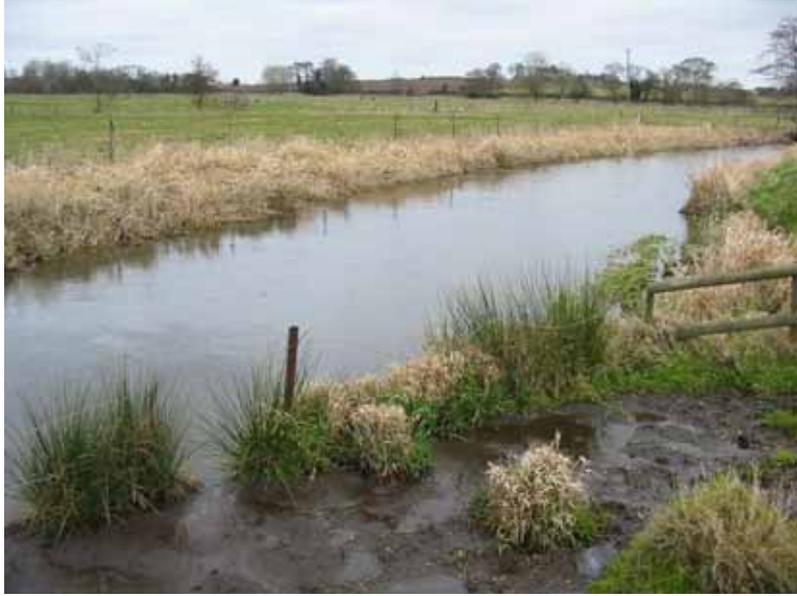
At the upstream limit of this reach, the gradient of the stream increased slightly, with more gravel riffles present. These areas were known to produce good numbers of wild trout to members throughout the fishing season. There was a poorly fenced cattle drink adjacent to a long riffle. Sediment was clearly being mobilised from the exposed mud at this location into the river.

**Shallow gravel riffle adjacent to poorly fenced cattle drink**

- Despite the presence of good fencing along most of the fishery, short sections remained un/poorly fenced, for instance at the cattle drink in the lower fishery. These remaining sources of fine sediment should be addressed, with adequate fencing provided against agricultural stock.

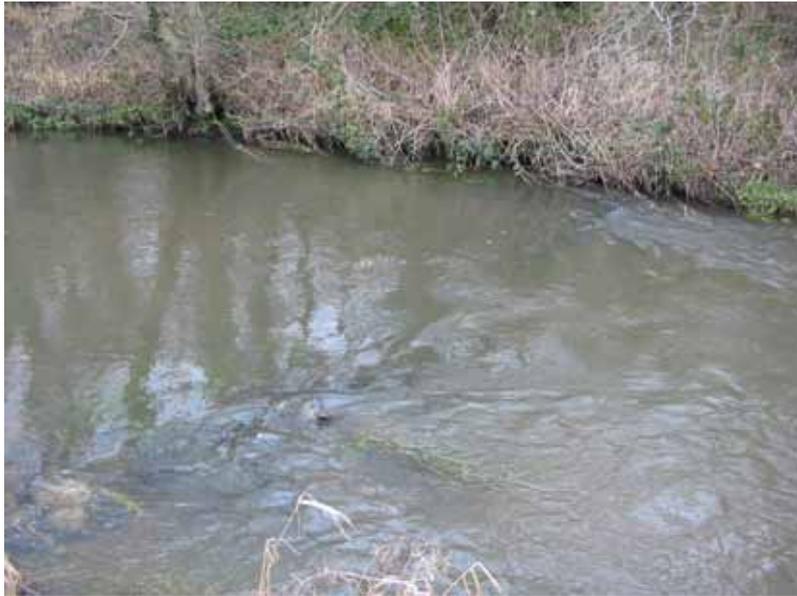
A small groyne had been constructed from flints. This was functioning well to create increased flow diversity and local scouring of bed sediment.

**Flint groyne**

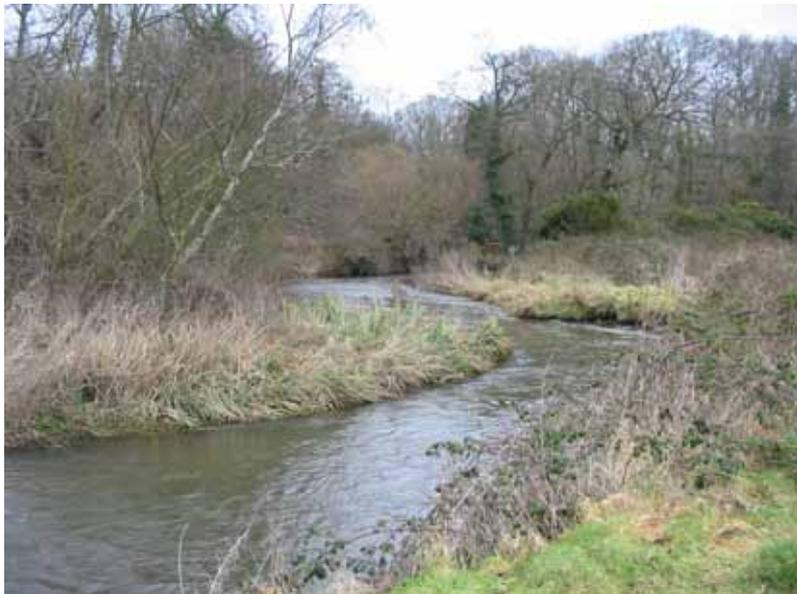
Through the Slaughter's Loke reach, woodland cover increased, with a strong LB fringe of mainly alder. The RB was more open and fenced, with land use beyond the fence line dominated by wet grassland. The channel was between 4m and 6m in width, and had a relatively steep gradient. There was a much less obvious raised flood bank along the river, indicating that less bed material had been removed during past dredging. The increased amount of shallow gravel riffle and glide habitat throughout the reach tended to confirm this observation. There were stands of lesser water parsnip in the channel, with a well-developed fringe of common reed *Phragmites australis* on the LB.

**Increased gradient and shallow riffles in Slaughter's Loke**

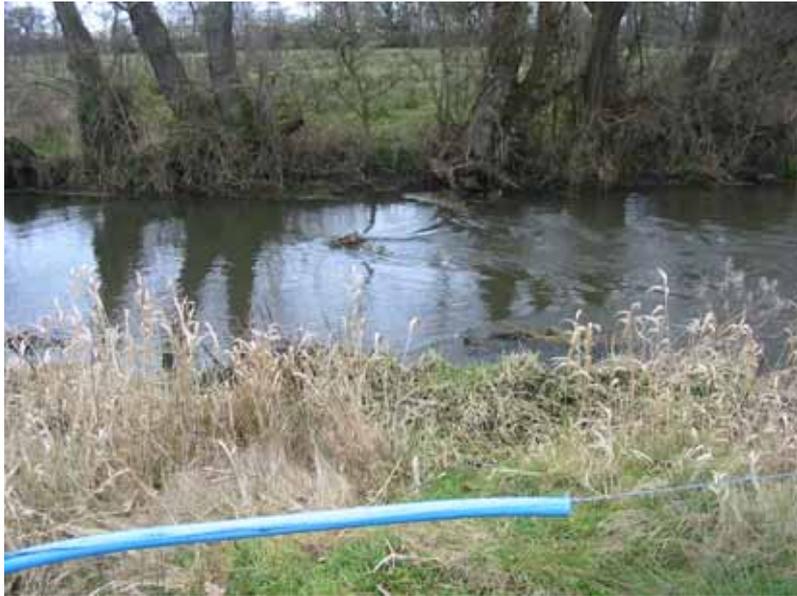
Upstream of Slaughter's Loke, the river ran through a wooded section. The channel was relatively shallow and wide, with significant amounts of fine sediment entrained within the sections of shallow riffle. As a consequence, the substrate was very uniform. This section of river would benefit greatly from an increase in the amount of LWD in the channel. The club had attempted to address the relative lack of feature in the channel by the construction of a number of small upstream facing 'v' groynes constructed from a mix of flint and wooden stakes. These were functioning well.

### Upstream 'v' groyne

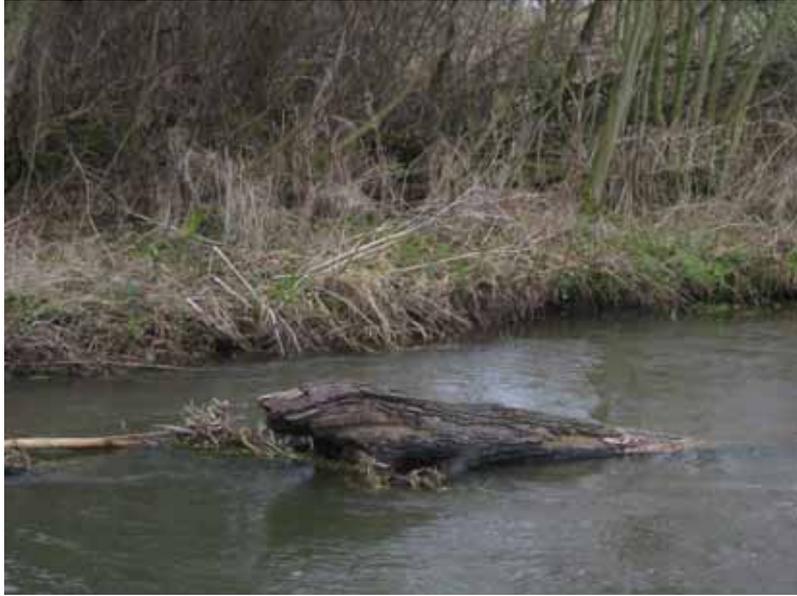
- The lack of any LWD in the fishery reduced the habitat quality significantly. In low energy lowland streams, the presence of LWD is one of the few habitat features that can increase local flow velocity enough to cause scouring and sorting of the bed. Without LWD in the channel, instream habitat will remain relatively homogeneous, with a uniform layer of fine sediment present over much of the bed. Practical management options to increase LWD include making use of fallen timber in order to create simple flow deflectors by wiring/staking these to the bank. Faggot bundles could be constructed from brushwood and used to infill the areas behind the LWD groynes. The groynes would scour relatively homogeneous riffle areas, creating deeper pools for used by adult fish. These small pools can provide shelter areas adjacent to riffles during spawning periods, increasing the numbers of spawning fish. Provided that the LWD is adequately secured in the channel there is very little risk of it posing an unacceptable local flood risk, particularly as land use either side of the fishery is managed as wet grassland or wet woodland.

### **LWD in the Bure at Blickling**

- Subject to full Health and Safety Training, a hand operated Tirfor winch <http://www.tirfor.co.uk/> would be of great use for the construction of groynes from felled timber.

- It is important that the EA is made aware of any adopted policy to retain LWD in the channel, in order to prevent its removal during routine management operations undertaken by the Agency. There seems little logic in the EA's continued removal of LWD from the channel in what appeared to be a relatively low risk area with respect to flooding. It is recommended that the Agency should be asked to justify their present policy that is having such a detrimental impact on the ecology of the river.
