**HABITAT ADVISORY VISIT
RIVER DEVER HAMPSHIRE
UNDERTAKEN BY VAUGHAN
LEWIS, WINDRUSH AEC ON
BEHALF OF SIMON CLARK.
MAY 2006**

**PART OF THE CINDERELLA CHALKSTREAMS PROJECT, JOINTLY
FUNDED BY THE ENVIRONMENT AGENCY AND ENGLISH NATURE**

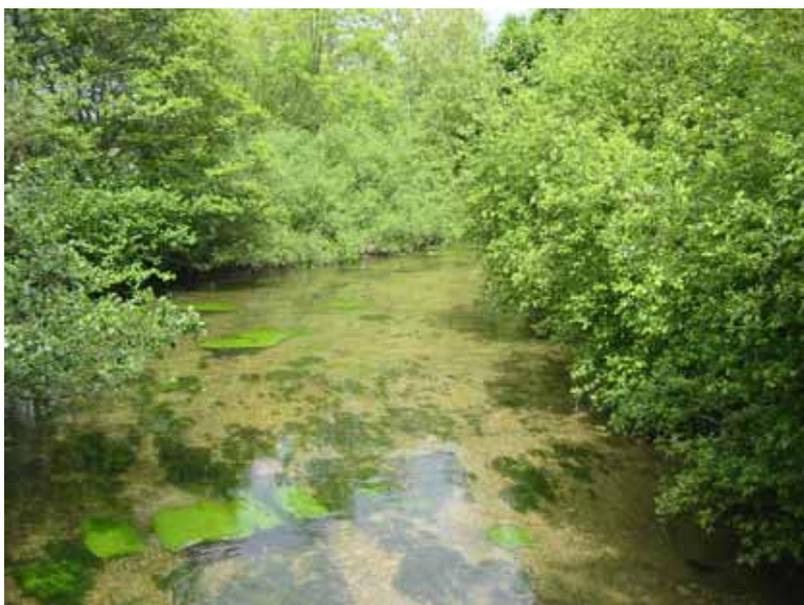
The downstream limit of the fishery was at Bransbury roadbridge. Immediately upstream, the channel was some 15m wide, with the water depth varying between 15cm and 75cm. The substrate was dominated by poorly sorted gravel and small flint cobbles, providing potentially excellent spawning for brown trout *Salmo trutta*, grayling *Thymallus thymallus* and potentially, Atlantic salmon *Salmo salar*. The bed throughout the fishery was relatively uniform, with limited sections of deeper water restricting habitat for adult fish.

There was a strong growth of mixed submerged vegetation including starwort *Callitriche* Spp., water crowfoot *Ranunculus* spp and water forget me not *Myosotis scorpioides*. The weed growth was less vigorous in sections of the river partially shaded by deciduous tree growth on both banks. Most of the shade was cast by the LB (south) trees, with those on the RB providing valuable low level cover.

Wide, partially shaded section of channel

- The downstream section of the fishery was slightly overshadowed, reducing the growth of instream plants. A careful regime of selective coppicing/pollarding undertaken could be used to partially open up the channel, and reduce shading locally. Care should be taken only to coppice/pollard small sections of the bankside trees, with more cutting undertaken in successive years. In addition to reducing shading, this will create a mosaic of uneven aged trees on the bank and dappled shade across the channel.

- The arisings from the tree trimming should be used to create faggots, roughly 2m long with a diameter of approximately 300mm. Once manufactured, the faggots could be used to reform a new edge to the river in the overwide downstream section. The channel should be narrowed locally by 1-3m (use the line of deposited silt as a guide to the exact width of the new channel) using the faggots. They should be pinned in place using wooden stakes and backfilled with secured brushings, overtopped with cut sods of sedge *Carex* spp., reed canary grass *Phalaris arundinacea* or yellow flag *Iris pseudacorus* obtained locally. These will help to promote rapid development of a protective marginal vegetation fringe. The top of the faggots should be set at approximately 100-150mm above mean summer water level. The faggot bundles could also be utilised to provide a 'soft', more natural edge to the concrete bank protection along the middle and upper section of the fishery. These sections of the fishery should be narrowed by no more than 1m. Whilst undertaking this work, it would be valuable to infill the holes in the bank behind the concrete, to prevent further erosion taking place in the future.

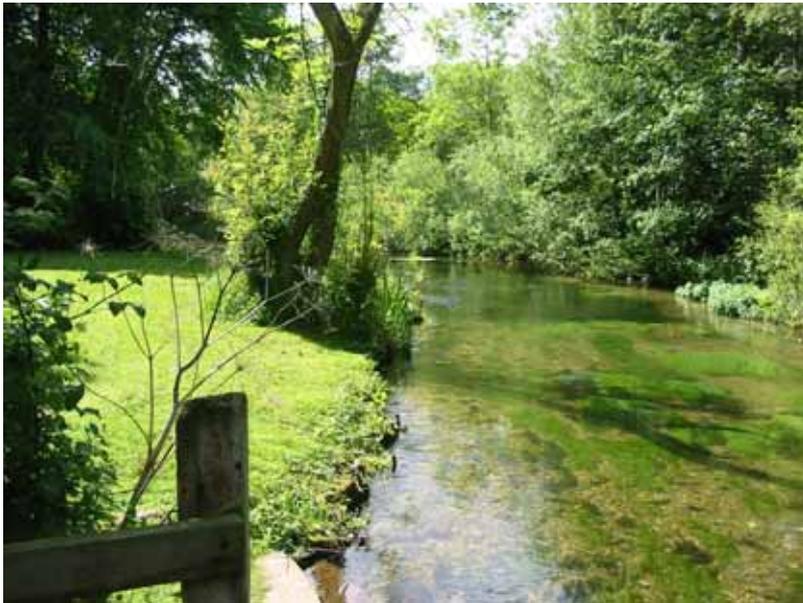
The middle section of the fishery had a more open LB, with the RB dominated by fringing deciduous trees. Attempts had been made in the past to protect the LB from erosion using a combination of artificial membranes and vertically driven wooden stakes. These had partially collapsed, with some loss of the bank line resulting. Present management of the LB comprised regular cutting to produce a uniform grass dominated sward. There was very little marginal vegetation present along this section.

Middle section of the fishery showing less shaded LB and RB tree cover

- The present regime of grass cutting should be modified along the whole reach in order to allow the development of a strong and erosion resistant fringe of vegetation, promoting linkage with the installed faggot revetment.

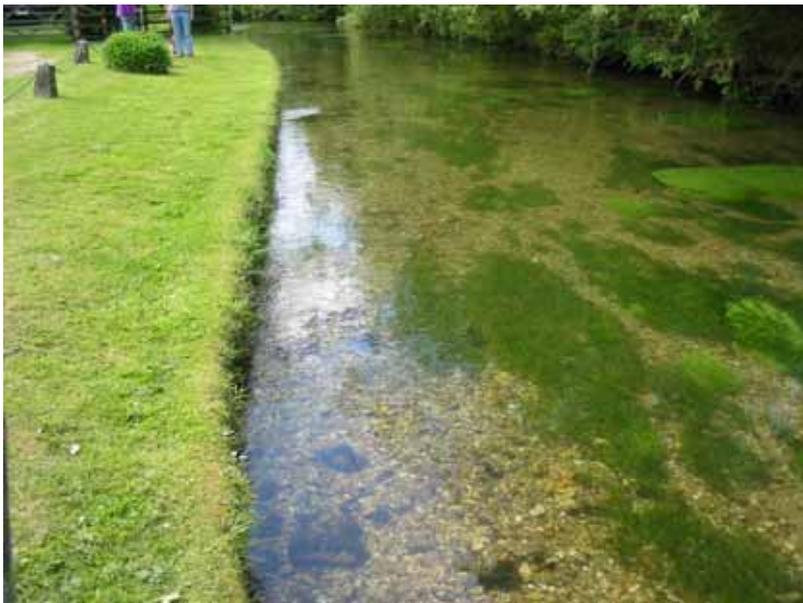
The LB of the upper section of the fishery had a concrete edge, with a sheer vertical face and no associated marginal vegetation.

Concrete revetted bank of the upper section of channel

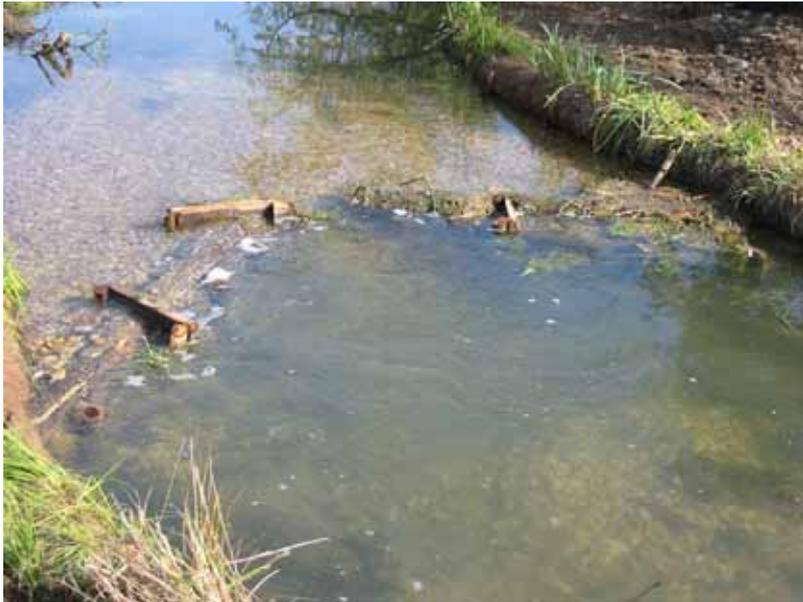
Upstream facing groynes showing scoured pool downstream

- There was a general paucity of deeper water habitat suitable for adult fish. As a consequence, much of the fishery was devoid of larger fish, that tended to congregate under overhanging trees on the RB. Additional adult habitat could be created by the use of upstream facing wooden deflectors that create scour and encourage the development of deeper water. These are easily constructed from lengths of timber arising from coppicing. The timber should be of between 15-20cm in diameter, and between 1.5m-3m in length. Install the logs on the bed of the river using a combination of stakes and wire.
