**HABITAT ADVISORY VISIT TO THE DODNASH
BROOK, SUFFOLK.**

**UNDERTAKEN BY VAUGHAN LEWIS,
WINDRUSH AEC LTD ON BEHALF OF CAROL
GURNEY AND RUPERT ELEY**

AUGUST 2006

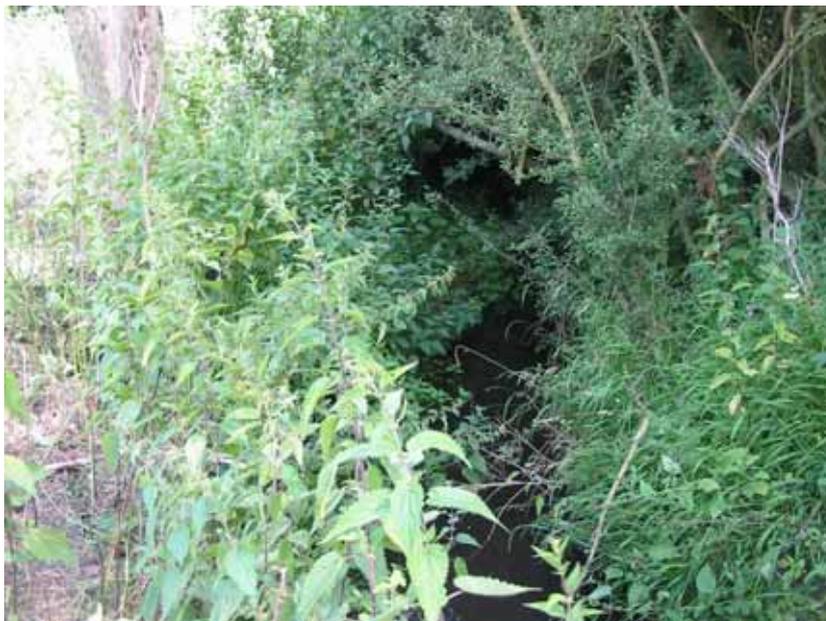
Much of the channel was heavily shaded by riparian trees, with species including ash *Fraxinus excelsior*, pedunculate oak *Quercus robur*, hawthorn *Crateagus monogyna* and blackthorn *Prunus spinosa* present. In some reaches, shading was so dense that the river was totally 'tunnelled', severely restricting the growth of instream and marginal vegetation.

Tunnelled section of the Dodnash Brook

- Coppicing or pollarding of riparian trees in sections of heavily shaded channel can be of great benefit. Coppicing and pollarding of trees are traditional and potentially valuable methods of managing trees. Wildlife associated with coppiced trees depends on maintaining a diversity of light and shade, so blocks of trees should be cut in rotation. Fringing marginal vegetation resulting from coppicing is of great importance to the survival of juvenile salmonids. However, some caution should be exercised in the cutting of trees as too much light falling on the channel may encourage the development of excessive emergent vegetation, particularly where the gradient is shallow. Ideally, coppicing should be restricted to those sections of the river where water velocity exceeds 20cmsec^{-1} , effectively limiting the growth of emergent plants.

The length of the coppicing cycle can vary between six and fifteen years, with a short cycle preventing development of mature trees, encouraging vigorous root growth and the dappled shade required by some specialist flora and fauna. This regime may well be suited to reaches of river where fishing is practised, allowing maximum room for casting. Species that can be successfully coppiced include hazel (*Corylus avellana*), alder, and (*Fraxinus excelsior*).

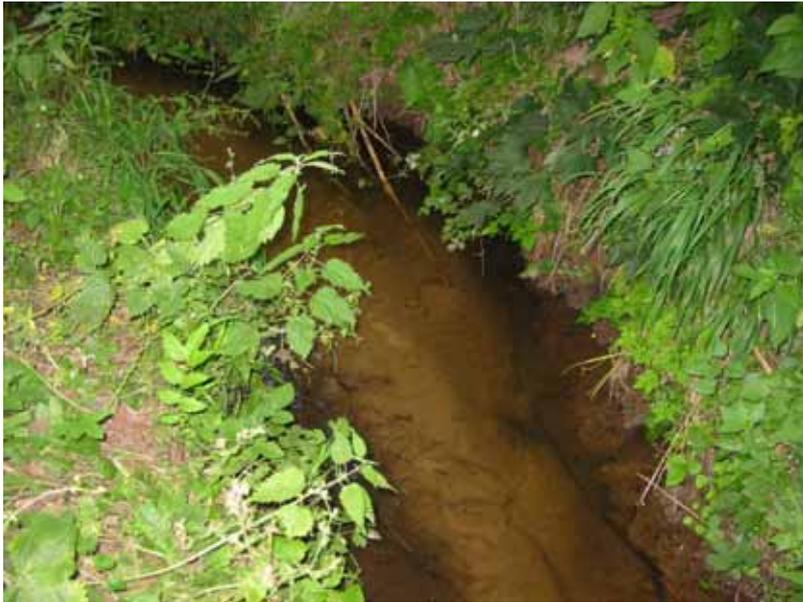
The narrow channel was heavily incised within a woodland setting, with up to 1.5m between the water level and surrounding land. The instream habitat was varied with sections of shallow glide, deep glide and pool. However, the availability of gravel bedded riffles was restricted. Those sections present had a substrate dominated by fine gravel, with a heavy burden of sand and fine sediment considerably reducing the value of the gravel for the incubation of trout eggs.

Fine sediment on the bed of the brook

Much of this fine sediment appeared to have originated from the surrounding arable fields, with crops such as wheat, potatoes, barley and sugar beet being cultivated on very fine, light and friable soils. Well-developed grass buffer strips protected the main brook from sediment-laden run-off over much of its length. Where arable fields ran close to river, the width of the buffer strip was reduced. A number of small tributary streams ran through the arable fields with only limited buffer strips present alongside these. As a consequence, they carried a heavy burden of sediment that bypassed the grass buffer strips and entered the main river.

Flow within the river was very low, further exacerbating the issue of deposition of fine sediment in the channel.

- A wide vegetated buffer strip should be created alongside all of the tributary streams and ditches in order to reduce the run-off of fine sediment into them. Additional protection from damaging fine sediment could be provided by creating reed-bed detention areas upstream of their confluence with the Dodnash Brook. Care should be taken when designing such systems not to damage the drainage regime of the surrounding arable land.

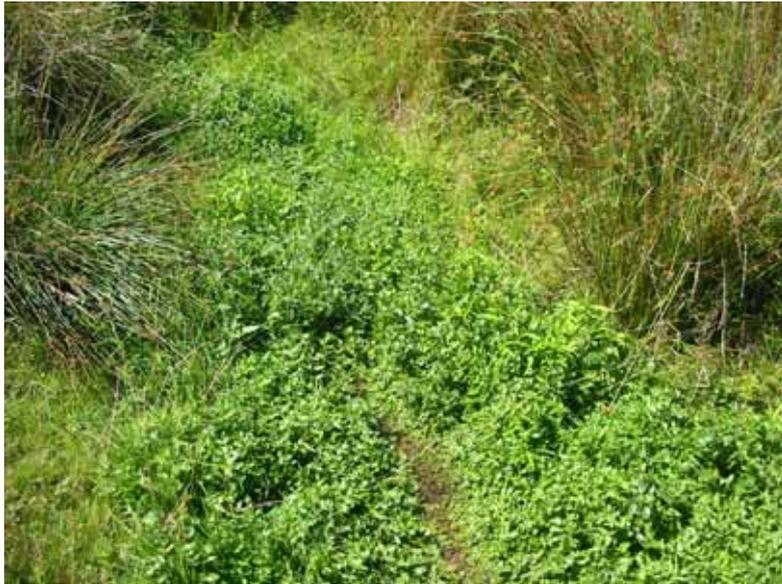
Growth of emergent aquatic vegetation in sections with reduced shading

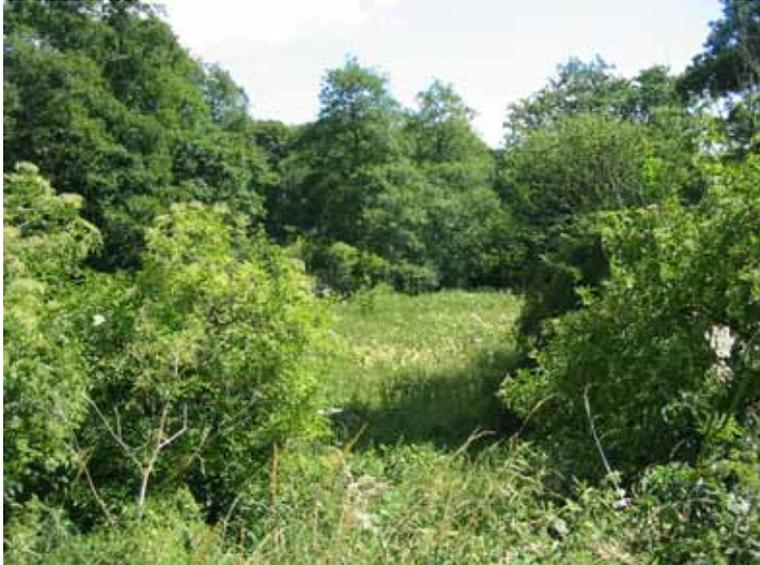
Section of wet grassland that might be suitable for excavation of wetland area

- It is understood that the estate may be entering the Higher Tier Countryside Stewardship Scheme. If this is the case, it would be possible to excavate some small flight ponds for duck shooting, along with associated wet flushes and scrapes in the floodplain near to the brook. These would have a high conservation value and, depending on the local surface geology, could provide a source of gravel that could be introduced into the brook in order to increase the abundance of riffle habitat, valuable for trout spawning. The best location for any such excavated wetlands would be in the old flood meadows towards the downstream end of the fishery.
