**HABITAT ADVISORY VISIT TO THE RIVER  
FROME, TELLISFORD, SOMERSET**

**UNDERTAKEN BY VAUGHAN LEWIS,  
WINDRUSH AEC LTD ON BEHALF OF WEST  
WILTS FLYFISHERS GUILD**

**FEBRUARY 2006**

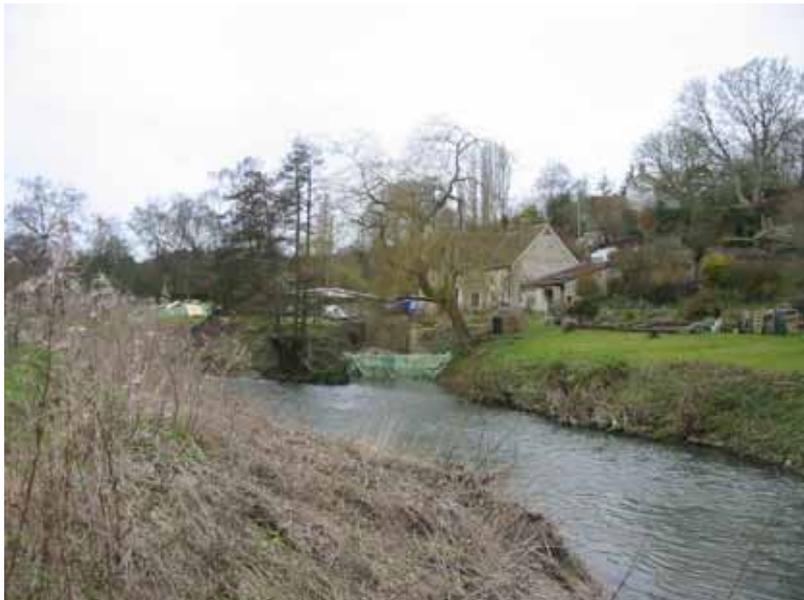
Of greater impact to the WWFG fishery was the reduction in flow likely to occur in the main river between the bridge and the downstream confluence of the mill leat during periods of generation. Depending on the timing of abstraction for power generation, this could potentially have a significant impact on the quality and availability of habitat for spawning brown trout *Salmo trutta*, grayling *Thymallus thymallus* and rheophilic (fast water loving) coarse fish.

**Tellisford Mill showing leat rejoining the main river on the LB**

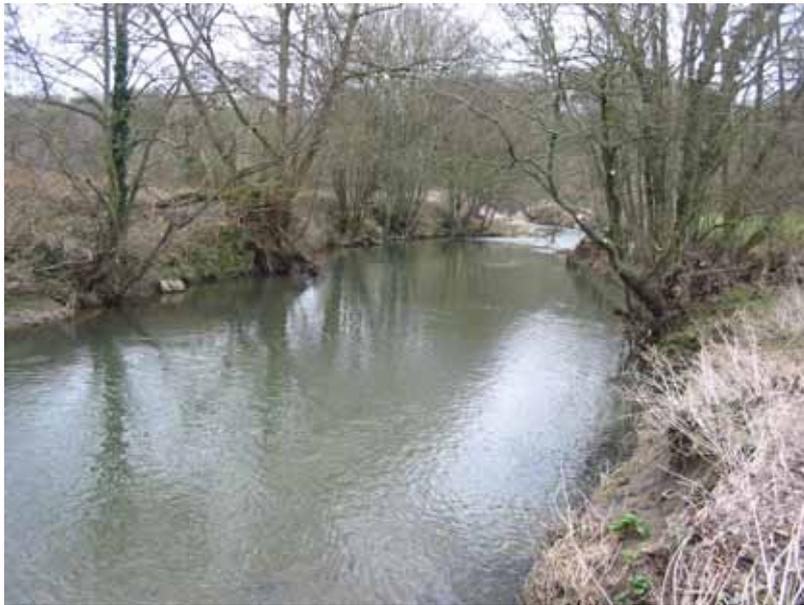
Downstream of the riffle, the river has a meandering planform, with instream habitat dominated by shallow glide, deep glide and pool, interspersed with short length of riffle. The channel was significantly incised (3m in places), with the banks comprised of friable alluvial soil. The river was generally less than 1.5m deep, with much of the angling undertaken by wading.

### **Typical section of the upper reach**

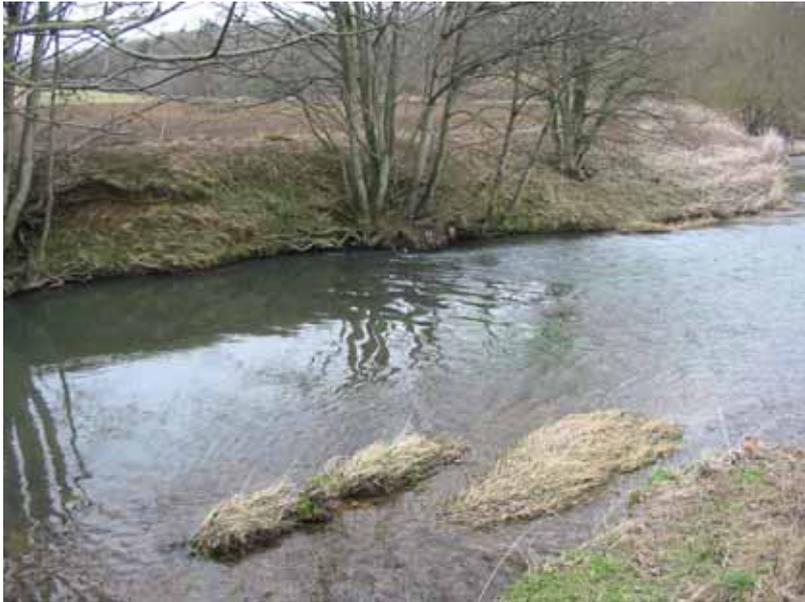
A number of small, vegetated gravel islands had formed within the river. These were very effective in narrowing the channel, hence increasing water velocity locally and encouraging sorting of the substrate. They also provided small areas of undisturbed habitat for a range of species.

**Small vegetated islands. Note arable land ploughed to top of LB**

Land use was dominated by semi-improved pasture and woodland on the RB, and by a mix of domestic gardens, semi-improved pasture and arable land on the LB. The latter fields were ploughed very close to the top of the bank, with only a narrow buffer of rough vegetation remaining.

- The cultivation of the arable land on the LB was potentially damaging to the fishery, with the narrow buffer strip providing limited protection from sediment run-off. Ideally, a wider buffer of at least 10m should be provided in such a vulnerable location.
- The quality of the gravel can be improved by continuing the regime of cleaning spawning gravels each September. This can be achieved by either manual raking, or by the use of high-pressure water jets. Care must be taken to clean riffles rotationally, with only short sections being treated annually. It is important that the EA are contacted prior to any cleaning of gravel, due to the possible discoloration of water in the river resulting from the operation. The same concerns dictate that downstream neighbours should also be forewarned of the operation.

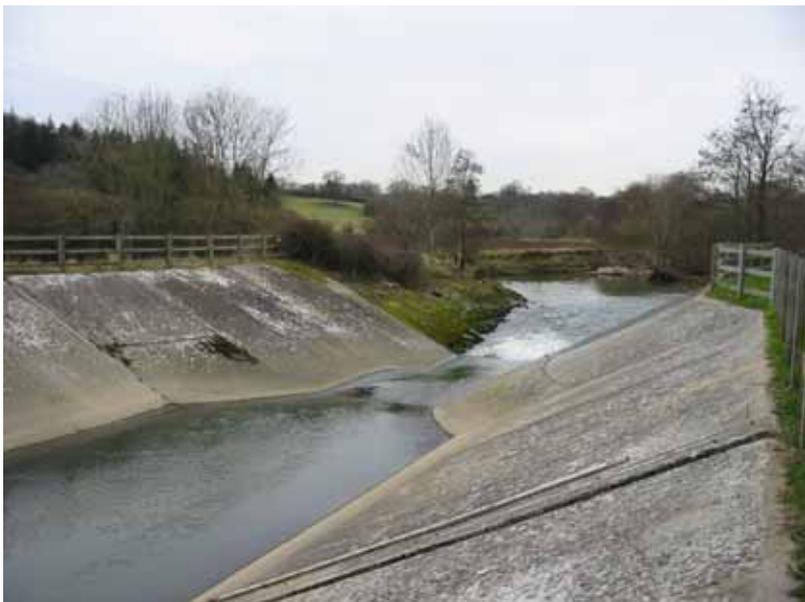
Instream habitat in the middle reach of the fishery was heavily influenced by the presence of an Environment Agency (EA) gauging weir. The backwater effect of this structure had resulted in considerable deepening of water upstream, with associated deposition of fine sediment on the bed. The design and construction of the weir were not beneficial to upstream migration of fish, resulting in partial spatial isolation of the fish populations upstream and downstream of the structure.

**Gauge weir**

- There is little doubt that the gauge weir is having a detrimental impact on both the instream habitat and the migration of fish. If it is indeed redundant, then an approach could be made to the EA with a view to its removal or modification. This would clearly be a very significant and expensive operation that would require a high degree of planning. However, the benefits accruing would be equally significant, improving both upstream habitat quality and allowing unimpeded passage of fish.
- The EA have apparently expressed a desire to remove some or all of the islands that have formed downstream of the weir. The logic for this aspiration is believed to be the erosion caused to the LB due to the presence of the island and their impact on flows.

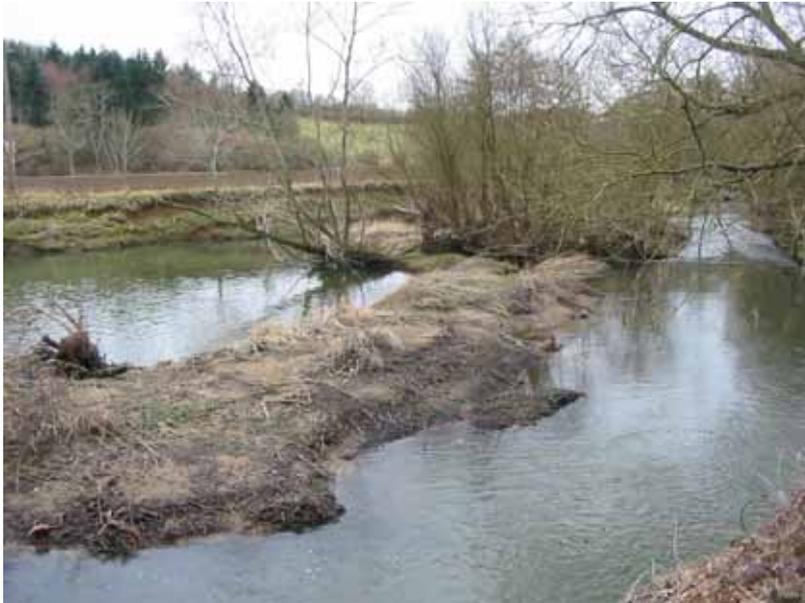
It is understood that the gauge weir may now be redundant. The increased water velocities caused by the gauge weir had caused LB and bed erosion downstream of the structure. Some of the eroded material had consolidated and vegetated, forming a series of three or four islands. These were valuable features, helping to narrow the channel and sort substrate. The resulting shallow, gravel dominated riffles were important spawning areas for both salmonids and coarse fish species. The islands also providing undisturbed terrestrial habitat for a range of species.

#### **Island ‘archipelago’ formed by erosion downstream of the weir**

It is strongly recommended that this course of action by the EA should be resisted. The islands have a high conservation value, both in their own right and as elements narrowing the river channel, helping to improve instream habitat quality for coarse fish and salmonids. If the only justification for their removal is indeed to protect the LB arable land from erosion, then other mechanisms should be considered first. The value of the arable land is relatively low, with present gross margins on cereal production at a similarly low level. The advent of the recent Single Farm Payment casts even further doubt on the financial sense of continued cereal production in sub-optimal areas, particularly within a floodplain. The economic justification for the ecologically damaging option of removal of the islands in order to protect the arable field from erosion is thus likely to be weak.

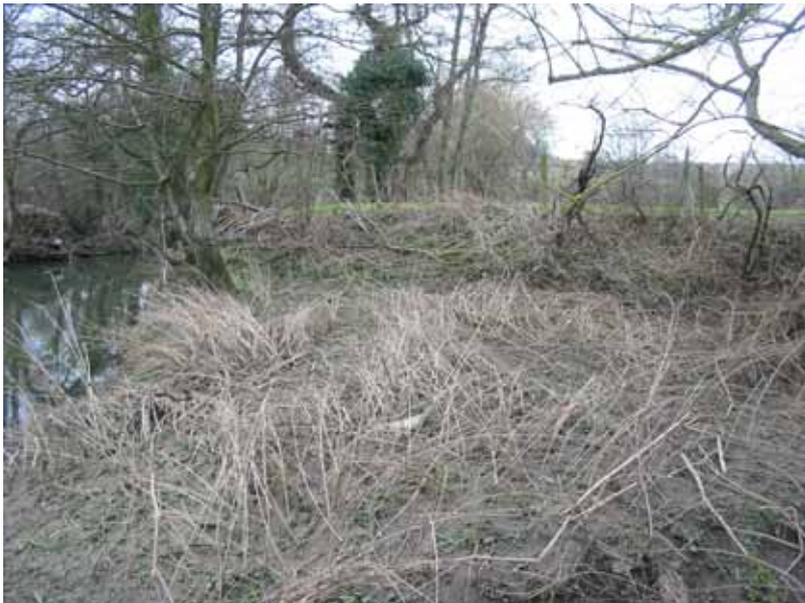
Further downstream, a RB channel previously entered the river. This had gradually accumulated sediment, with secondary regrowth of crack willow *Salix fragilis*. As a consequence, there were no remaining open areas of water.

#### **Silted up mouth of old RB channel**

- The silted up old channel on the RB below the weir could be excavated in order to create a wide, deep bay and channel, offering a valuable low velocity refuge for coarse fish fry during high discharge periods. Survivorship of young of the year fry during spates, particularly during summer the summer/autumn period, is strongly correlated to subsequent year class strength.

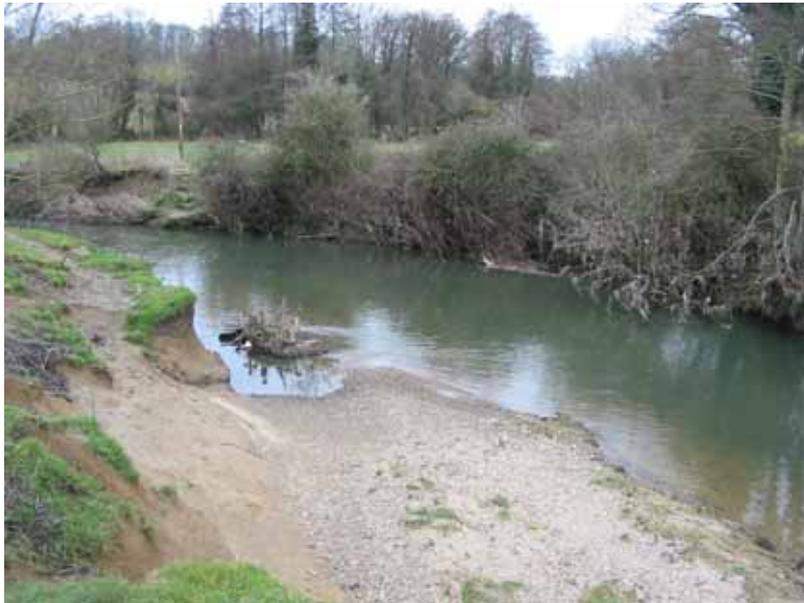
The reach alongside and downstream of Pomeroy Wood was characterised by deep, slow instream habitat, largely as a result of the backwater effect of the substantial downstream weir. There was little habitat suitable for spawning or juvenile brown trout or grayling. Sheep and beef cattle had been kept in the unfenced RB field of this reach at relatively high densities. Overgrazing of the riparian vegetation and significant erosion of the banks had occurred as a result, with large areas of slumping visible. LB land use was arable, with a well-developed fringe of trees and shrubs offering some protection from erosion.

### **Eroded, slumping bank and resulting unconsolidated sediment**

- The overgrazing and subsequent erosion of the RB of the lower reach is very damaging to the fishery. It should be addressed as a matter of some urgency. Ideally, agricultural stocking densities should be reduced to a level that prevents significant bank damage. However, this is unlikely to happen. A more practical

alternative would be to erect a fence along the length of the riverbank in order to create a well-vegetated buffer strip of at least 5m width. Fencing costs are likely to be in the order of £4/linear metre, with stiles, and access gates additional costs. There will be some maintenance liabilities associated with the fenced area, mainly focussed on regular cutting of vegetation in order to allow access for anglers. Part funding for this and other habitat work could potentially be provided by the WTT (contact Edward Twiddy) and/or the EA.

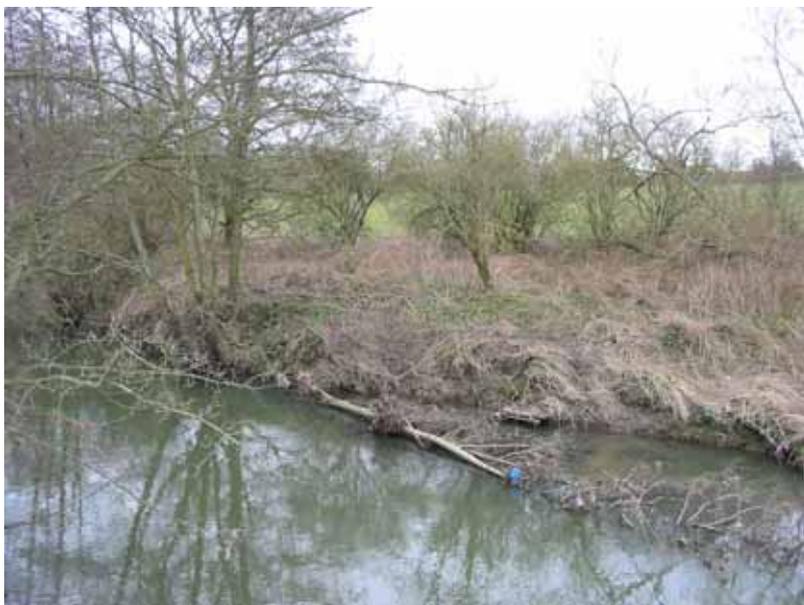
### **Good example of stable LWD in the lower fishery**

Whilst gravel washing is a potentially useful aid to enhancement of hatching success for trout eggs, it is very labour intensive. A simpler, longer-term enhancements can be achieved by careful placement of LWD in areas of gravel riffle. Practical management options to increase LWD include making use of fallen or cut timber in order to create simple flow deflectors by wiring/staking these to the bank. These can be used to scour relatively homogeneous riffle areas in order to sort the gravel and create deeper pools used by adult fish. These small pools can provide shelter areas adjacent to riffles during spawning periods, increasing the numbers of spawning fish.

It is important that the Environment Agency is made aware of any adopted policy to retain LWD in the channel, both in order to assess potential flood risk (likely to be very low), and to prevent its removal during routine management operations undertaken by the Agency.

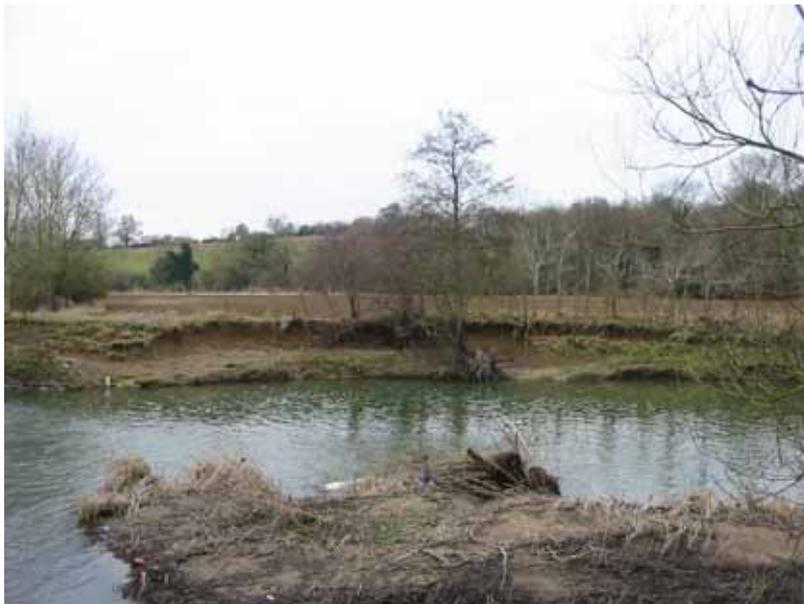
### **Erosion on LB of the river adjacent to the islands**

Given this, it is recommended that a combination of local re-grading of the eroded bank in order to create a shallower, less easily eroded profile and the creation of a well-vegetated buffer of at least 20m would provide a more acceptable and cost effective solution to this issue.
