Habitat Advisory Visit

River Colne, Lancashire

On behalf of the Colne Water Angling Club

June 2006

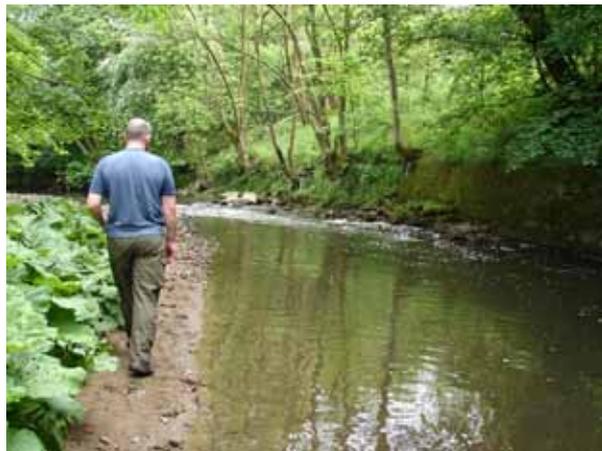
This geomorphology of this section of river active with a well developed pool riffle system. Both bank are characterised by a fringe of deciduous woodland. In many places the banks have been engineered with block stone, which is now in various states of disrepair. The LHB immediately above the M65 road bridge is eroding and requires urgent attention to stop the ingress of the river behind the bridge supports during peak flood flows when erosive forces are at their greatest.

A) Good pool: riffle sequence

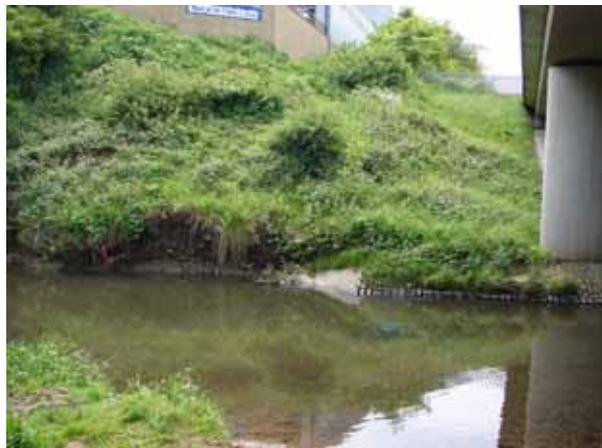
B) Erosion near M65 road bridge

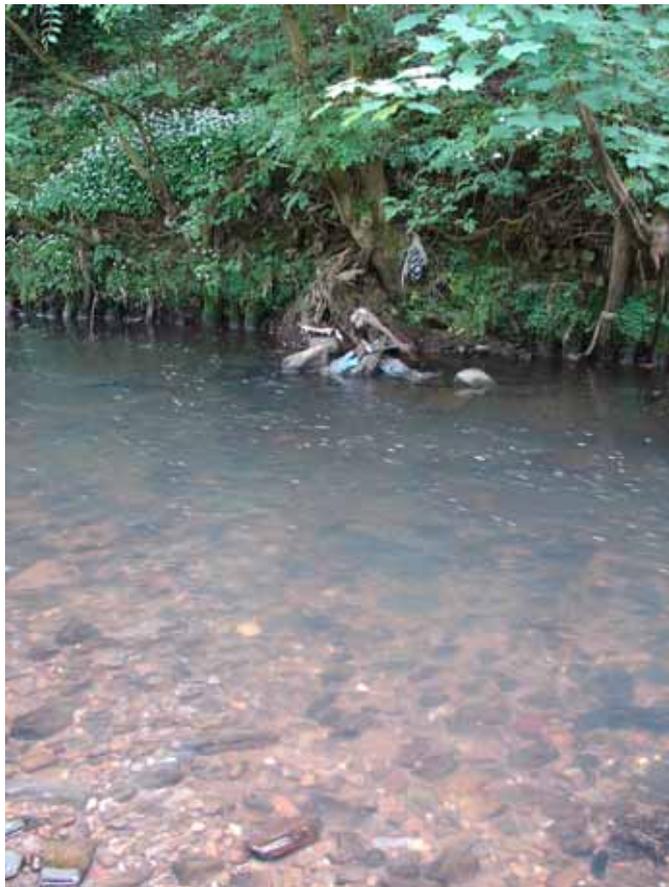
Water quality appears to be affected by the sewage treatment works upstream in Colne. At the time of the visit the water was visibly turbid and was tinged with the smell of effluent. There is also a pipe on the LHB discharging into the river above the motorway bridge. It is recommended that CWAC contact the Environment Agency to assess the nature and quality of this discharge. Generally speaking the Colne can be classed a spate river. Downstream the village of Barrowford has recently undergone a £20 million Environment Agency flood defence capital improvement project to address historical problems of severe flooding. The river skirts an relict landfill site and deciduous wood on the RHB and there are localised erosion problems which could potentially affect habitat and water quality. There are large amounts of household and industrial waste (pallets, prams, plastic sheeting, wire, etc) in the channel, some of which represents a considerable hazard to wildlife and anglers.

Throughout this reach there is an apparent lack of deeper pool habitat, to provide cover from swim-up fry and adult fish. Riffle areas appear to have a considerable loading of fine sand limiting their value as potential spawning redds.

C) Household / Industrial Waste – Note the 'milky' colour of the water from Sewage Works and the deposition of sands within the gravel matrix.

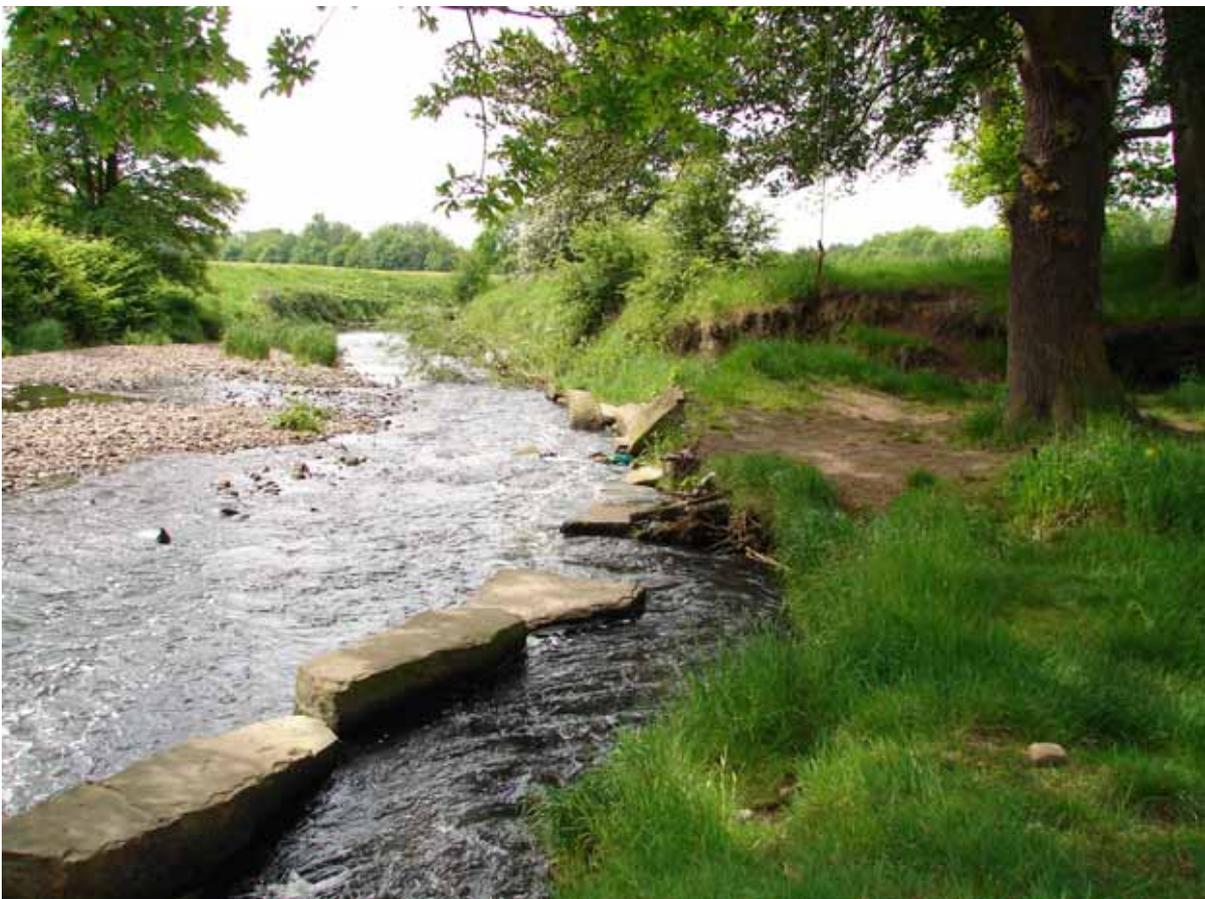
As the river enters the Borrowdale Community Woodland area there are several areas of localised erosion on the LHB. Opposite the Swinden housing estate previous block stone revetment work to protect the M65 motorway has been breached and the river is eroding on the RHB and forming a vegetated mid-channel shoal. This has caused a major bank slump. The slump has taken several mature oak trees with it that remain unscathed! If left unchecked this land will continue to erode quickly which will deposit more fine sediment in the river which may affect spawning redds further downstream.

D) Failed block stone revetment, resulting erosion and major land slump.

River banks can be re-profiled, seeded and planted with appropriate vegetation and the bank toe (bit next to the water), can be faced off with willow withies to protect it from erosion. 'Green' willow withies are woven through 'green' willow stakes, which continue to grow, putting out root systems and binding the soil together. In areas where grazing occurs fences should be repaired and installed. CWAC should contact landowners who may be able to get funding for this work through the DEFRA Entry Level and Higher Level Farm Payment Schemes. Fencing should aim to create buffer strips a minimum of 4m wide.

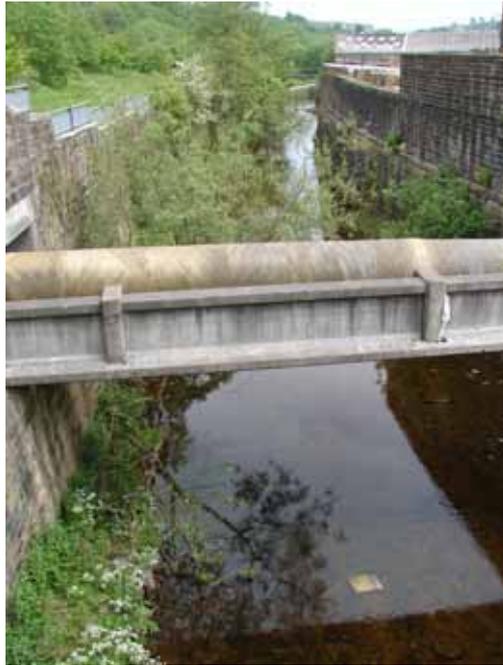
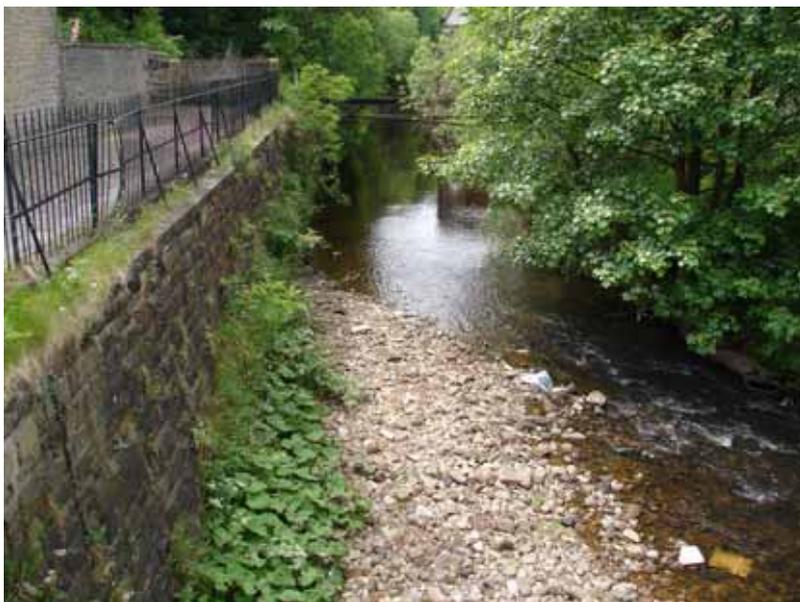
The river now runs through the centre of Colne where a once thriving cotton milling industry was based. Evidence of the industrial past and its lasting effects on the river channel and its ecology is obvious. Most banks are heavily reveted with stone and in places are twenty feet higher than the wetted perimeter. With milling all but disappeared the river is slowly recovering some more natural characteristics. In places pool:riffle sequences are re-forming, with associated vegetated shoals and islands.

E & F) – Nature slowly reclaiming the industrial landscape (tree growth / natural in-channel features)

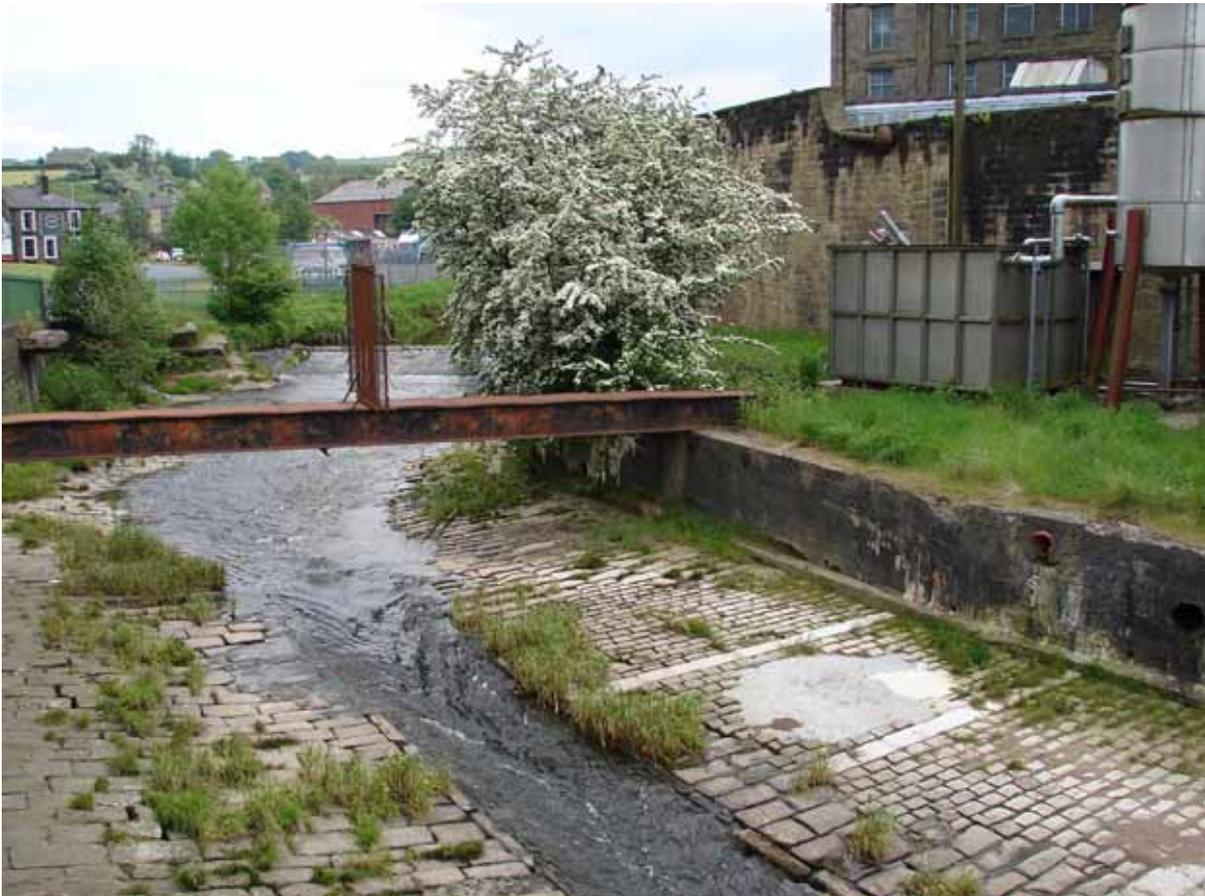
There are numerous old mill structures and artificial channel features all of which represent considerable barriers to fish passage (brown and possibly future sea trout and salmon movements).

G) Relict mill structure and block stone channel upstream of Waterside Bridge.

There are many impassable structures on the Colne. These represent a considerable bottleneck limiting the natural production of the fishery. Where possible structures should either be removed or modified to allow the free passage of salmonids from within and outside the catchment to the upper reaches for spawning.

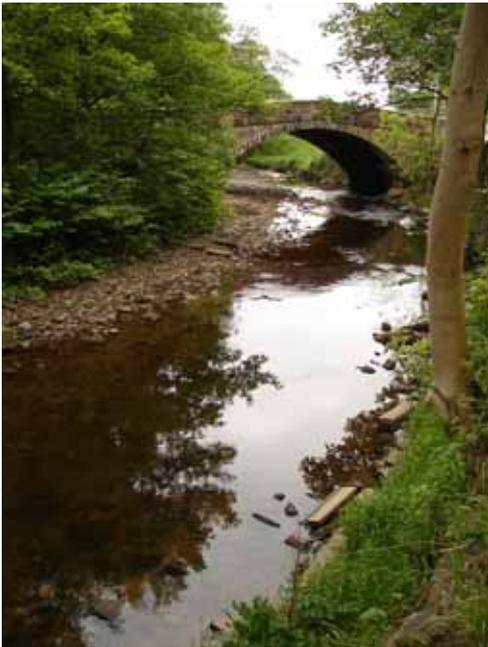
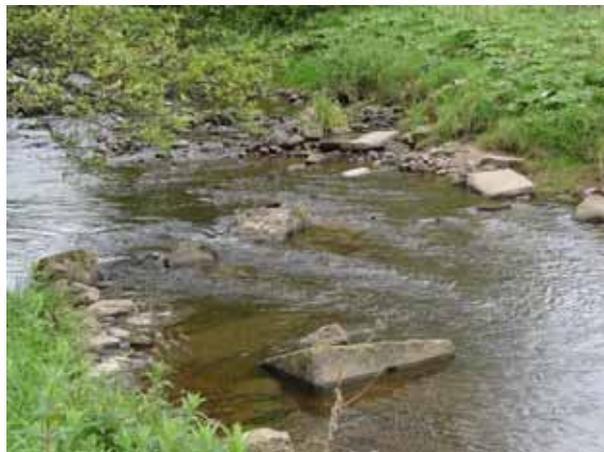
H&I) Upstream of Carry Bridge and old bank / weir blockstones creating useful pool habitat.

The channel is still confined within blockstone banks. In many places these historical features of a past industrial age are in a state of disrepair.. Where the river has broken down these revetments natural bank profiles have also formed with good fringing plant cover. This habitat is extremely important for juvenile brown trout, both in terms of cover from predators and as a source of invertebrates for food. In many places individual block stones have created useful pool habitat. As with the river downstream of Colne there appears to be a general lack of deeper holding pool habitat, other than shallow pools downstream of riffles and upstream of weirs.

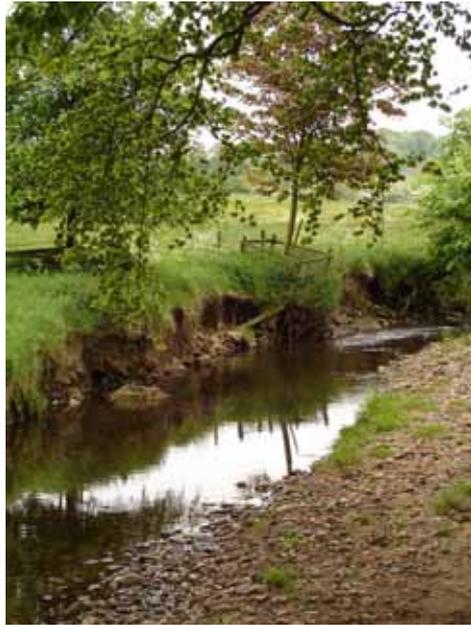
As the river moves upstream through the Ball Grove nature reserve large seams of millstone Grit are exposed creating some interesting long glides and pools. The river now leaves the wooded section and enters a landscape dominated by grazing. In places the fencing has fallen into a state of disrepair and cattle have gained access, causing problems of bank erosion. These areas could possibly be a source of the fine sediment deposition observed further downstream below Colne.

J) Areas of localised erosion

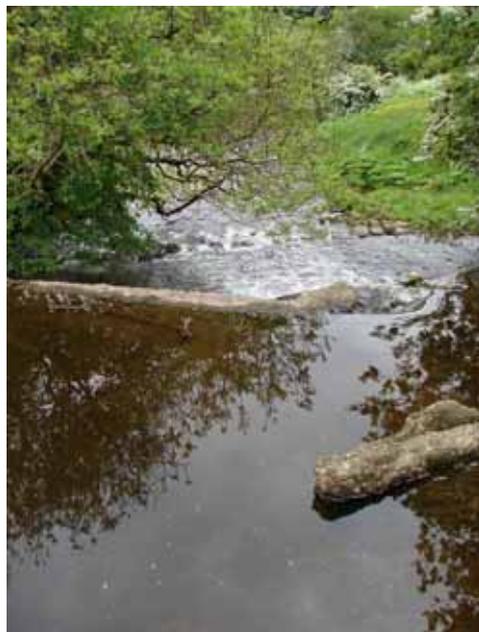
Although this section of river is more rural there are still numerous relict mill structures inhibiting fish passage. One or two mill structures have been destroyed by the powerful flood flows that come off the Pennines each winter. On the one hand this has solved fish migration issues but in many places it has created localised erosion problems as the river tries to establish a new equilibrium.

K) Semi-collapsed mill structure

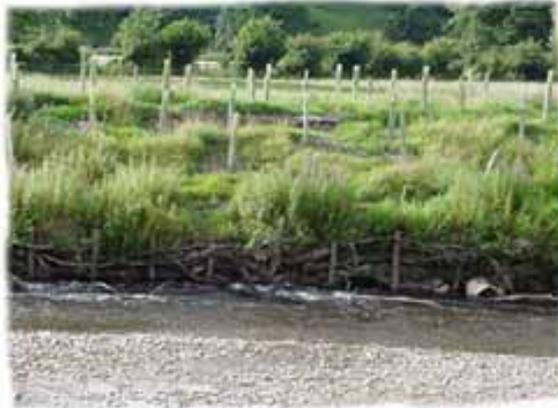
L) Use of willow withies, reprofiling and planting

The use of willow withies and willow stakes has proved to be less costly and more effective than 'hard' forms of river engineering. It is also sustainable and has far less environmental impact than the alternatives.

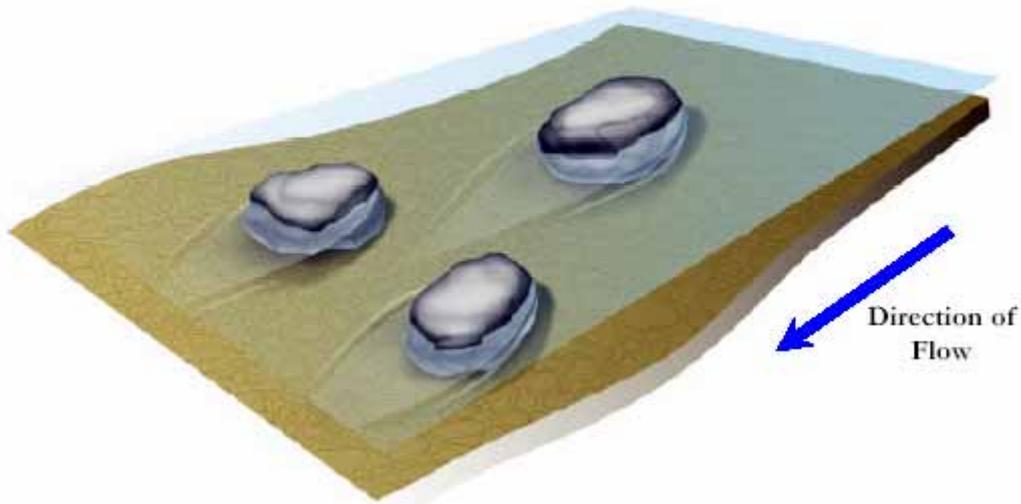
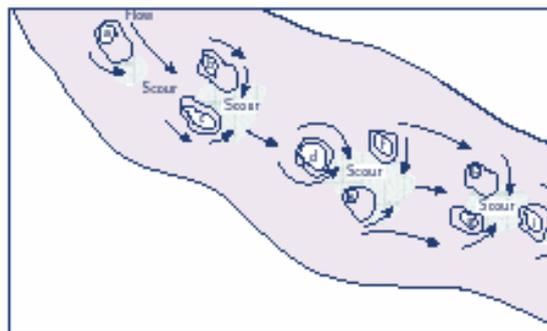
Figures 1&2 – Boulder / Blockstone Placement.

In many sections of the river the apparent lack of holding pool habitat may be a factor limiting the fishery. As with erosion control there are many options open to CWAC. A guiding principle in most schemes should be to avoid the purchase of expensive materials as much as is possible i.e. try to work with what the river can provide. In many locations there is an abundant supply of blockstone scattered on the banks and within the channel. This material could potentially be used to create small runs and pools using a long reach excavator to individually place stones in the channel (see figure 1). These small pools would be particularly useful for trout parr, which are highly territorial and require cover. The net result would be a more diverse flow and range of depths.

Figure 5: Use of different boulder configurations which may help create fish cover in certain types of stream. The examples show how single boulders (a), boulder pairs (b,c) or boulder clusters (d,e,f and g,h,i) can be used to encourage scour. Note boulders should be set well clear of the stream banks as not to accelerate bank erosion (after Cowx and Welcomme, 1998).

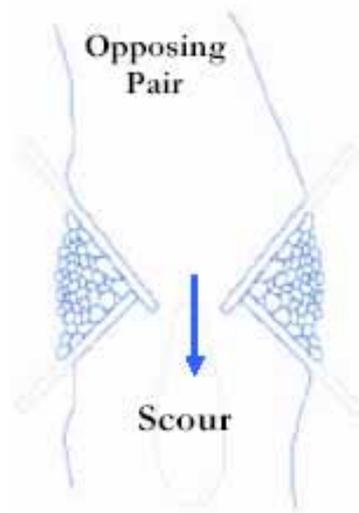
2

Another option may be to use the block stone to create low vortex weirs or paired deflectors (see fig 2). These should ideally be located mid-way down long shallow pools in areas where smaller substrate is present to allow the creation of larger scour pools. Double Logs can be used but they should be pinned to the bed of the river with pins at least 2m deep to cope with the high energy flooding events that occur in the catchment. Electro fishing studies have shown these features to be particularly useful at holding numbers of trout parr
