Habitat Advisory visit to the Lorrha
River, Lorrha, Co.Tipperary, Eire
Undertaken on behalf of Lorrha and
Rathcabban Anglers by Vaughan
Lewis, Windrush AEC Ltd
December 2006

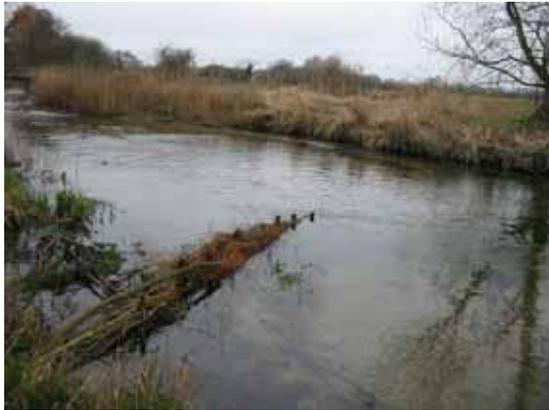
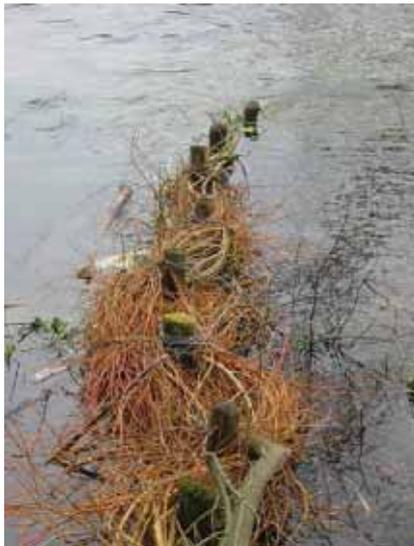
- Free access into and out of Friar's Lough should be maintained. Rather than resort to damaging and relatively expensive dredging operations, it may be preferable to use the herbicide glyphosate. This chemical is approved for use in and near to watercourses and is inactivated by contact with water. Provided that all necessary consents are obtained from the regulatory authority in Ireland and the manufacturers instructions are followed, this is a safe and cost effective method of vegetation control.
- Salmon lies can potentially be created on the Brosna by the use of wooden groynes. These have proved very effective in lowland southern England streams that are not dissimilar to the Brosna. They can be easily be constructed from woven hazel or willow as in the photographs below.
