**A 'CINDERELLA CHALKSTREAM' HABITAT  
ADVISORY VISIT TO THE NINE MILE RIVER,  
WILTSHIRE  
UNDERTAKEN BY VAUGHAN LEWIS,  
WINDRUSH AEC LTD ON BEHALF OF Dr.  
CHARLES GOODSON-WICKES  
AUGUST 2006**

## 1.0 Introduction

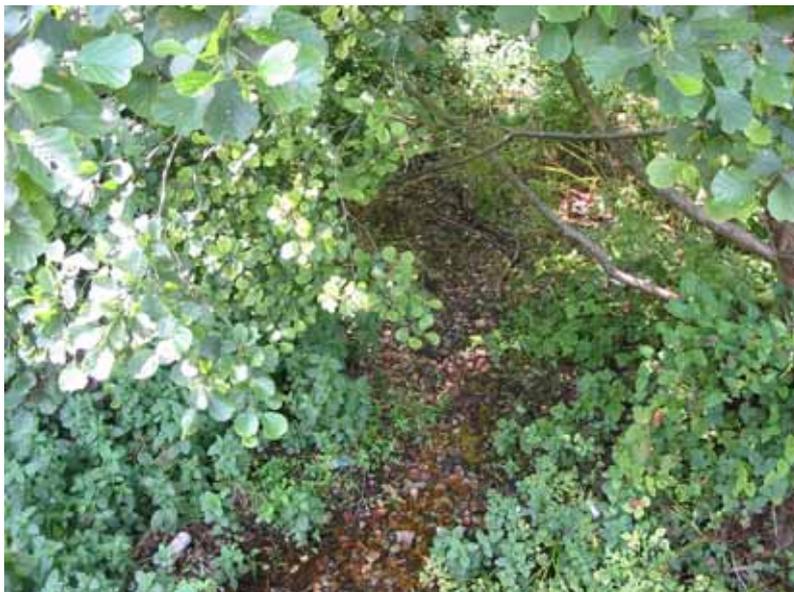
Approximately 1 km downstream, a water company pumping station was located near to Bulford. This is apparently one of three similar abstractions near to the Nine Mile River. Recent studies by the Environment Agency including the Catchment Management Abstraction strategy (CAMS), have attempted to evaluate the impact of these abstractions on the river. Any impacts of abstraction on the river's flow and its ecology, will have been exacerbated by the recent drought in the south of England. The river at this location did have water in it, but had no discernable flow, with a series of pools connected by stationary shallow water. Despite this, instream gravel quality was excellent, with numbers of brown trout *Salmo trutta* previously known to use the site for spawning. Small numbers of fish (probably sticklebacks) were seen in the channel. The lack of flow had almost certainly prevented survival of any brown trout parr in this reach, with any fish either having either migrated downstream or died. Bankside trees were present along the length of the channel, resulting in localised overshading.

**River bed showing excellent spawning gravel and lack of any flow**

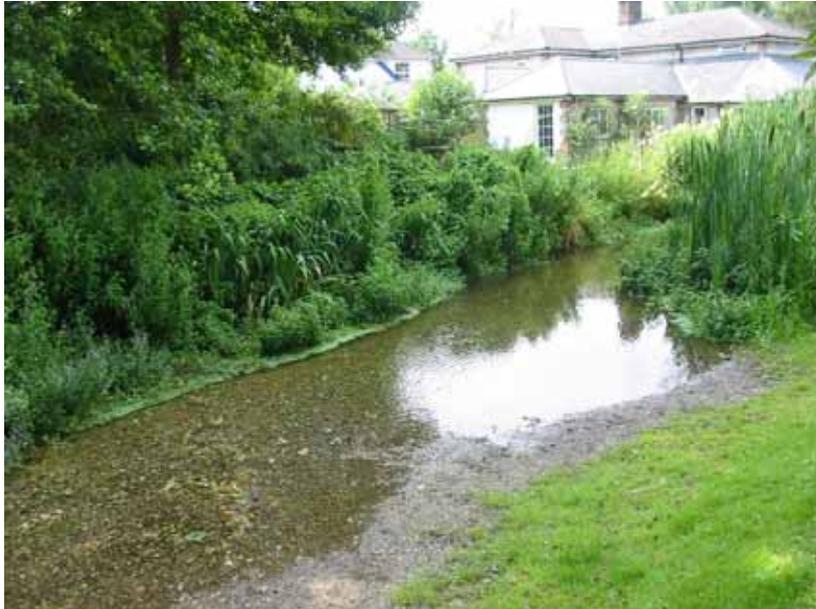
At Bulford village bridge, there was a low flow of water in the river, with continuity of habitat maintained between pools and shallower areas. This section represented the effective head of the river on the day of the advisory visit. There were stands of starwort *Callitriche* Spp. and abundant sections of gravel riffle present.

**River at Bulford village bridge. Note low but continuous water flow in the river**

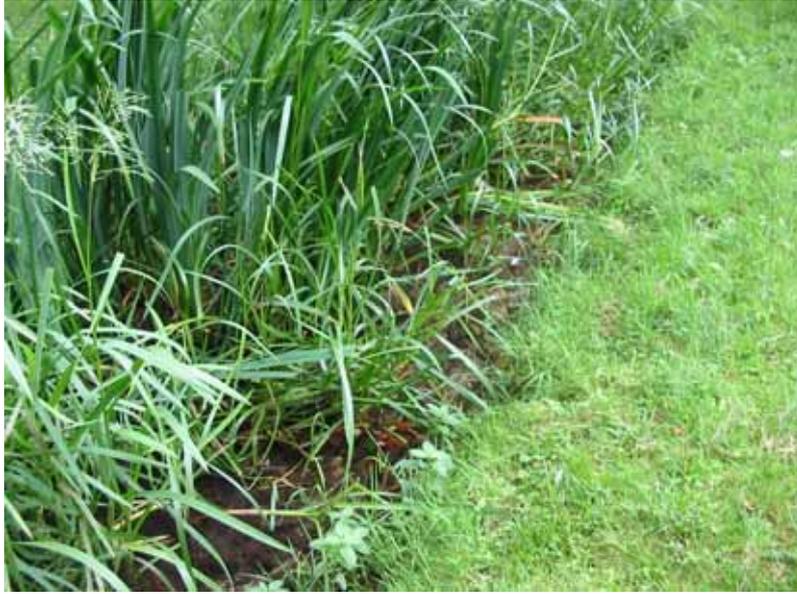
Further downstream, a number of similar wooden impoundments had been installed. Each one retained a head of perhaps 20cm of water. Significant volumes of fine sediment had accumulated upstream, with associated growth of emergent vegetation occluding the channel. As a consequence, all potential habitat for spawning and juvenile trout had been lost in these sections.

### **Emergent growing behind wooden impoundments**

- The series of impoundments present within the stream have significantly reduced the available habitat for both spawning and juvenile salmonids. It is recommended that they should be removed as a matter of some urgency, ideally prior to the winter period. This will allow higher flows to remove some of the accumulated sediment. Due to the dense growth of emergent vegetation present, it may be necessary to dig it out or perhaps herbicide it in the central section of the river, thus creating a clear channel perhaps 0.5m-0.75m in width. Selective chemical control with the herbicide glyphosate when the plants are actively growing in early spring should be effective. Note that the use of glyphosate or any other herbicide on or near water requires the consent in writing of the Environment Agency.

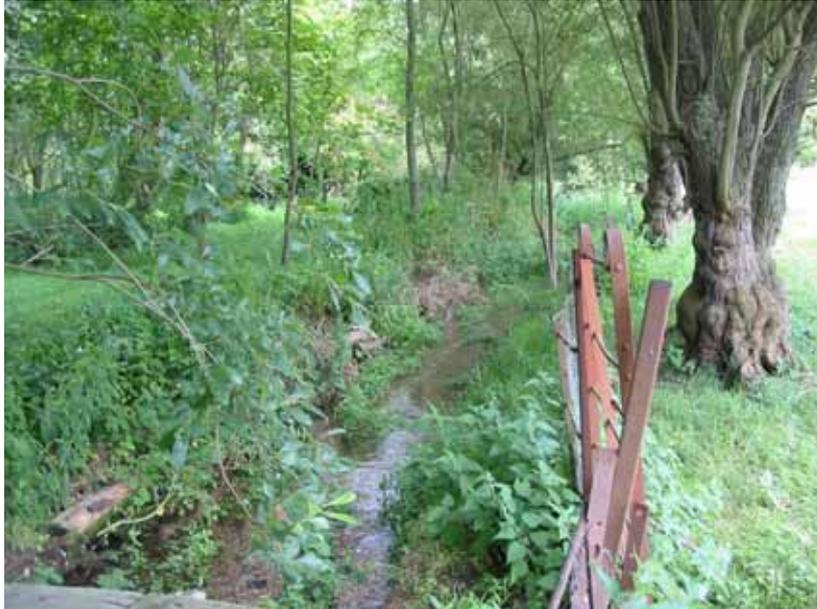
A small spring fed carrier was present between the Nine Mile River and River Avon. This had apparently not dried up during the last 21 years and was indeed flowing relatively strongly on the day of the advisory visit.

**Small spring fed channel lying between Nine Mile River and Avon**

- It would be of some interest to monitor flows in the Nine Mile River and adjacent spring fed watercourse during 2006. In the event of a differential drying out of the two channels, information should be sought from the Environment Agency regarding flows in the channels and abstraction from their groundwater catchments.

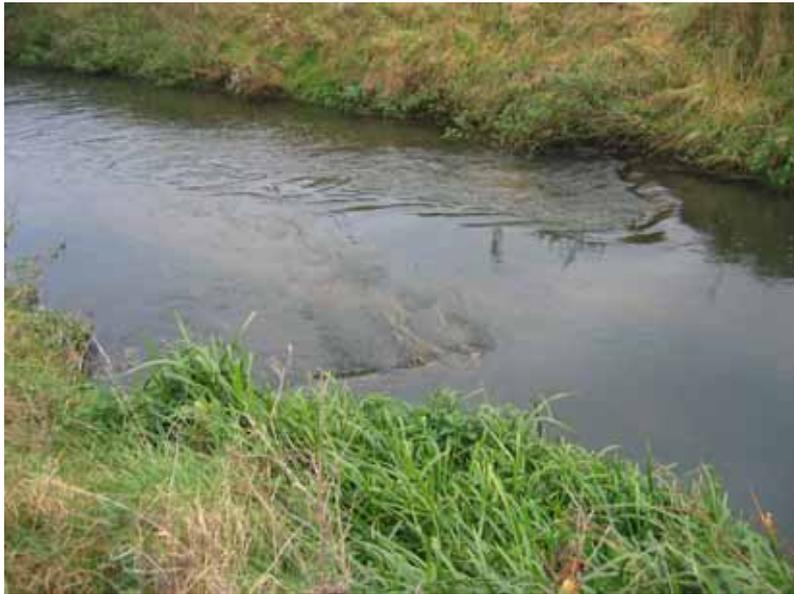
Practical management options to increase LWD include making use of fallen timber in order to create simple flow deflectors by wiring/staking these to the bank or by the construction of upstream facing 'v' groynes in the channel. These can be used to scour relatively homogeneous riffle areas in order to create deeper pools used by adult fish, and offer an effective and natural alternative to constructed gabion groynes. The resultant small pools can provide shelter areas adjacent to riffles during spawning periods, increasing the numbers of spawning fish.

**Paired upstream facing groynes**

- It is recommended that Large Woody Debris (LWD) should be introduced and stabilised in the River Avon in order to promote controlled bed scouring. The benefits for retaining LWD are clearly laid out in the recent EA R&D document, "Large Woody Debris in British Headwater Rivers". Key conclusions of the report include:
