**HABITAT ADVISORY VISIT TO THE RIVER
SEVERN, CAERSWS, WALES**

**UNDERTAKEN BY VAUGHAN LEWIS,
WINDRUSH AEC LTD ON BEHALF OF
CAERSWS ANGLING ASSOCIATION**

MARCH 2006

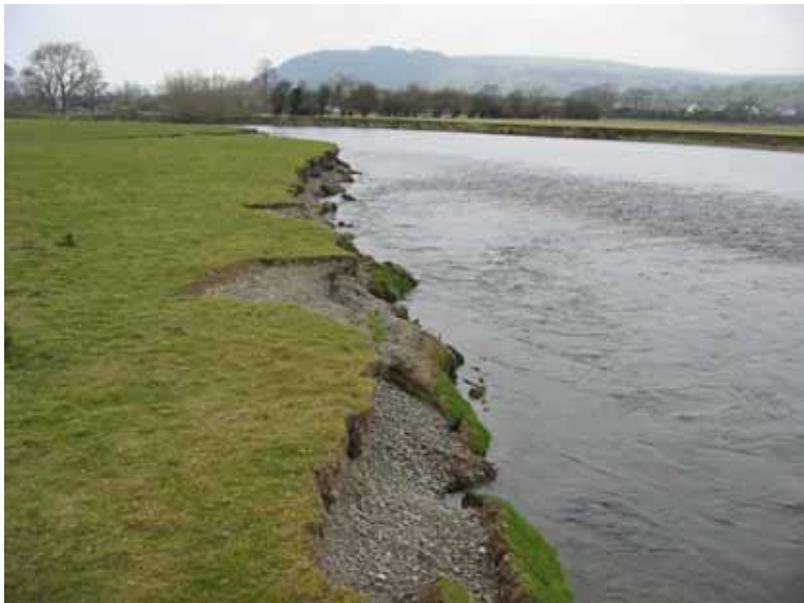
The river downstream of Caersws bridge was severely damaged by the impact of grazing sheep. Large numbers of animals on both banks had grazed the vegetation leaving only very short-cropped grass. As a consequence, there was no coarse vegetation remaining to protect the banks from erosion, whilst the root structure of the riparian grass was weak. Extensive erosion of the banks had taken place, with large block failures of the bank resulting in rapid movement of the river channel laterally across the flood plain. Very extensive areas of bare gravel were also present along this reach. Whilst these were of undoubted value for breeding waders and specialised invertebrate species, the extent of the exposed shingle banks had been increased to an artificially high level by the impact of grazing sheep.

Heavily grazed vegetation and resultant erosion

The solution to this problem is straightforward. The number of sheep having access to the river banks must be significantly reduced, either by an overall reduction in

numbers of animals in the flood meadows or by the erection of fencing to keep them away from the river bank.

Fencing is likely to be problematical as large flood events may sweep away sections of any new fence line. Erection of fencing parallel to the river will reduce the impact of flood damage. This issue has been addressed in details on Cumbrian rivers with similarly fierce floods. For instance, in some reaches of the River Derwent, sections of 'sacrificial' fence are provided in areas known to be vulnerable to damage. Short sections of fencing are thus regularly lost and replaced, rather than having to replace a whole length of fence. In addition, any fencing erected would need to be 40m-50m from the river to enable the growth of protective vegetation before erosion threatened the fence line.

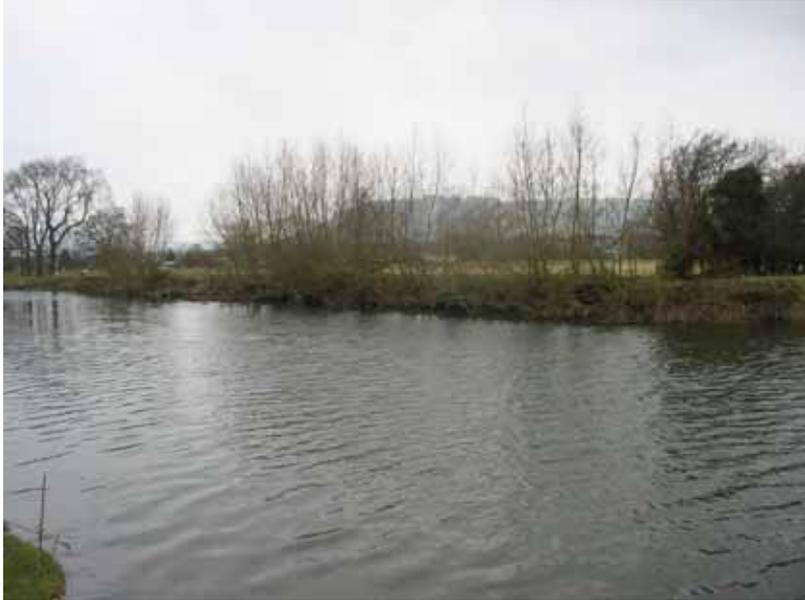
There was a short section of willow *Salix* trees on the LB. These were providing an element of bank protection. However, sheep grazing pressure was threatening to isolate the trees, with subsequent erosion likely to topple them into the river.

Line of willow trees on LB providing limited protection from erosion

- If it proves possible to prevent unrestricted access of stock to the river, then tree planting offers the potential for speeding up restoration of the eroded river. Sacrificial bands of fast growing trees such as alder *Alnus glutinosa* and goat willow *Salix caprea* can be used to slow down erosion rates across the floodplain. The Welsh woodland charity Coed Cymru, based at Tregynon, has undertaken studies in conjunction with research institutions of the benefits of floodplain tree planting. Contact their director David Jenkins 01686 650777 or <http://www.coedcymru.org.uk/staff.htm> for further information.

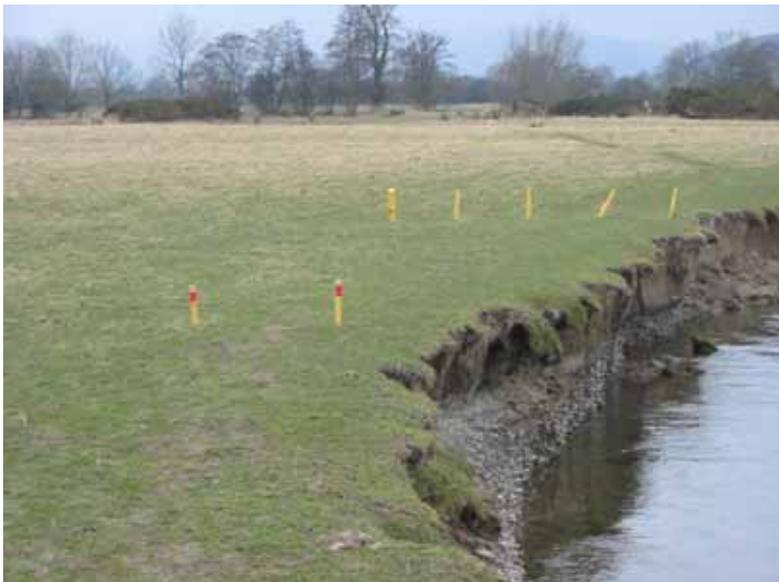
Upstream of Caersws bridge, the banks were again heavily sheep grazed, with erosion problems similar to the downstream reach. The rate of erosion was being monitored by a research institution, with erosion marker pegs visible along this reach of the river.

Erosion markers upstream of Caersws bridge

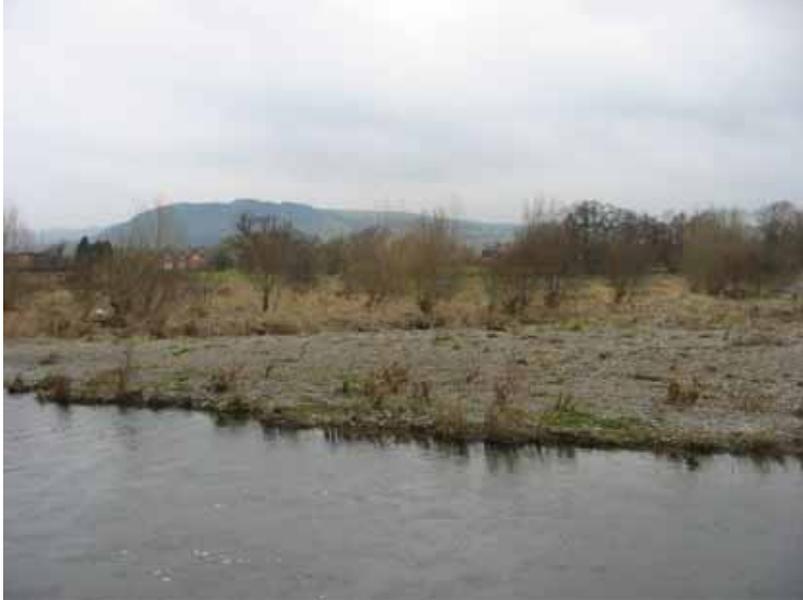
Small isolated stands of largely willow trees were present along the LB bank. Where sheep had been excluded by fencing on the LB, a strong growth of scrubby vegetation

and trees was apparent. This short section of river highlighted the benefits of excluding grazing stock.

Strong growth of coarse vegetation and trees in area from which sheep had been excluded

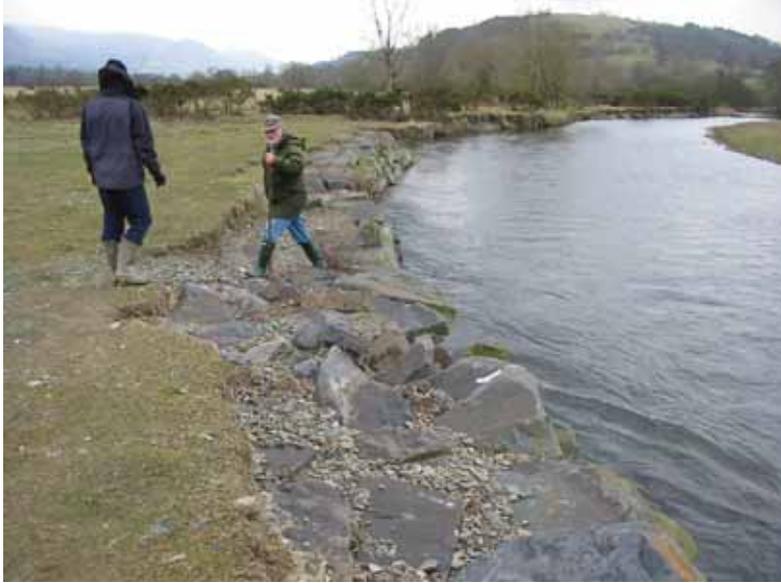
The erosive power of the river on the sheep grazed banks was well illustrated by the loss of stone pitching protection installed around a newly laid gas main. This was torn out during a subsequent flood event and needed rapid replacement. Trees planted to provide a degree of bank protection as part of the scheme were grazed by sheep and rapidly killed.

**Re-instated section of stone pitching adjacent to a new gas main.
The initial bank protection was eroded during a large flood event**

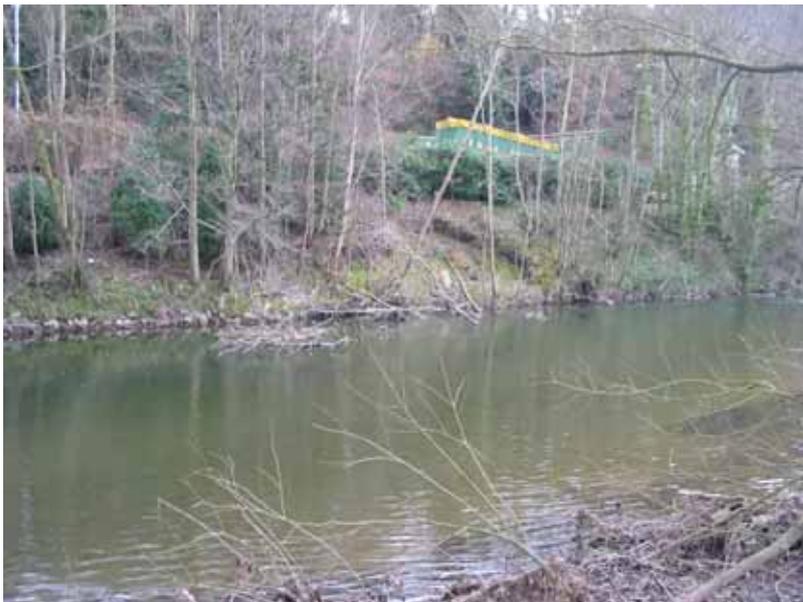
Downstream of Llandinam bridge, the composition of the river banks was dominated by larger gravel and stone. There was a significant volume of Large Woody Debris (LWD) in the channel. Club policy was to leave this in place, merely trimming the ends of large branches in order to allow access for angling. Instream habitat was excellent, with good sections of riffle, pool and shallow glide. Water crowfoot was abundant during the summer months, perhaps benefiting from the buffering effect of the liming of the Clewedog catchment above the reservoir. Small numbers of large grayling were noted in some of the pools.

Large Woody Debris in the channel downstream of Llandinam Bridge

- The club's policy of retaining LWD where possible is supported. . The benefits for retaining it are clearly laid out in the recent Environment Agency R&D document, "Large Woody Debris in British Headwater Rivers". Key conclusions of the report include:

Building on this simple truism, it is recommended that before any future work to remove LWD from river channels is undertaken, the wider implications of the proposal on the whole river system are considered, rather than just the potential (in many cases unproven) benefits to salmonid populations. In addition, the impact of planned riparian tree work on the supply of LWD to the river should be considered. In some circumstances, it may be beneficial to allow trees to fall into the channel. Provided that the tree can be stabilised in the river channel, there appeared to be little risk of increased local flooding. Stable LWD of this sort is of particular long term value, allowing the build up of weed/debris rafts and associated beneficial macroinvertebrates that are vital components of the energy cycle of river systems. There is no problem with continued cutting of small overhanging branches for angling access.

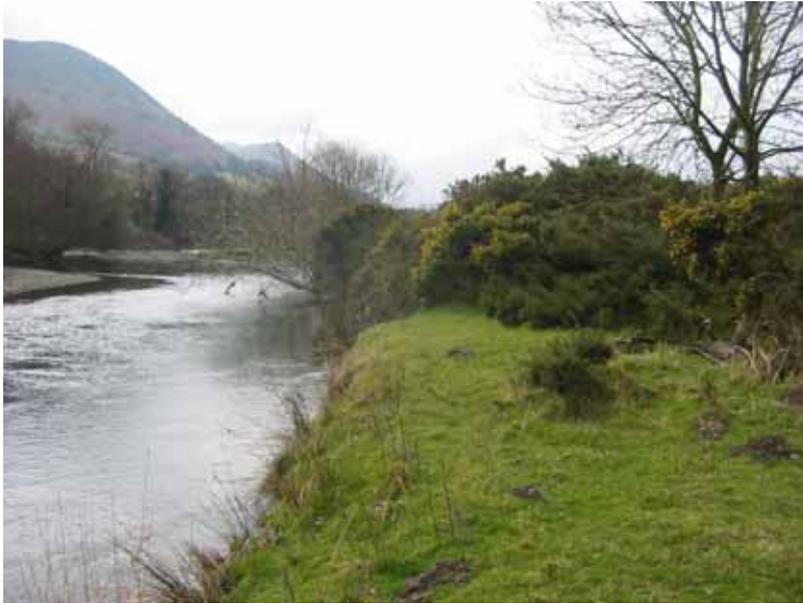
The top of the fishery was located adjacent to the Llandinam Gravels nature reserve. The Montgomeryshire Wildlife Trust was managing the grazing pressure on the land in order to restrict erosion of the river's banks. This had resulted in areas of increase vegetation growth, with strong stands of gorse *Ulex europaeus* present. There was also a well-developed band of alder and other trees on lengths of the far bank, from which sheep had been excluded.

Extensive growth of gorse on the LB of the river at Llandinam

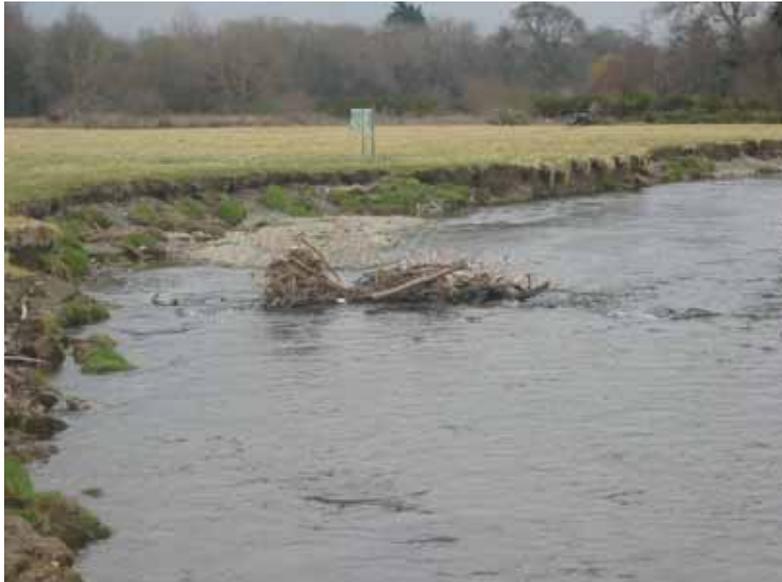
In-channel habitat was excellent, with extensive gravel riffles and shallow glides, interspersed with deeper pools. Strong stands of weed (probably hemlock water dropwort *Oenanthe crocata*) were present in the channel. There were a number of pieces of LWD within the channel providing valuable mid-channel sorting of the substrate.

LWD in the channel at Llandinam Gravels reserve

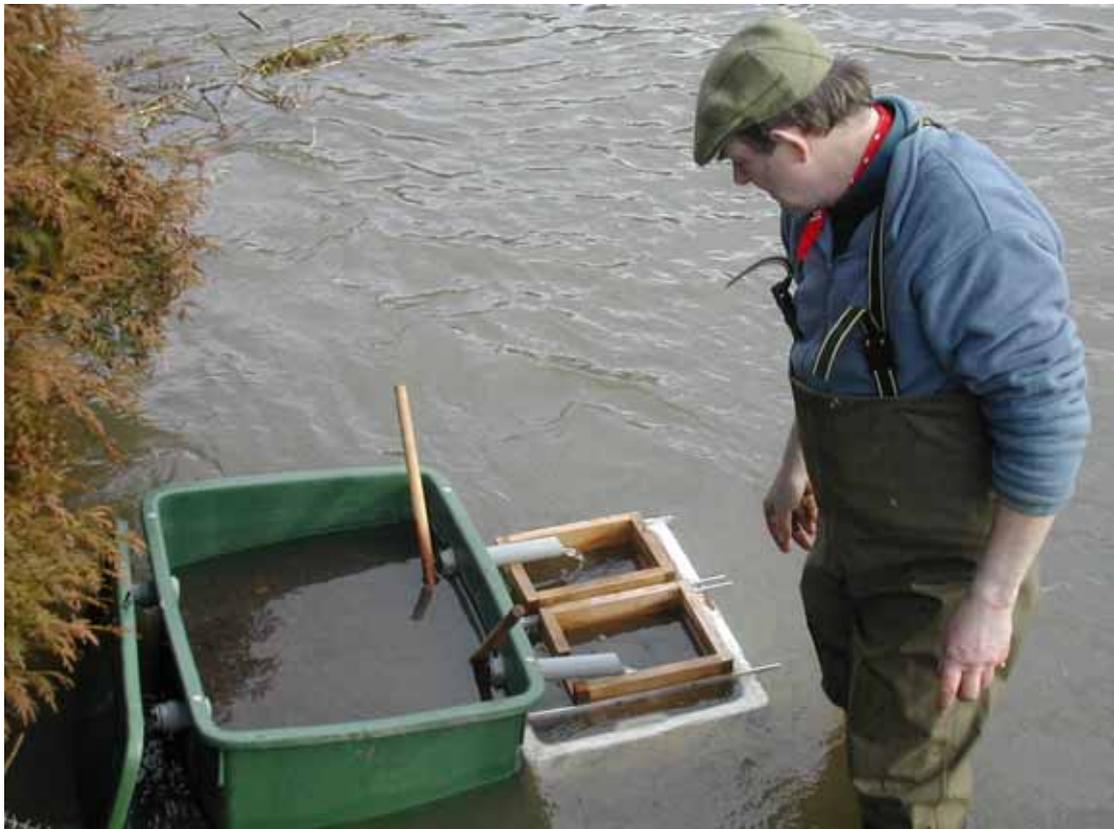
- The club was interested in the possible use of deep substrate incubation boxes. These could be of potential use in one of the tributary streams. Basically, they are gravel filled boxes, approximately 0.6m in each dimension, which are filled with suitably sized gravel and seeded with 10,000 - 20,000 trout eggs. A feed of water to the bottom of the box allows the eggs to incubate and hatch. Once they reach the swim-up fry stage, they leave the box via the overspill pipes, stocking themselves into the river. In effect, they are naturally reared fish without the unhelpful behavioural modifications associated with hatcheries. More details on incubation boxes can be found on the Wild Trout Trust web site www.wildtrout.org or in Volume 2 of the Trust's magazine, *Salmo trutta*.

Deep substrate incubation box running. Note the fine mesh boxes for trapping emerging fry

If such a box were to be used, it would need to be set up on one of the main tributary streams which had an adequate supply of juvenile habitat. If shown to be successful the club might, over time, be able to reduce its reliance on hatchery reared stock fish.
