Advisory Visit to the River
Swarbourne, Staffordshire

Undertaken on behalf of the Wild Trout
Trust, by Vaughan Lewis, Windrush
AEC Ltd

September 2006

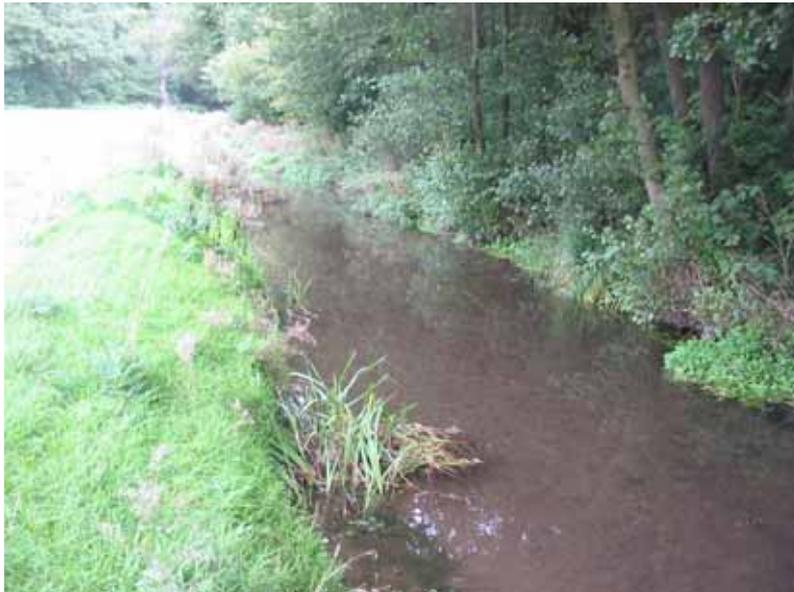
The upper reach of the river ran through a wooded area. The river was relatively wide, generally between 4m-5m. In the wider sections, the bed was poorly differentiated, with a uniform, poorly sorted bed, often dominated by mixed gravel and sand. This type of habitat offered only limited habitat for all lifestages of trout.

**Poorly sorted, uniform section of upper fishery**

- However, where sections of overwide, uniform channel existed, it is recommended that LWD should be used to create scour and sort the bed material, improving diversity and producing better conditions for spawning and juvenile trout. LWD can be introduced in the form of large branches or tree trunks securely anchored to the bend and banks using stakes and/or wire. Alternatively, LWD can be arranged to form upstream facing 'v' shaped groynes that will effectively scour small pools with an associated downstream length of clean spawning gravel.

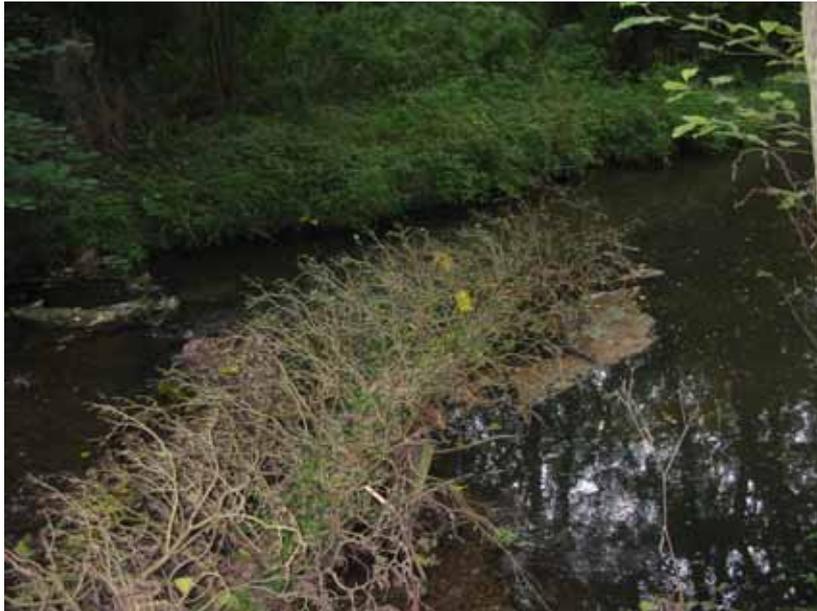
Within the wood, much of the channel was heavily shaded, often by large, mature trees. Where the shade was heavy there was little marginal vegetation with a consequently wider (5m-6m) channel. In the more open sections or where fallen timber had been allowed to remain, the channel was considerably narrower, with deeper scoured pools present.

Fallen timber (LWD) narrowing the channel and promoting scour of the substrate

- The balance between shade, light and LWD is the key to managing the woodland sections of the fishery. Where the river was shady, the channel was wider, with poorly differentiated substrate. Less shade and the addition of LWD generally encouraged scour, promoting a more diverse bed profile and better sorted gravel, valuable for spawning and juvenile trout. In theory it would be good to reduce shade in some parts of the river, in order to allow growth of marginal vegetation. However, this is not likely to be practical in a lot of areas, due to the large size and landscape importance of many of the trees.

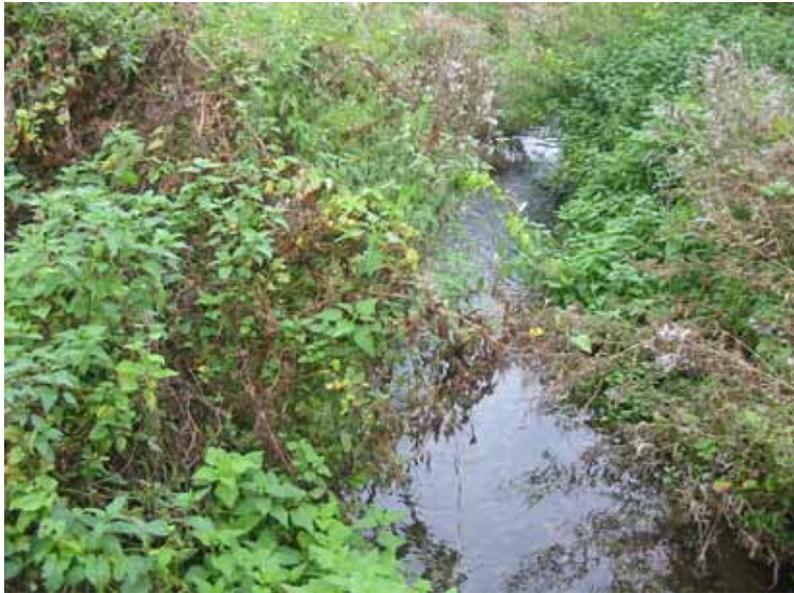
Typical section of the lower fishery

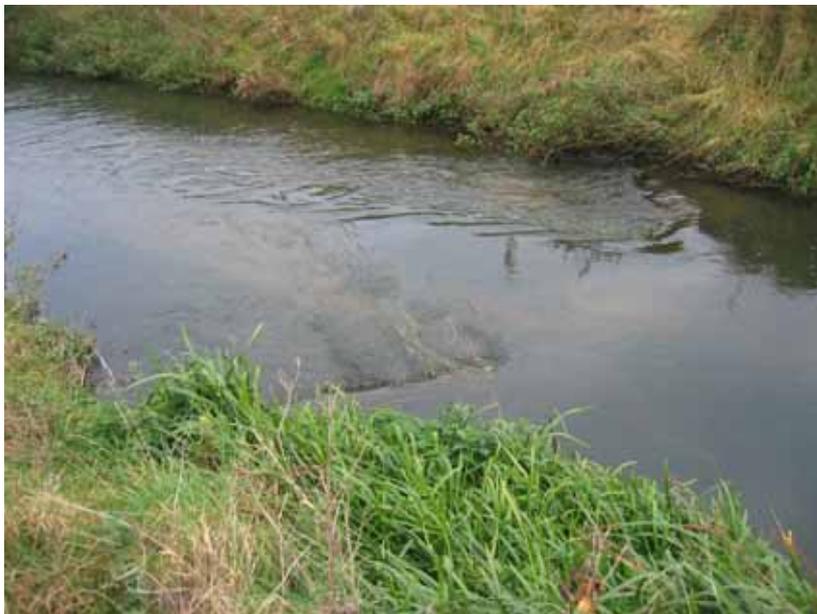
Upstream facing 'v' shaped groynes creating mid-stream scour

Care should be taken to position all groynes so as to create scour where required, and to avoid excessive erosion either bank.
