Habitat Advisory Visit

River Test – Fulling Mill Beat

Whitchurch

July 2006

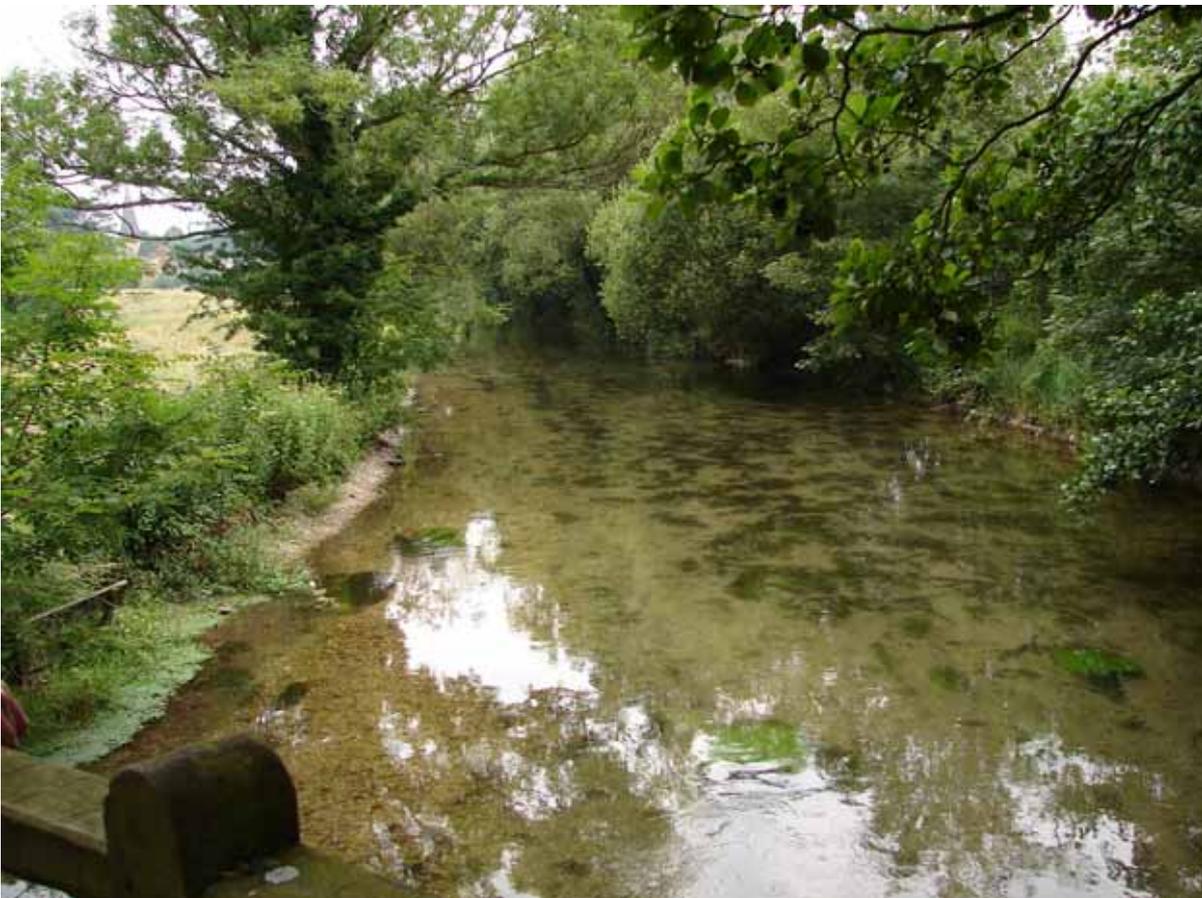
The mill structure has a 'back-watering' effect on for the first 150m u/s after which there is a fairly good flow regime. If left un-managed, the trees along this reach may eventually cause problems of over-shading. Over-shading can inhibit the growth of in-river macrophytes and can also suppress bankside vegetation, the roots of which are a natural defence against erosion. It is recommended that management of trees be undertaken on a 'little and often' basis.

Picture 1) Immediately u/s of Fulling Mill – Note potential over-shading and the over-wide nature of this reach.

In this over-wide section a new bank line should be created using brushwood faggots staked along the RHB¹. As a rough guide narrowing should be at least 4m to achieve improvements in flow velocity and channel depth. At various points it is also recommended that flows be 'pinched' by installing paired and single faggot deflectors to allow the river to scour pool habitat². Backfill for these features can be sourced from local chalk pits or using arisings from any tree works on-site. The new bank should be set no more than 10cm above summer water level to allow the development of emergent wetland plants such as sedge, water forget-me-not, brooklime, yellow flag-iris and water mint, etc. Consideration should be given to transplanting well-established emergent vegetation from adjacent areas to facilitate the colonisation process. A density of four plants per square metre should achieve rapid results.

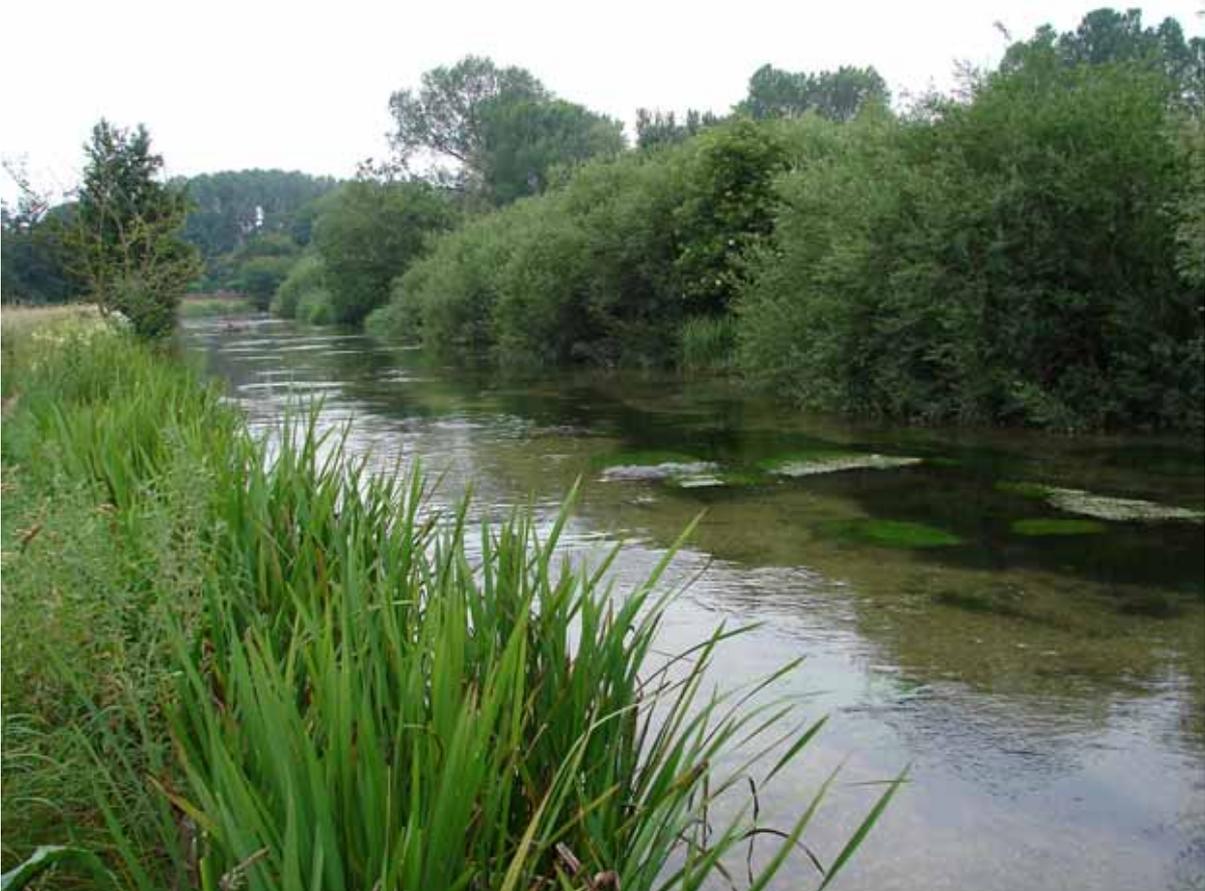
There is a public footpath on the RHB running from the top of the section down to the mill. The bank on the RHB is eroding and provides very little in the way of emergent and fringing vegetation. In many places the vegetated margin is less than 2 metres wide. English Nature has classified the RHB as being in 'un-favourable' condition. There are draft plans in place to restore the banks and narrow this section of river. During the AV only a brief inspection of the Land Drainage Consent was possible. The LHB comprises fen type habitat comprising reed, willow, alder and sallow. This may form a land parcel of the Test SSSI. Current low flows may be having a detrimental effect on fen plant communities due to a lower water table.

Picture 2) Looking u/s of Fulling Mill.

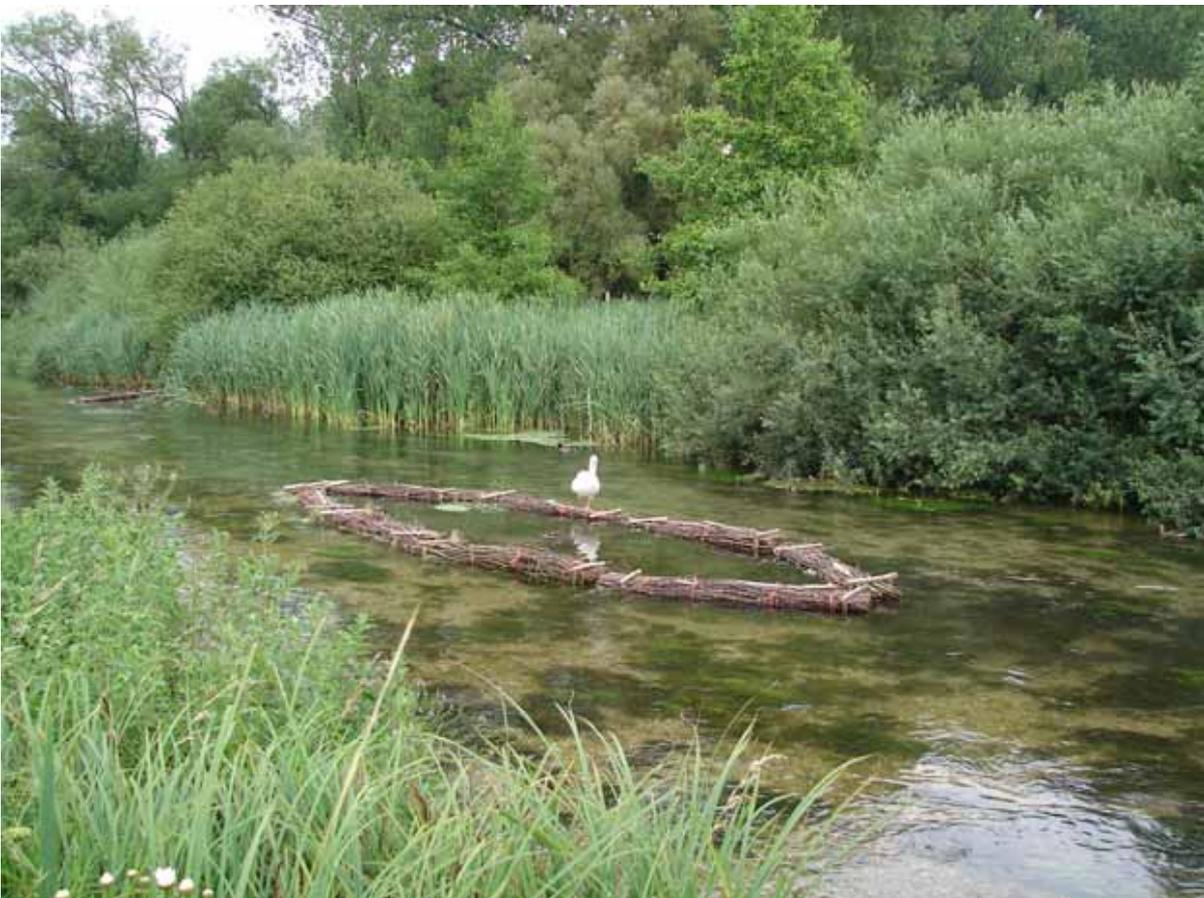
Several faggot deflectors and mid-channel islands have been recently installed. In places they are encouraging silt deposition that will, over time, encourage the river to narrow itself and improve localised flow velocities. Overall there is a severe lack of pool habitat, a fact made worse by the very low flows and absence of water crowfoot to retain water levels. The lack of fringing vegetation on the RHB means there is very little cover afforded to 'swim-up fry' as they emerge from spawning gravels. The faggot deflectors could be better placed by being set upstream facing and approximately 30-40 degrees to the bank to encourage over-topping winter flows into the centre of the channel. The current 90-degree setting may cause some back-eddying and lead to localised erosion.

Picture 3) recently installed 'faggot Island'

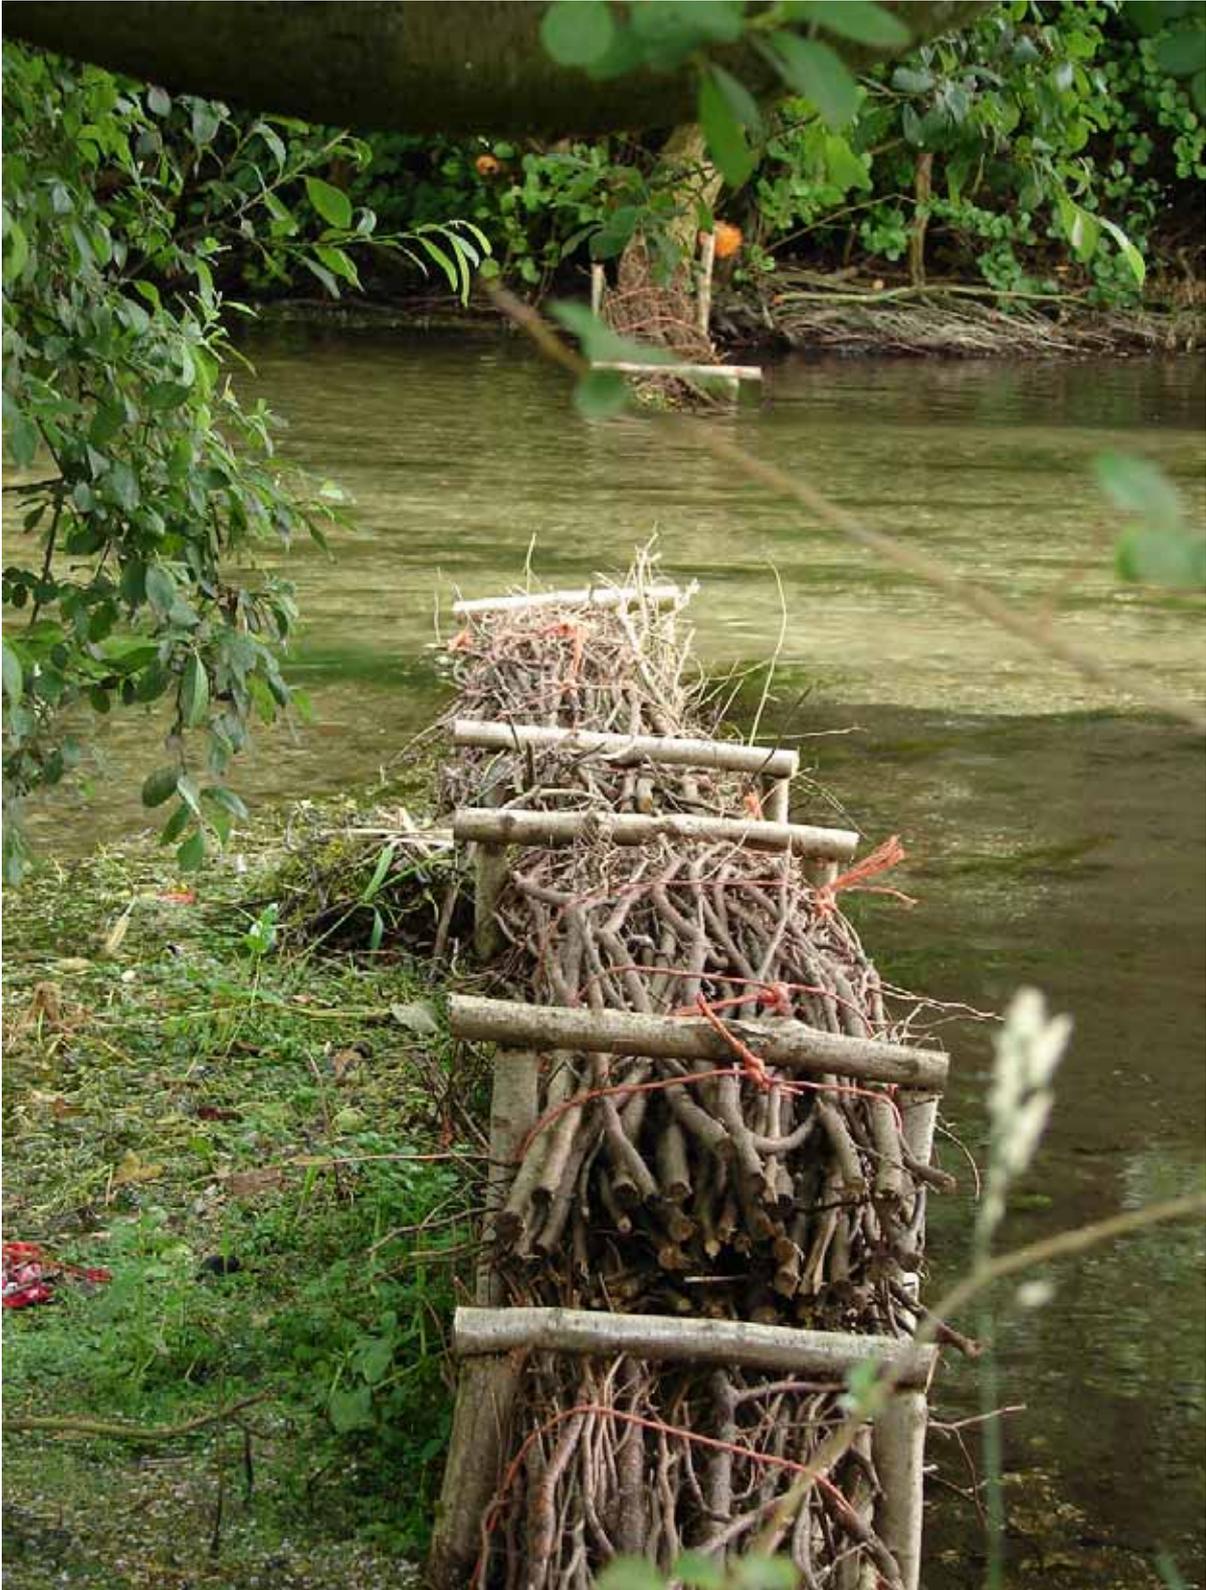
Picture 4) – Recently installed paired faggot deflectors. Note silt deposition and scoured gravel d/s of faggots. Note 90-degree position.

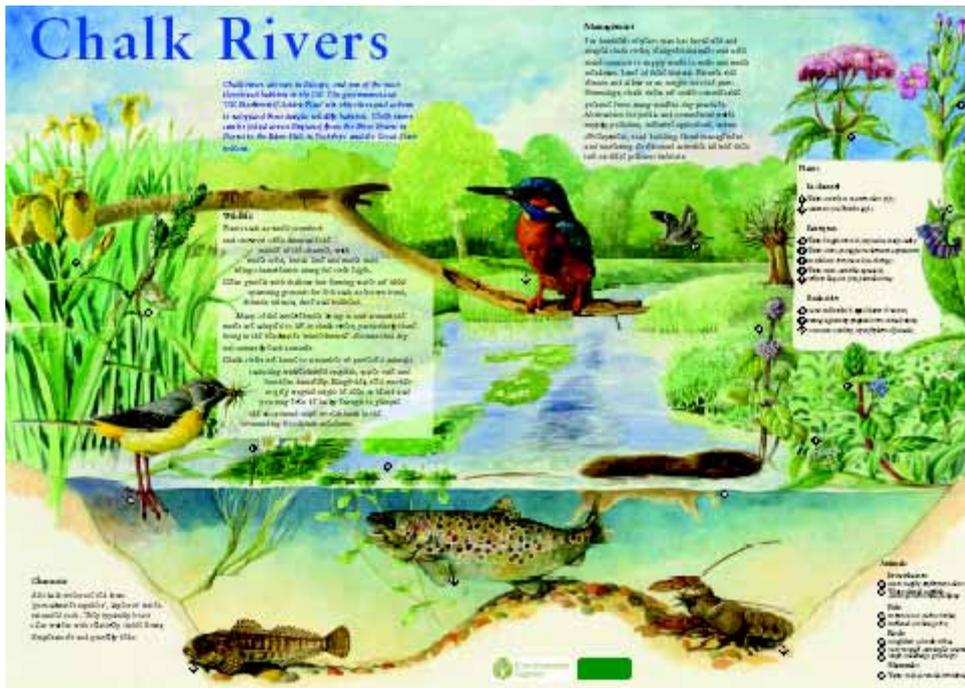
Example of an interpretation 'Chalk Rivers' interpretation board

This habitat is particularly important for grey wagtails, reed warblers, southern damselfly and water voles, (which are known to forage along wet vegetated berms). Fringing vegetation will also provide cover for trout fry on emergence from spawning gravels. The newly restored bank and wet-berm may need to be protected using temporary fencing to allow plants to colonise and stabilise unconsolidated materials. There are issues related to the footpath and a temporary diversion into the adjoining paddock may be a short-term solution to maintaining current levels of public access. A series of interpretation boards could also be installed along the reach to inform the public about the conservation benefits that the project will deliver.

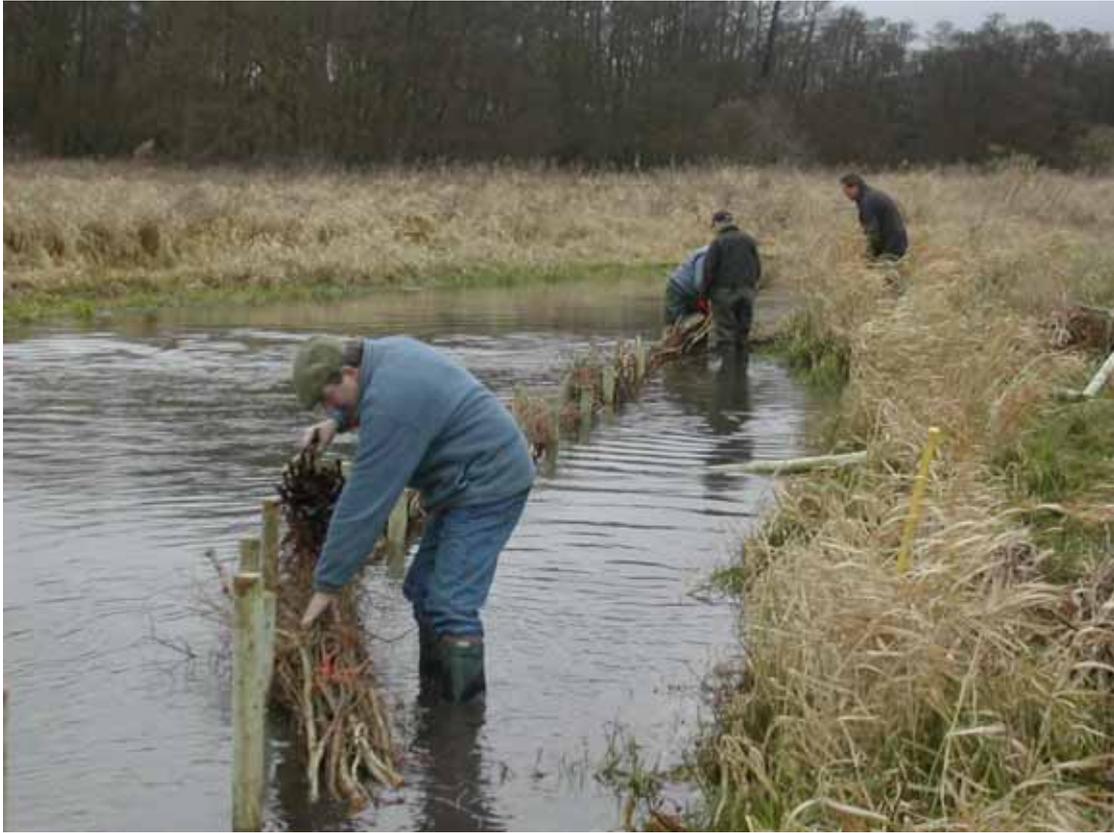
Picture 5

Fallen timber can be used to create flow deflectors. Deflectors need to be; 1) keyed into the bank to avoid localised erosion and; 2) staked and wired to the bed of the river to avoid being washed-away. During winter flows the deflectors will scour out pools and naturally sort and clean gravels suitable for trout spawning. As a very rough guide deflectors should be set at approximately 30 degrees to the bank with a length of between 40-50% of channel width, or staked in mid channel as paired submerged upstream facing logs. Deflectors keyed in from the bank should be set just at summer water level. Scour pools have been shown to be very important habitat for all life stages of brown trout. Deflectors could be particularly useful if placed silted riffle areas. Pairs of submerged upstream facing logs could be pinned the river bed to scour pool habitat / sort gravels.

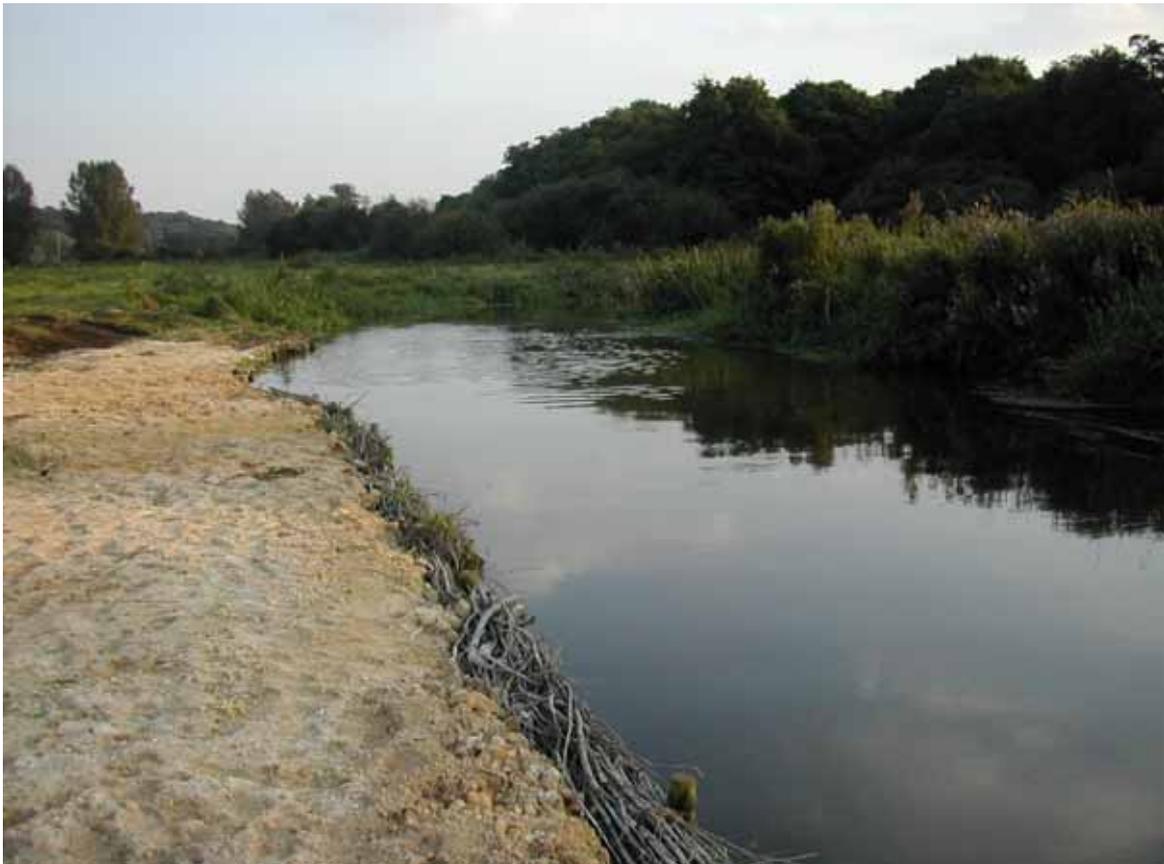
Picture 6) Installation of new bank using faggots and chalk backfill on the River Wensum, Norfolk

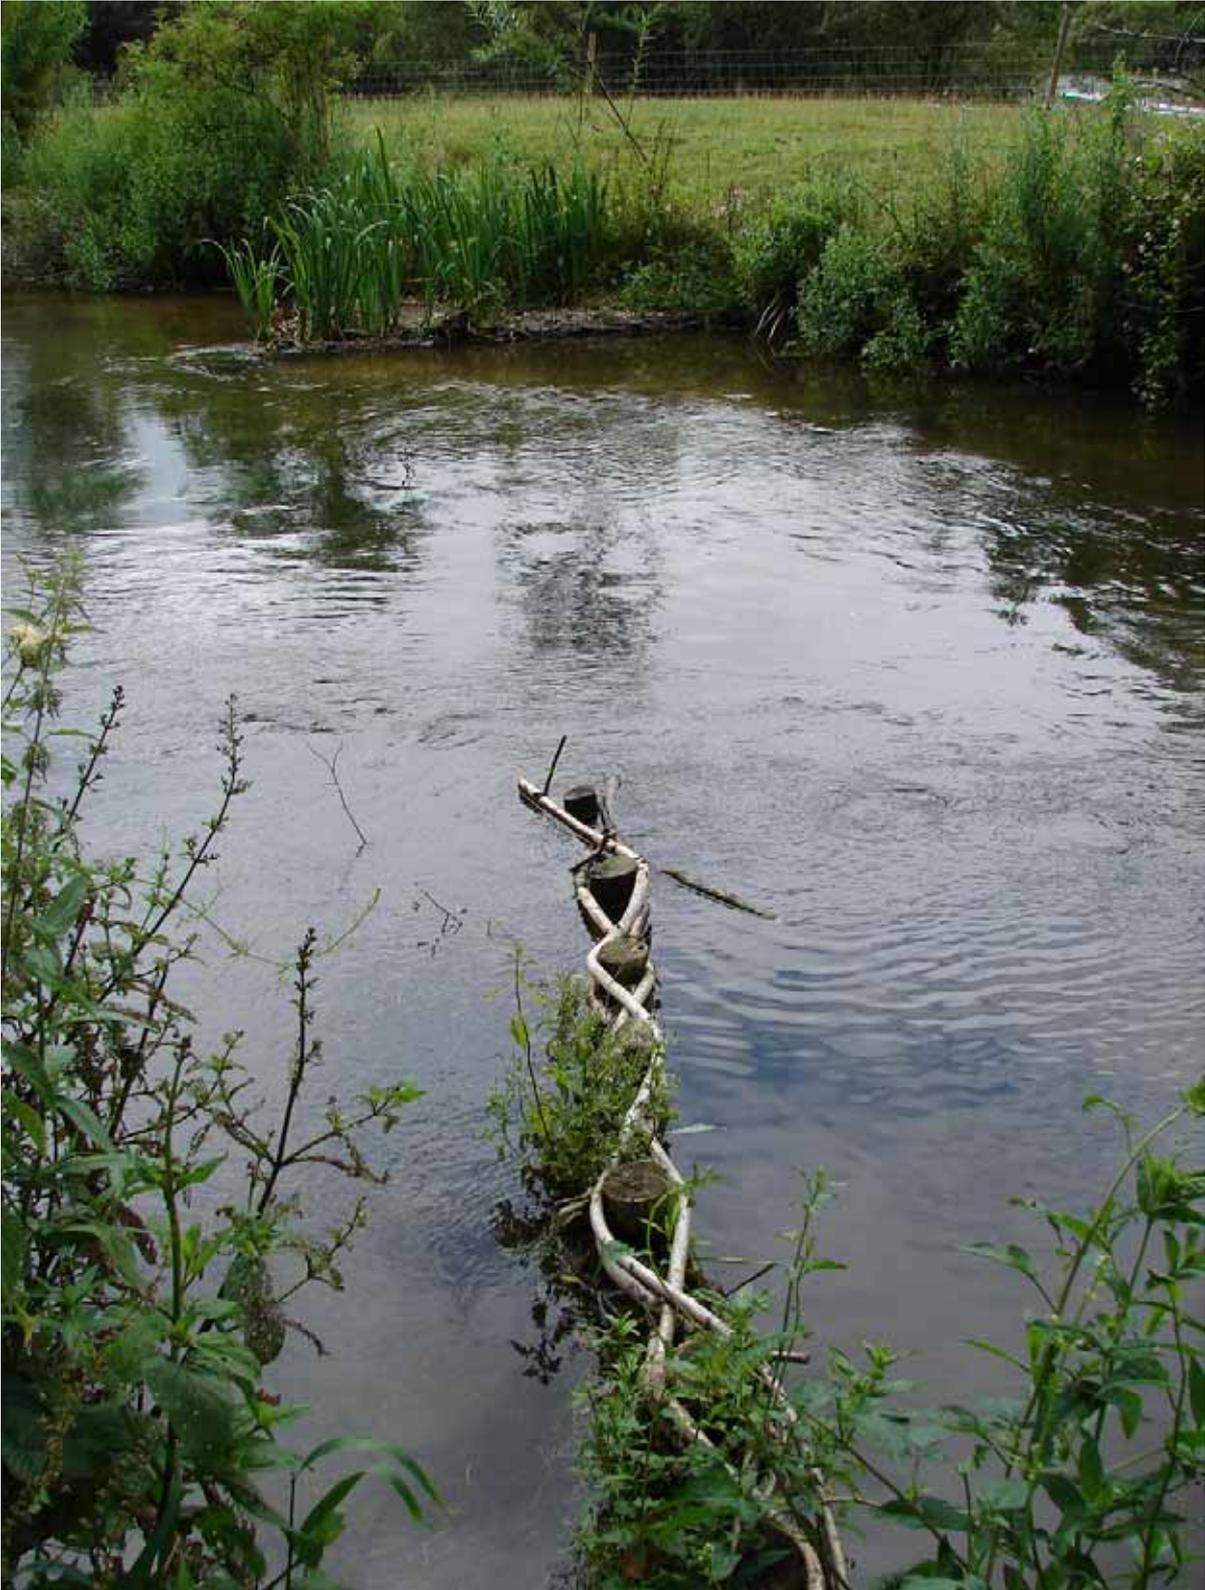
Picture 7) Introduction of single u/s 'natural' deflectors (single, near bank and triangular' far bank) on the Wylde in Wiltshire formed a chicane, sending flow from one bank to another. Note set just above summer water levels.

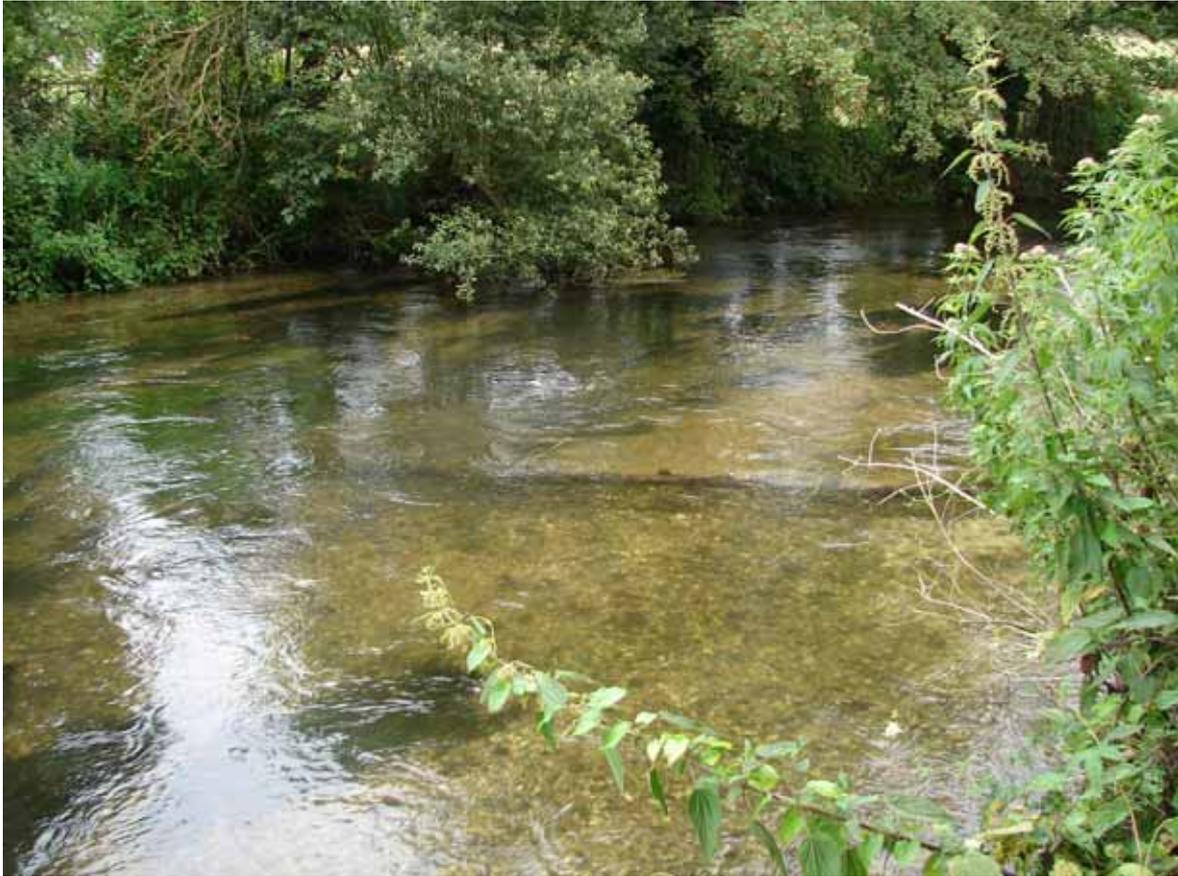
Picture 8) Installation of these upstream facing 'paired logs' has created valuable mid-channel pool habitat.
