Habitat Advisory visit to the River  
Tone, Nr Taunton, Somerset  
undertaken on behalf of Taunton Fly  
Fishing Club by Vaughan Lewis,  
Windrush AEC Ltd  
January 2006

## **1.0 Introduction**

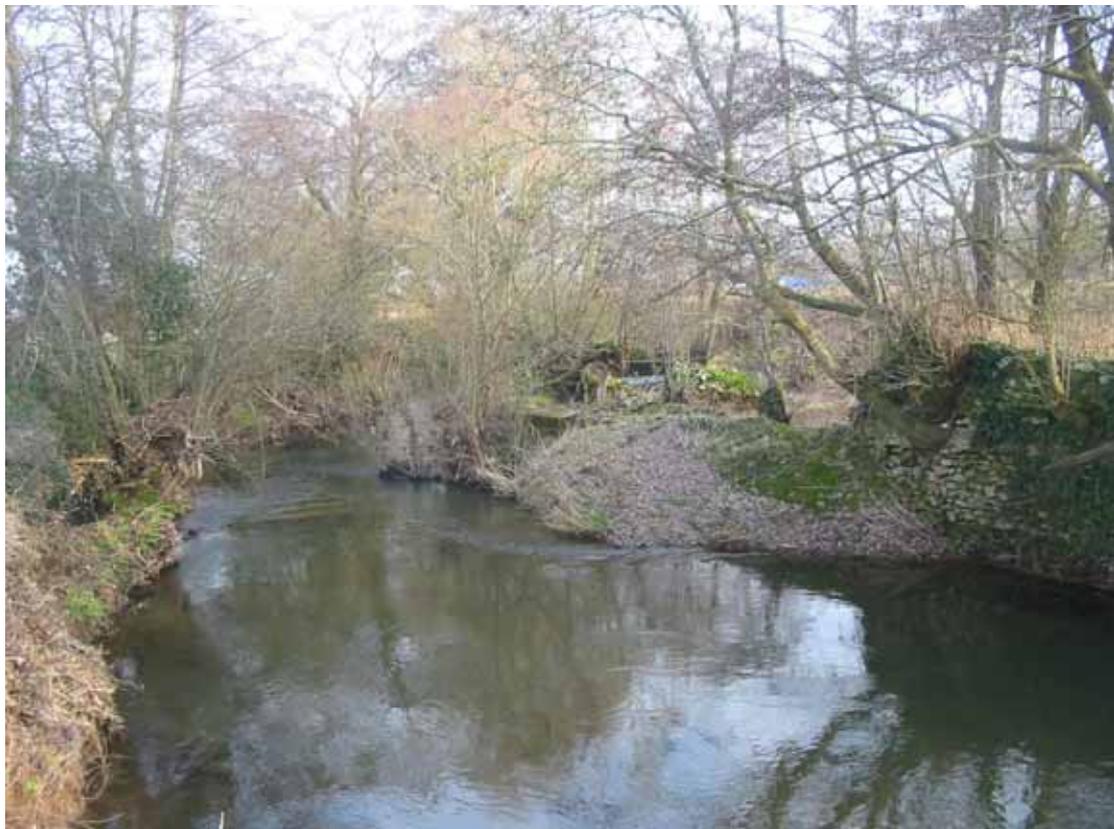
**Instream habitat on the Hele Bridge reach. Note incised nature of channel, build up of gravel on the RB and heavy tree shading**

There was significant erosion along the whole of the reach, with block failure of the soft, friable sandstone banks in several locations. This erosion was worsened by overgrazing of the meadows by large numbers of sheep, and suppression of rough bankside vegetation by the numerous trees, particularly alder *Alnus glutinosa*. Many of these were infected with *Phytophthora*, a hybrid fungal disease that has developed throughout much of the UK during the past 15 years.

- The friable nature of the banks of the river renders it very vulnerable to erosion. Erosion is a natural process. However, the grazing pressure exerted by the large numbers of sheep present above Hele Bridge, had resulted in loss of marginal vegetation, physical degradation of the bank and an unacceptably high rate of bank erosion. The shade cast by the riparian trees further restricted the growth of fringing vegetation, exacerbating the damage caused by grazing sheep.

In order to address these issues, it is recommended that fencing be erected to prevent stock access to the riverbank. Fencing could be either permanent or temporary

Shade from the riparian trees, particularly the alders, was restricting the growth of marginal vegetation, with associated damaging impacts on the rate of erosion, the provision of marginal cover for fry, and water flow velocity. In order to address overshading, the establishment of a regime of rotational coppicing would be of great benefit. Increasing light penetration into presently overshadowed river sections would be of benefit to instream vegetation and valuable fringing marginal vegetation. The aim should be to produce a pattern of dappled shade over the width of the channel. In order to achieve this, approximately 40% of the current trees should be coppiced during the first season, with subsequently smaller tranches taken in subsequent years in order to create a varied, uneven age structure. The conservation value of the existing trees should not be under-estimated and great care should be exercised in the selection of trees to be cut. A felling licence may be required from the Forestry Authority. Felling should cease by mid-March to minimise any risk to nesting birds.

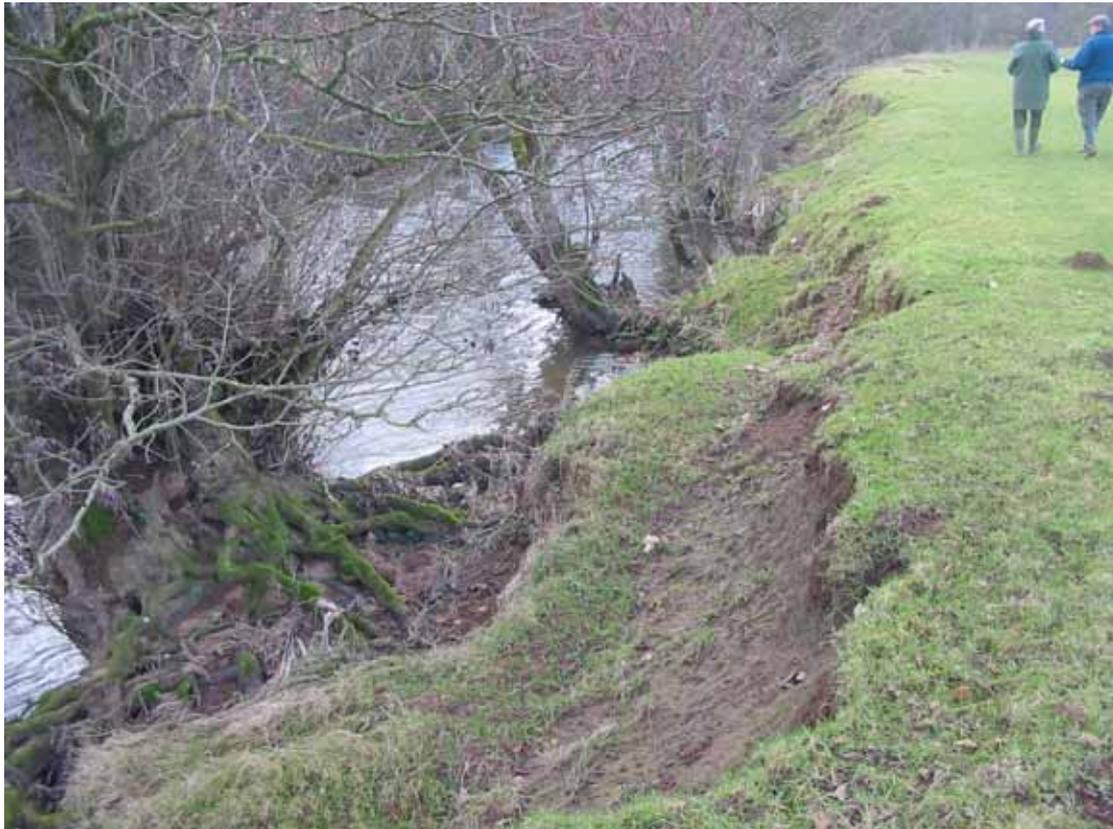
**Bank erosion. Note heavily cropped vegetation due to grazing sheep and shade cast by riparian trees**

The mobile nature of the banks and the extent of erosion were also highlighted by the presence of well-developed, un-vegetated gravel/stone point bars on the inside of many bends.

electric. The provisions of the Single Farm Payment Cross Compliance regulations (see below) could potentially be used to help reinforce the message that protection of riverbanks from excessive erosion is of prime importance to the river.

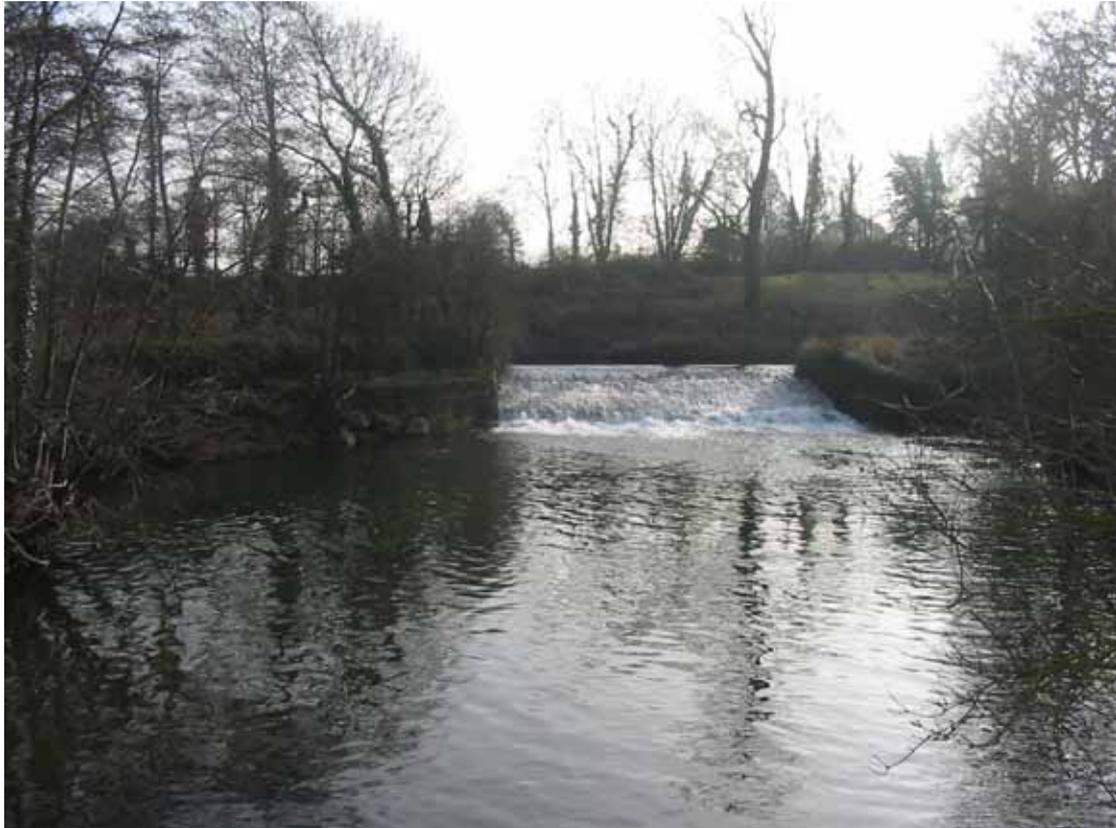
### **Bradford weir**

Downstream of Bradford on Tone bridge, the river was very uniform in appearance, with the impounding effect of the downstream weir all too apparent. Recent work by the EA had apparently removed much of the instream cover and LWD. The weir was a significant structure with a head loss of  $>1.5\text{m}$ . Passage for fish over the weir over the range of normal discharges was virtually impossible, although the presence of

adult salmon in upstream reaches proved that some large fish could traverse the weir at, presumably, higher discharges when the head difference was reduced.

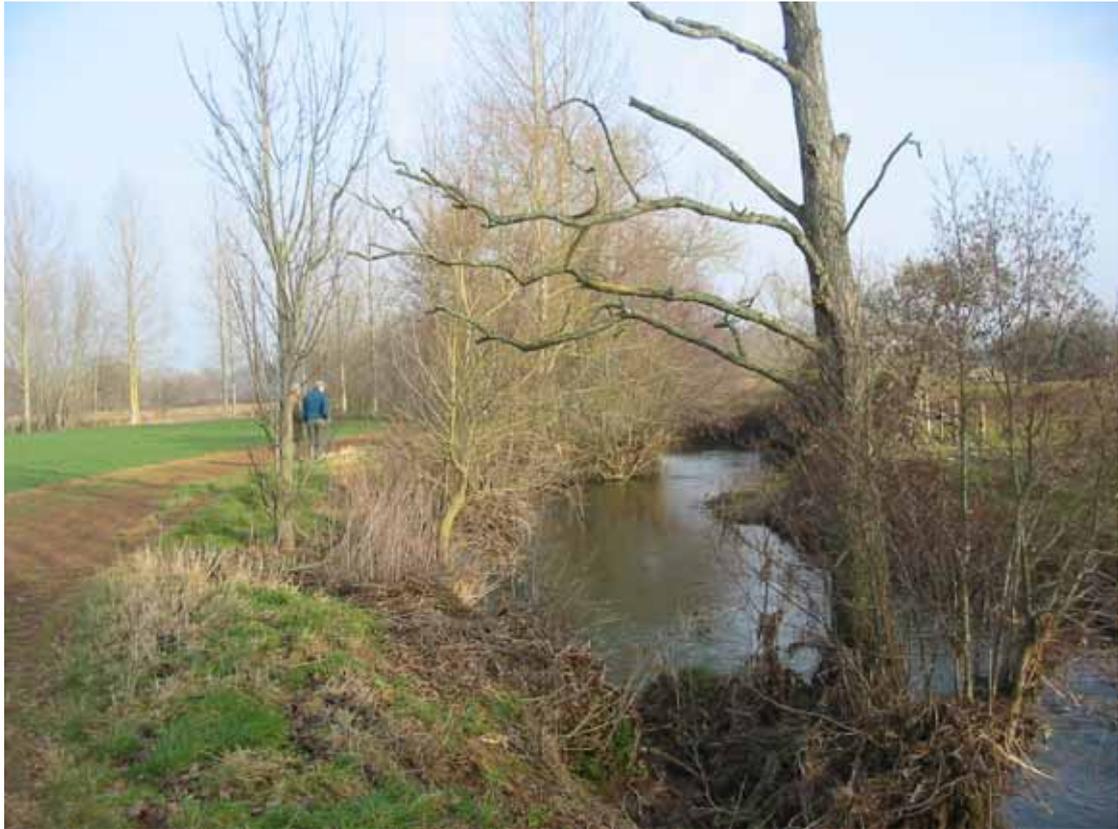
If anything, the river was more heavily shaded by trees than at Hele Bridge, with some sections effectively tunnelled. There was an extensive growth of nettles and other ruderal species on the banks where shading was not excessive. The banks were incised, with the water  $>1.5\text{m}$  below banktop for much of the reach.

Land use on the RB was dominated by an equestrian establishment, with fencing to prevent horse access to the river. Arable fields dominated the LB, with a wide (5m) headland alongside the river planted with grass. Unfortunately, the volume of pedestrian traffic along the path had severely restricted the growth of the grass, with exposed bare earth over much of the headland.

**Fishery downstream of Bradford Weir showing heavy tree cover, and LB headland strip**

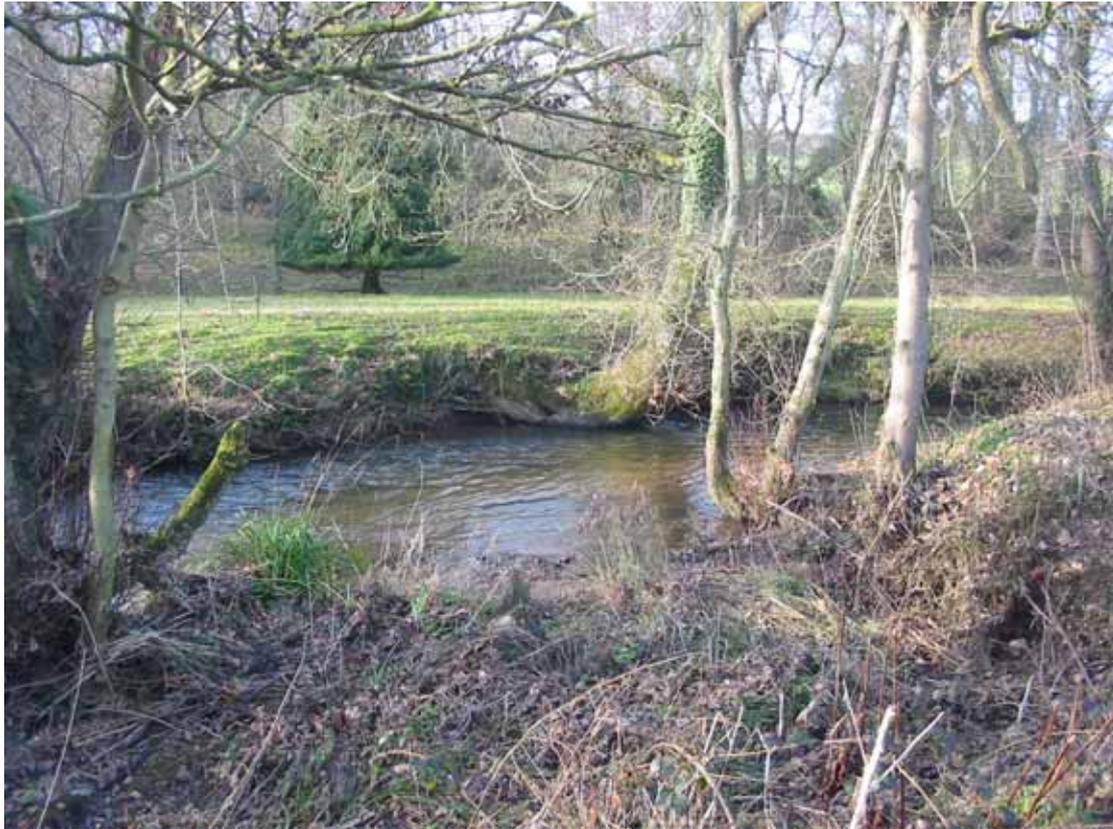
### **Typical section of river downstream of Luxley Bridge**

Downstream of Luxley Bridge, the club owned a section of upper river fishing. The river was well fenced on both banks, with temporary fencing on the LB and permanent sheep netting and wooden fencing on the RB creating buffer strips around 3m in width. As a consequence, the banks were well vegetated, with very little bare sections of bank visible. Uncontrolled erosion was less prevalent along this reach.

Instream habitat of the river was again excellent, with abundant riffles, shallow/deep glides and pools present. The substrate present on the riffles was dominated by large gravel and pebbles, and was generally above the optimum size for trout. A large (>7kg) salmon was found dead on this reach during winter 2005-6, indicating the suitability of gravel size for spawning salmon. The river was less incised than downstream, perhaps reflecting differing geology and past management practices.

The channel was heavily lined with trees, with increased percentages of ash *Fraxinus excelsior* and hazel *Corylus avellana* mixed in with the ubiquitous alder.
