**HABITAT ADVISORY VISIT TO THE RIVER
TROTHY, MONMOUTH, WALES**

**UNDERTAKEN BY VAUGHAN LEWIS,
WINDRUSH AEC LTD ON BEHALF OF
MONMOUTH AND DISTRICT ANGLING
ASSOCIATION**

MARCH 2006

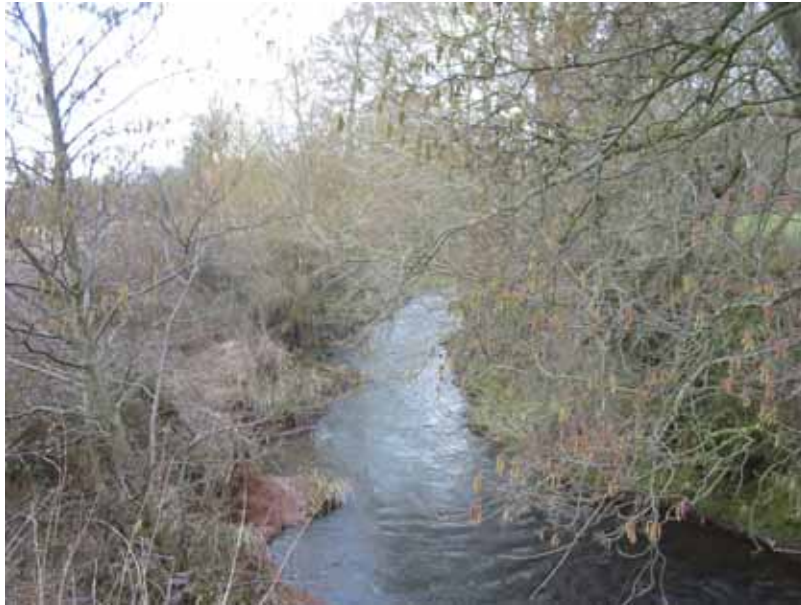
The lower reach of the club's fishery was located either side of Jingle Bridge. Downstream of the bridge the river was very heavily incised, with the water level some 4m-5m below the level of the surrounding land. Although none of the club members could remember any dredging during the past 40 years, this incision was indicative of some past channel modification. Members remarked that the channel had become increasingly deepened during the past 20-30 years. There were sections of gravel bed riffle and shallow glide present, providing potentially good habitat for spawning and juvenile salmonids. Hatches of river flies remained strong, with mayfly *Ephemera danica* abundant in some years. The presence of dipper *Cinclus cinclus* reinforced this observation.

Land use downstream of the bridge was semi-improved pasture, with some overgrazing visible. Despite this, there were some significant stands of bramble *Rubus fruticosus* that had developed in places, reducing access to the river for anglers. This was a key issue in this reach, with the river banks too high for fishing from and the river tunnelled by trees and too deep for safe wading.

River Trothy downstream of Jingle Bridge

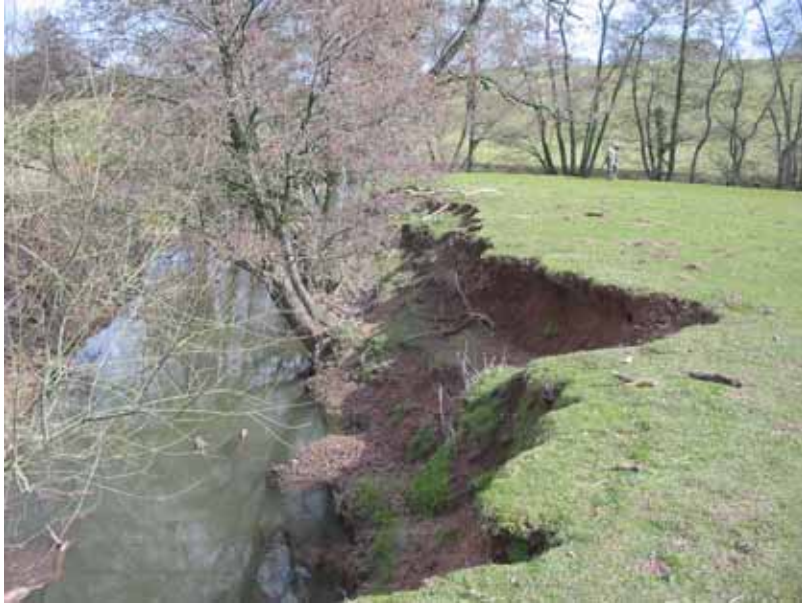
At Lower Llanthrothy Farm, the most important impact on the river was the overgrazing of the floodplain fields by sheep. There was little or no coarse vegetation remaining on the banks, with the result that the rate of erosion was considerably higher than would be expected, with large sections of the bank being lost annually. The presence of alder trees and the shade they cast was exacerbating this problem. Many of the alders were infected with the fungal disease *Phytophthora*, resulting in the death of some of them.

Sheep grazed, eroded banks at Lower Llantrothy

- The impact of grazing sheep on the Lower Llantrothy reach had resulted in a dramatic and damaging increase in the rate of bank erosion, largely due to a loss of valuable binding vegetation. As a consequence, the banks were continually eroding, forming a heavy burden of fine sediment on the bed.

The solution to this problem is straightforward. The number of sheep having access to the river banks must be significantly reduced, either by an overall reduction in numbers of animals in the flood meadows or by the erection of fencing to keep them away from the river bank.

Fencing is likely to be problematical as large flood events may sweep away sections of any new fence line. Erection of fencing parallel to the river will reduce the impact of flood damage. This issue has been addressed in details on Cumbrian rivers with similarly fierce floods. For instance, in some reaches of the River Derwent, sections of 'sacrificial' fence are provided in areas known to be vulnerable to damage. Short sections of fencing are thus regularly lost and replaced, rather than having to replace a whole length of fence. In addition, any fencing erected would need to be 40m-50m from the river to enable the growth of protective vegetation before erosion threatened the fence line. It may be possible to fence off meander loops and provide a degree of

protection to banks within these areas. Small numbers of sheep could then be allowed to lightly graze these enclosures, maintaining a dense sward of rough grass but preventing the development of dense scrub.

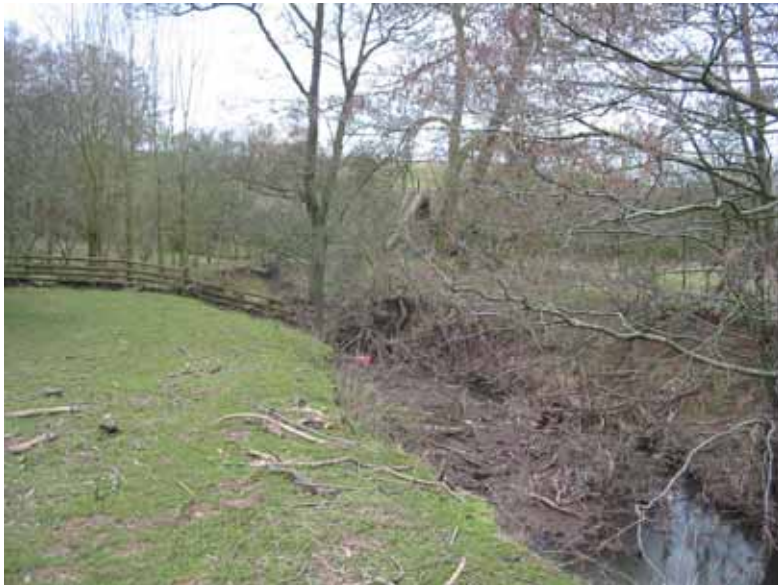
There were a number of significant LWD rafts in the river, providing excellent habitat for a range of species, and increasing heterogeneity of the local habitat.

Large woody debris raft at Lower Llantrothy

- The club and landowners should adopt a policy of retaining LWD where possible. The benefits for retaining it are clearly laid out in the recent Environment Agency R&D document, “Large Woody Debris in British Headwater Rivers”. Key conclusions of the report include:
 - An increase in both mean flow depth and velocity and variability of both parameters.
 - The development of high physical habitat diversity both in-channel and in the floodplain. Removal of LWD reduces both habitat quality and availability for juvenile and adult brown trout.
 - Although active LWD dams may impair upstream migration of fish at low flows, they rarely do so at high flows.
 - LWD have significant benefits to the control of run-off at the catchment scale.
 - River and riparian management has important effects on the distribution and character of dead wood accumulation within the river system.
