Wild Trout Trust Advisory Visit
West Allen, River Tyne
For the Tyne Rivers Trust

Carried out by Alistair Maltby MSc CEnv MIFM
On behalf of Windrush AEC Ltd, May 2006

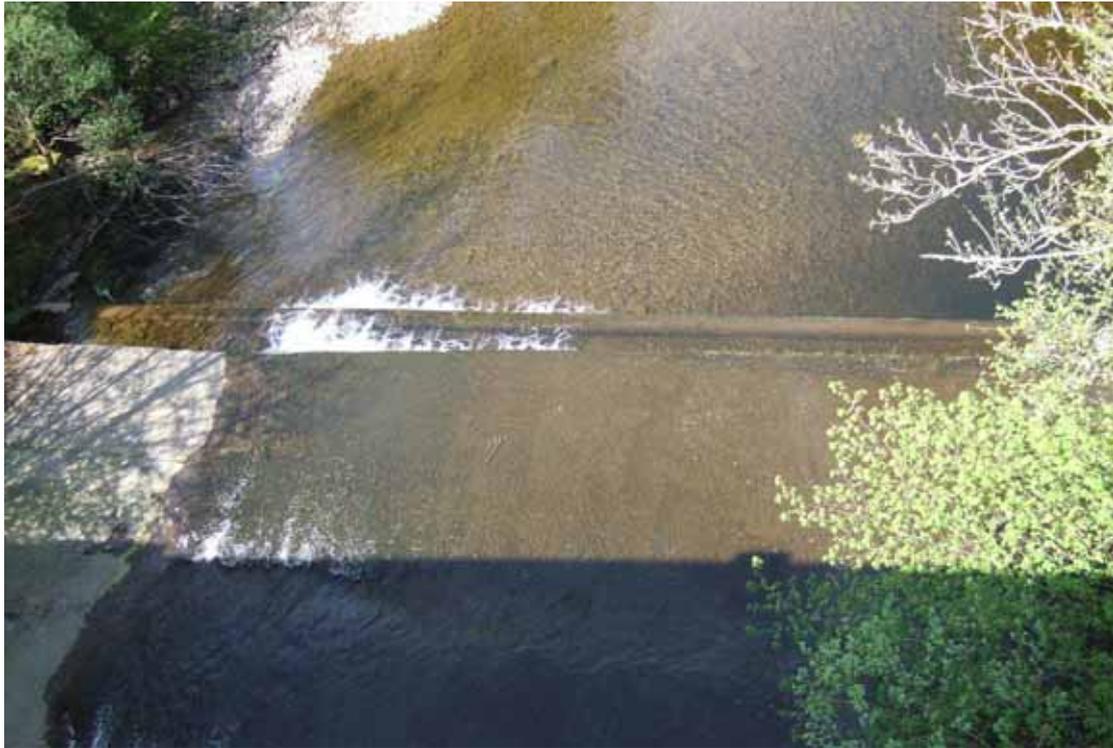
The first man-made structure that causes a problem for fish passage is underneath the road bridge in Whitfield itself. The structure consists of a double step of concrete followed by a length of flat concrete apron. The step itself does not appear to be too high, but the extensive length of concrete apron is a significant barrier.

It would appear from local observation that migratory fish do get over this barrier in some flow conditions. At most flows, however, it will be very difficult with flows far too low and/or fast over the concrete apron. This will be a particular issue for the smaller migrating brown trout.

The concrete apron is a significant barrier to migrating fish at this site.

The remedy for this barrier could be relatively cheap, and would be necessary if the upstream barrier is to be tackled. Flow should be concentrated in one part of the concrete apron, either through a baffle style fish pass, or by cutting an artificial channel through the concrete.

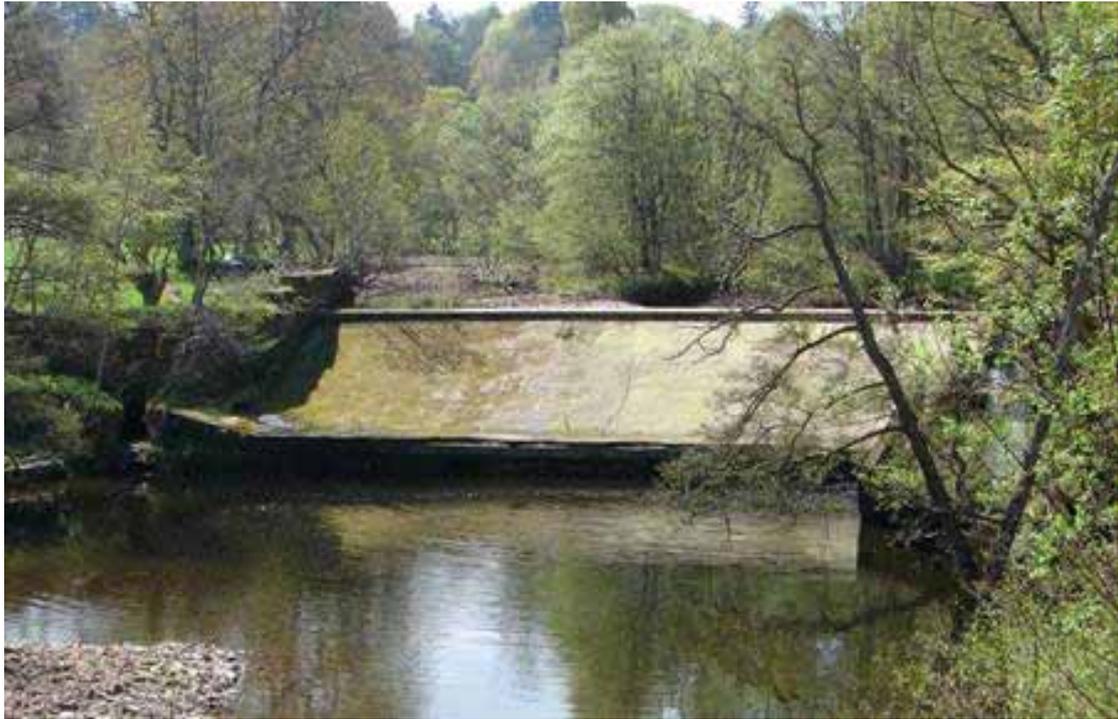
The second weir is a complete barrier to fish migration. The history and ownership are not clear from estate records but it remains in poor repair. An old fish pass was thought to exist on the right bank side of the weir, but further investigation suggests that this is a simple bypass sluice and not built for fish passage.

The weir has also acted as a trap to prevent much coarse substrate from moving downstream. This could explain the excessive erosion in the reach immediately downstream of the weir. The predominance of bedrock in the downstream gorge has prevented what could otherwise have been more significant erosion. The free movement of substrate should be a major consideration in determining the appropriate course of action for the weir.

The second weir no longer serves any purpose and does not appear to incorporate an historic fish pass.

There are several potential solutions for fish passage across this weir, including complete removal, which would need to be investigated by an engineer.

1. Contract a suitable engineer to assess options for improving fish passage at the two man-made barriers. This should include plans suitable for tendering to civil engineering companies and outline costs for budgetary purposes. Assess cost against benefit in terms of the objectives of the Trust. Plans should allow for passage by smaller salmonids as well as salmon.

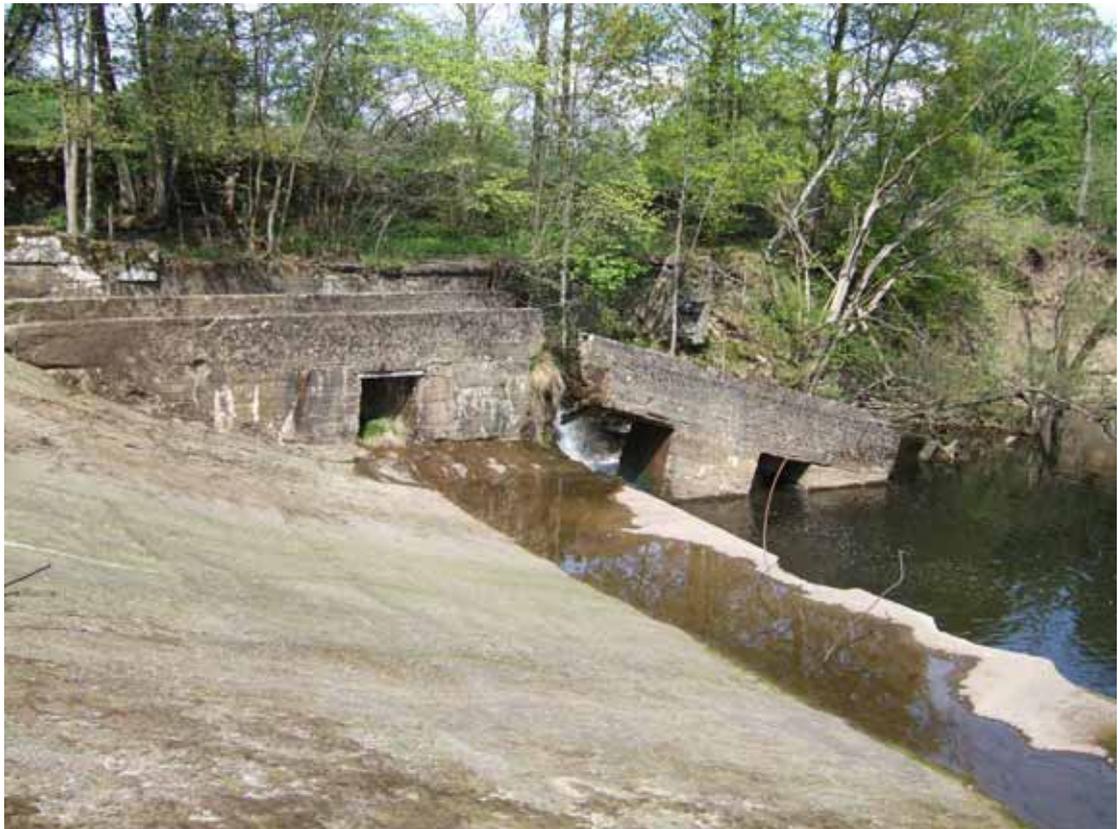
The weir is in poor repair with reinforced concrete starting to erode away, and steel reinforcement exposed.

The poor repair of parts of the weir suggest that a 'do nothing' option may result in its future failure. It is recommended that the risk of catastrophic failure should be properly evaluated by a structural engineer in the near future. Migratory fish have been observed jumping at the weir and it is very likely that upstream areas were once accessible.

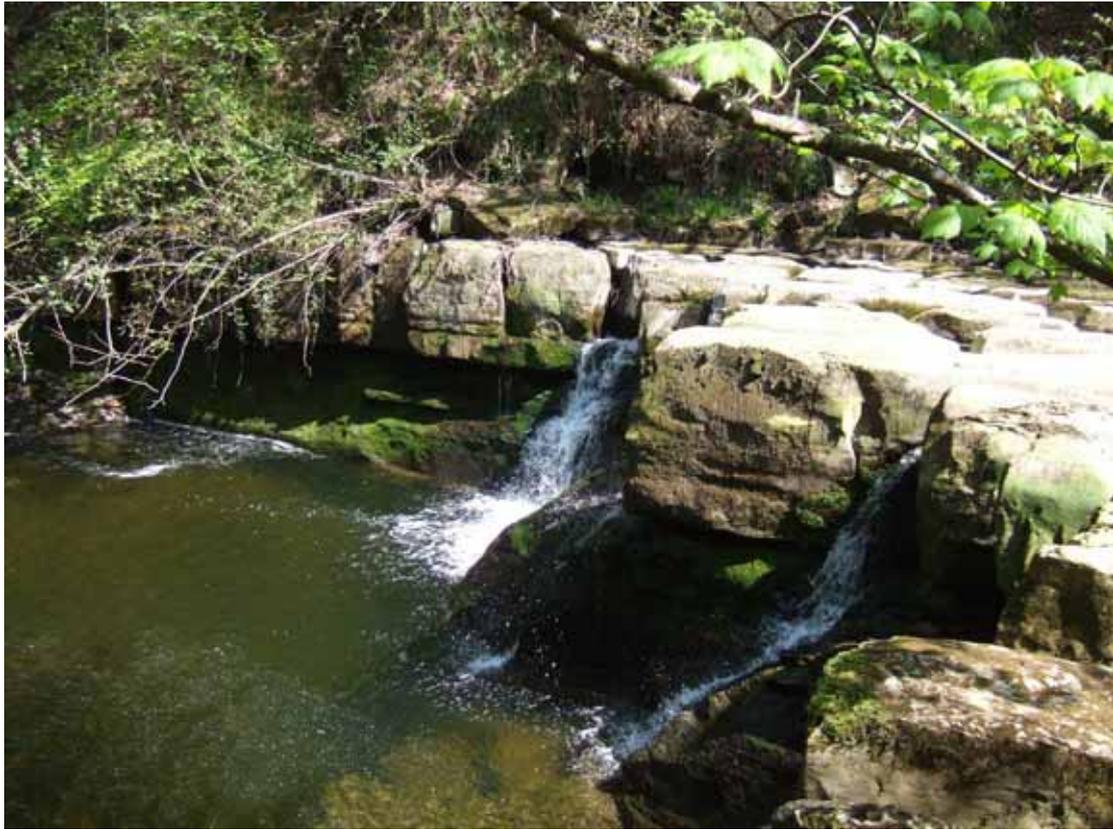
The West Allen was walked up to the bridge just below Ninebanks. Trout were observed in favourable habitat throughout the reach indicating that there is a population present, albeit in relatively low numbers. A natural barrier exists approximately 1.5km from the weir, which will be impassable to salmonids in all but a few flow conditions. There is anecdotal evidence that fish have passed over the falls in the past, but this is unsubstantiated. The plunge pool below the falls is certainly deep enough to facilitate jumping and the falls are no higher than Stainforth force on the Ribble, which is passable at times. It will be very interesting to see if fish can make it.

The falls may be passable in certain flow conditions thanks to the deep incisions in the bedrock and deep plunge pool.

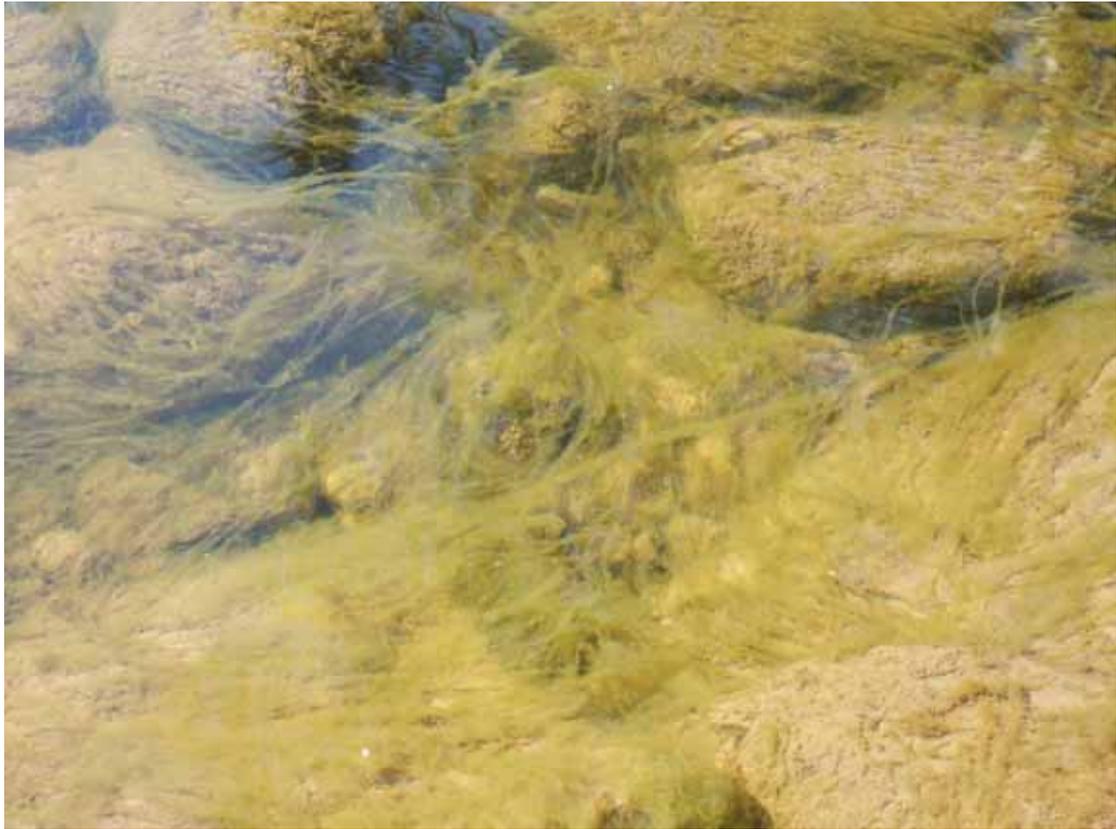
Whereas tributary streams appeared clean and clear with strong invertebrate communities, the West Allen itself appeared far too eutrophic for an upland river, dominated by filamentous algae, and with far fewer invertebrates than the tributaries. The cause of eutrophication and excessive nutrient input needs to be assessed by surveying upstream for possible causes.

Filamentous algae dominates the West Allen in this area and is a sign of water quality problems.

2. Explore options for improving stewardship of the river upstream of the weir by generating an income from letting the fishing.
3. Investigate source of apparent eutrophication of the main West Allen upstream of the weirs.

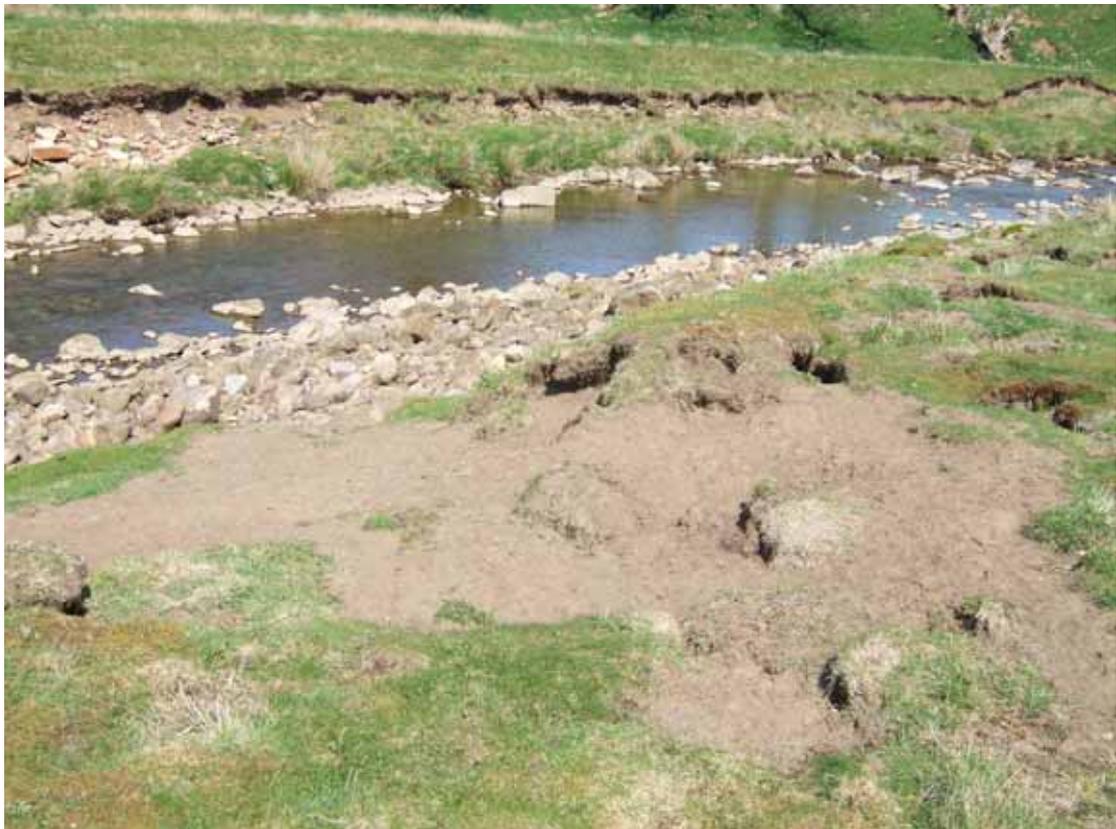
Parts of the West Allen do show some signs of erosion caused by agricultural stock but this is not considered severe and will recover easily with suitable fencing and tree planting. The exception is just below the bridge at Ninebanks. This is caused by the flow around the gravel built up below the bridge and is unlikely to recover by fencing alone. Willow planting may slow the erosion to an acceptable degree and is really the only option for a Trust to recommend in this instance.

Moderate bank erosion that will recover by fencing. Tree planting will also help conditions for trout.

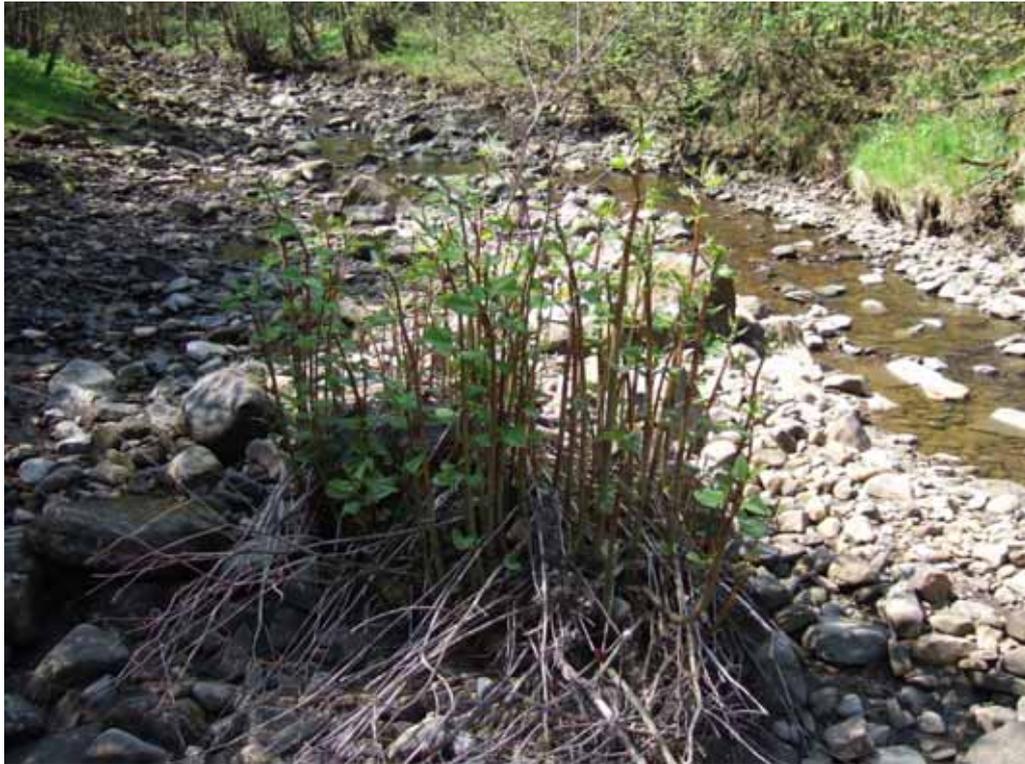
A small stand of Japanese Knotweed was observed at the bottom of Carr's burn near the confluence with the West Allen. It would be simple to walk this system and ensure eradication of this exotic invasive plant down to the confluence with the West Allen and perhaps further, as a start to clearing it from feasible parts of the Tyne catchment.

Japanese Knotweed is highly invasive and a risk to the whole catchment. A source this high up allows for strategic control measures to be implemented.

4. Survey for and treat Japanese Knotweed in the sub-catchment.
5. Check brown trout access into the Blaeberry burn.
6. Recommend landowner carries out some habitat improvement works along the main river and tributaries.

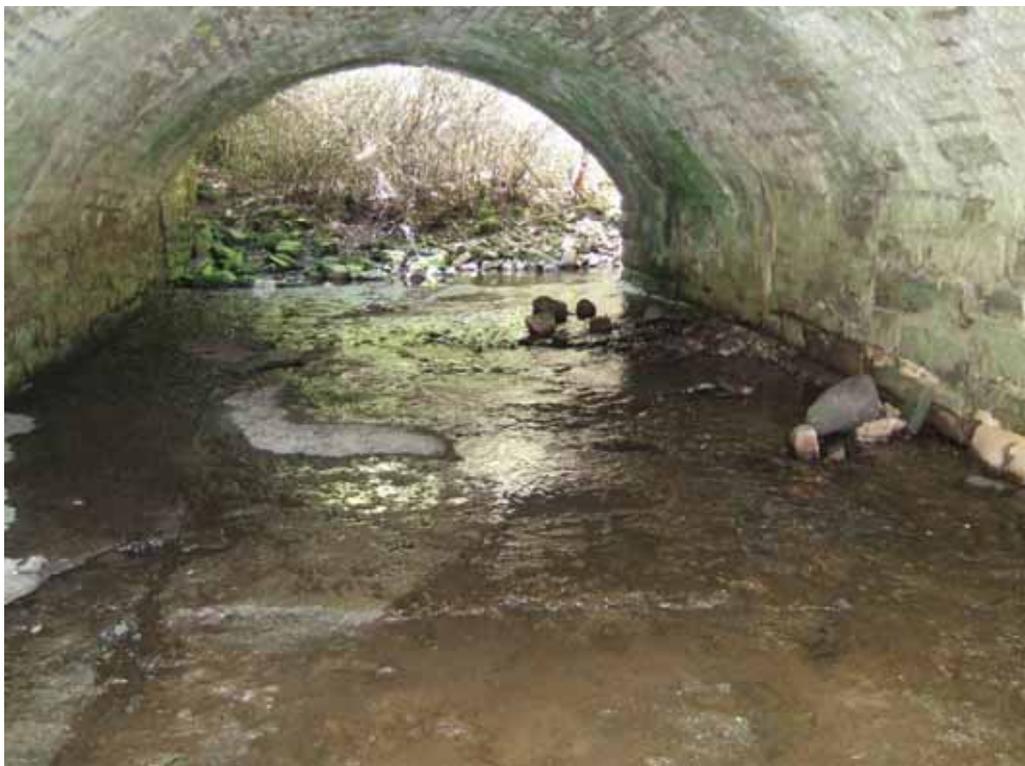
The entrance of Blaeberry burn is partially obstructed by a concrete sill associated with the road bridge. Trout can probably pass up the left hand side in certain flows but passage could certainly be eased quite cheaply by concentrating flow in one part of the sill. The Tyne Trust should be aware of small obstructions like this, as well as concrete culverts and pipes, which can restrict movement within many of the smaller spawning tributaries of a catchment.

A long concrete culvert can restrict access for fish but may be easily rectified by concentrating the flow.

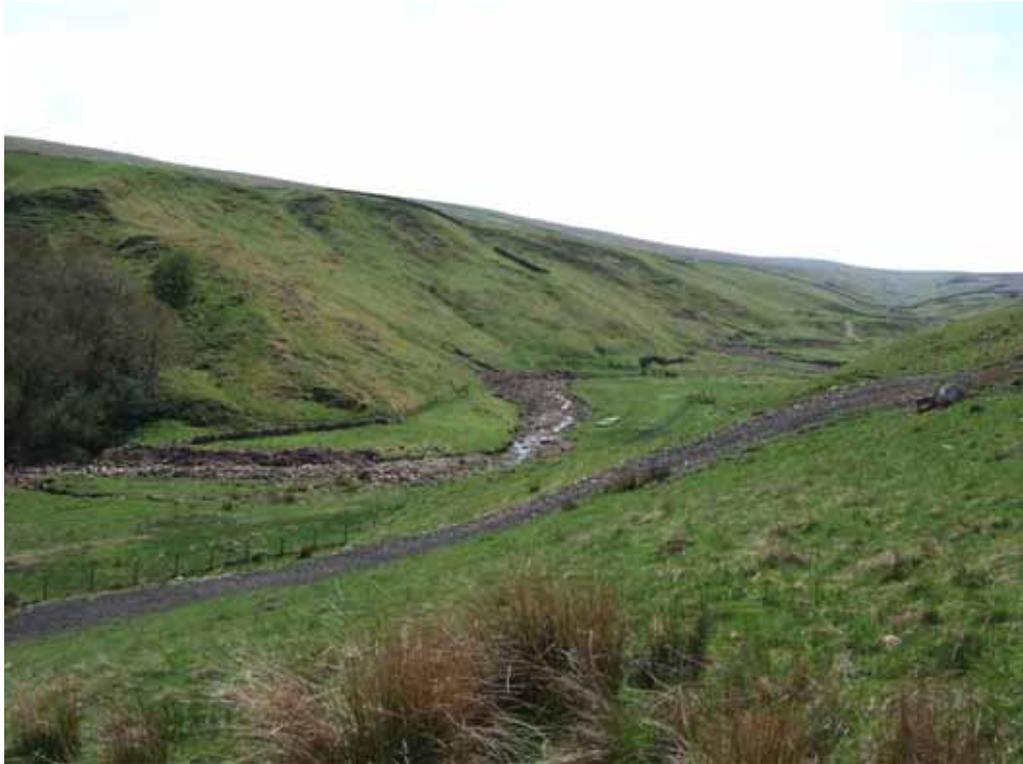
Both tributaries run straight up on to moorland and appear to have excellent water quality with plenty of invertebrates present. Both are ideal salmonid juvenile habitat but whether they are operating well or not can only be assessed by electrofishing survey. A pool well up Carr's burn was like an aquarium, stuffed with juvenile brown trout. This was where trees had formed a pool, and extending areas of habitat up this valley, would be beneficial for juvenile trout and probably boost the population.

The top of Carr's burn is open with little bankside habitat. The 'aquarium' is on the left of the picture, associated with the trees. Some patches of tree planting would be beneficial.

8. Consider habitat improvement works on Carr's burn to increase tree cover further up the valley.
9. Check Blaeberry burn for impact from commercial forestry.
