Habitat Advisory Visit

River Whitewater, Hampshire

**On behalf of Mr Richard Burt
8th September 2006**

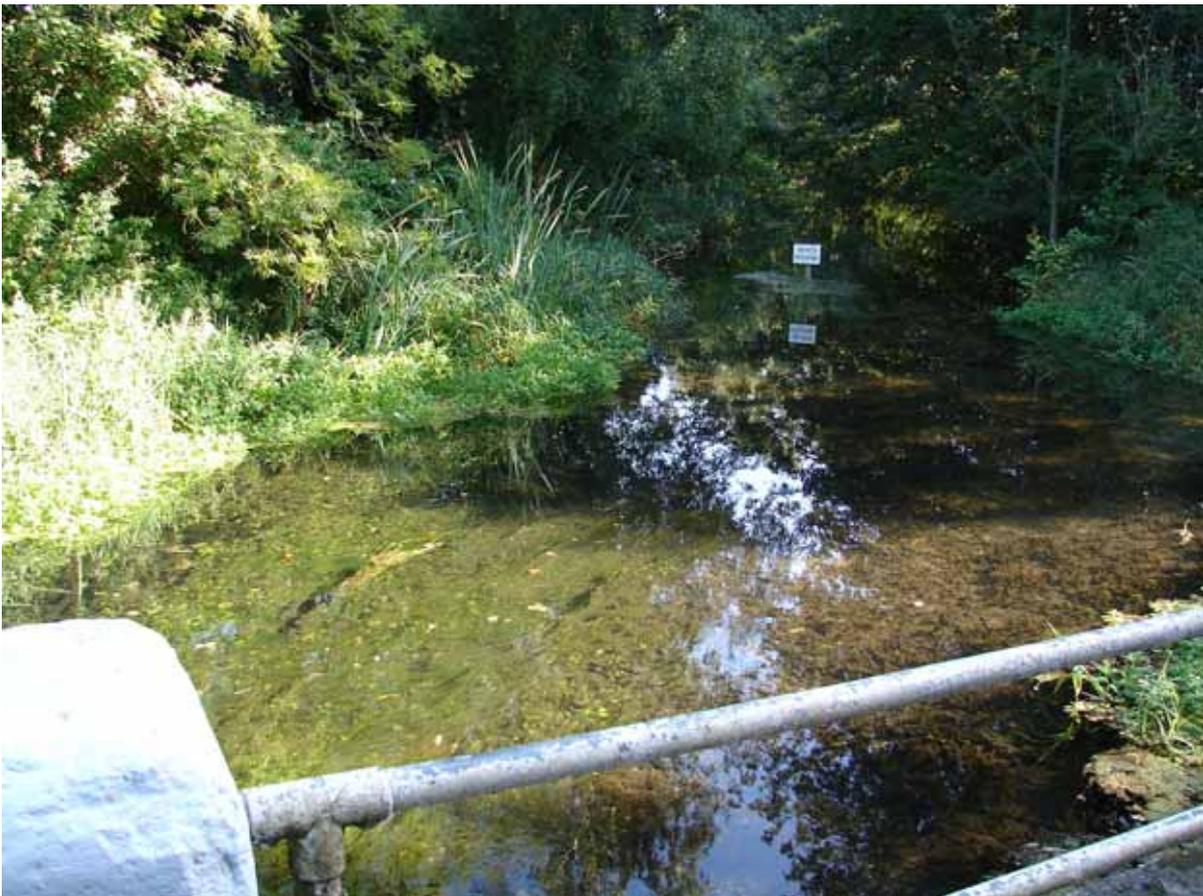
The river here appears to be suffering from the effects of low flows . Filamentous algae covers most of the bed of the river with very little remaining in the way macrophyte growth (e.g. Starwort). The low flow velocity is exacerbated further due to the presence of a weir structure 50m d/s of the bridge.

The Whitewater d/s Deptford Bridge (note 100% algal coverage)

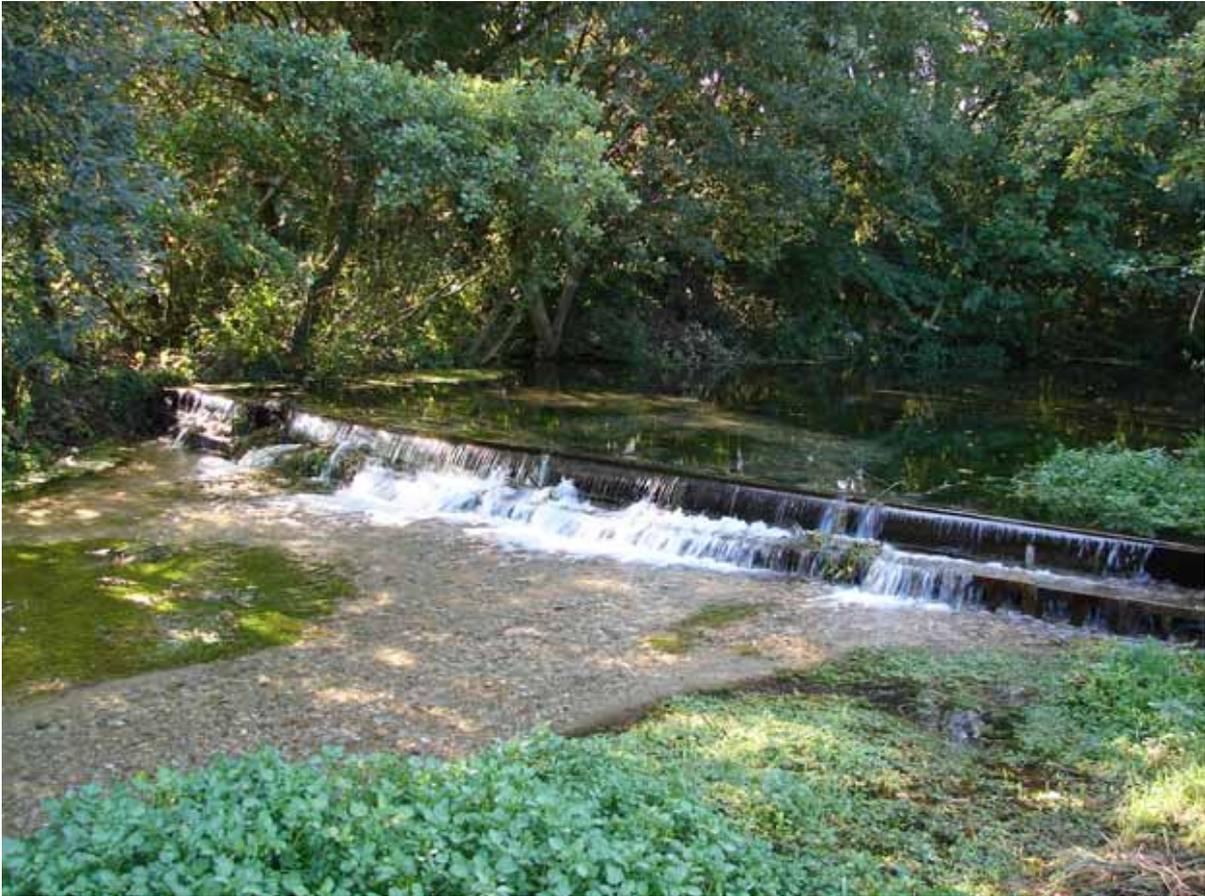
Weir structure d/s Deptford Bridge

The weir at this location should be removed. It is not delivering any real benefit and works to introduce LWD and paired flow deflectors throughout the reach will create more valuable and sustainable sequence of pool:riffle habitat. There is a real risk of erosion on the LHB requiring periodic and costly maintenance. Consideration should also be given to the removal of the weir d/s of Deptford Bridge for the same reasons, although the risk of erosion is not as acute.

A potential location for the deep substrate box would be at the weir below Deptford Bridge which would facilitate the downstream migration of fry / parr.

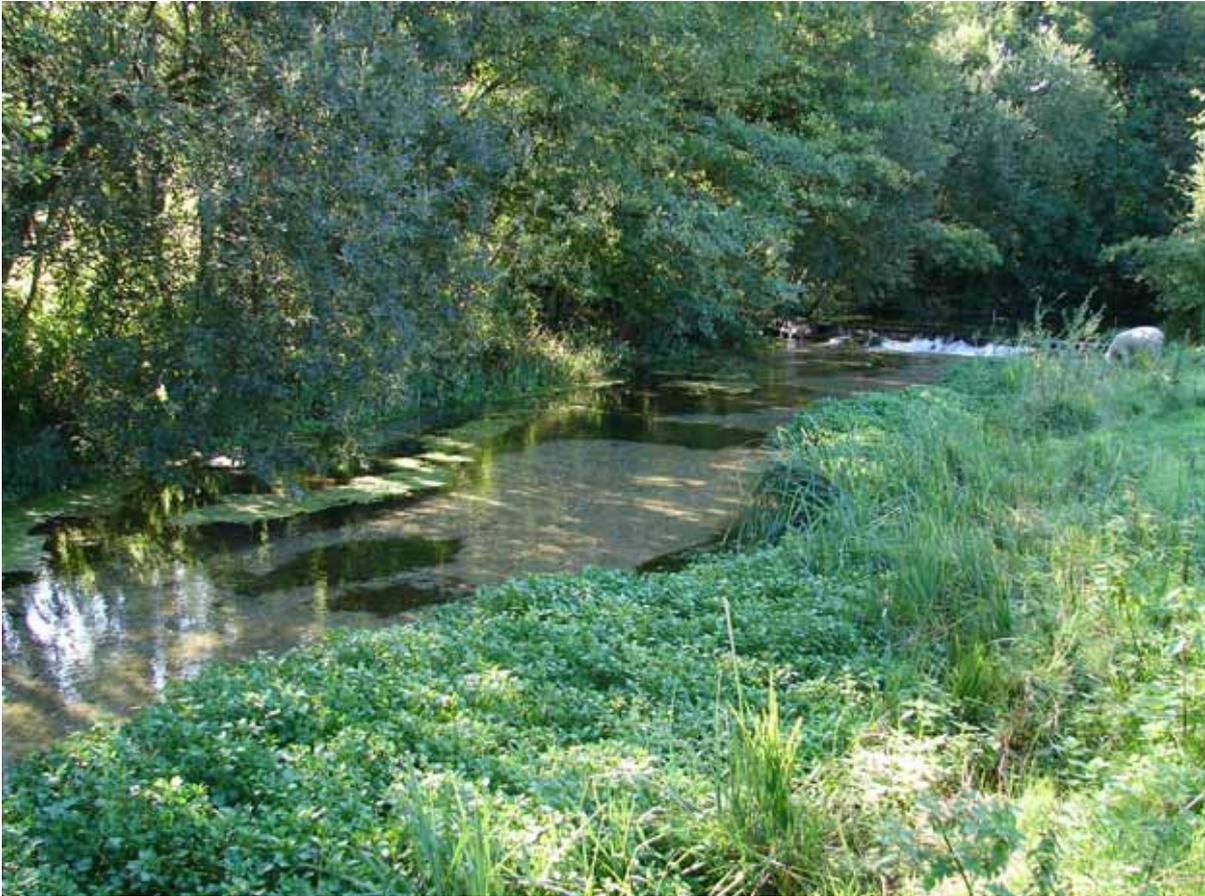
Below the weir the stream takes on more natural 'chalk stream' characteristics. The bed substrate is comprised of gravels and cobbles, however there appears to be an ingress of silt into the gravels, which could be limiting factor affecting spawning success. The reach has undergone a programme of tree management by the current owners, resulting in good balance of light and shade entering the channel. This has allowed the development of in stream macrophytes (starwort spp/ ranunculus spp) and a well vegetated littoral margin containing emergent (watercress spp / watermint) and fringing vegetation (sedge) . The historic over shading forced the river to form a wider and shallower channel with very little in the way of pool habitat that is especially useful for parr and adult trout to seek refuge. The growth of bankside plants is facilitating a gradual narrowing of the channel and increased stream velocities. Sheep are in the meadow on the LHB and this is cause for some concern as the margins are unfenced and grazing pressure could lead to a loss of vegetation and erosion of fragile wet margins and banks. The 4000 fingerlings were release in this section.

D/s of 1st weir (note development of vegetated margins, narrowing the stream)

The stream in this section is over-wide (approx 7m). There are sections where channel width narrows to around 4m and stream velocities improve and exposed gravels are present. It is these sections that provide a good template for restoration works d/s. In over-wide sections a new bank line should be created using brushwood faggots staked along the RHB¹. At various points it is also recommended that flows be 'pinched' by installing paired and single faggot deflectors to allow the river to scour pool habitat². Chalk should be used as suitable backfill for these features. The new bank should be set no more than 10cm above summer water level to allow the development of emergent wetland plants such as sedge, water forget-me-not, brooklime, yellow flag-iris and water mint, etc. Consideration should be given to transplanting well-established emergent vegetation from adjacent areas to facilitate the colonisation process. A density of four plants per square metre should achieve rapid results.

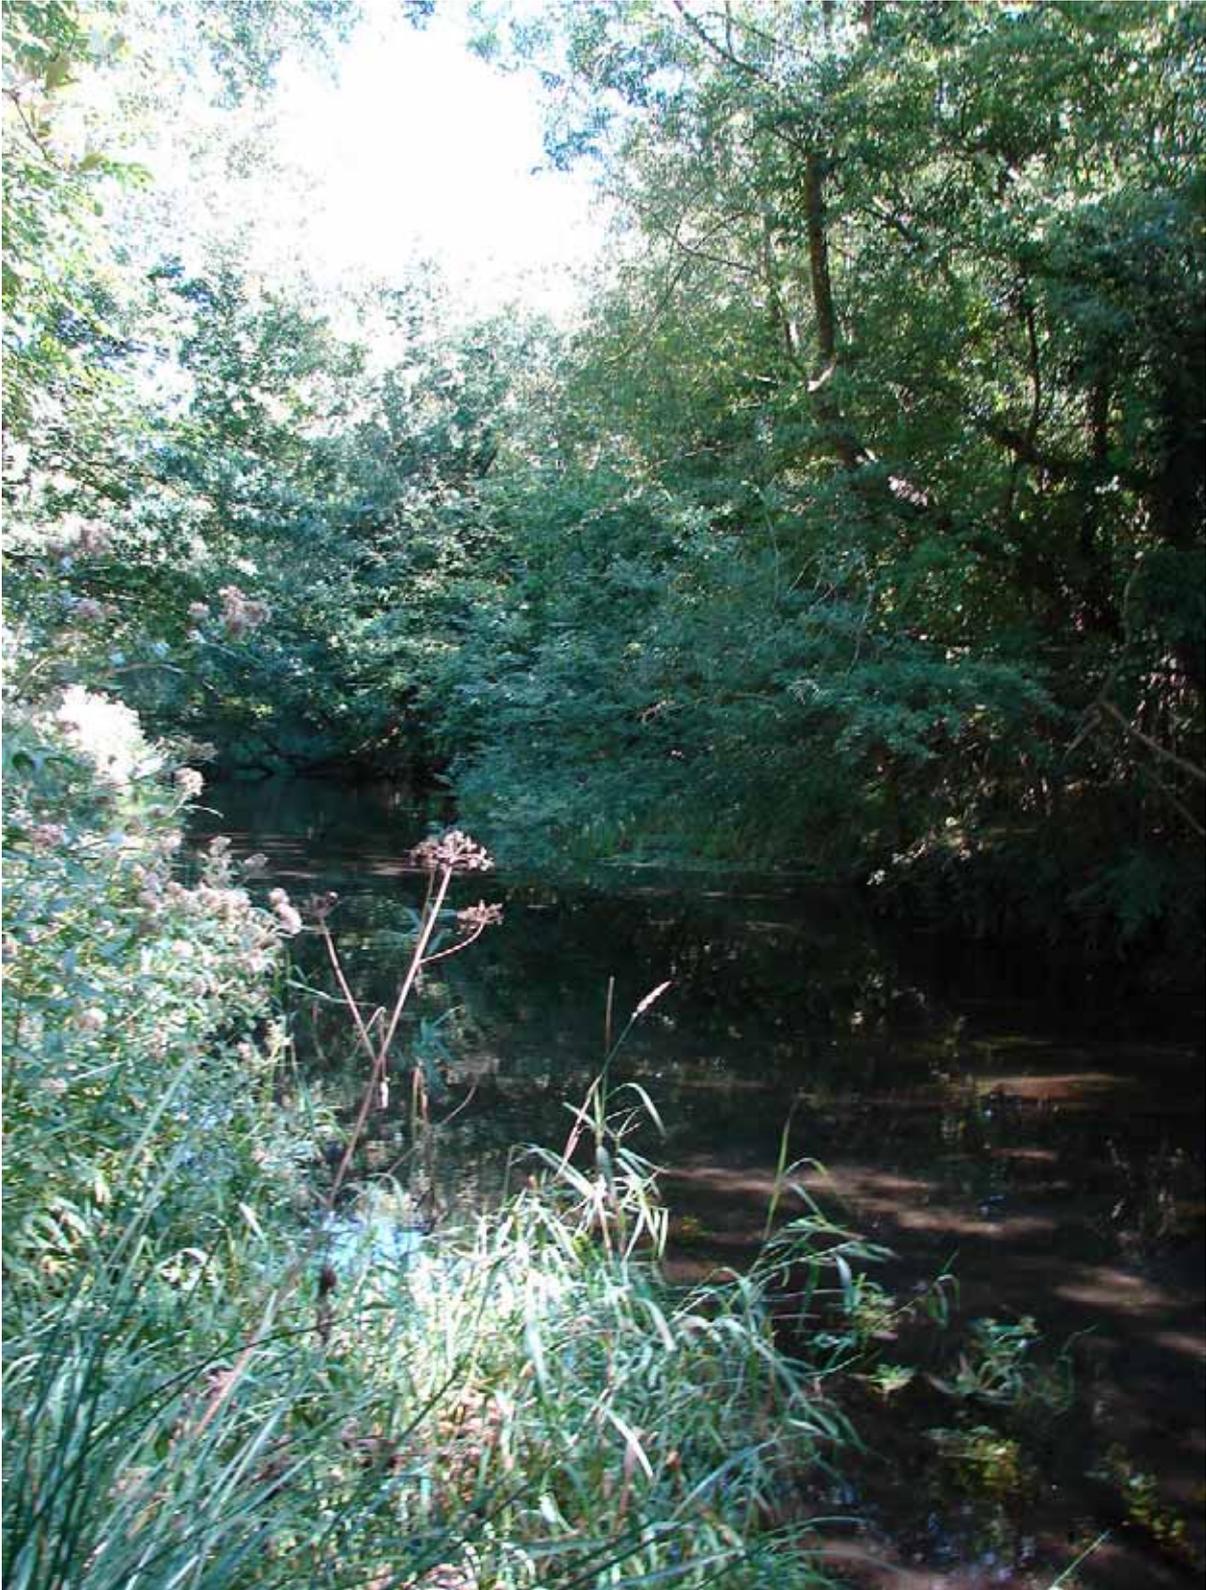
The stream then runs into a heavily over-shaded section of around 150m in length. The channel is over-wide and silty, with gravels underneath. There are shooting interests in the wood adjacent to the river and any negotiations regarding tree work should be handled with a degree of pragmatism.

Over-shaded wide silty reach.

The middle section of this river is heavily over-shaded and a programme of coppicing and pollarding is recommended. Recent works d/s of Weir one should be used as a template to achieve the right balance of light and shade. As with u/s it is also recommended to undertake a programme of stream narrowing in LHB to scour silt from gravels. Arisings from the tree work can be used for narrowing and the introduction of LWD to form pool habitat throughout the whole reach.

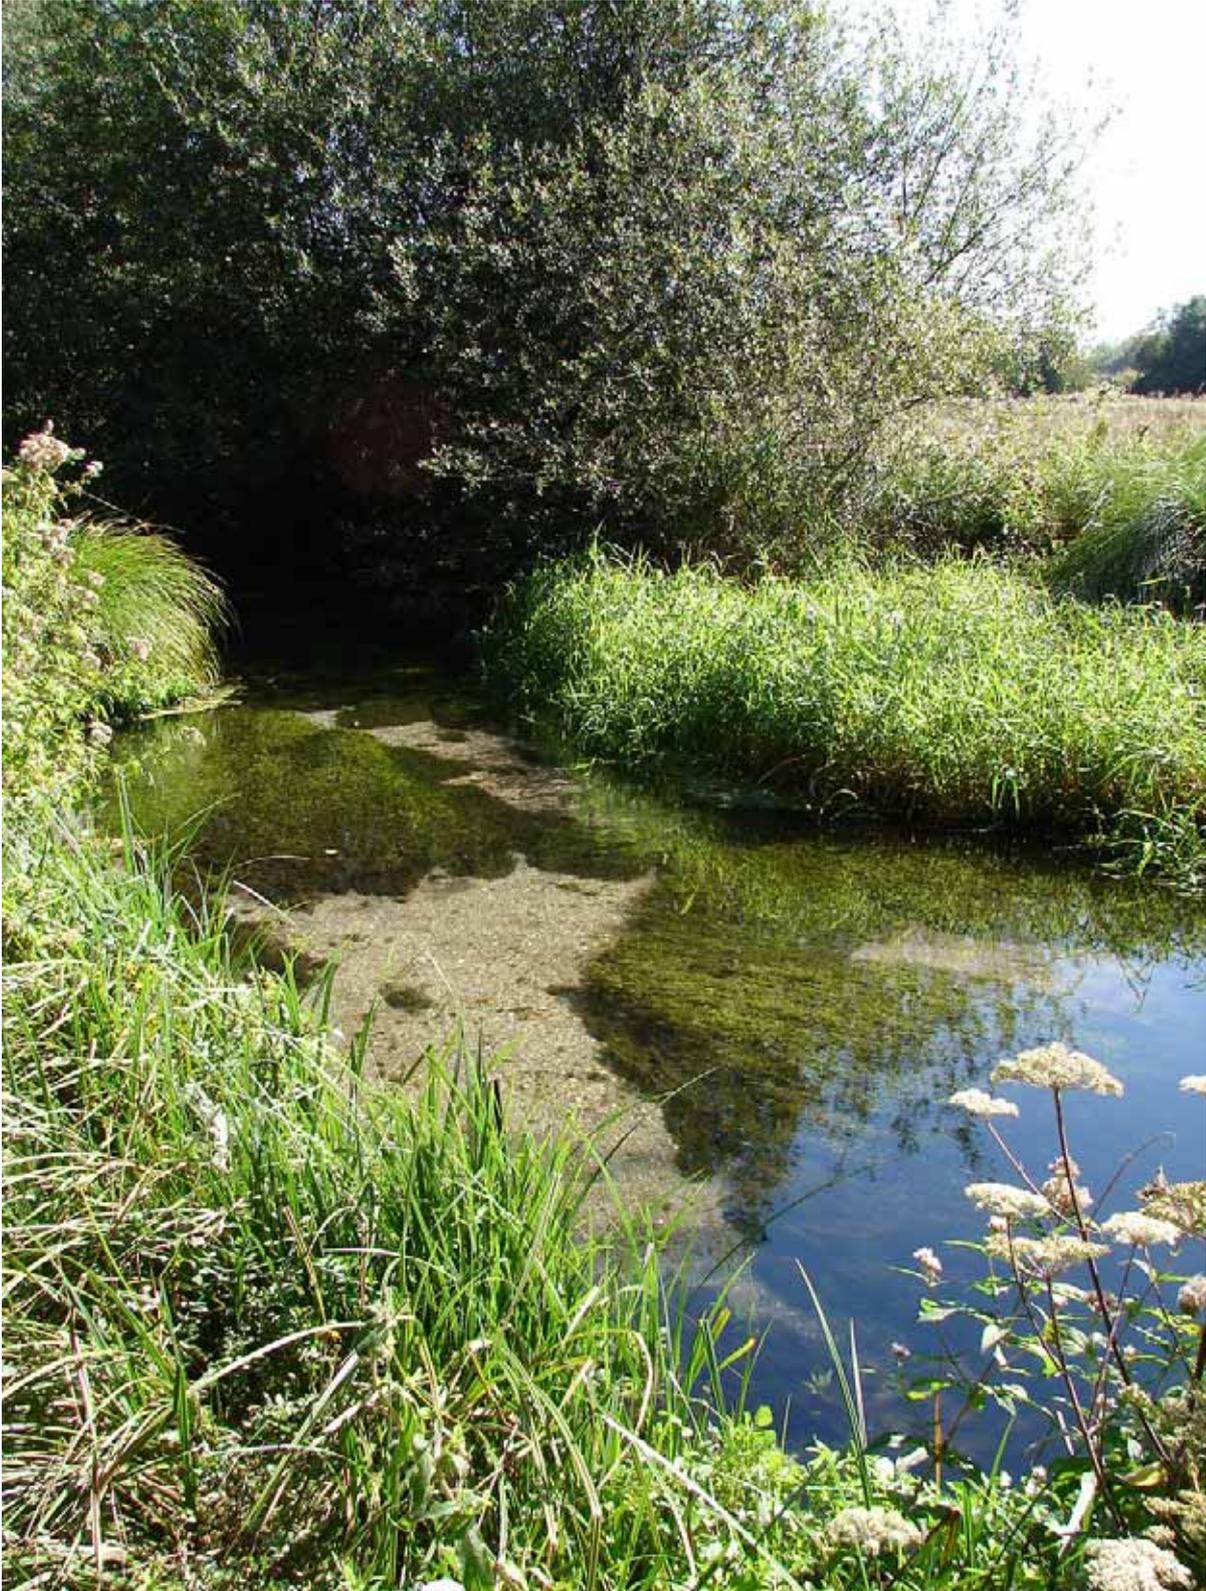
The river then leaves the heavily shaded section to form a more natural looking section. Good stands of starwort and ranunculus are evident which has created a good mix of erosional and depositional features such as mini-runs and pools albeit in limited supply. Marginal vegetation is

assisting this recovery process further, however at this point filamentous algae start to re-appear.

More natural channel d/s of the wood

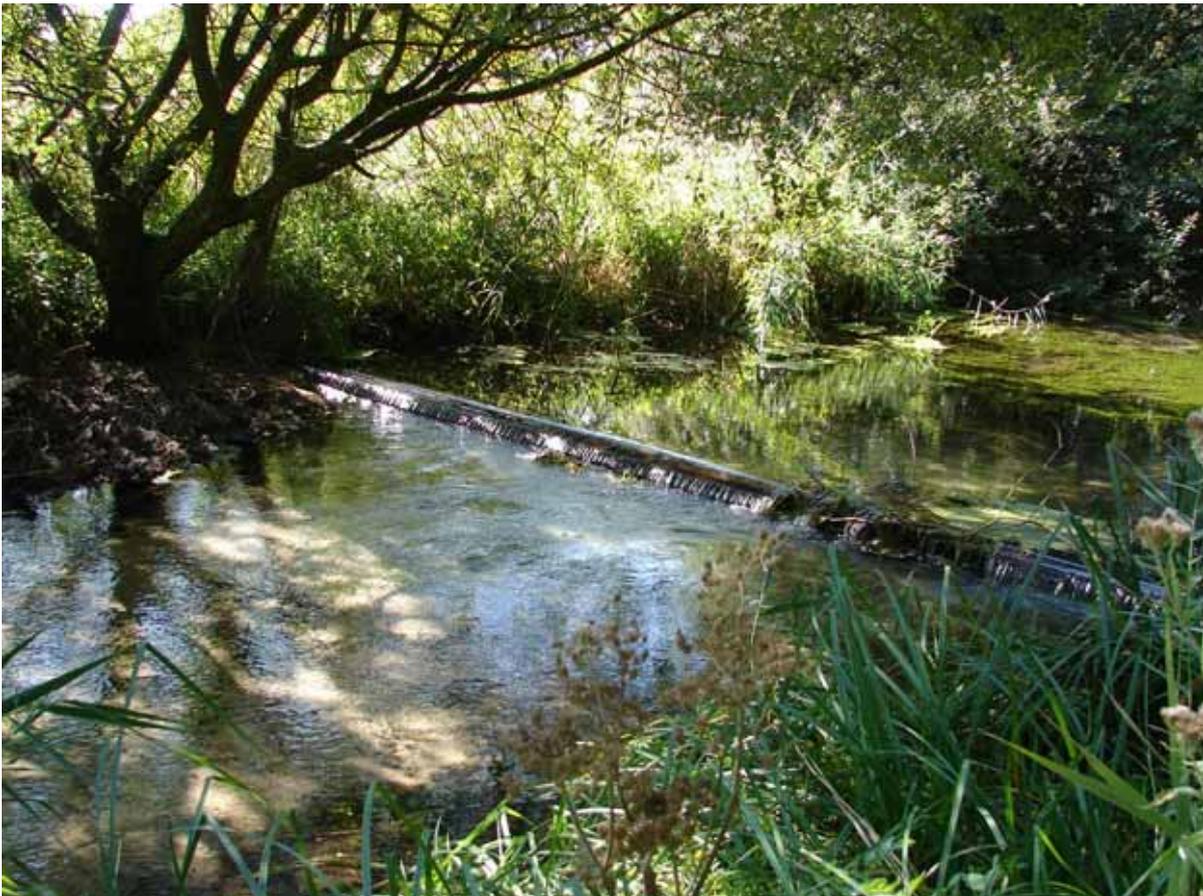
A weir has been constructed at this point using sections of iron girder. The structure has created a useful pool a habitat feature lacking in the reach. However the structure is backing-up flows upstream and has the potential to cause localised erosion problems, especially to the RHB. The structure could also present a barrier to resident trout in the reach wishing to spawn on the gravels d/s of Deptford Bridge.

2nd Weir note pool d/s a backed-up flows and algae u/s.

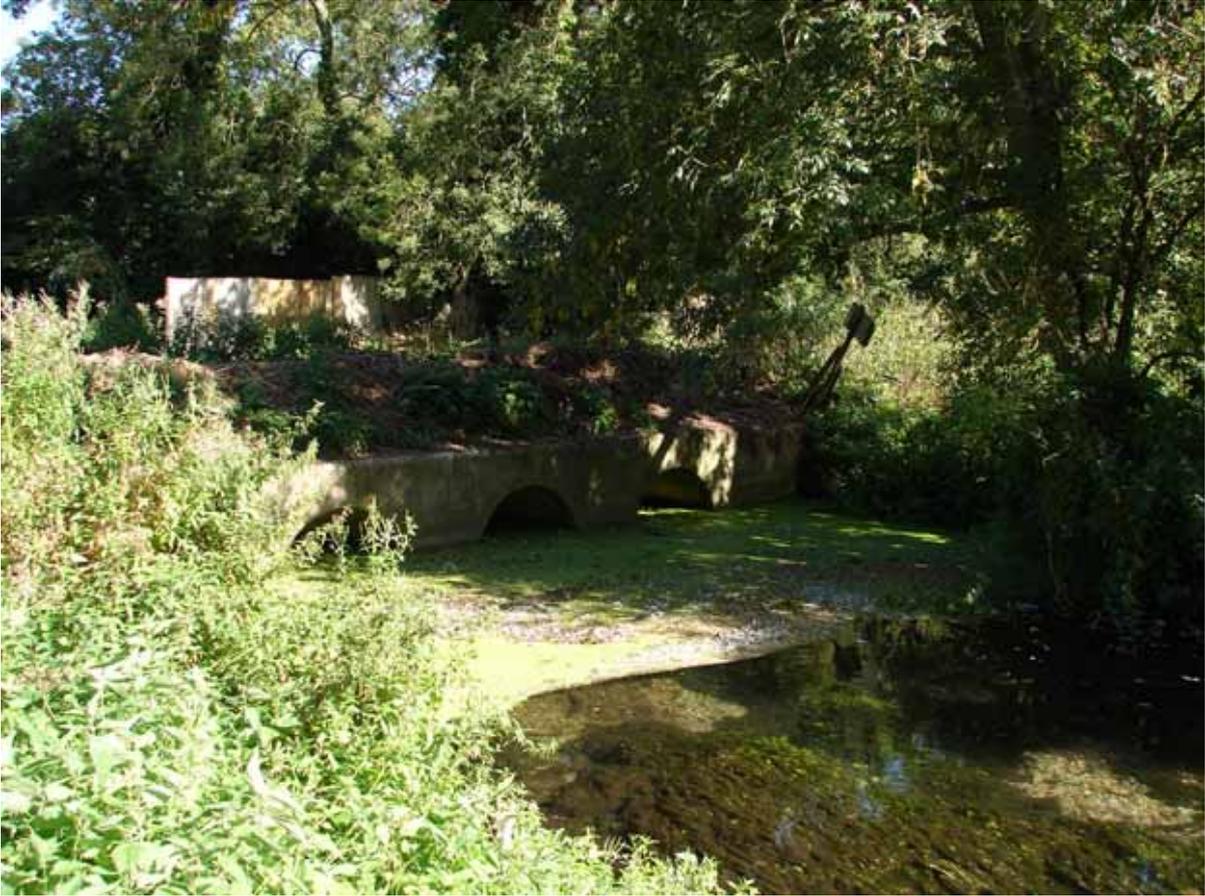
At the end of the reach the river goes through a culvert underneath the Basingstoke Canal. Flows are being backed-up entrance to each culvert due to a build-up of material including braches and detritus. To maintain flows the culvert should be periodically cleared especially after periods of high winds and prolonged rainfall.

Obstructed entrance to culverts.

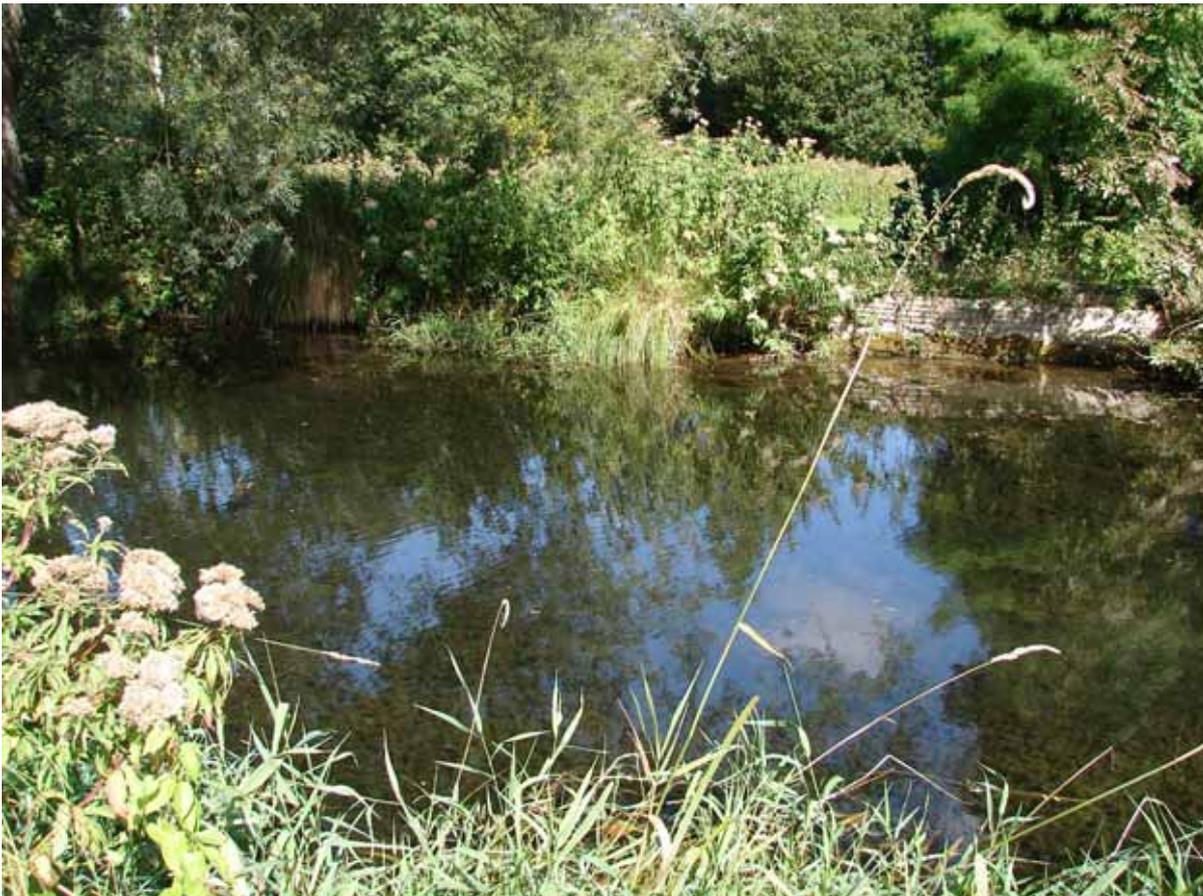
U/ of the Mill house the river is wide, silty and shallow. In places the channel width is 15m. Filamentous algae has covered the bed of stream. The width coupled with levels that are backed-up by the presence of the Sluice meant there was also no perceptible flow at this point. There is extensive deposition of fine silts and sands and very little in the way of exposed gravels and macrophyte growth.

The approach to address habitat improvement of this reach requires a differing scale of approach to that upstream. Downstream for approximately 100m from the canal culvert it is recommended that a programme of significant narrowing (5m+) be undertaken. This could be either narrow from the RHB or perhaps the installation of mid-channel brushwood islands.⁵

Both prescriptions should be installed to just above mean summer water levels to allow them to drown out at high winter flows. Some consideration needs to be given to the fact that the river is experiencing drought conditions and this will need to be factored into any design works. The net effect of both features will be to increase flow velocity and depth to create a deeper flowing channel with an exposed gravel substrate, promoting the growth of starwort and ranunculus spp.

The mill structure may be having a significant impact on flow velocities within the reach. Consideration should be given to the manipulation of water levels by lowering the sluice gates to increase flow velocity. This option needs to be discussed in detail with the Environment Agency and Natural England who will have views on the Water Resource implications and possible impacts on ground water levels in Greywell Fen. A possible option here would be to install a gravel riffle downstream of Greywell Fen to maintain water groundwater levels.

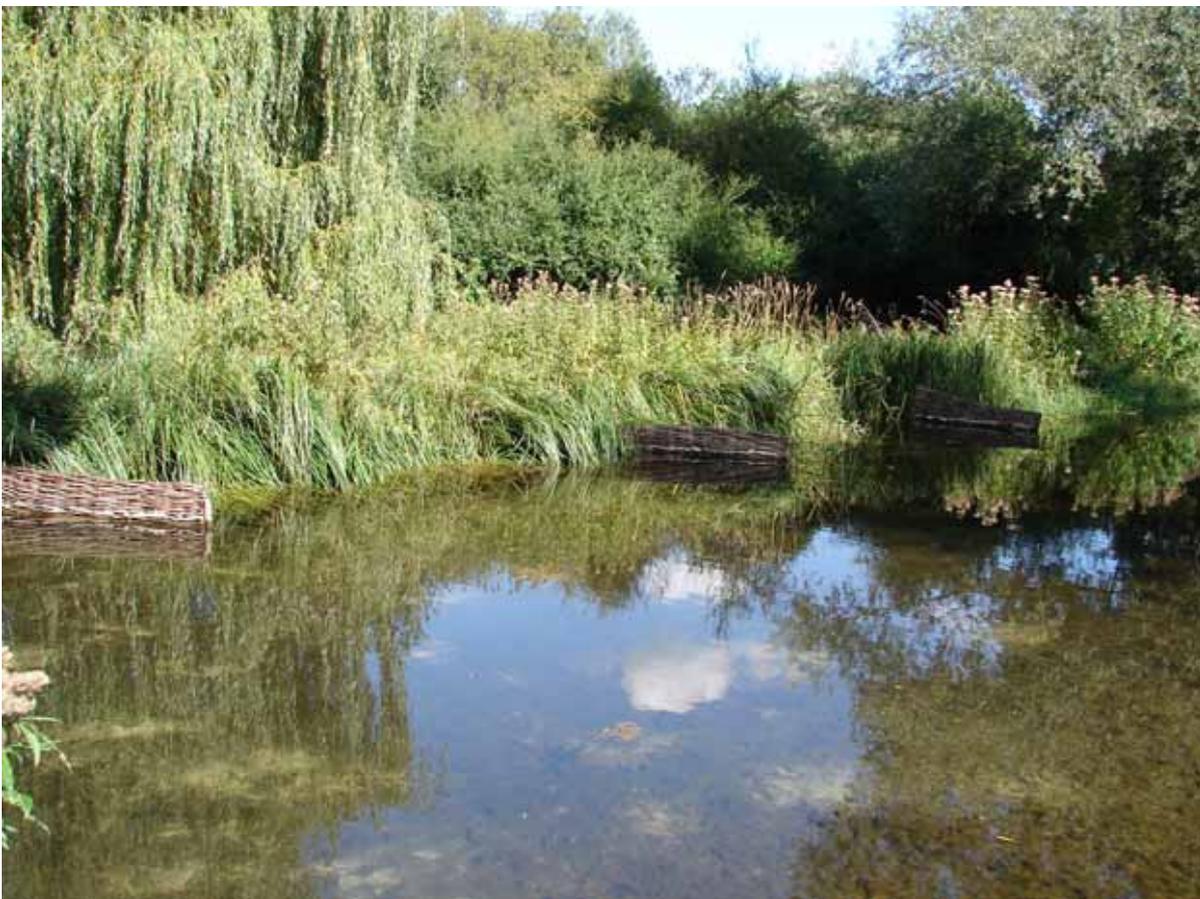
100m u/s of the house the river does narrow to around 10m. From wading this section there appears to be a soft layer of fine sediment at least 0.3m deep, however there are gravel present underneath this layer of fines. In a bid to narrow the stream a series of panel flow deflectors has been installed on the LHB. These are encouraging marginal vegetation colonise which has facilitated limited narrowing of the channel. A few trout to 4lbs+ were observed in this reach, which are likely to be from earlier stockings. In years of good flows the bed of the stream at this location was comprised of "glistening gravels" with classic chalkstream starwort and ranunculus beds and was a noted trout fishery of some reputation. The previous river keeper used to take great pride in cutting the weed 'traditional checkerboard style', which is some indication of the historical flows experienced in the stream.

Straight , silted and shallow....note flow deflectors on LHB

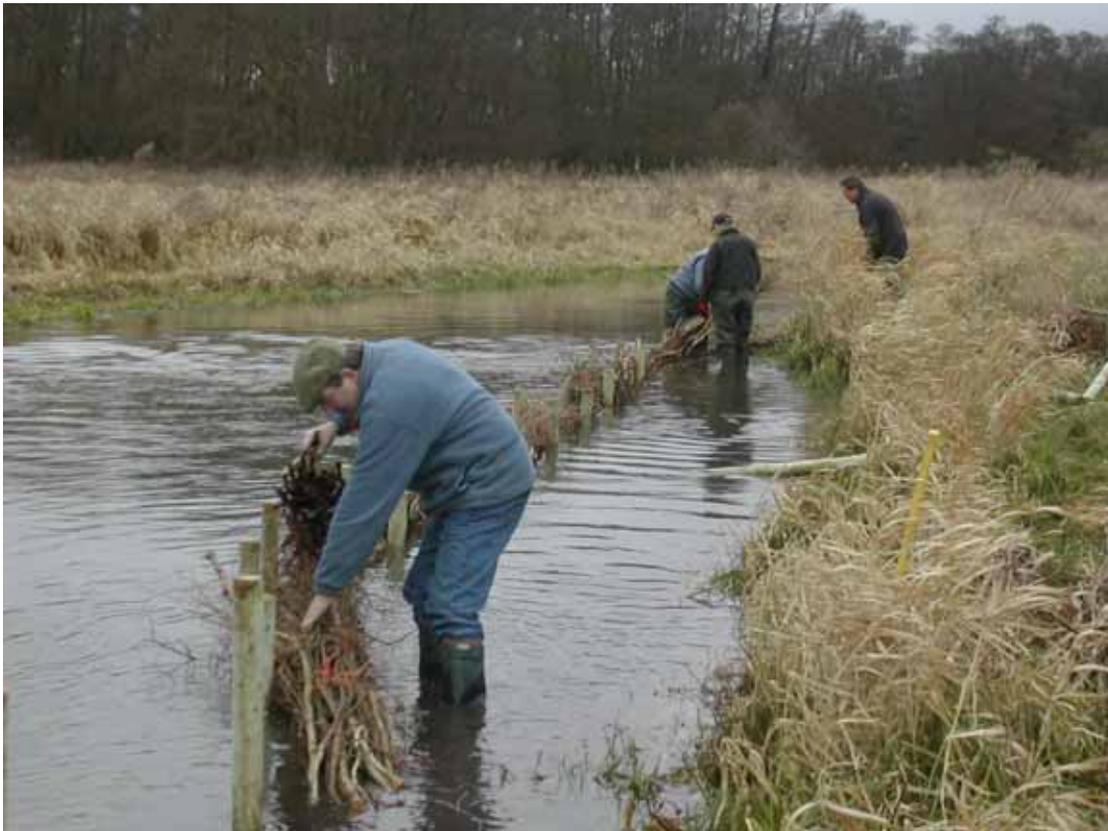
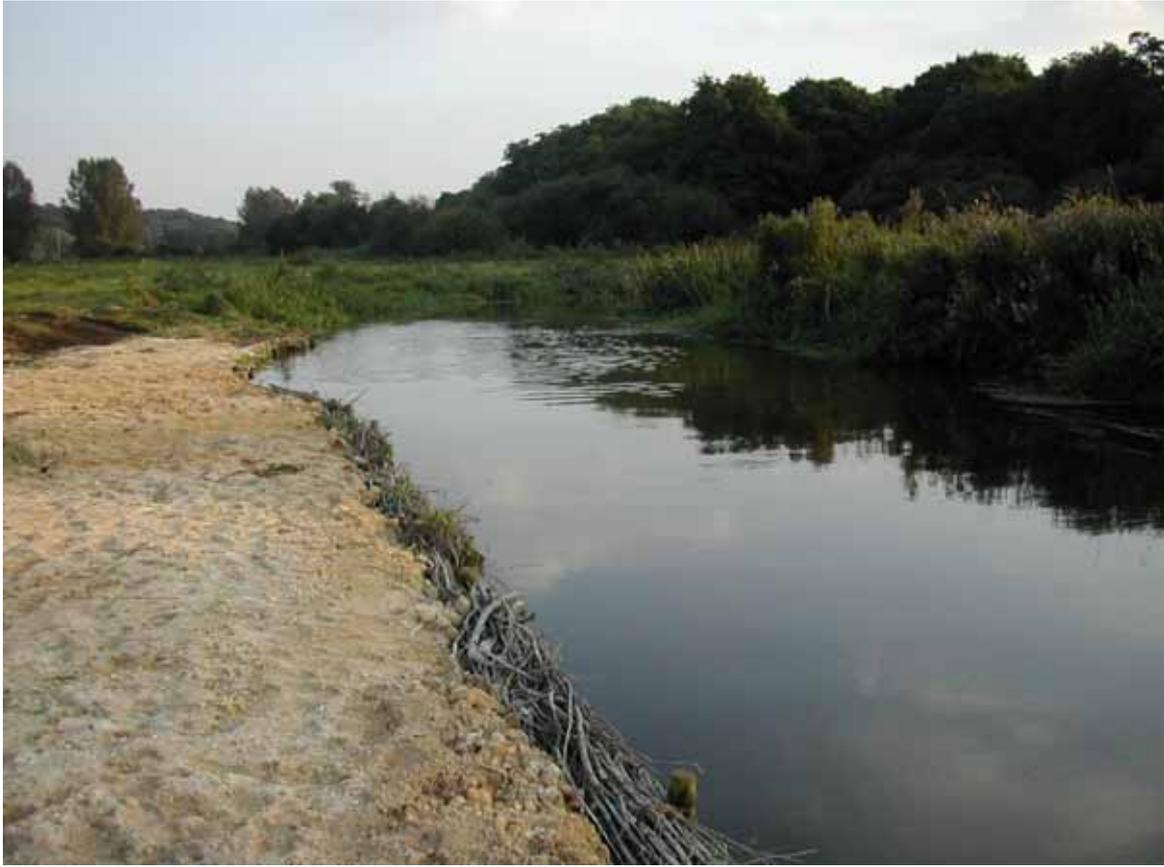
**Installation of new bank using faggots and chalk backfill on the River Wensum,
Norfolk**

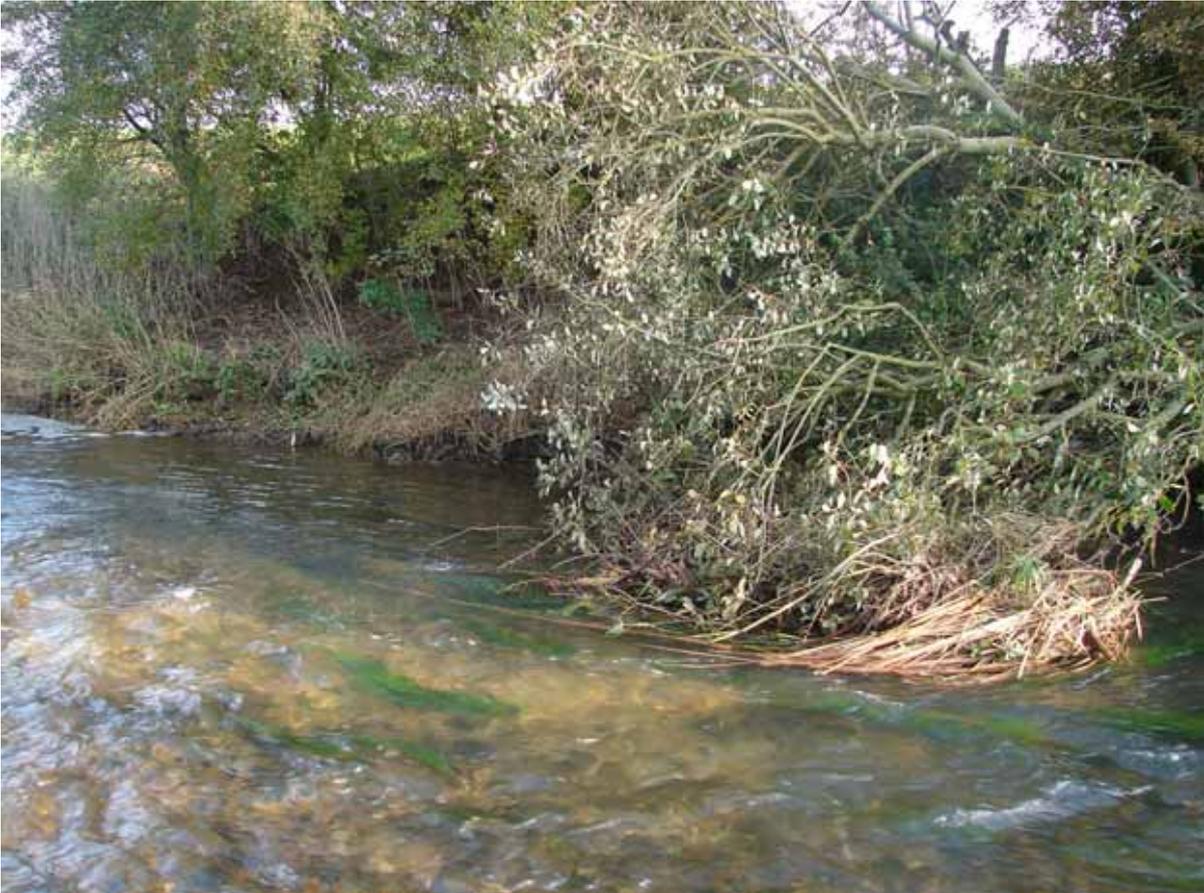
Hinging a tree into the channel has increased local flow velocities, which have 'naturally' sorted and cleaned gravels, suitable for trout spawning (lighter area)

It is also recommended that spawning shallows, or riffles as they are known, be introduced in this section. At several locations there are rises in bed level indicating past locations of riffles before possibly being dredged from the channel. At these locations gravels (well mixed 5-40mm size range) to a depth of at least 20cm should be placed into the channel⁴. Careful sighting of these features is required in areas of adequate gradient to avoid excessive back-watering.

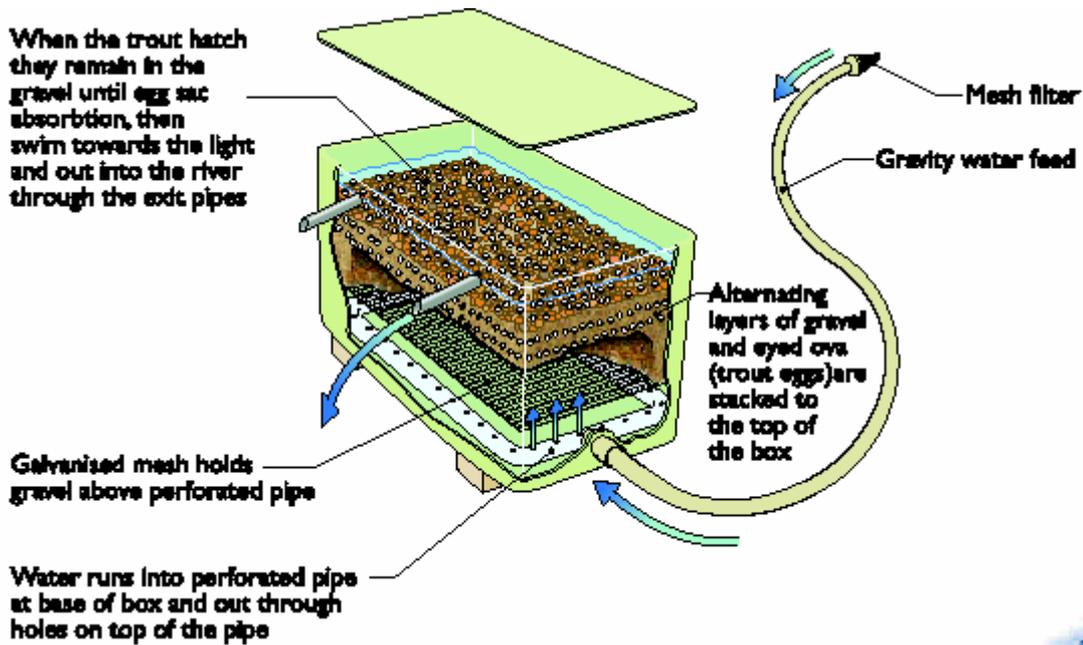
The use of deep substrate incubation boxes on the Whitewater could potentially be a useful short to medium term measure to address the apparent spawning habitat 'bottleneck'. These are gravel filled boxes,

approximately 60cm in each dimension that are filled with suitably sized gravel and seeded with 10,000 –20,000 trout eggs.

A water feed at the bottom of the box allows the eggs to incubate and hatch. Once they reach the swim-up fry stage, they leave the box via the overspill pipes, stocking themselves into the river. It is vital however that good quality marginal habitat is available for fry to seek cover and develop into parr. Section 30 Consent, under the Salmon & Freshwater Fisheries Act, 1975, is required from the Environment Agency prior to the introduction, of fish, fry or ova into inland waters. A good head of water is required to get water to feed through the boxes.
