Advisory Visit Report

River Derwent, County Durham

On Behalf of River Derwent Angling Association

29th March 2007

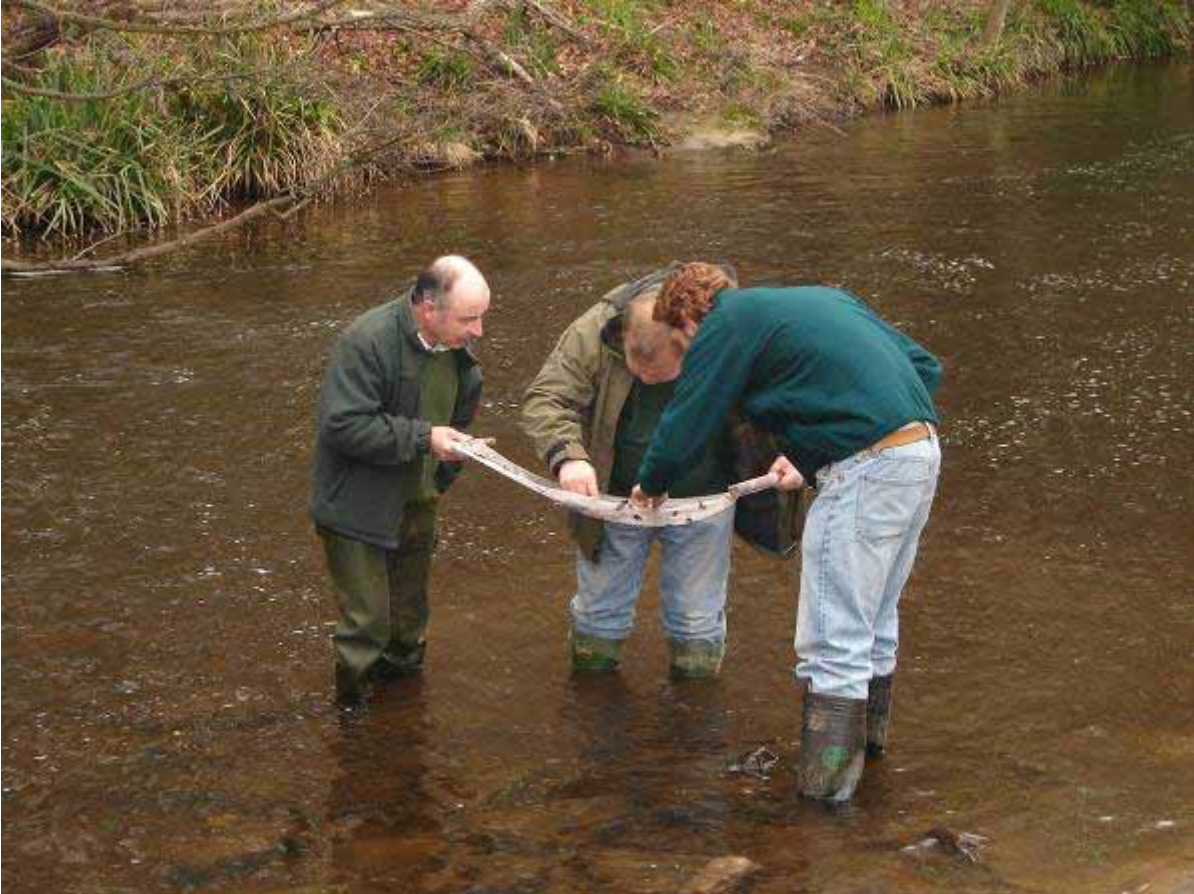
Flylife in the river appears excellent with various species of up-winged flies, stonefly and caddis all present. In both reaches freshwater shrimp appeared to be absent perhaps indicating very good water quality. They are known to be downstream below a sewage treatment works. There are some concerns about the decline in Large Dark Olives and Iron Blues.

Invert sampling d/s Allensford Bridge

Lastly, it is vital that angling clubs understand what is happening to populations of riverflies in their streams and rivers. To this end WTT recommends that fisheries register their interest in taking part in the Riverfly Partnership monitoring and training initiative. The initiative aims to support fishing clubs to monitor and help conserve the environment. More details can be found on www.riverflies.org

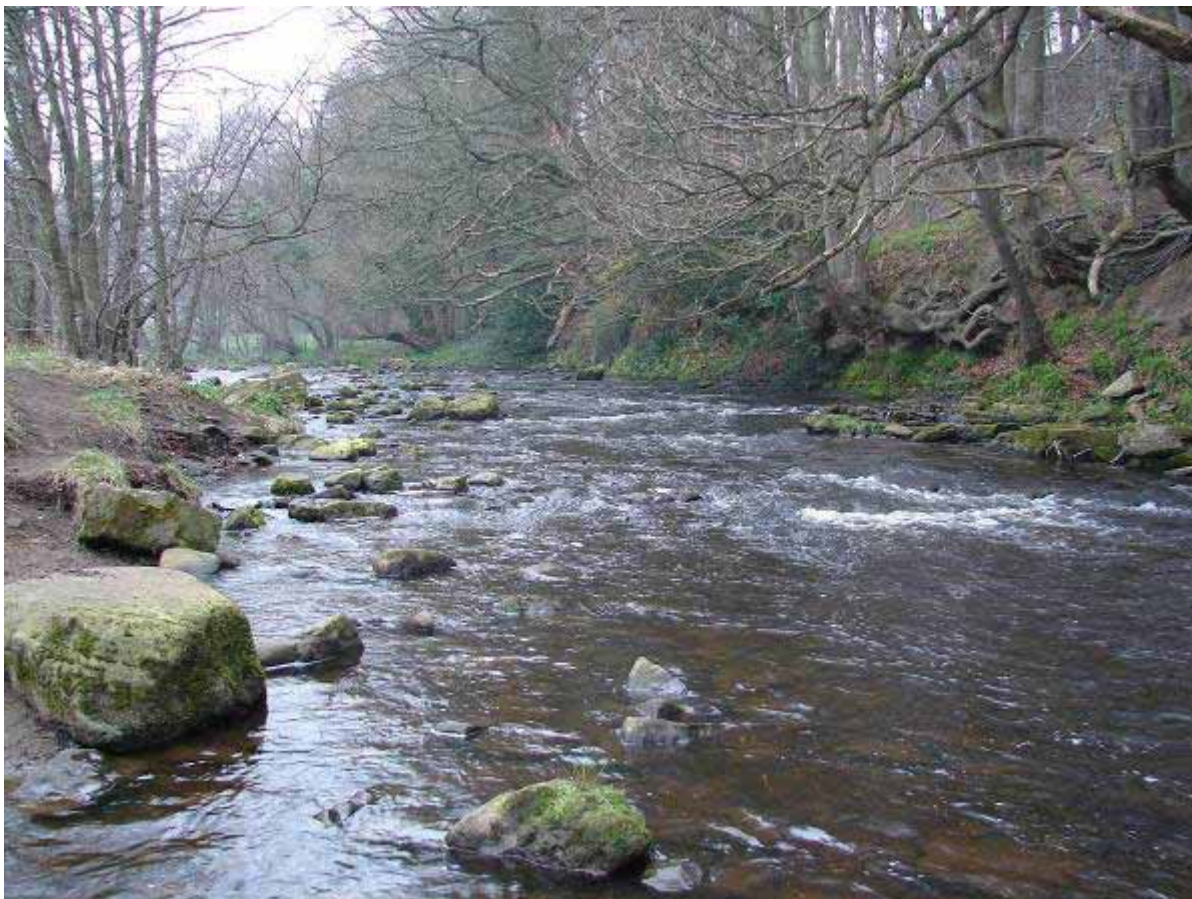
Habitat at the top end of this reach just below the bridge is characterised as being shallow and interspaced with boulders and large stones. This is excellent juvenile and parr habitat. The site flows through a public park and in one or two areas un-managed access is causing some localised erosion (nick points) of the banks.

Good in-stream habitat (Note lack of low cover and localised erosion on RHB)

Tree cover is good, but if left un-managed there is potential for some over-shading of the channel. Tree cover is mainly high canopy with very little in the way of low level cover in the form of boughs and bushes.

In both reaches there is a predominance of high canopy tree growth, which may lead to problems of over-shading of the channel. It is recommended that the club undertakes a programme of selective coppicing to allow more light into the channel and promote low bankside cover in the form of overhanging bush growth. A little and often programme needs to be adopted with regard to tree management on the fishery to achieve a good balance of LWD, light and shade. Willows can be 'trained' to hang over the channel by nicking the trunks and pushing them over.

The margins of the LHB downstream of Allensford Bridge are in places showing early signs of being eroded by the public / dogs at this popular recreational park. It is recommended that a wider strip of grass is left uncut to create a 'conservation area' which will hopefully have the net effect of directing the public to one or two 'honey pot' access points along the river. This minimal intervention may just be enough to reduce pressure on the banks whilst still allowing full access. An interpretation board explaining the change in management and the importance of good habitat for the rivers wildlife will hopefully reduce the likelihood of complaints.

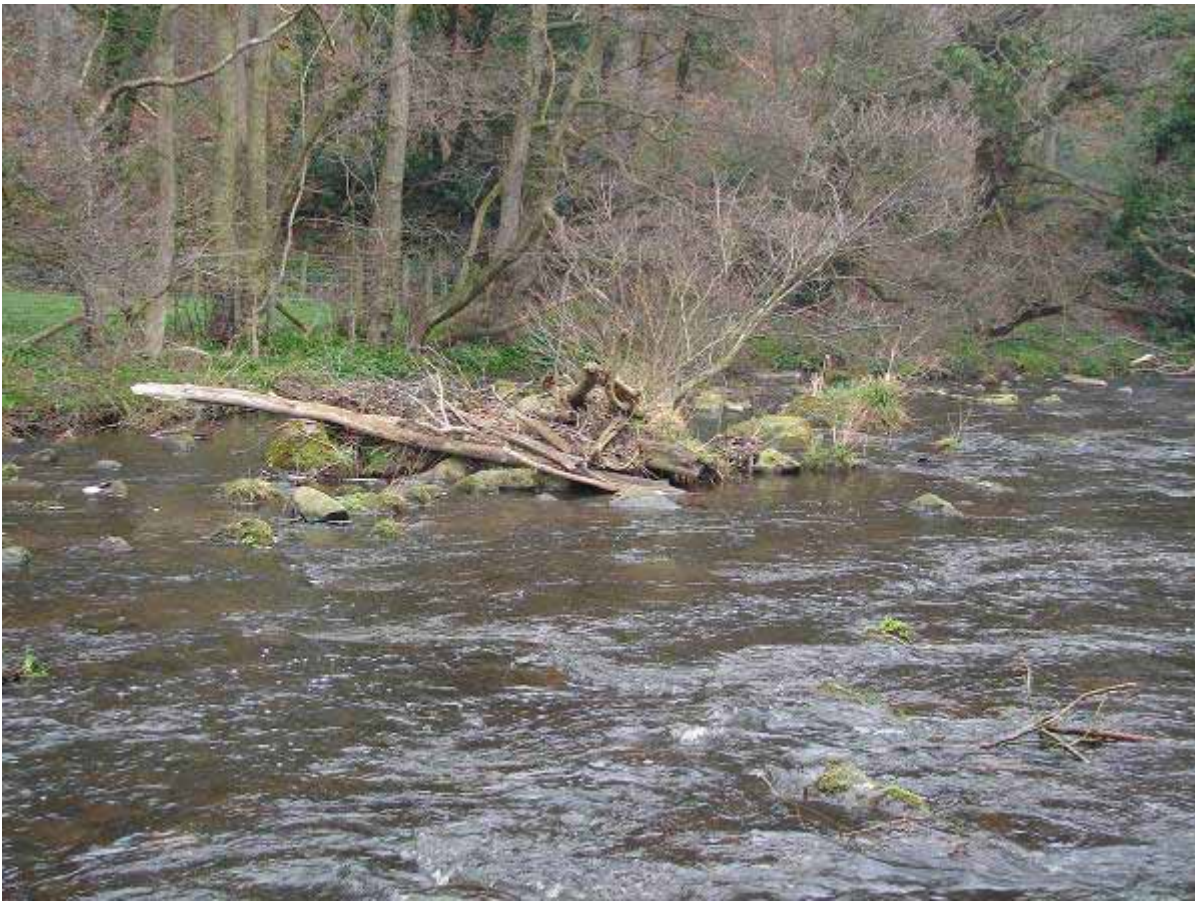
Woody Debris in the Derwent (d/s Allensford Bridge)

The club should adopt a policy of leaving LWD in river unless it is causing significant problems. As a guide the following check list has been developed by the West Country Rivers Trust:

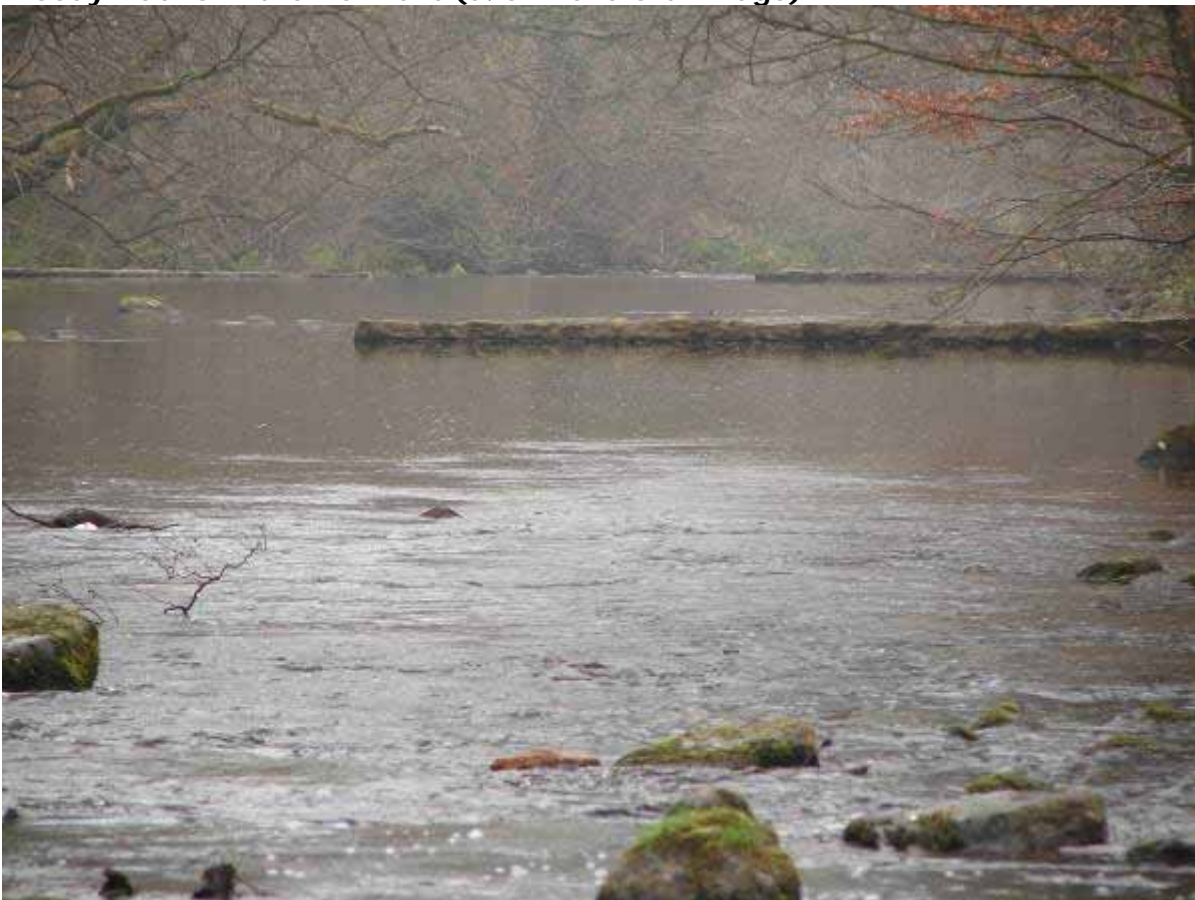
At the end of the reach there are two dams that were constructed by the club some years back. These were built in a bid to aerate the river in low summer flows. It is questionable if they actually fulfil this function and it appears that they are acting as silt traps due to the upstream 'ponding' of flows.

Two dams d/s Allensford Bridge, which can be seen to be having an effect on flows upstream (silt-trap)

It is also recommended that the two weirs at Allensford are modified or even removed to increase flow velocity and remove the build-up of silt above each structure.

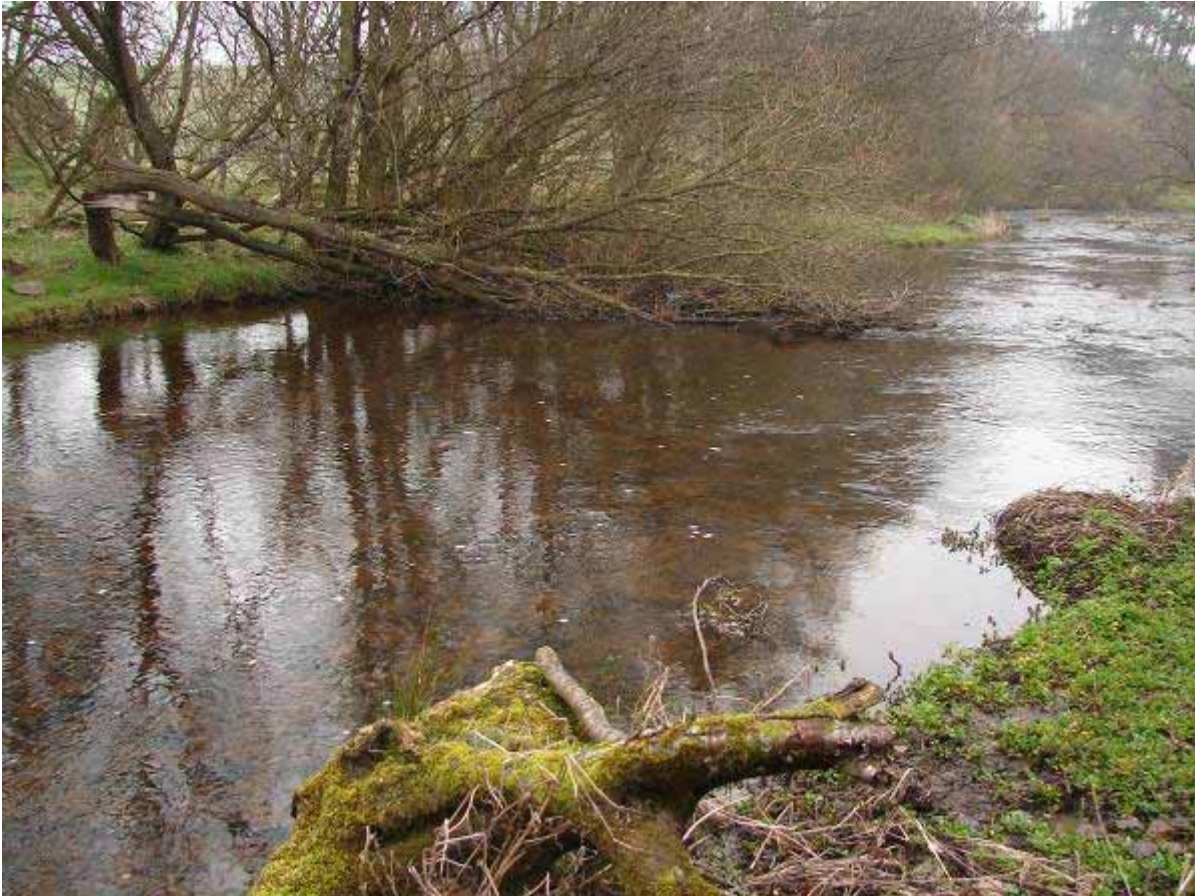
The river immediately downstream of the bridge is wide, shallow and inter-spaced with boulders. There is a general lack of pool habitat and large woody debris. However there is a particularly good example of 'hinged' LWD on the LHB

'Hinged' LWD on the LHB

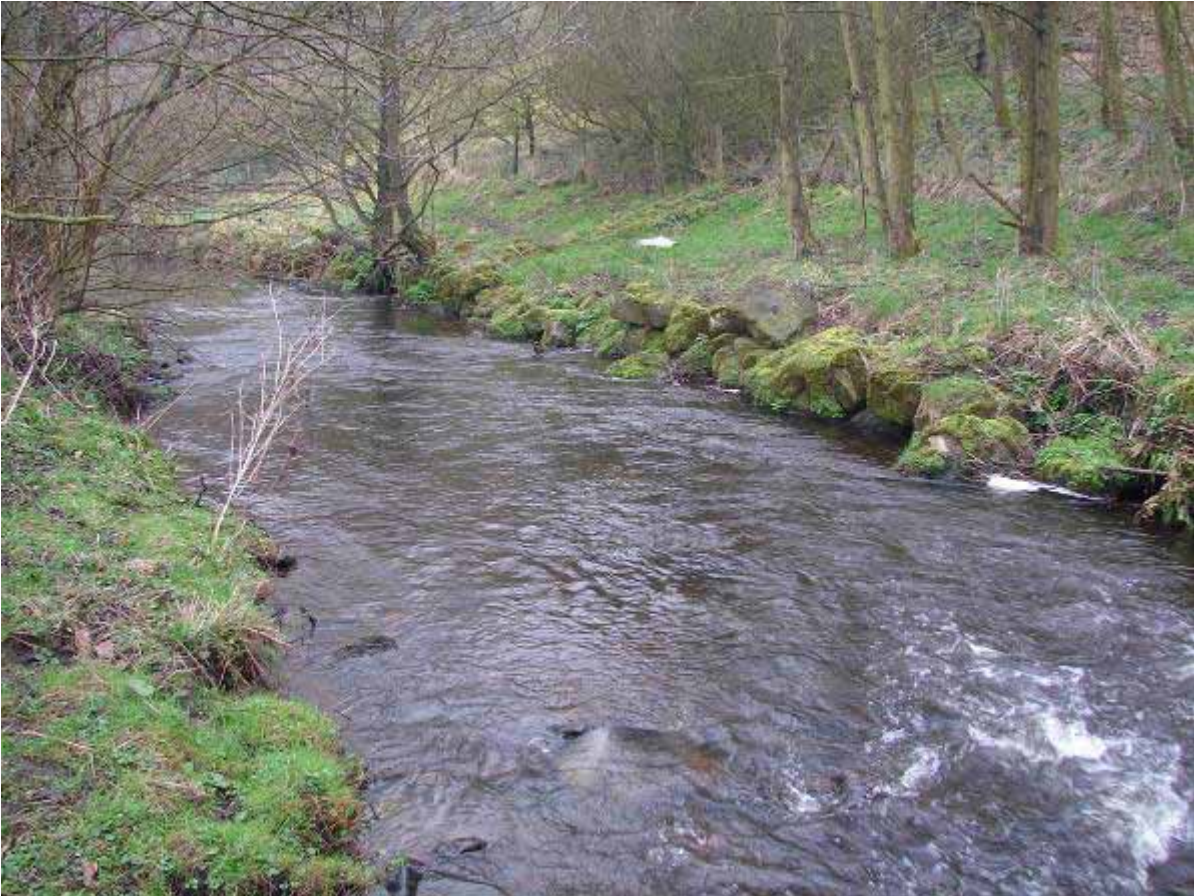
Further downstream there has been some stone revetment work to protect the RHB from erosion. Large stones and boulders have been incorporated into the revetment and have been removed from the channel and deposited on the LHB. This has created a fairly uniform channel which provides very little in the way of in-stream cover. There is also a lack of low tree cover.

Stone revetment on RHB

On the RHB downstream of Kenny's Bridge the rock revetment work could do with planting-up with willows. This would create overhead cover and become a future source of LWD. The river in this short section appears to have been dredged and it is recommended that a proportion of the large boulders that are still on the bank are placed back into the channel. This will create good in-stream cover for all life stages of trout.

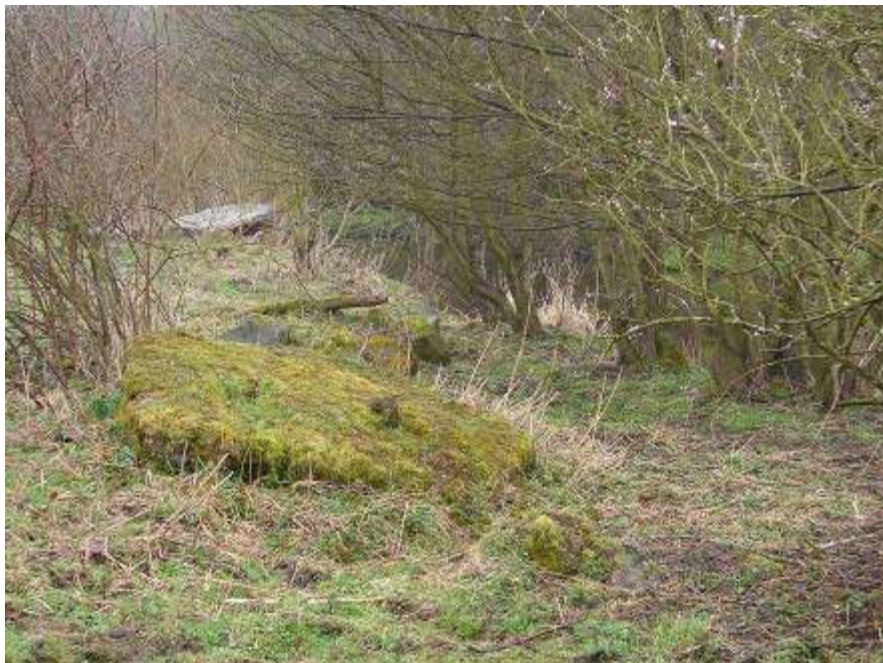
Stones removed from channel on LHB

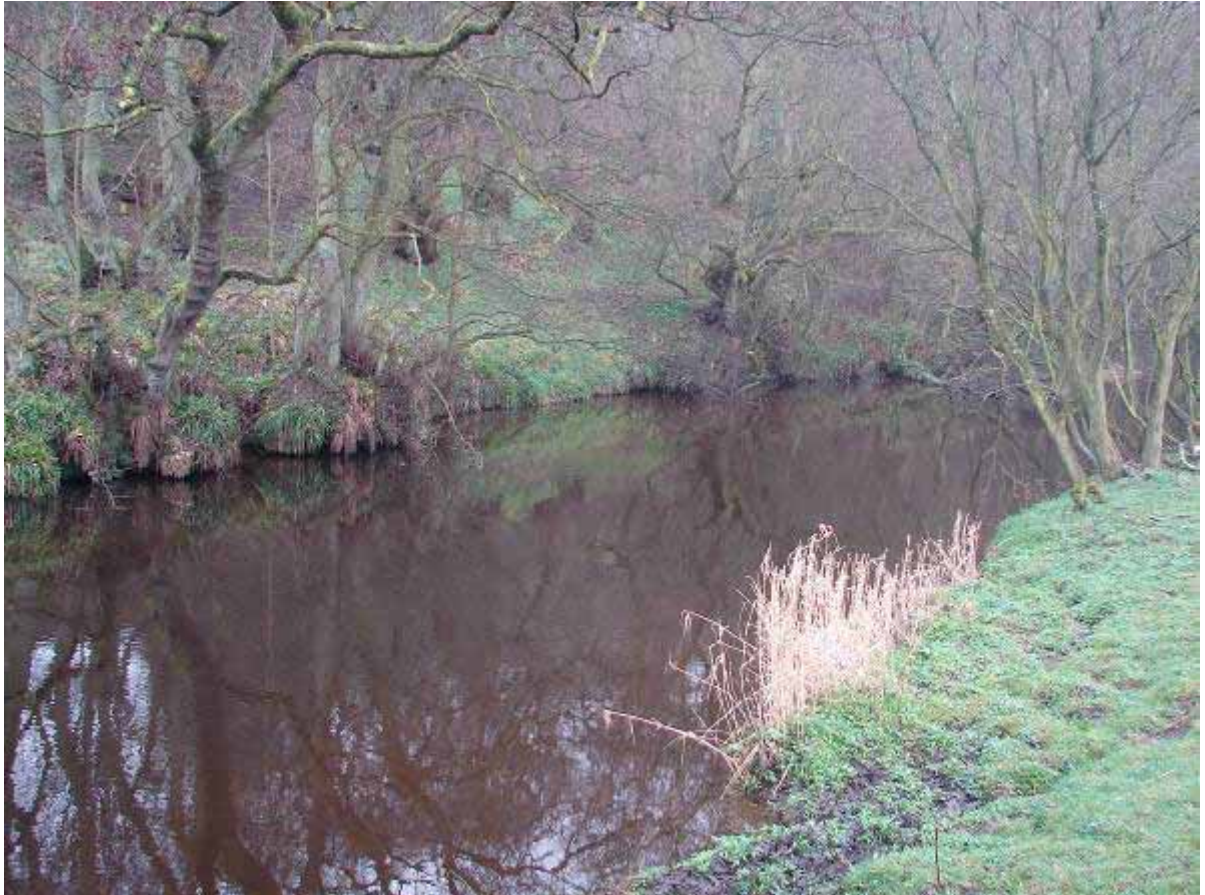
The bottom end of the reach runs through grazing pasture (horses and cattle). The cattle's grazing is causing widespread poaching of the banks leading to a loss of marginal plants and low tree cover. The Club have also undertaken some limited tree work on both banks which may have removed an important future source LWD from the channel. This section of the river is again fairly uniform with very little diversity in terms of both in-stream and riparian habitat.

Note lack of LWD and poached banks (LHB).

The fence line downstream of Kenny's Bridge where the river runs through two grazing pastures (horses and cattle) needs to be re-installed as a matter of some urgency. Unhindered access by stock to the river is causing bank-side poaching which is leading to the loss of valuable vegetated margins. It is suggested that a buffer strip of at least 9 metres be created. Formalised 'post and rail' cattle drinks can be created to facilitate safe, clean access for stock.

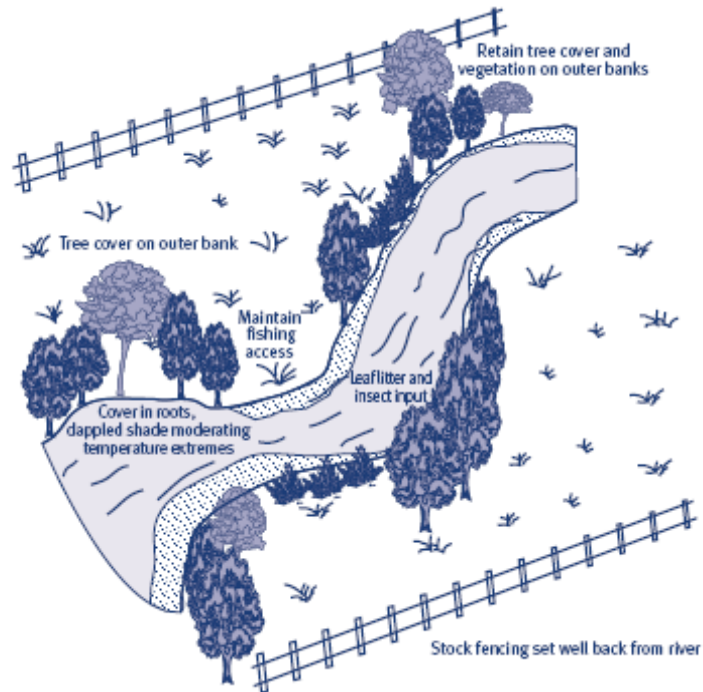
Example of a hypothetical fencing scheme

The fence line should be placed well back from the bank in a straight line to avoid trash getting caught on wires (causing 'blow-out') during peak flows.

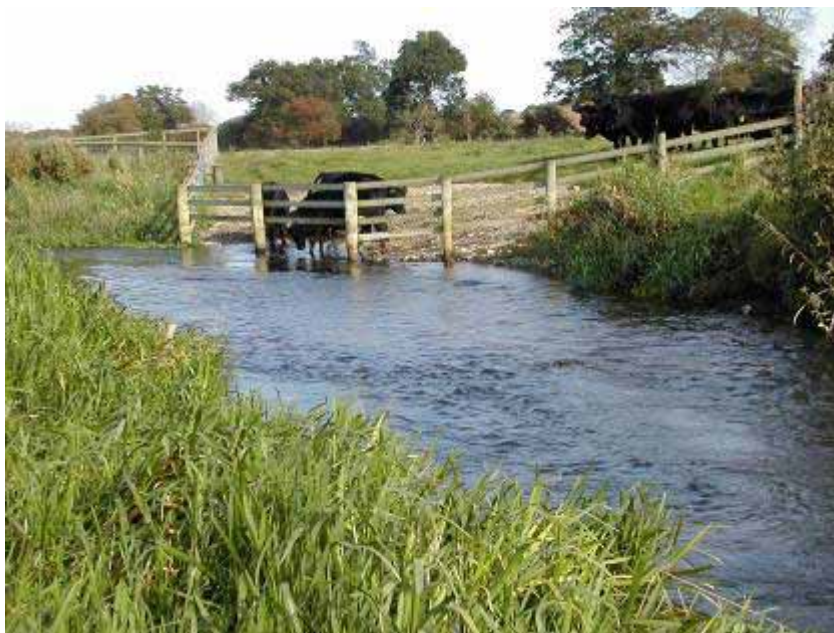
Example of 'post and rail' cattle drink
