Advisory Visit Report
River Wharfe, Yorkshire Dales
On Behalf of Hubby Angling Club
19th July 2007

1.0 Introduction

This report is the output of a site visit undertaken by the Wild Trout Trust and jointly sponsored by the Grayling Society, on the River Wharfe on 19th July 2007.

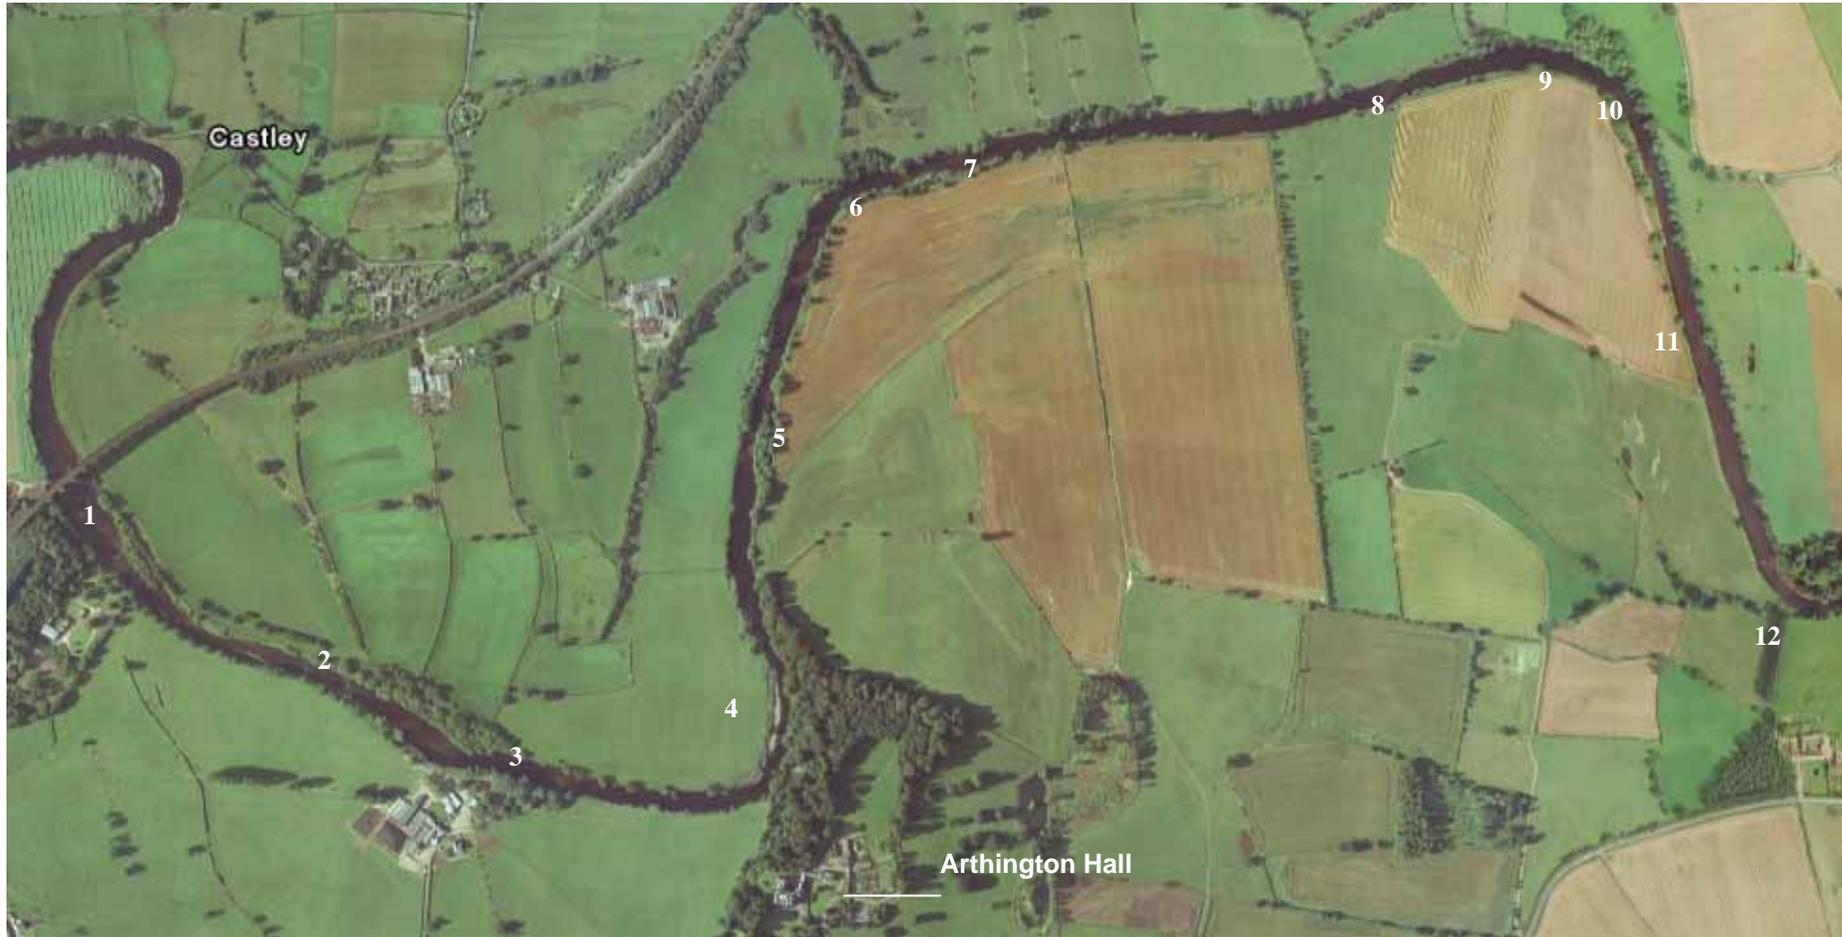
Huby Anglers – Pool Guide, River Wharfe

| 1 - | Viaduct Run | 5 - | Top Island Run | 9 - | Pinnacle Wood |
| 2 - | Farm Run | 6 - | Paradise Corner | 10 - | Middle Pool |
| 3 - | Mill Stream | 7 - | Bottom Island | 11 - | Willow Glide |
| 4 - | Belt Wood | 8 - | Wescoe Hill | 12 | (Feeder beck |

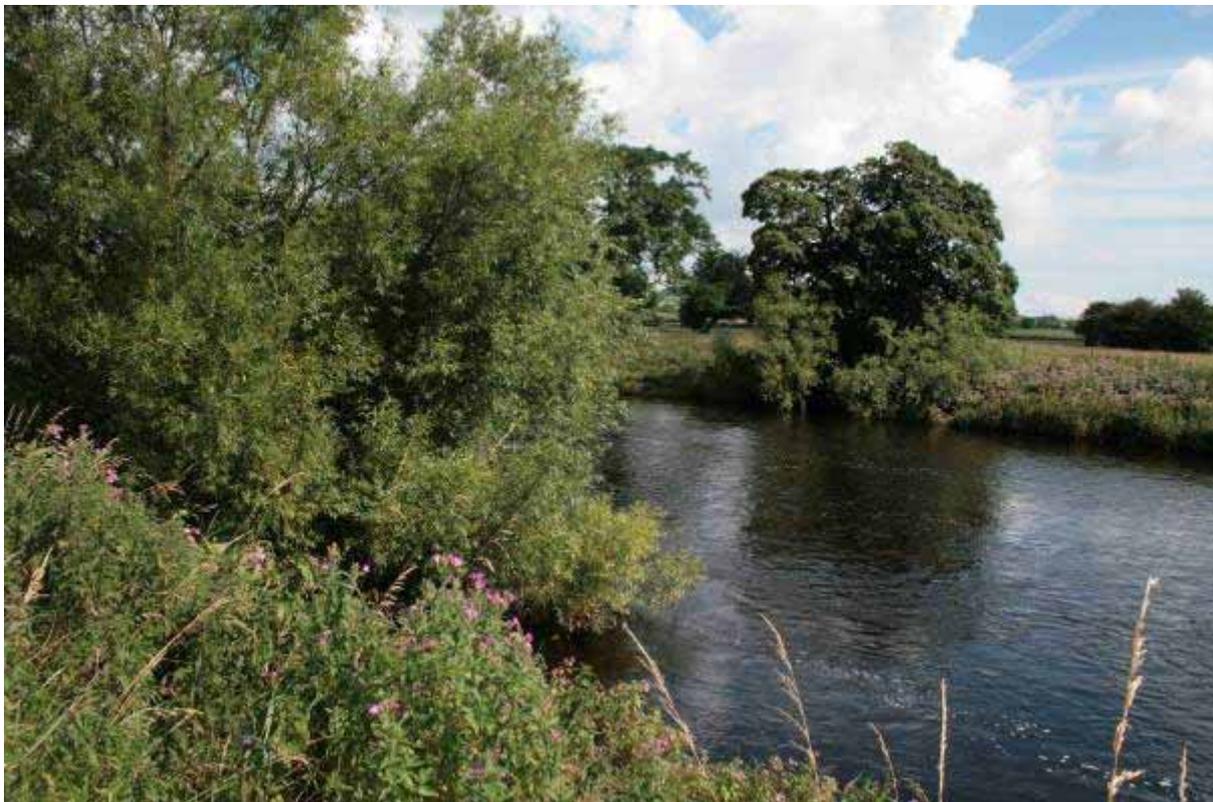
It should be of no surprise that in this section the only willows overhanging the RHB are good fish holding areas
(Oliver Edwards - *pers.comm*)

The main fish holding habitat in this section on the RHB

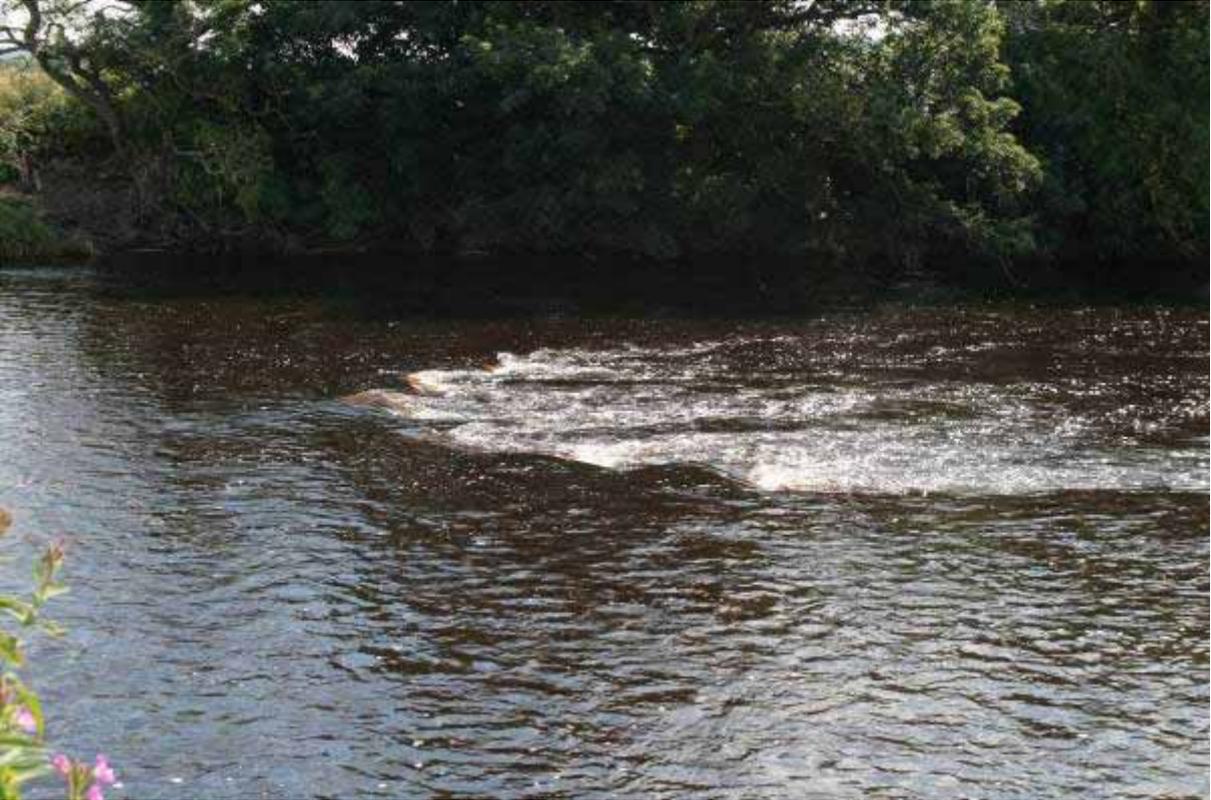
In a bid to create pool habitat the EA introduced several very large limestone boulders and these have created deeper scour pools: a much needed variation in the profile of the riverbed. A boulder croy has been installed on the RHB and is causing some localised erosion to this bank. If left un-checked this could cause a significant problem. Croys and deflectors need to be placed facing upstream and securely 'keyed' into the bank to stop the river eroding the banks behind these features.

Close up of boulders

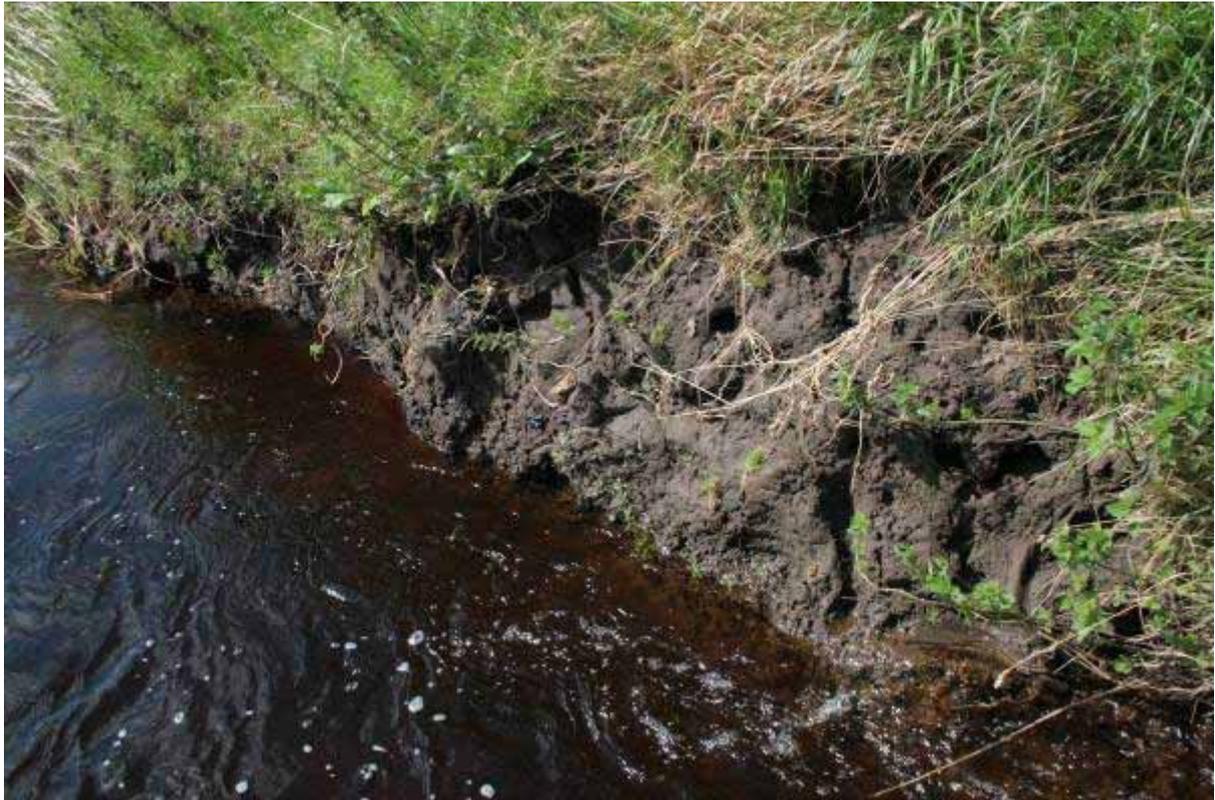
Resulting erosion caused by the boulder croy.

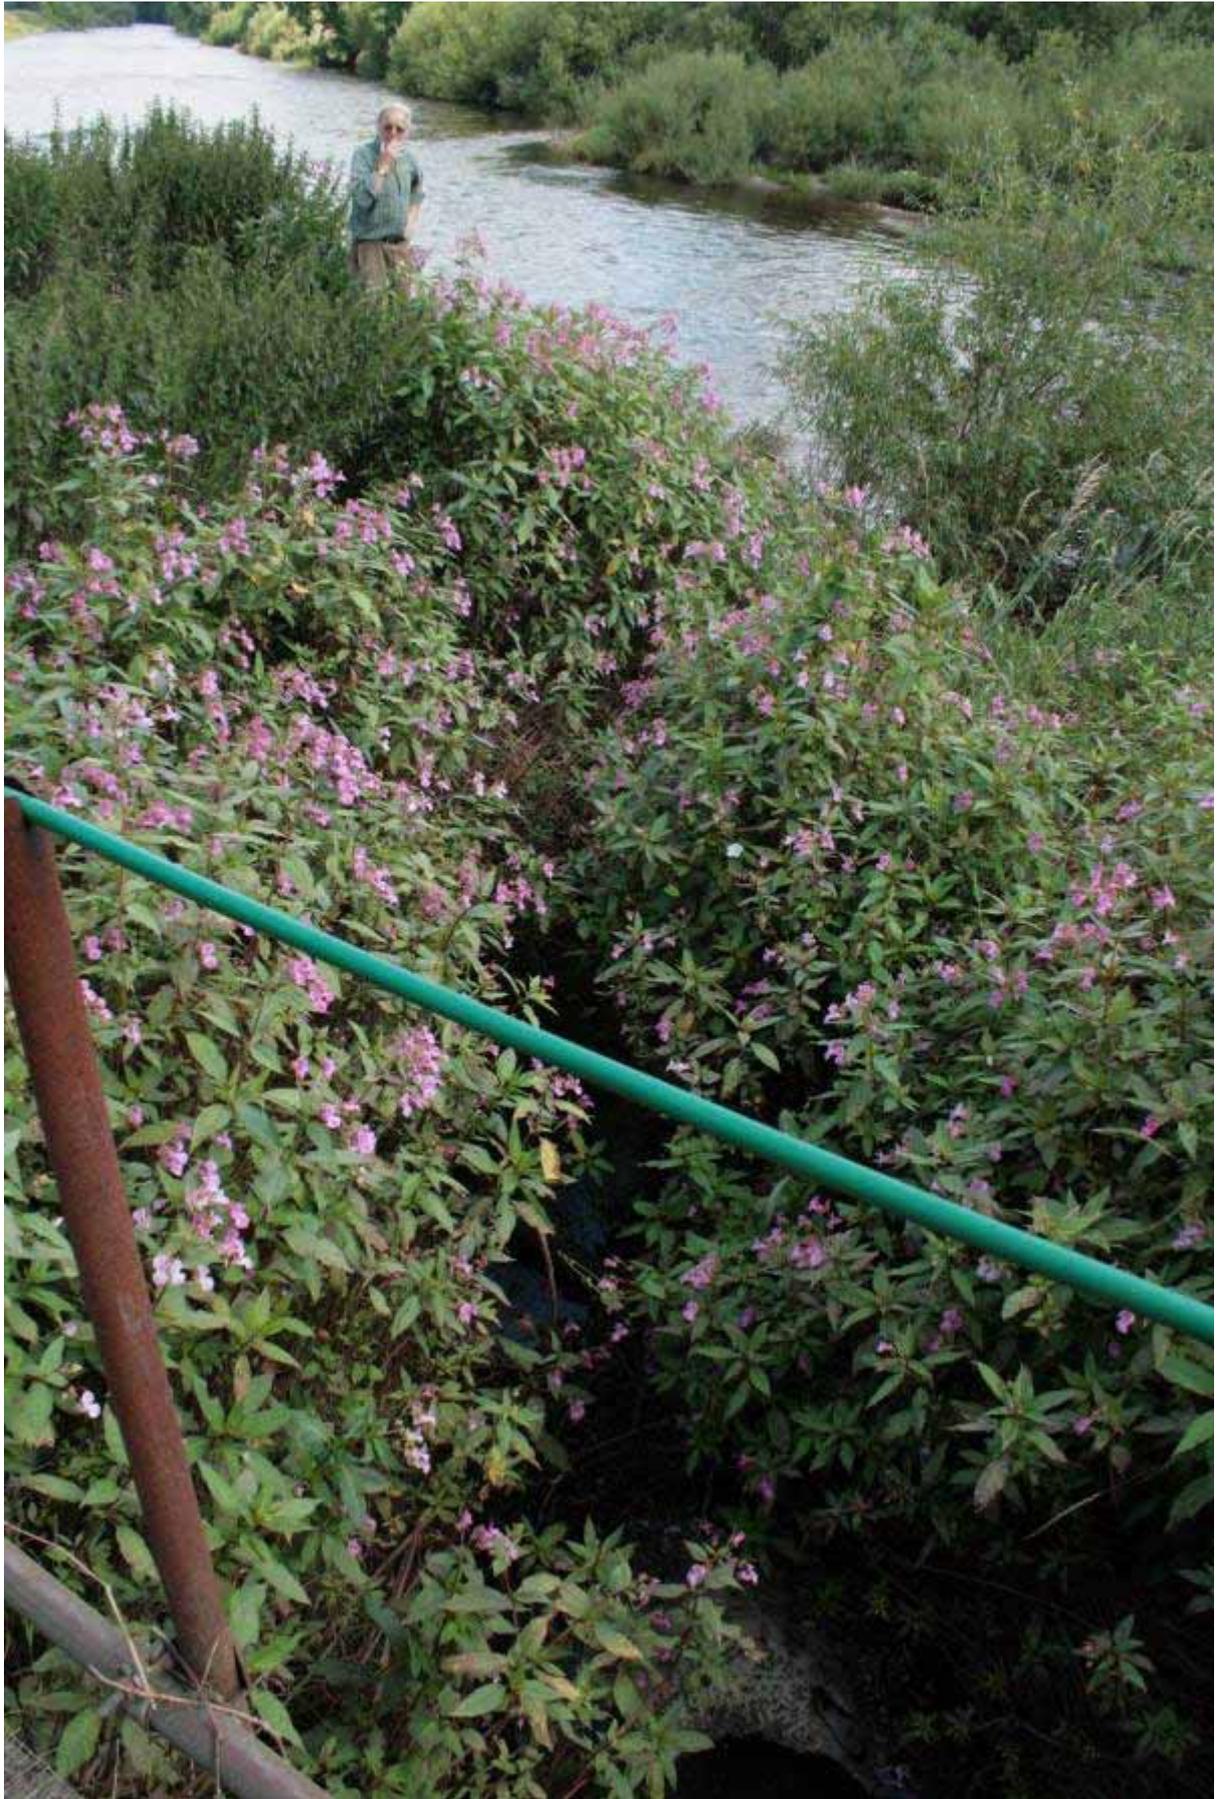
At the very bottom of the reach and on land leased by the West Riding Anglers there is a spawning stream on the RHB. The banks were completely encroached with Himalayan Balsam and thus it was difficult to ascertain its likely suitability as a spawning and nursery area for wild trout and grayling.

Potential spawning stream / nursery area?

It would be a worthwhile exercise for the club to understand the status of spawning areas which trout and grayling may use in the main stem upstream, and in accessible tributaries. These areas are the engine rooms of rivers and there maybe habitat quality issues limiting them as both spawning and nursery areas.

To this end it is recommended that the club ask the Environment Agency to undertake a fishery survey of the main river and spawning streams. There may also be partnership opportunities with the Yorkshire Dales Rivers Trust (YDRT) who are embarking upon a similar study on the Ure, part-funded by the Wild Trout Trust.

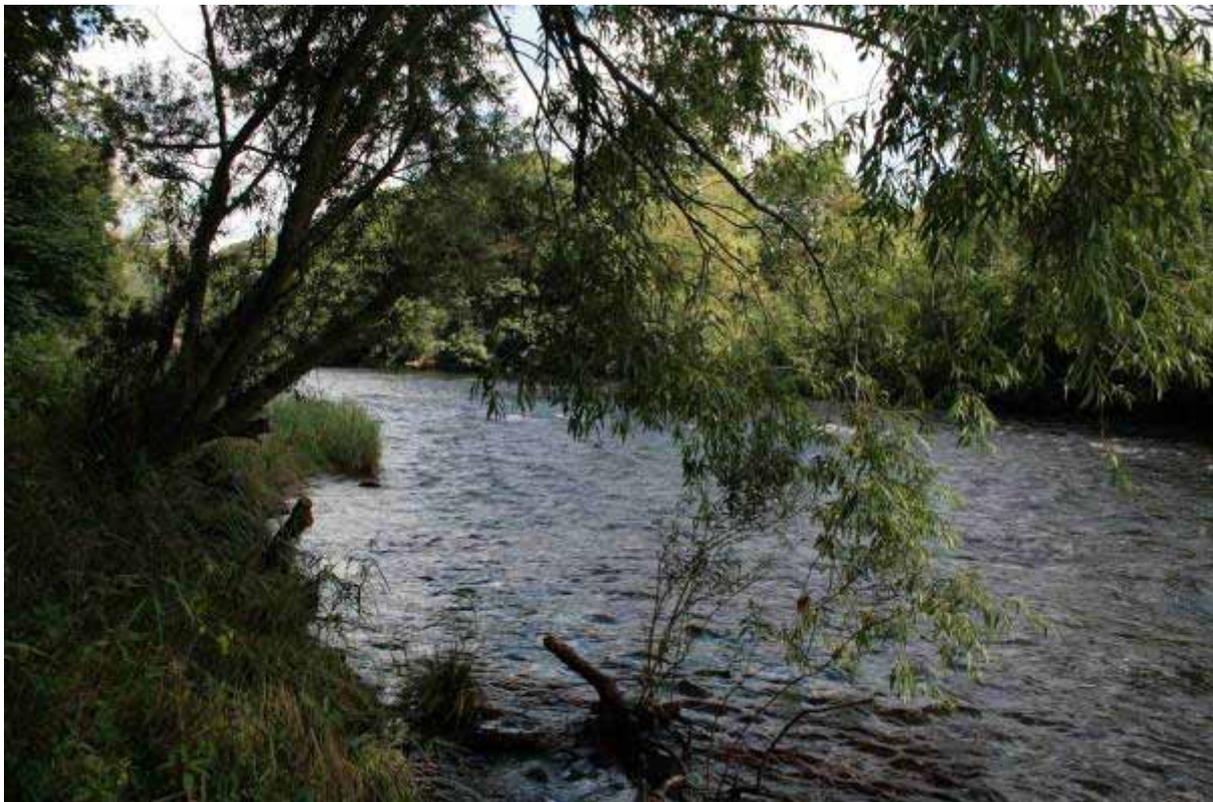
In the area known as 'Middle Pool' there has been removal of LWD from the RHB. **The importance of LWD to wild trout and grayling cannot be overstated**

Site of unnecessary LWD removal on the RHB

The club should adopt a policy of leaving LWD in river unless it is causing significant problems. As a guide the following simple check list has been developed by the West Country Rivers Trust:

1. Is the debris fixed, if yes then continue to 2, if not continue to 5.
2. Is the debris causing excess erosion by redirecting the current into a vulnerable bank? If yes then go to 5 if not then go to 3.
3. Would fish be able to migrate past it (take into account high river flows). If yes got to 4, if no go to 5.
4. **Retain the woody debris in the river.**
5. **Extract the debris.**

Note: If the debris dam needs to be removed but there is still a significant amount of the root system attached to the bank then it is recommended that the stump be retained for its wildlife habitat value and its stabilising effect on the bank.

The club should seek to adopt the LWD management protocol recommended on page 8 of this report. In the short-term the club should 'introduce' LWD

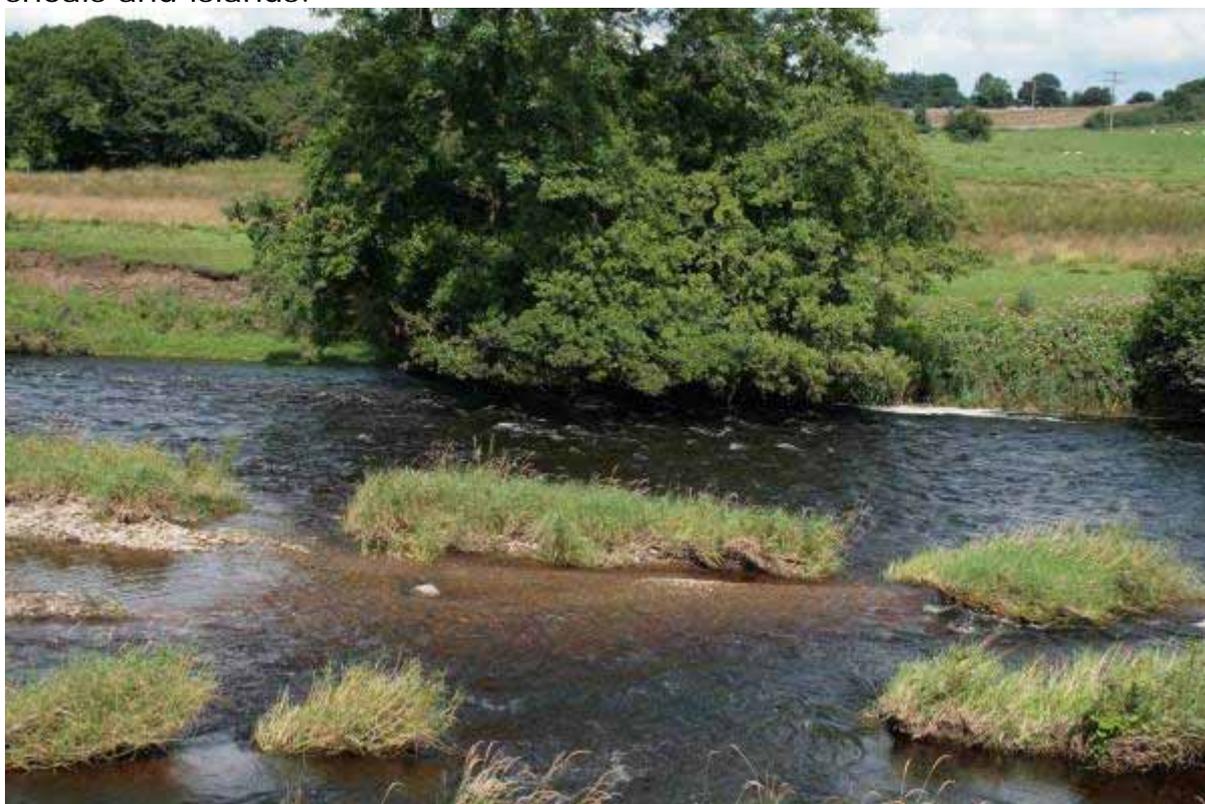
The area from 'Walkers Flat' through to Paradise corner contains some areas that may be suitable for some main river spawning. The active geomorphology in the reach has given rise to some vegetated mid-river shoals and islands.

Potential main river spawning sites.

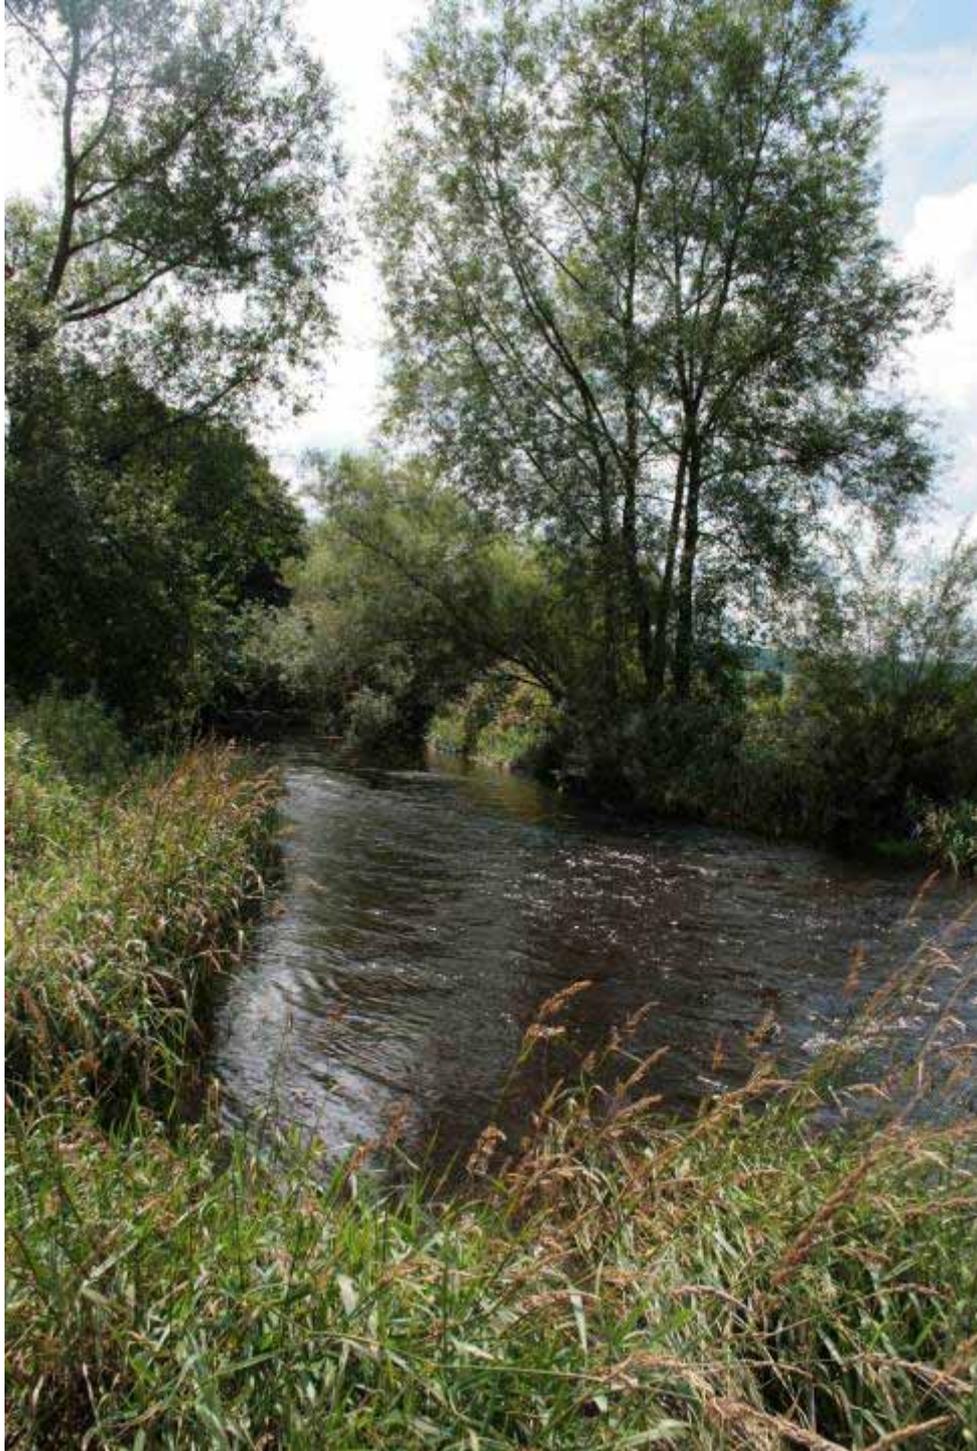
The river goes through areas of open grazing and tree lined banks, the later providing some valuable cover for adult trout and grayling. There is still a lack of 'in-channel' LWD.

Good pool: riffle sequence / tree cover below 'Belt Wood'

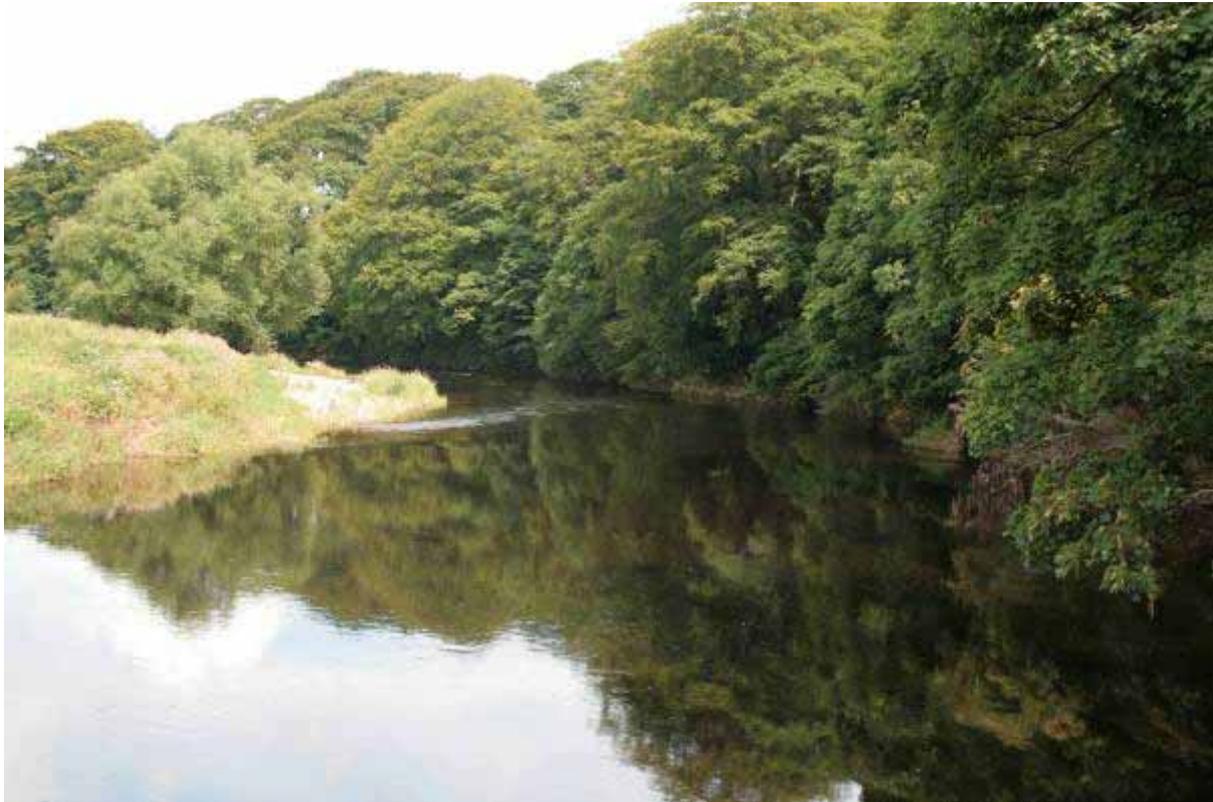
As the river skirts Belt Wood the RHB has good overhead tree cover with some in-channel LWD.

Belt Wood

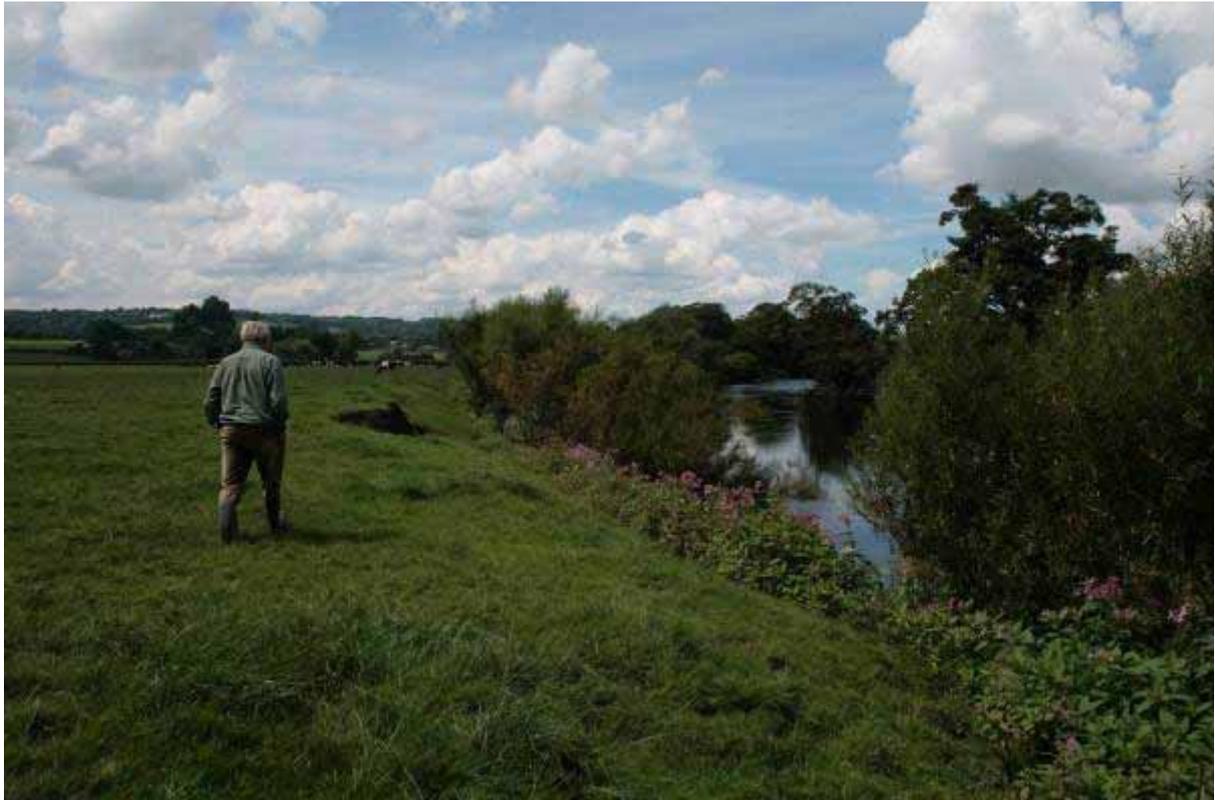
Both upstream and downstream of the farm the land is grazed on the RHB. The banks downstream are relatively steep which has dissuaded cattle from poaching the banks to get drinking water. Upstream of the Mill Farm the RHB comprises a low level berm which is unfenced and has been grazed and subsequently poached by cattle entering the river. The LHB comprises good growth of willow which is an on-going source of LWD.

Downstream of Mill Farm

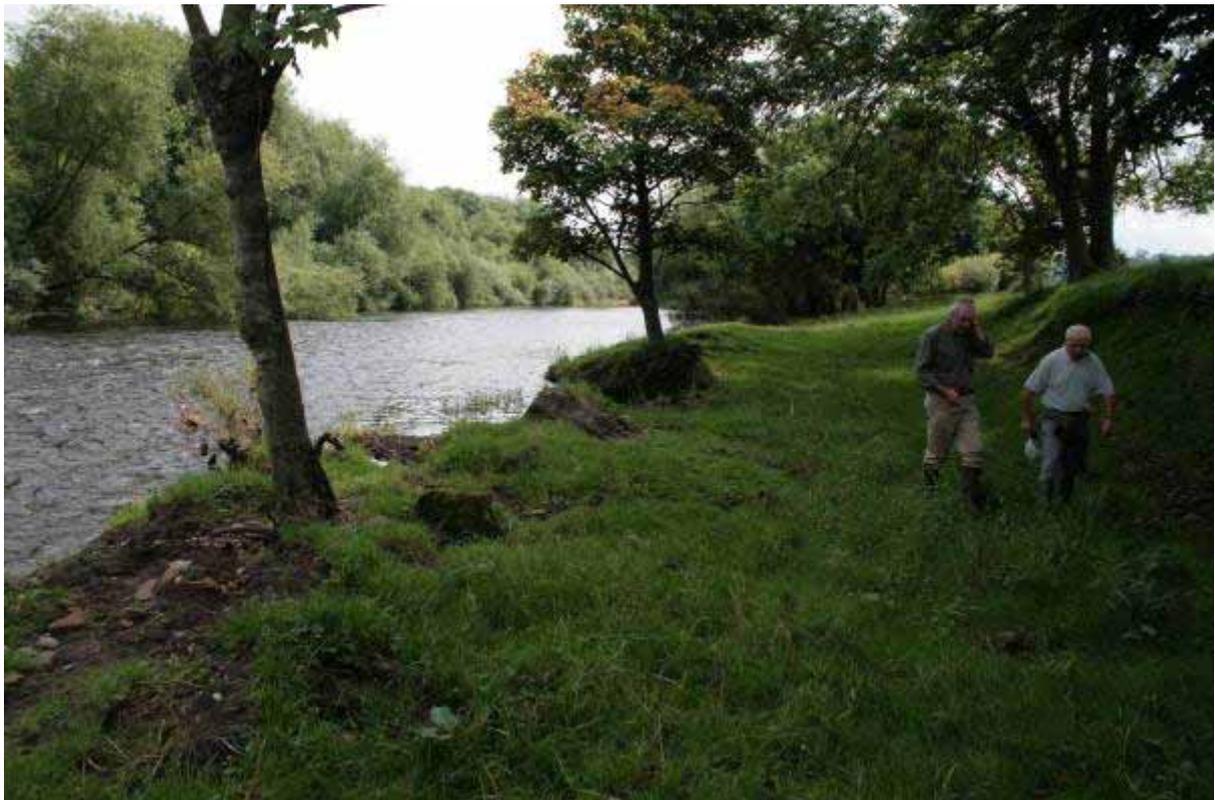
Upstream of Mill Farm

A fence should be installed upstream of Mill Farm as a matter of some urgency. Unhindered access by stock to the river is causing bank-side poaching which is leading to the loss of valuable vegetated margins. It is suggested that a buffer strip of at least 9 metres be created. Formalised 'post and rail' cattle drinks can be created to facilitate safe, clean access for stock.

The fence line should be placed well back from the bank in a straight line to avoid trash getting caught on wires (causing 'blow-out') during peak flows.

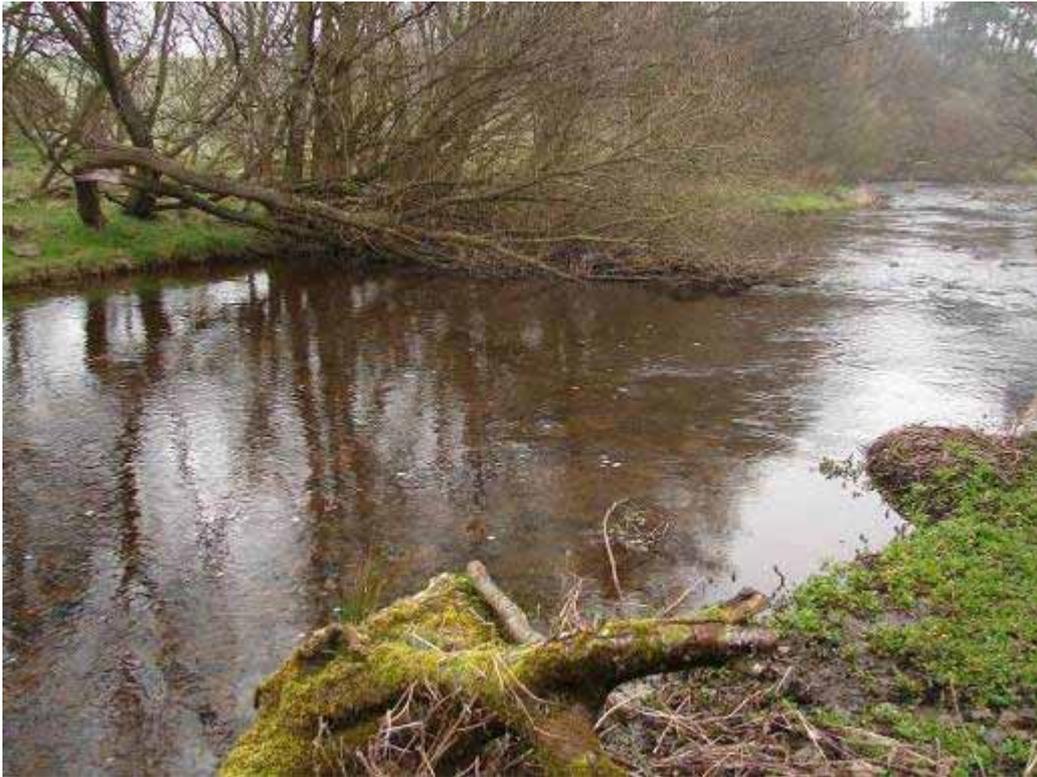
Example of hinged LWD on River Derwent (Co Durham)

A little and often programme needs to be adopted with regard to tree management on the fishery to achieve a good balance of LWD, light and shade. Willows can be 'trained' to hang over the channel by nicking the trunks and pushing them over.

Arisings from this tree work could be used to install LWD. It is recommended to introduce upstream facing submerged log deflectors (single or paired) to create localised scour pools in the margins and mid-channel. LWD will need to be securely 'keyed' into the bank and possibly the river bed using posts or rebar and wire to avoid problems of washout. Another option would be to 'hinge' trees, leaving them still connected to stumps, again for added security these can be secured to the bed of the river using posts and wire. Arisings from future tree work undertaken by the club could be bundled into 'faggots' and pinned into the margins, thus creating much needed overhangs for trout to use for refuge.

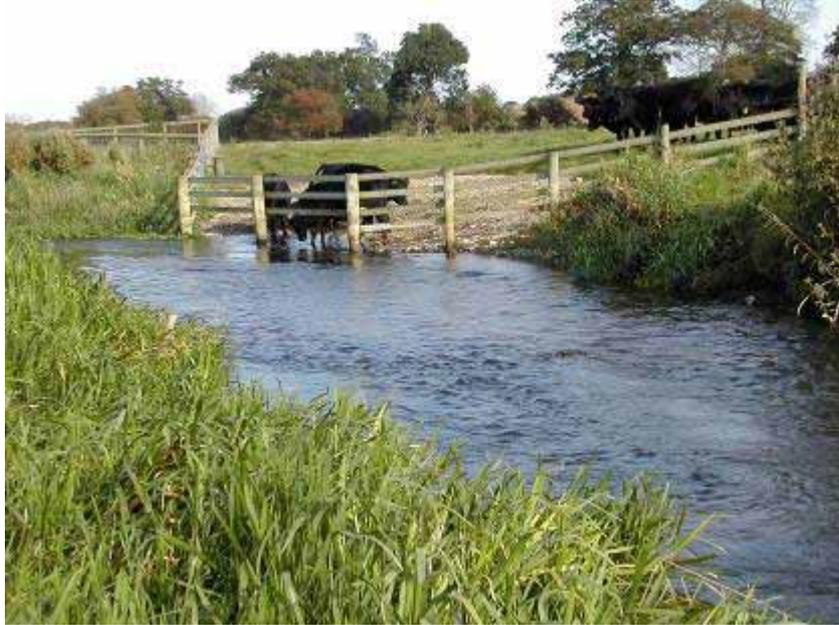
Example of a post and rail cattle drink
