## **Rother - Adhurst**

**An advisory visit carried out by the Wild Trout Trust – May 2013**

## 1. Introduction

This report is the output of a Wild Trout Trust Advisory Visit (AV) undertaken on a 1.5-km section of the River Western Rother at Adhurst, near Sheet. The beat inspected ran from the railway bridge on the upstream boundary at NGR SU 766 256 down to the Mill in Sheet at SU 760 247.

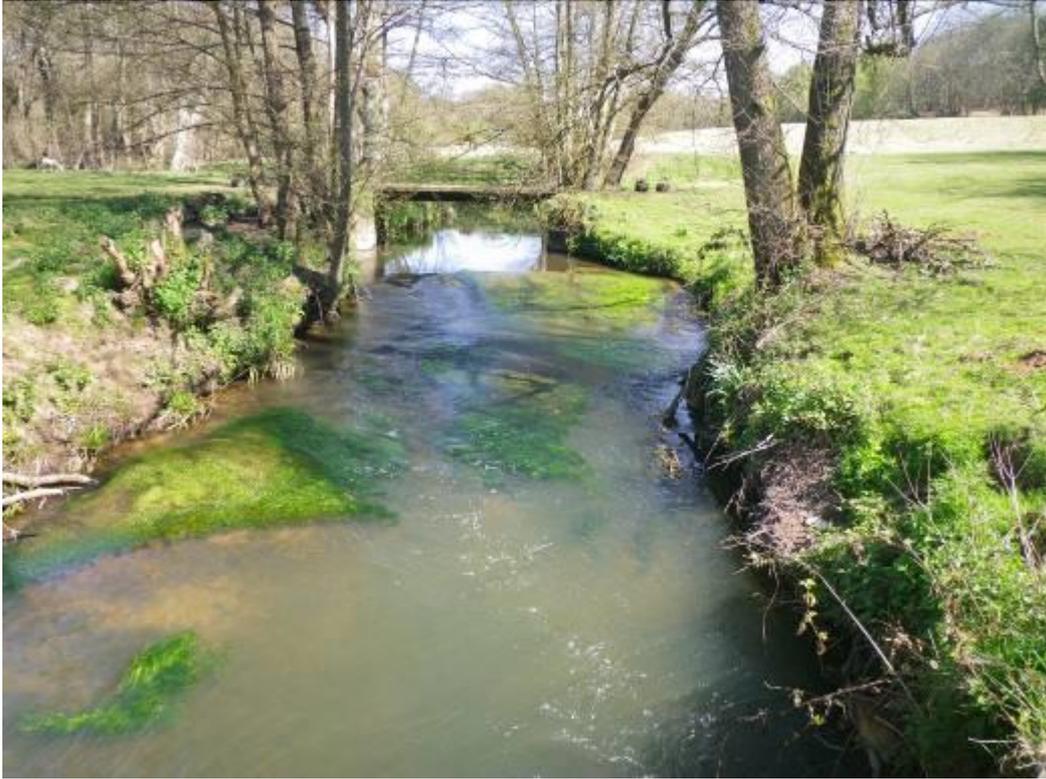
Where direct sunlight was penetrating the channel there were beds of water crowfoot especially where the flow was brisk and the river bed stable. Starwort (*Callitriche* spp.) was also present growing in areas of lower flow velocity over softer river bed material. Both plants provide excellent cover for trout and are important habitats for a range of aquatic invertebrates. Species such as water crowfoot need plenty of sunlight, and these plants are hosts to many of the invertebrates that trout and other fish will feed upon. A mix of 50:50 direct sunlight and shade is a good ratio to aim for.

Photo 1 Healthy beds of water crowfoot flourishing where the river bed is gravel lined and where the sunlight hits the water.

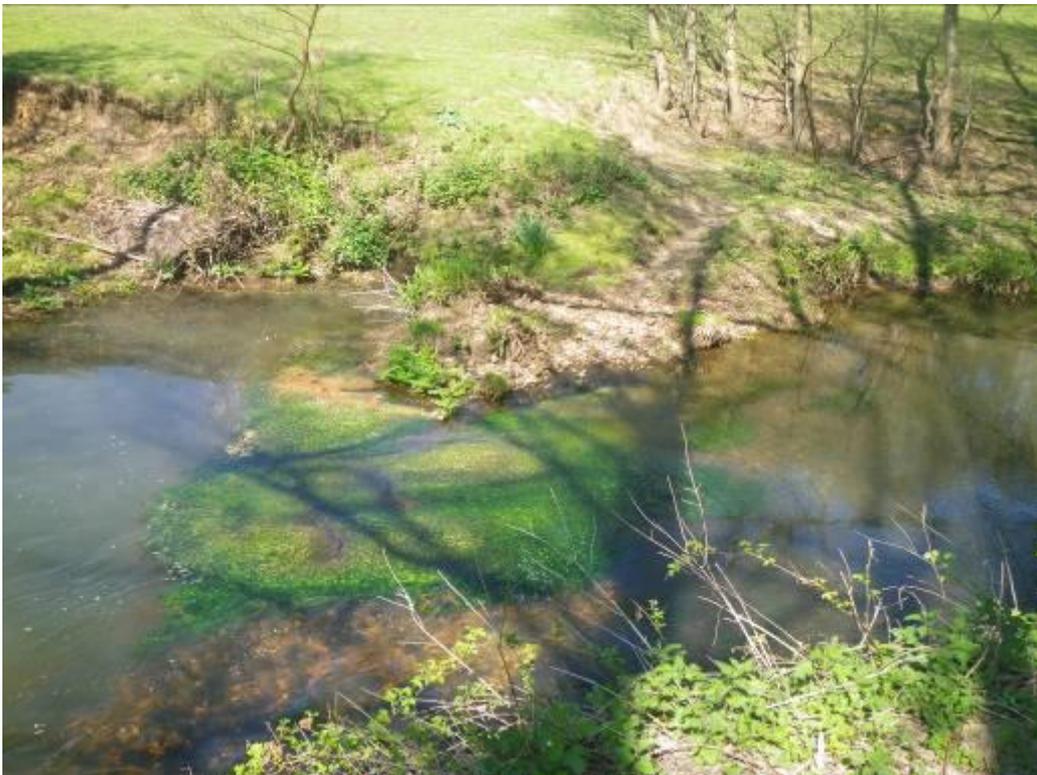
Photo 2. Diversity in channel shape - promoting great trout habitat

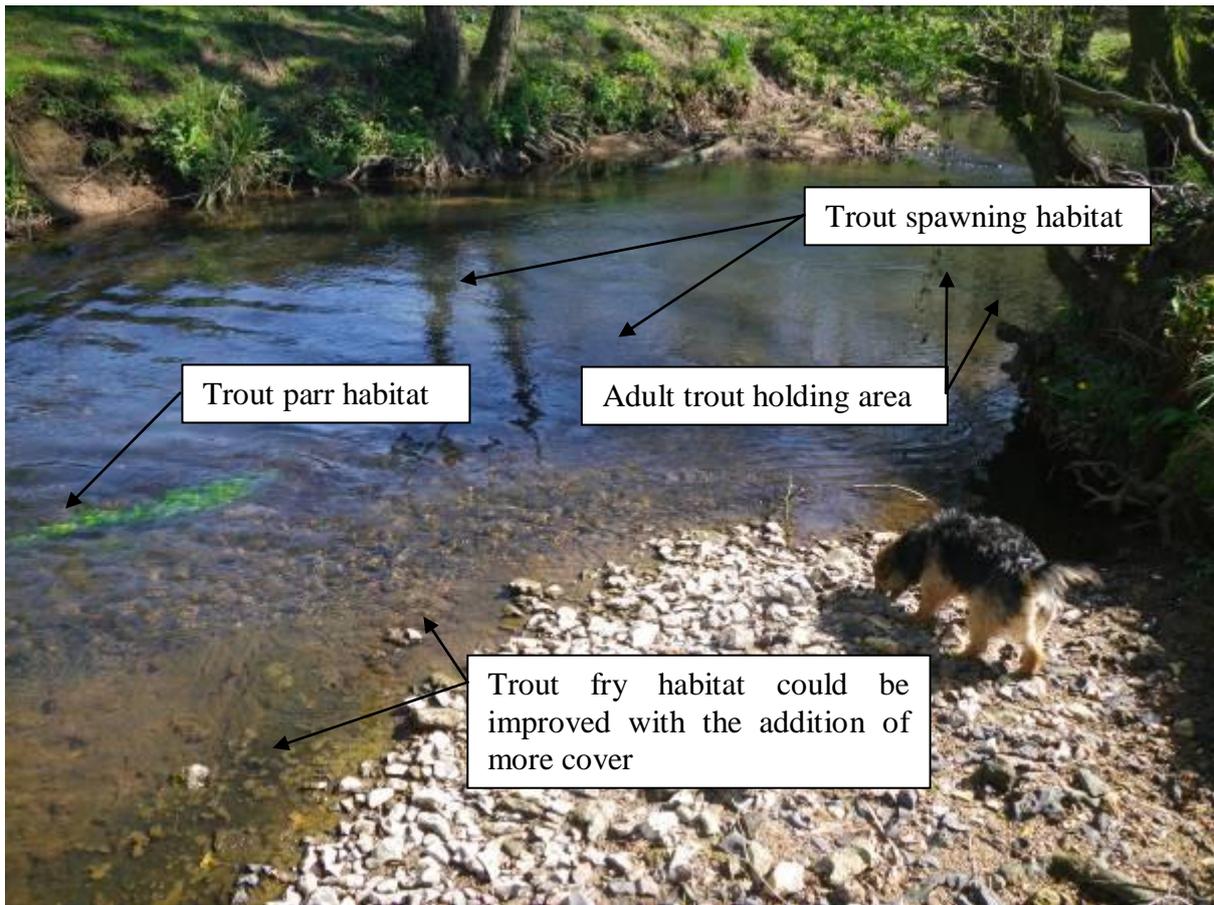
A very welcome and somewhat unusual component of the habitat at Adhurst compared to the middle and lower Rother are the regular outcrops of flint based gravels. Where these have eroded out from the bank or bed, usually adjacent to a leaning or previously fallen tree, they have provided some high quality trout and lamprey spawning sites. In addition, where sufficient light penetrates to the river bed, the hard gravel bottom has provided a suitable environment for beds of water crowfoot to establish. This plant is a comparatively unusual site on the Western Rother and is synonymous with high quality trout habitat. The plant is particularly important because as well as trapping fine sediments, it sweeps the bed clean in between the weed tresses and provides valuable in-channel cover for trout of all sizes. Water crowfoot is the preferred habitat for the larval stage of a number of important river invertebrates, many of which form an important component of trout diet and also provide the adult river flies so important to the trout fly fisherman.

Photo 3 A rich gravel seam and potentially good habitat for all life stages.

There were numerous examples of good quality habitat for trout, ranging from deep holding pools for adults through to the tail of pools flowing over clean gravels which are ideal for spawning and holding juveniles. Habitat could be further improved with the provision of more brashy cover (coarse woody debris), particularly adjacent to shallow margins (Photo 3) to provide improved cover for fry and parr. This is particularly important in helping to reduce predation pressures.

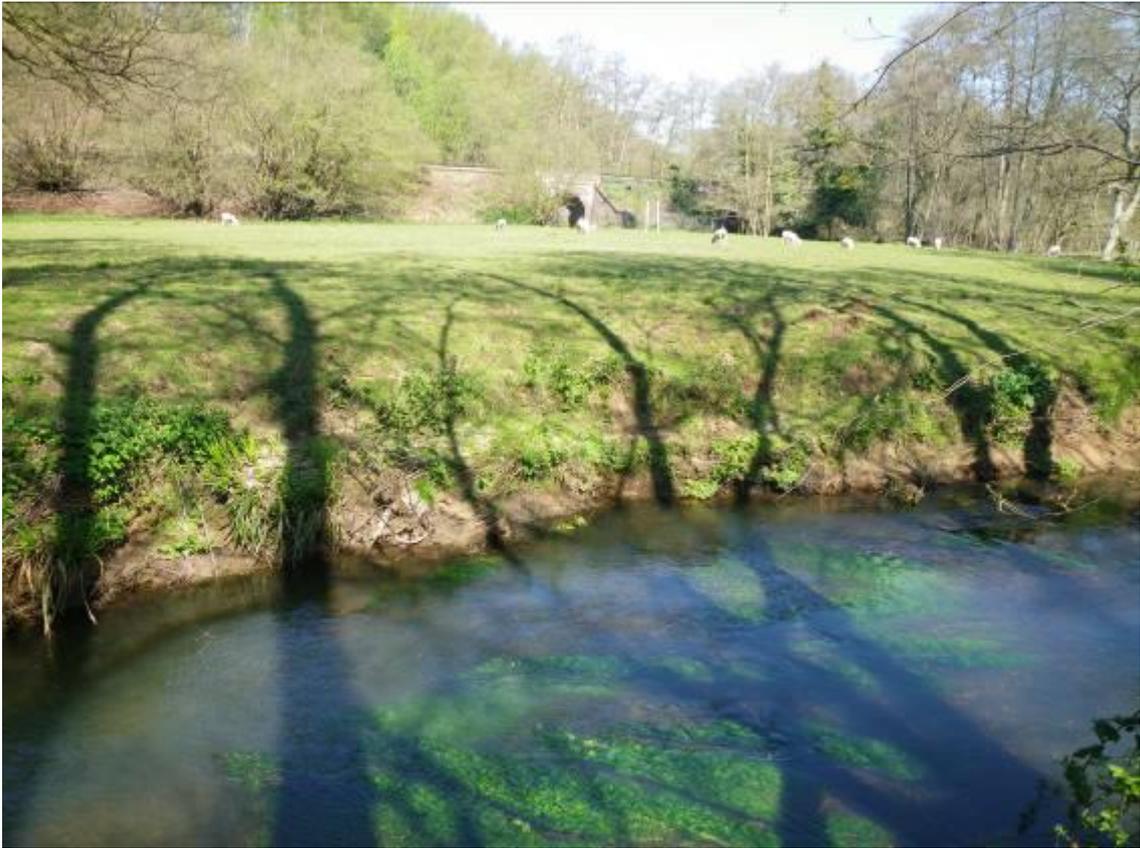
River margin habitat was generally more luxurious from the LB compared to the RB, mainly due to local grazing pressures (photo 4). High densities of grazing animals with unrestricted access to the river bank can do serious harm to in-channel habitat by leaving soft banks vulnerable to erosion under high flow conditions (photo 5). The low, scrubby cover which overhangs the river channel on un-grazed sections provides improved cover and a source of food via terrestrial insects that fall into the channel. Many landowners and fishery managers choose to erect fences to create a buffer zone between the livestock and the river. Suitable areas to provide drinking opportunities can be created and fencing is a very effective method of providing improved bank protection and erosion control. Some maintenance will be required inside any buffer zone to avoid too much high scrub developing.

Photo 4. Livestock grazing can leave banks vulnerable to erosion pressures.

- Monitor the densities of sheep grazing adjacent to the RB and consider fencing the area to create an un-grazed buffer zone.
- Take advice from professionals on the control and hopefully eradication of the Japanese knotweed.

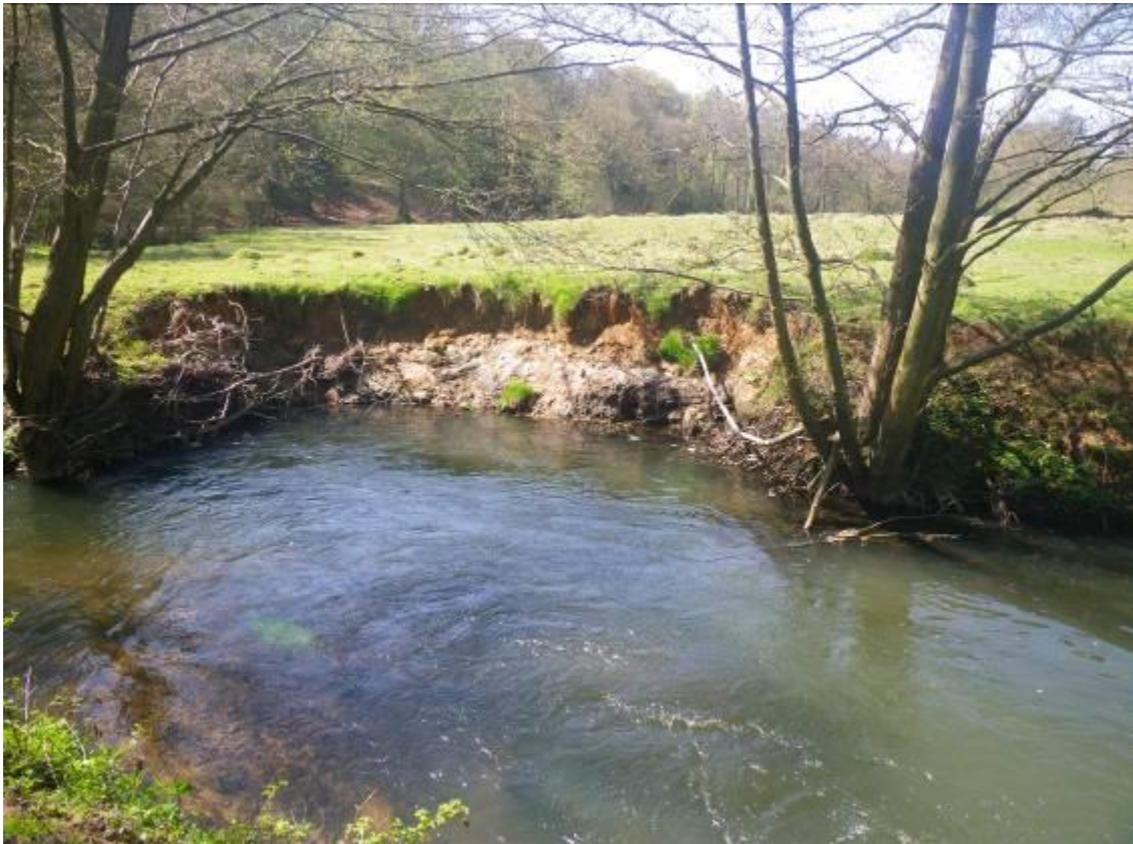
Photo 5. Erosion caused by winter back eddy impacting on a heavily grazed bank

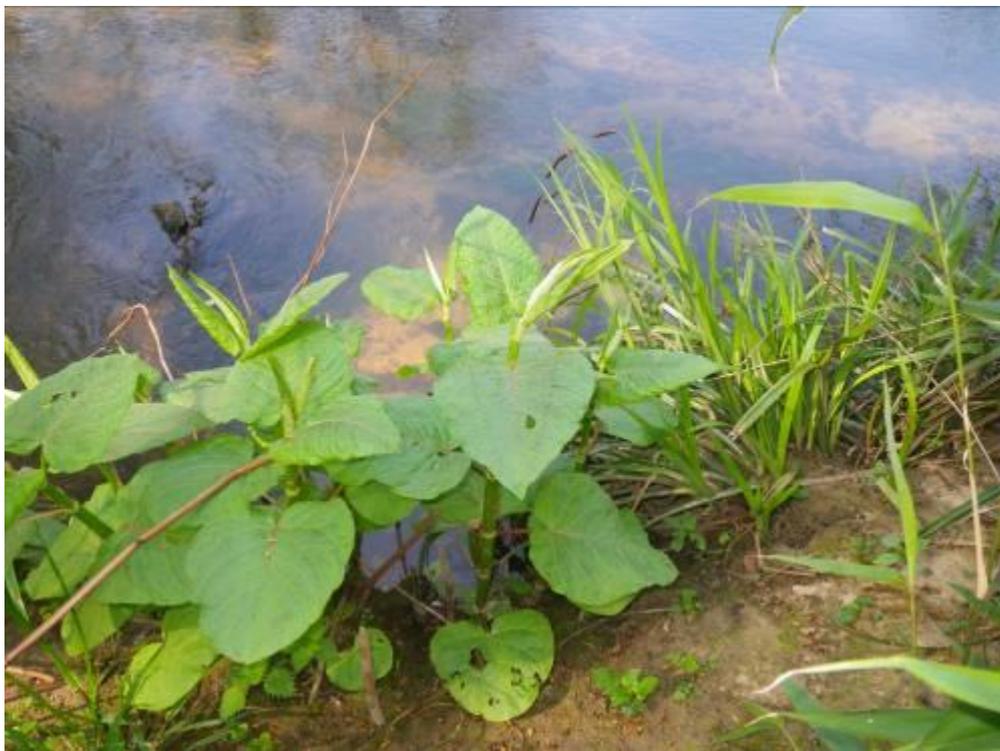
Of more concern was the presence of a modest sized clump of Japanese knotweed *Fallopia japonica* (photo 6). This plant is potentially extremely invasive and damages river banks in a similar way to balsam. The eradication of this plant at an early stage is a priority action and it is recommended that some specialist advice is taken over control methods.

Photo 6. Japanese knotweed on the river bank at Adhurst. Potentially a big threat to the local Rother ecology.

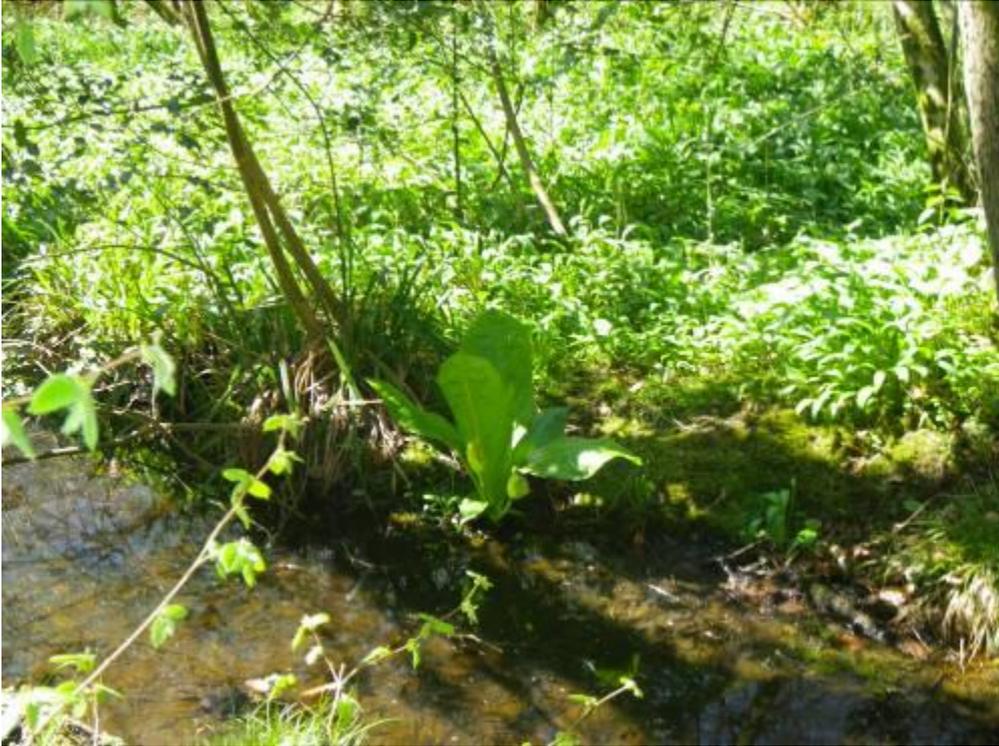
A single skunk cabbage *Lysichiton americanus* (photo 7) was also seen and should be removed before the plant becomes established.

Photo 7. Skunk cabbage. Should be controlled now before it becomes a problem
