Advisory Visit

River Welland, Duddington, Northamptonshire

July 2018

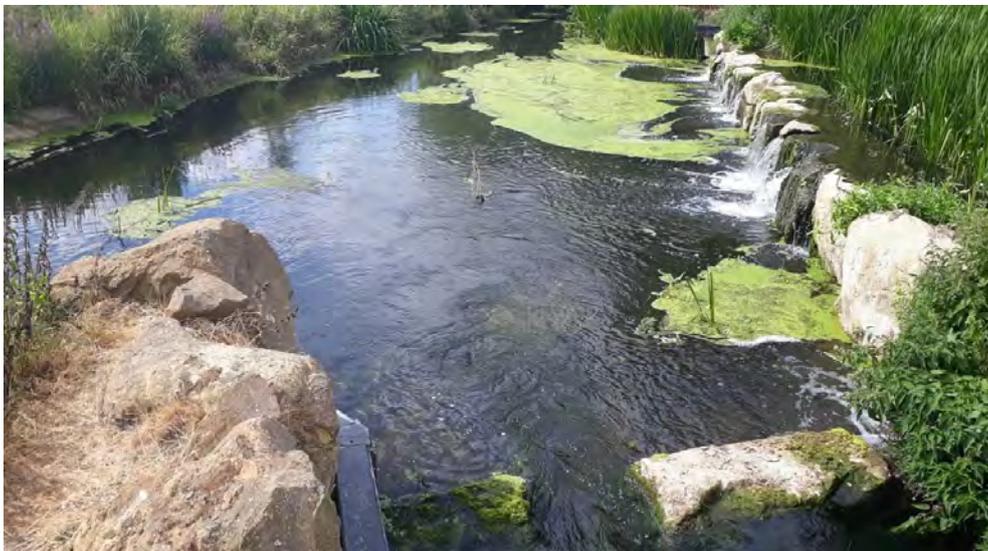
The visit commenced at the downstream of end the fish pass at Duddington Mill (pic 1). The fish pass has been constructed to provide a naturalistic pool/cascade channel to allow fish to ascend the weir that retains a head of water behind the mill. The fish pass has been constructed from large limestone blocks which should weather-in given time and should become partially vegetated as plants gain a foothold in cracks and trail down to the water. The fish pass also appeared to have an eel pass attached to it which is strange as one would have expected the channel to have been passable for coarse fish species (the dominant species in this reach of the Welland). The occurrence of the eel pass simply introduces an additional maintenance requirement.

Pic 1 – The outfall from the fish pass channel. The fish pass was completed in 2013.

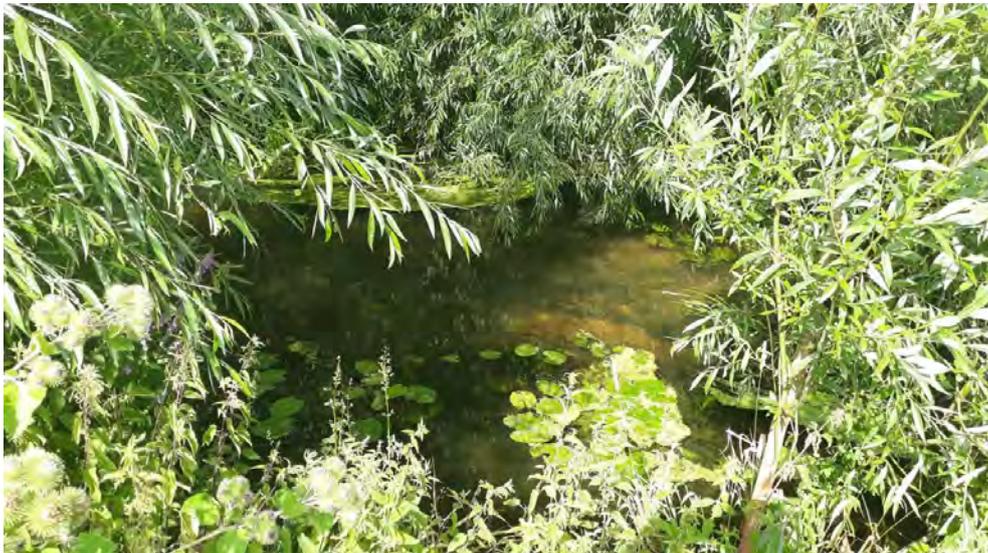
Pic 2 – A short distance downstream of the fish pass the channel was shaded by willows. The shade cast prevented the channel from becoming extensively choked, and it cooled the water.

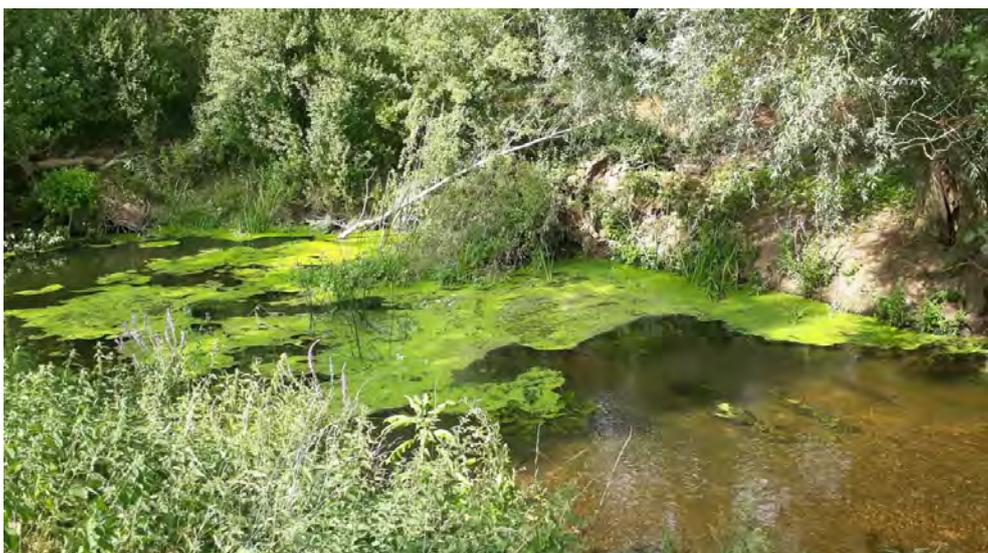
Pic 3 – This glide (or low energy riffle) barely has enough water velocity to cleanse algae from the surface of the pool. Narrowing the channel through a combination of berm creation and flow deflectors may energise the flow suitably to keep the pool clear.

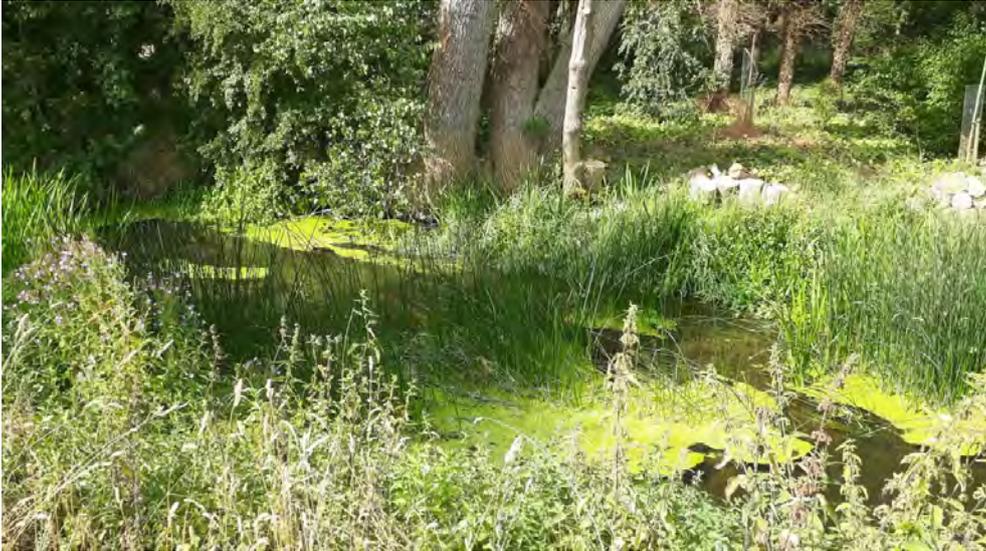
Pic 4 – Slower and deeper glides were becoming dominated by common club rush. The most sustainable means of addressing their growth would be to undertake bed raising with imported gravel and stone to create a self-cleansing channel that is in a better balance with the flow velocities normally conveyed by the river.

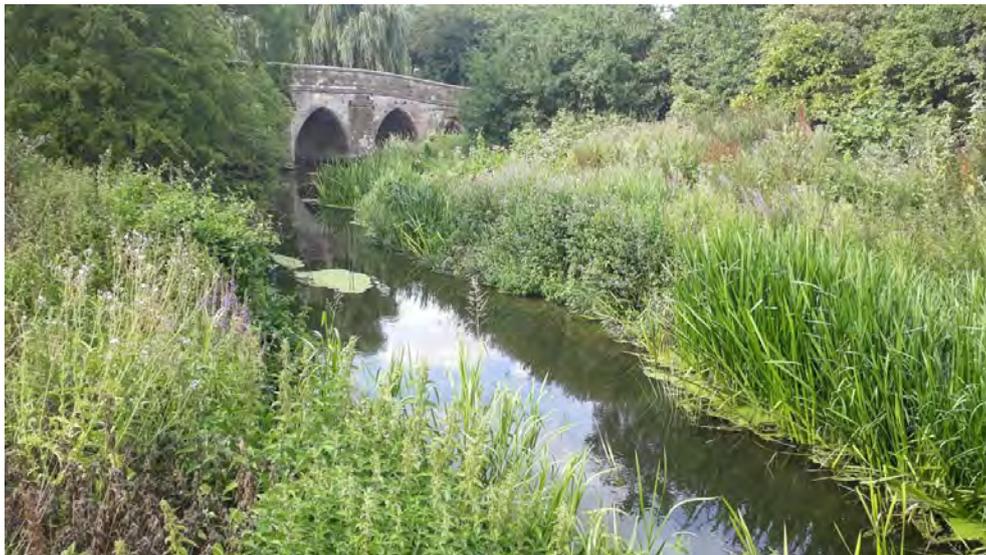
As the historic Duddington bridge was approached a favoured angling glide was pointed out (pic 5). That glide is ~3.5m in width and ~0.8m deep, and was not excessively weeded-up. It might be possible to use the channel dimensions for proposing new glide habitats.

Pic 5 – There was one glide of ~20m in length that was still able to maintain an open channel. The bed varied from ~0.7m to ~1m with a width no greater than ~3.5m.

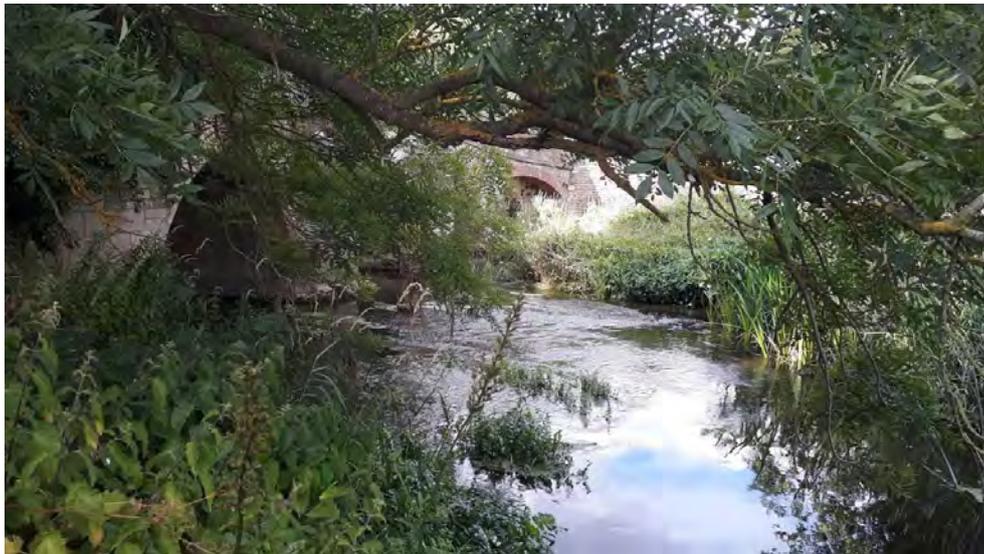
Upstream of the Duddington bridge the bed rose to form a riffle (pic 6). It is likely that the bed rise is actually the original bed level and was not dredged for fear of damaging the bridge footings. The occurrence of a raised bed provides a very useful template for bed restoration extending upstream to the tail of the weir pool downstream of the fish pass.

Pic 6 – A riffle is present immediately upstream of the Duddington bridge, most probably indicating the original bed level.

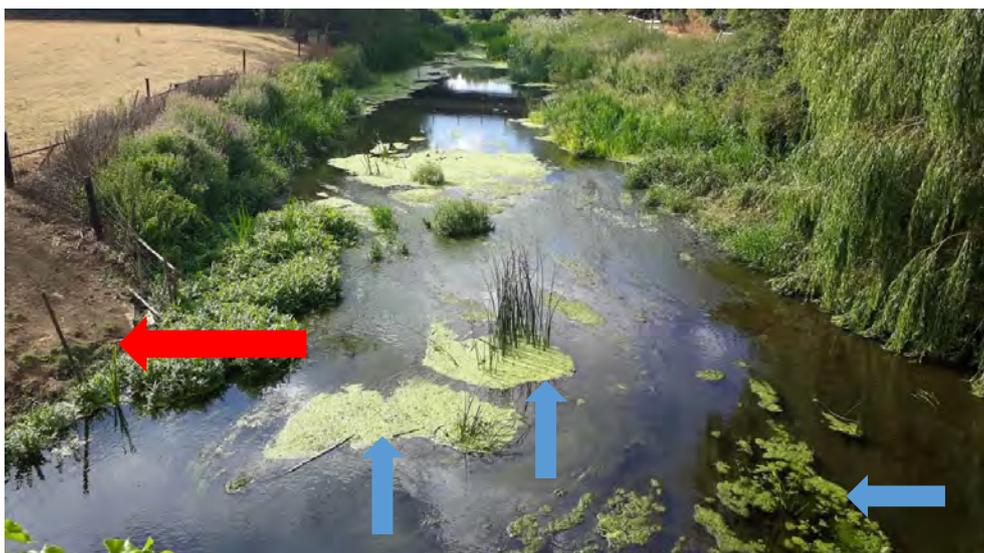
The channel is shallow and wide downstream of the bridge for ~15m (pic 7). Water cress was growing from the LB and will provide some degree of natural narrowing and marginal cover throughout the summer months. The weeping willow on the RB is suppressing marginal growth and subsequent narrowing from the RB.

Pic 7 – The view from the Duddington bridge. Note the input of fine sediment from the cattle drink (red arrow). Sediment will increase the river's nutrient loading. The occurrence of filamentous algae (blue arrows) is indicative of high nutrient loading, especially of phosphates.

Wide shallow areas (riffles) can be important for invertebrate production and fish spawning, and should not be narrowed without understanding how they perform at normal flow conditions. However, at the time of the visit, the shallow areas could be enhanced through the use of flow deflectors to increase water velocity and bed scour.

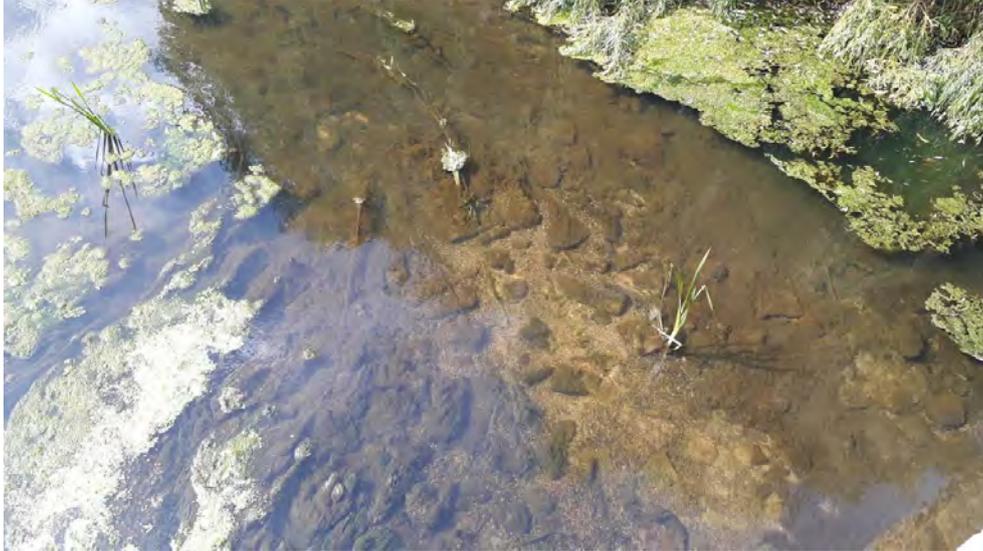
The bed of the channel immediately below the bridge was abundant in coarse substrate but it was overlaid by high amounts of sand and silt, in addition to brown algae (pic 8). Increased water velocity may enable the

Pic 8 – The bed downstream of the bridge consisted of coarse substrate overlain by sand and algae.

river to cleanse itself better. The author was informed that the river is usually in better condition at this location in a normal flow year.

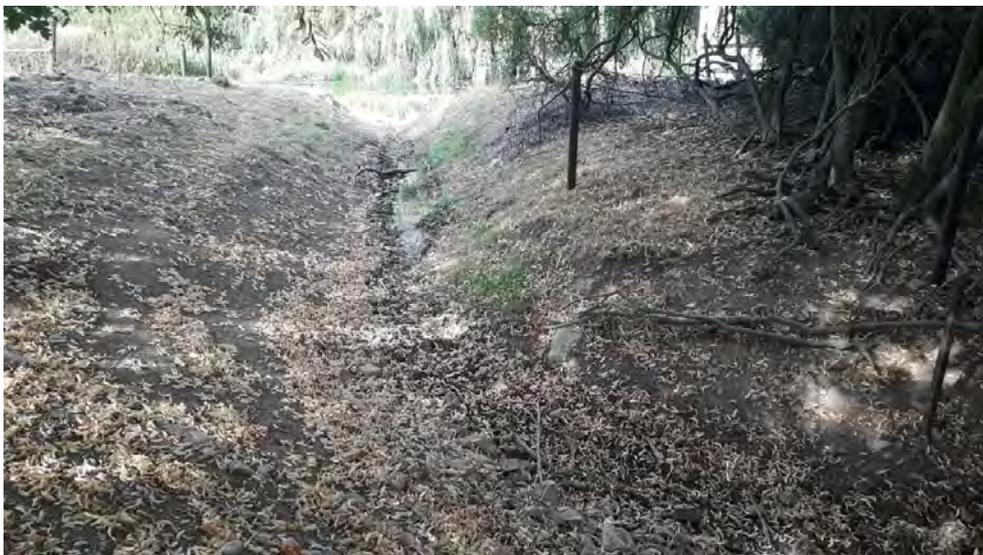
Pic 9 – This small feeder ditch is a significant source of fine sediment to the river.

Downstream of the bridge a perched ditch met the river (suggesting how much bed lowering may have occurred during dredging). The ditch had been dredged earlier this year resulting in a large number of stones being removed from its base. Consequently the soft base of the ditch has been disturbed as animals have sought water, resulting in silt entering the river. The stones could be collected and placed back in the base of the ditch or be placed within the adjacent cattle drink to provide some hardstanding to reduce silt input.

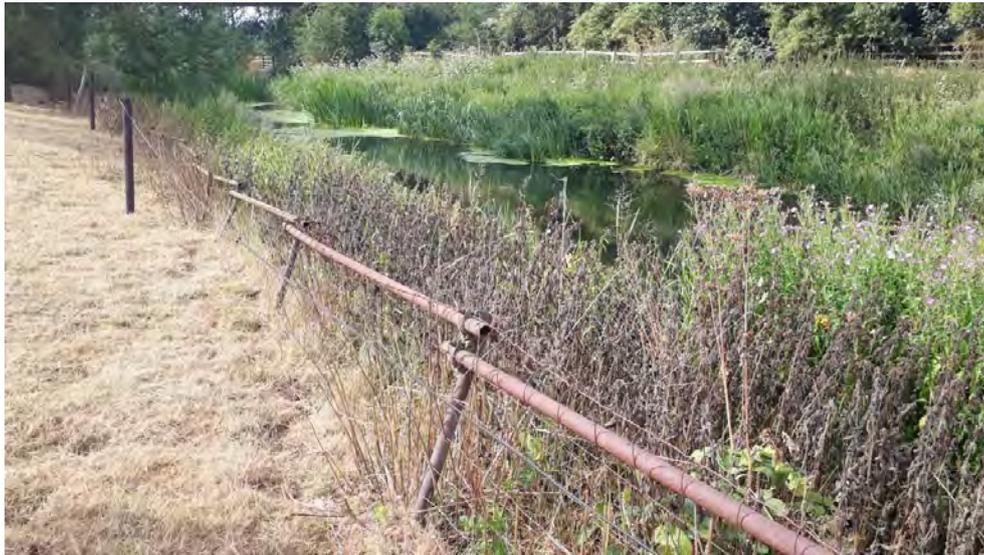
Throughout the length of the reach visited herbicide had been used to control broad-leaved plant growth beneath the fence, it also extended down the slope of the bank (pic 10). The use of herbicide in this manner is detrimental for a number of reasons. Firstly, the herbicide is killing off the bankside and marginal plants that are host to a wide diversity of invertebrates. Those invertebrates may in turn may become food for fish. Secondly, bankside plants will be contributing to bank stability. Thirdly, the

bankside plants control the run-off of soil particles which may otherwise enter the river.

Pic 10 – Herbicide has been used extensively to kill vegetation at the top of bank beneath the fence. The use of scaffold poles also detracts from the naturalness of the river side setting. Electric sheep netting would be a better alternative.

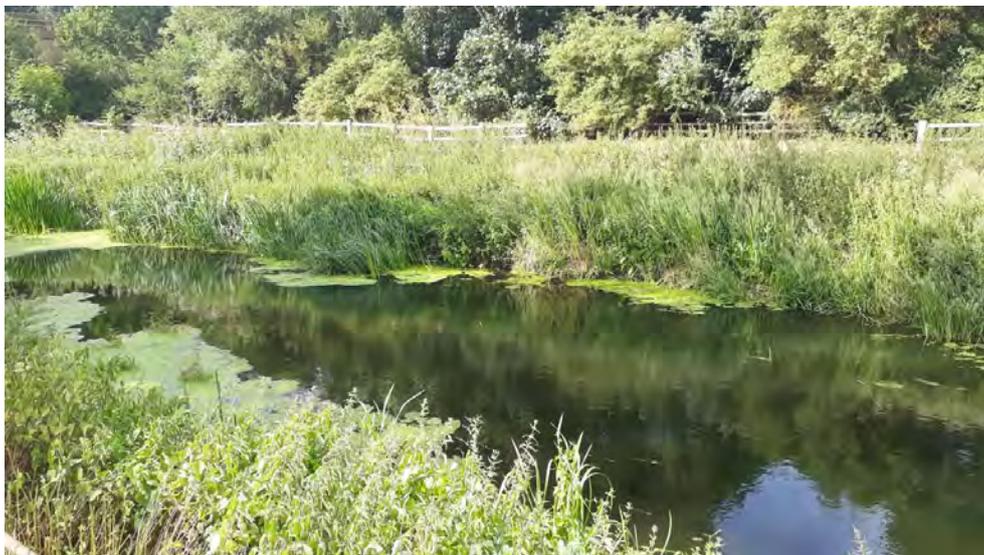
Pic 11 – A deep (~1.5m) and wide (~8m) pool above the A47 bridge. This pool appears to receive scouring flow from the shallow reach downstream of Duddington bridge.

After the shallows downstream of the bridge there is a large pool. The pool could benefit from further cover to increase habitat for adult fish. The placement of tree-top flow deflectors would be suitable and may enable the scouring flow to be deflected further downstream rather than dissipated at the head of the pool.

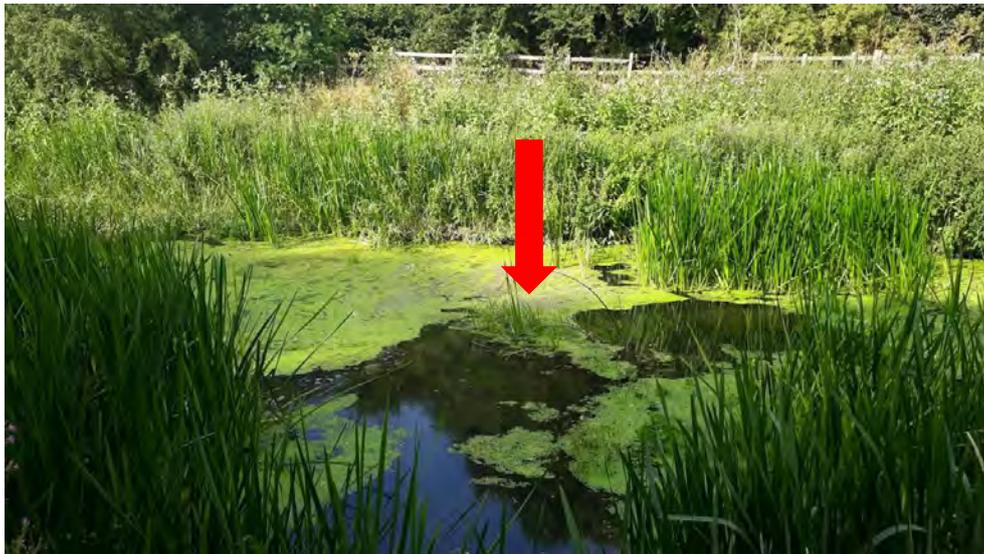
Pic 12 – This pic was taken ~10m downstream of pic 11. The water velocity has slowed enabling bur reed to become established mid-channel together with a floating raft of reed sweet grass (red arrow) and filamentous algae. This is not what is expected in a river fished for wild brown trout.

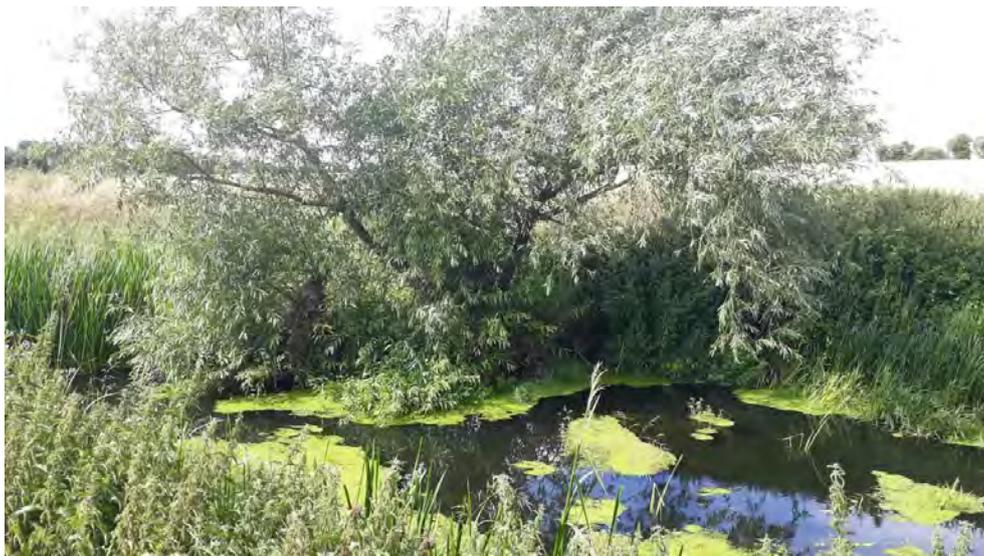
Pic 13 – Trailing willow branches at water level provide an important habitat for both fish and invertebrates.

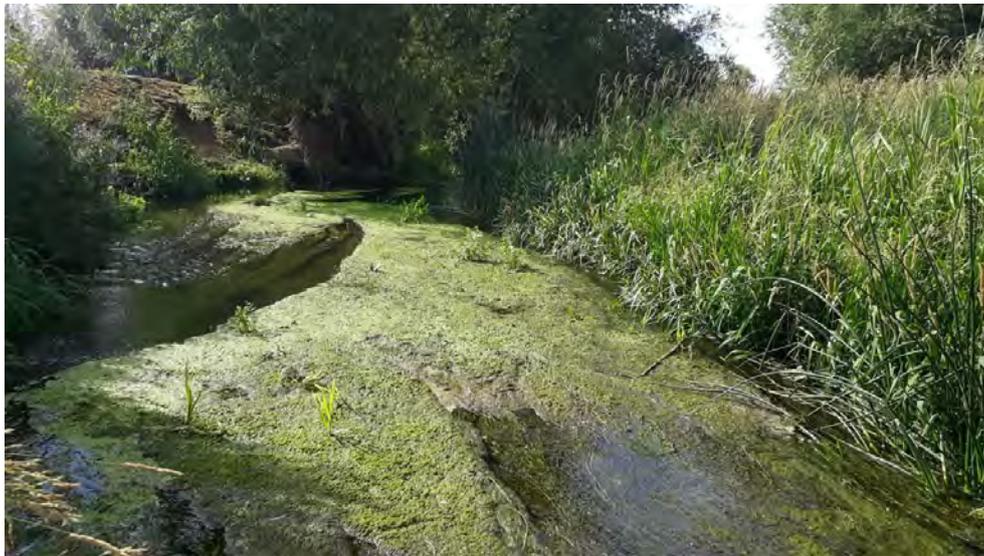
Pic 14 – A riffle with water crowfoot growth almost entirely smothered by filamentous algae.

Occasional riffles were observed and represent important juvenile brown trout habitat in a river much restricted in such habitat. Sadly at the time of the visit the water crowfoot had been almost overgrown by filamentous algae (pic 14). Water crowfoot is important for retaining water depth, increasing in-channel cover, providing shade, and for providing a spawning substrate for many coarse fish species. The plant is typical of clean swift flowing rivers.

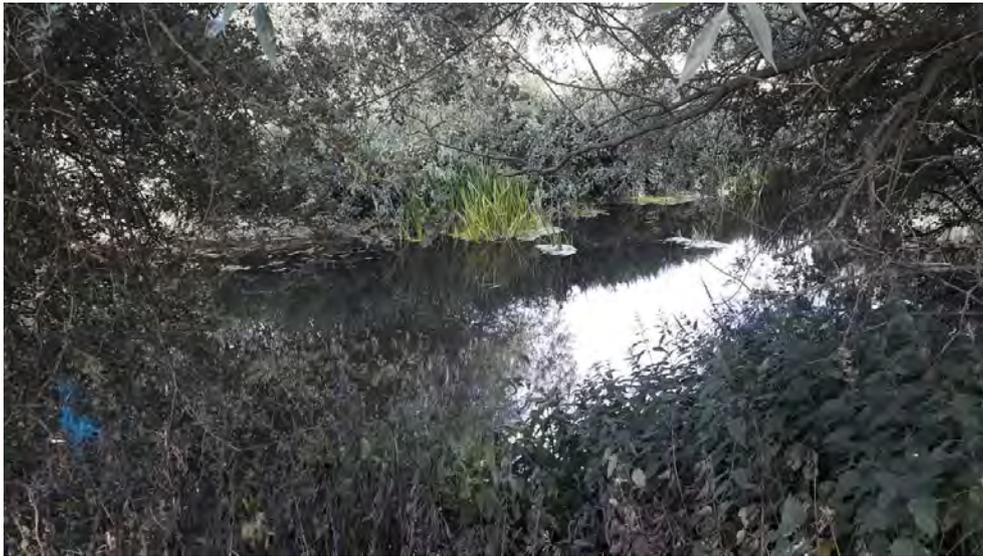
Pic 15 – A shaded pool habitat where a large trout (~40cm) was seen together with a number of chub.

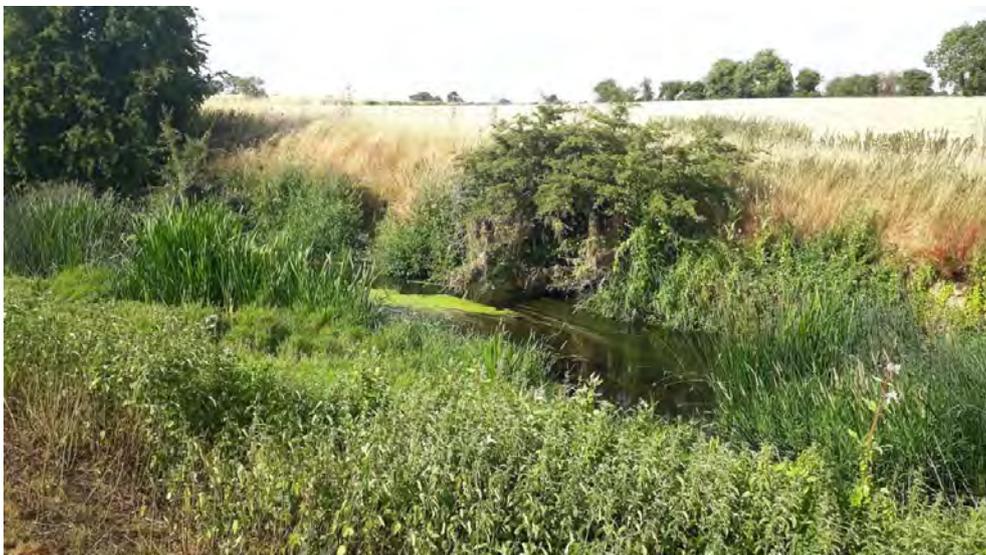
Pic 16 – Berms provides an important transition from the dry top-of-bank habitat to the damp marginal habitat. The gradual transition increases the available niches for specialised plants and invertebrates.

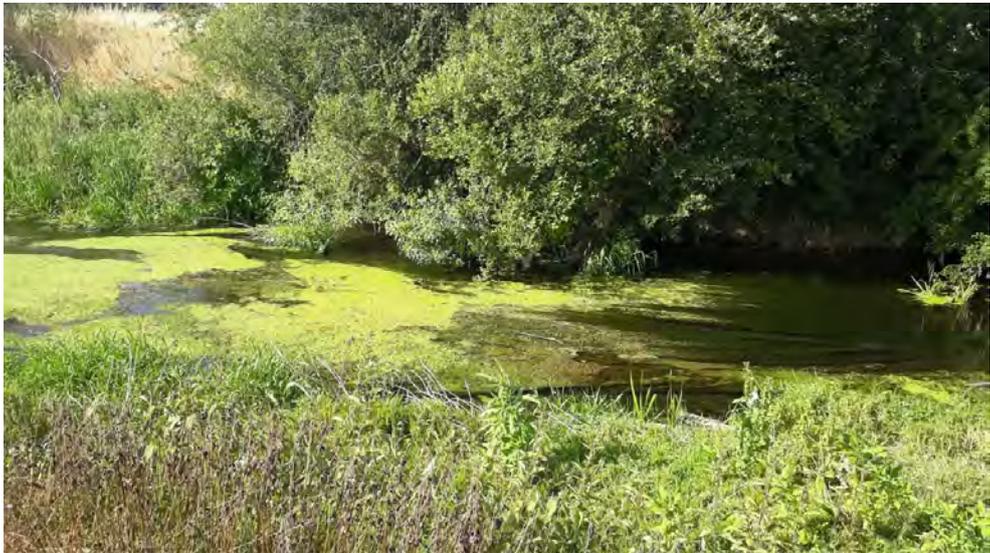
Pic 17 – The occurrence of trees trailing down to water level should be encouraged as this type of feature provides excellent overhead cover for fish.

Tree management should also have regard to the need to retain trees, particularly over pools, for their shading to aid summer cooling and for controlling vegetation growth. Trailing branches at water level should not be removed unless absolutely necessary as trailing branches will increase the number of lies within a river for brown trout.

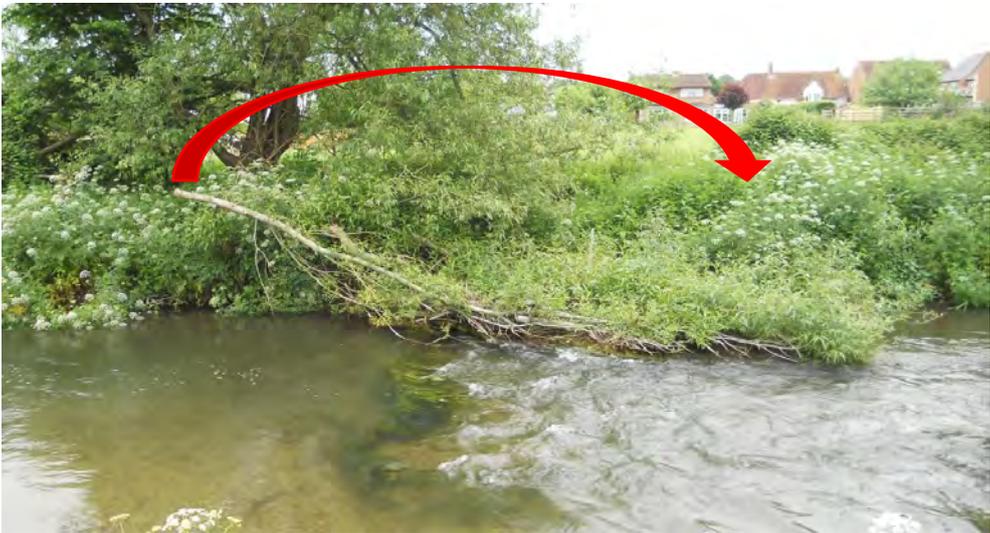
Pic 18 – An example of tree hinging, a simple and effective technique for increasing cover in a river.

Fallen trees can be managed to retain their habitat value by winching them to a secure bankside position and securing them with stakes and/or cable rope. Where riparian trees require thinning and their habitat potential as fallen LWM would otherwise be removed, a technique known as tree-hinging can be used (pic 18). Tree-hinging is similar to hedge laying in that it retains a living hinge that secures the cut stem to the tree stump. The hinge continues to allow the tree to live so structural strength is retained. With the tree-top laid at water level it provides excellent over-head cover, flow deflection and a spawning substrate for many coarse fish. These two approaches would be suitable for some of the trees within the reach visited.

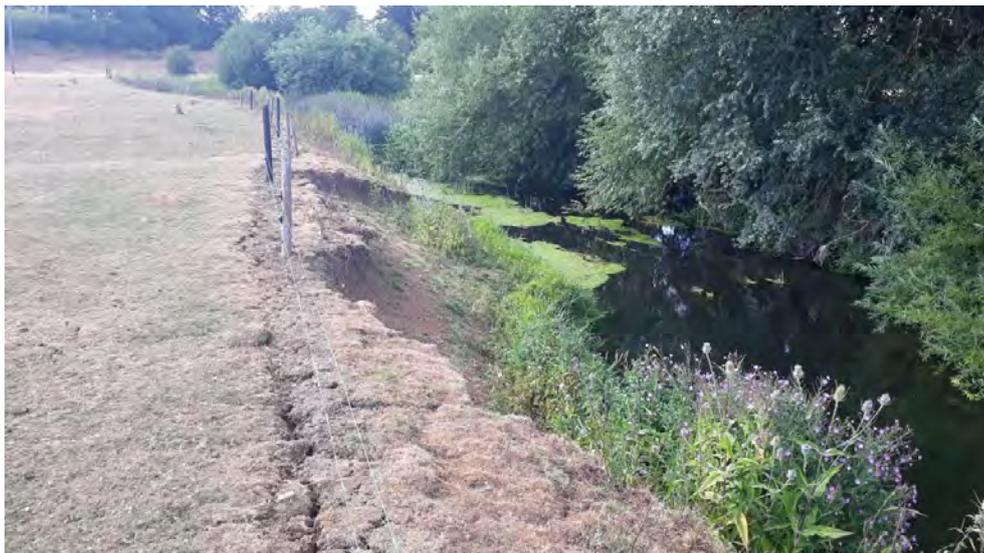
Sheep grazing presents a problem to river banks. Sheep graze plants to a very low level, repeated grazing often results in only grasses surviving. Tree saplings are completely grazed-off resulting in a loss of the future tree stock. With only grasses to bind the soil, run-off can result in the release of fine particles from the soil to the river, and without any strong root system (that trees would provide) the banks become susceptible to collapse. That situation is occurring along this reach of Welland, and whilst the banks may reach a shallower angle (which was cited as desirable for the anglers) the toe of the bank is unprotected. An unprotected bank is likely to be washed away in high flows resulting in a large volume of fine sediment entering the river. Fine sediment will degrade the riffles and fill the pool habitats.

Pic 19 – Although a fence is in place sheep have been able to graze to water level. A fault line is emerging beneath the fence. Once the ground becomes wet it is likely that rotational slumping will occur along the fault line resulting in the loss of a substantial volume of bank material to the river. Even without bank failure, the over-grazed soil has left fine sediment to be washed into the river.

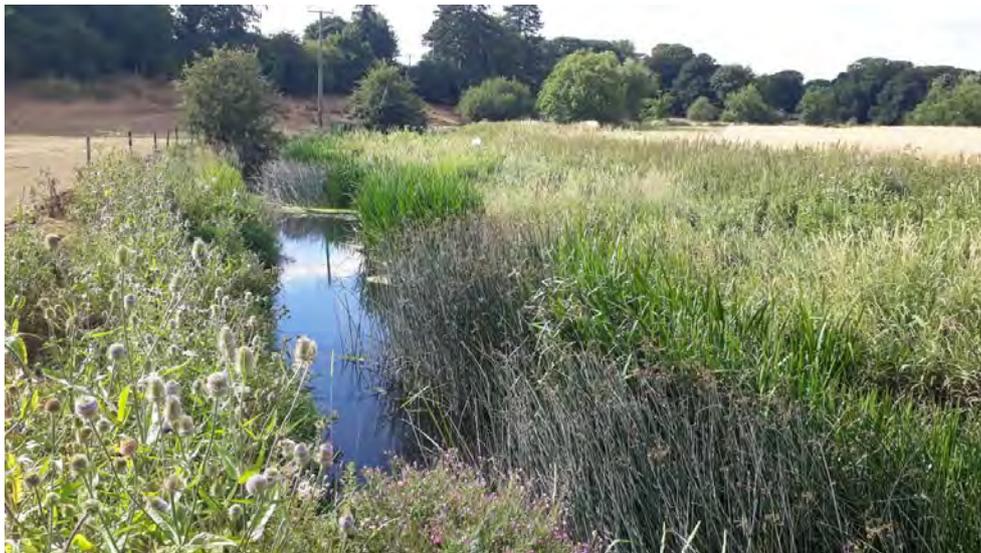
Pic 20 – At some locations the excessive plant growth appeared to be holding back the flow resulting in almost static conditions.

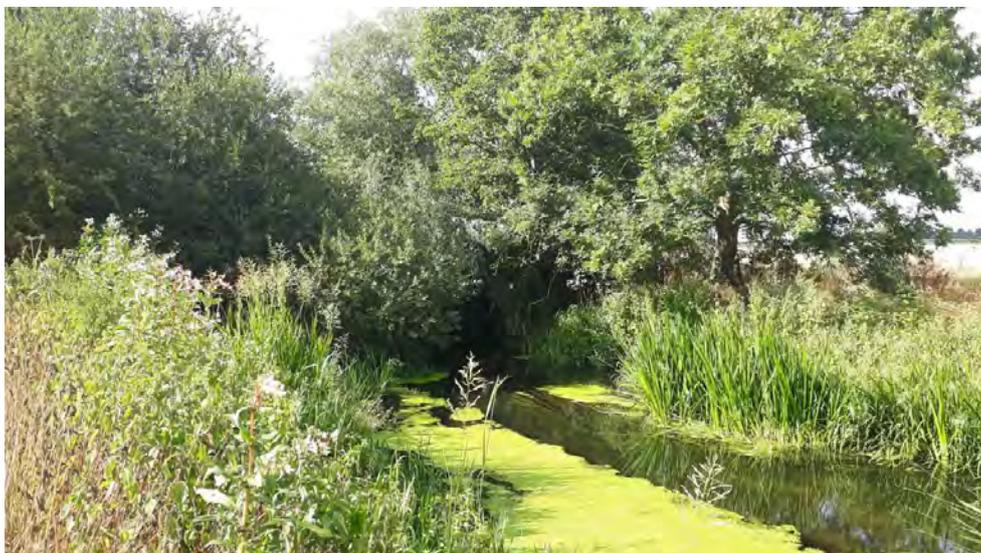
Pic 21 – Total channel tree coverage provides an important refuge area for fish and prevents total encroachment by vegetation.

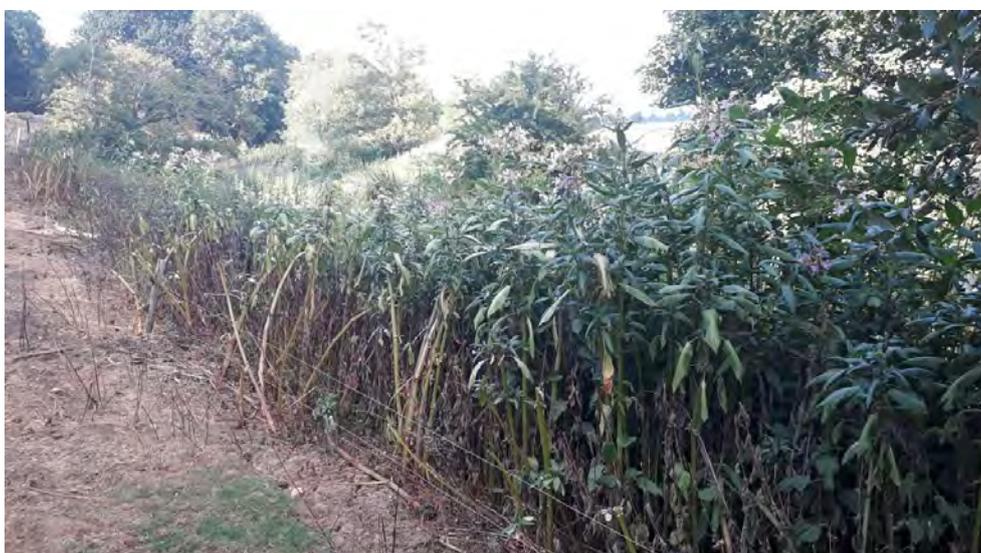
Pic 22 – Himalayan balsam is present throughout the majority of the reach, but at its lower end it was starting to form dense monoculture stands.

As an invasive non-native species, Himalayan balsam presents a serious risk to the Welland. The plant is spread by seeds and is very adept at colonising riverbanks. Once present, its tall growth enables it to outcompete many native plants. The balsam then establishes monocultures further reducing low-growing species, such as grasses, which are crucially important for binding the soil. Furthermore, balsam dies-off in the winter leaving riverbanks almost completely devoid of vegetation and prone to erosion by rain and scour. It is far better to undertake control of balsam when it is in low numbers before it becomes a problem.

The Himalayan balsam should be eradicated through pulling or strimming (below the first growth nodule) in order to prevent it from forming further extensive monocultures.

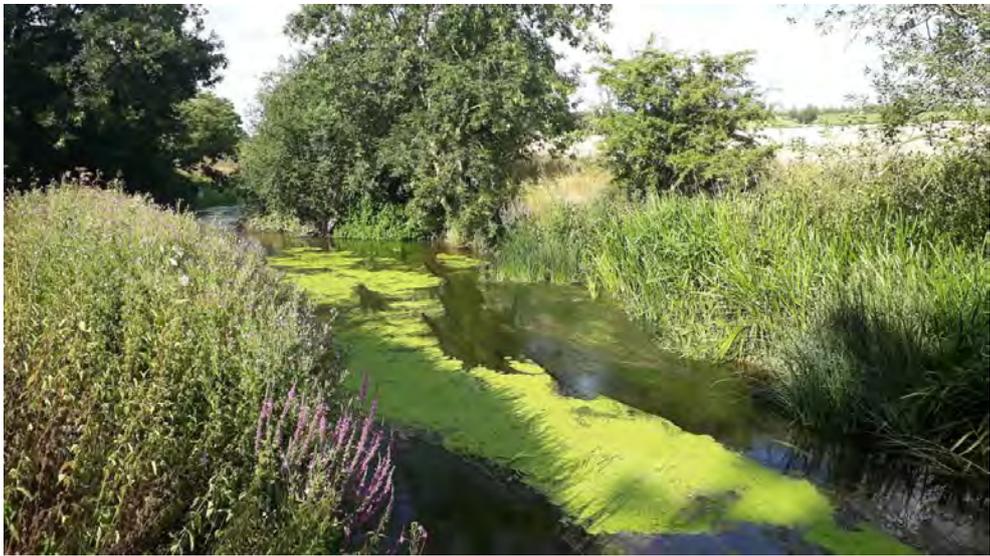
Pic 23 – Selective narrowing and/or the use of flow deflectors could retain water velocities capable of preventing the establishment of algae upon the water crowfoot.

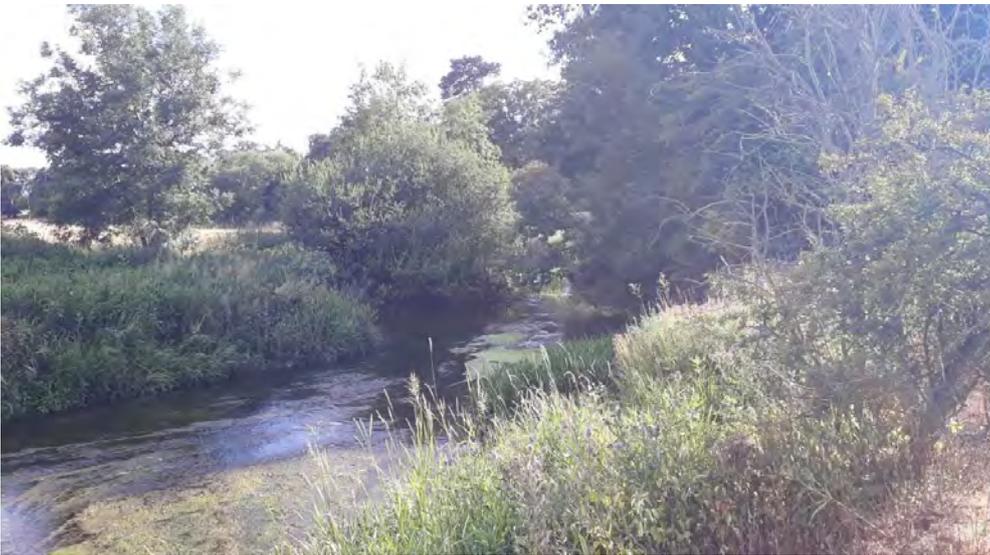
Pic 24 – opposing bankside trees provide total cover to the channel. Strategic tree planting could establish similar stands of trees for the future benefit of the river.

Tree planting could address bank instability in the medium to long term. Any tree planting would need to be set-back to allow the trees to establish a strong root system before the bank becomes unstable. Alternatively (or in combination), quick growing willow species could be grown at the toe of the bank with the intention of laying them to give a greater degree of bank protection once they are above top of bank height. Trees particularly valuable for planting adjacent to rivers include willow species, common alder, native black poplar and hazel.
