River Afan – Afan Valley Angling Club

An advisory visit carried out by the Wild Trout Trust – February 2010

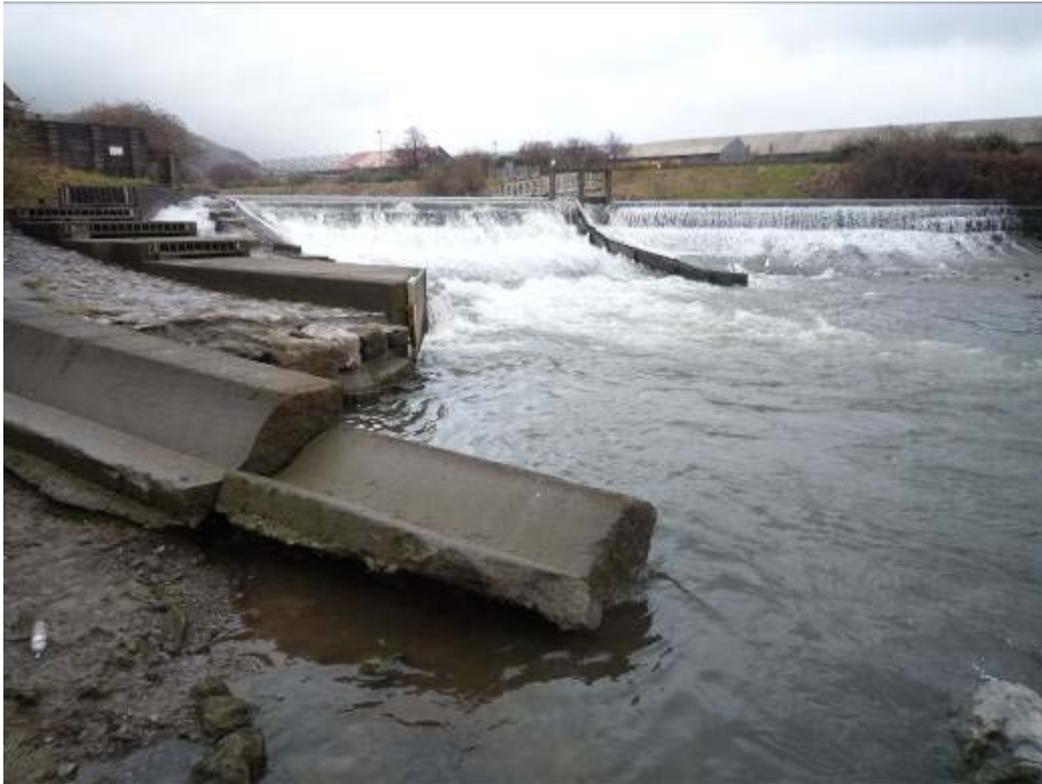
The large tidal pool at the bottom of the Afan.

Looking upstream from the very bottom of the system, it is evident that the river has been severely constrained by the urban development. The tidal pool which demarks the end of the fluvial river does not form part of the fishery but it is evident that this area will attract significant numbers of migratory salmonids to settle prior to upstream migration. The weir does have a fish pass, constructed at least 20 years ago, which is located adjacent to the RB margin. There was some discussion as to the efficacy of this pass, due to its location on the weir and also the levels of attractant flow; the structure also periodically blocks with assorted trash.

As a registered fish pass the Environment Agency (EA) is responsible for its maintenance but some concerns were expressed over the difficulties involved in clearing blockages because of the enclosed design, possibly leading to some

downtime when migrating fish could be delayed from ascending into the club's waters.

Upstream access for migratory trout is obviously of critical importance. Delays in being able to navigate upstream can lead to stress related problems and increased predation pressures. It is recommended that the AVAC asks the EA to carry out a re-evaluation of the fish pass maintenance programme on the bottom tidal pool to see if there is any scope to avoid frequent blockages to the pass. In addition enquiries should be made as to the current use of the gauging weir and whether there is any long term plans to improve access for fish at this important site.

- Open a dialogue with the EA over the design and maintenance of the fish pass on the tidal pool.
- Ask the EA for their plans on the long term future of the flow-gauging crump weir.

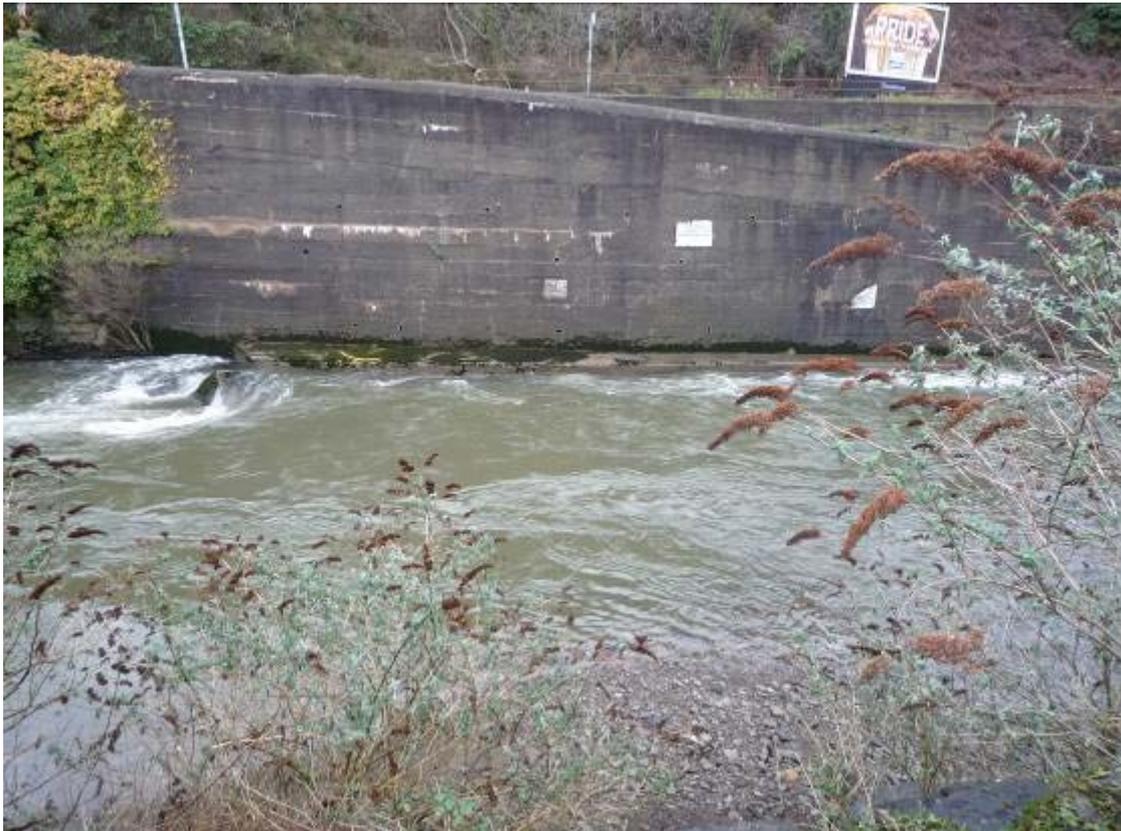
Further upstream the river was inspected north of the M4 crossing. Here it was evident how constrained the river channel is in places, flowing down a very steep gradient and often reveted with brick and concrete walls. Despite the obvious lack of natural marginal cover, the active morphology of the channel has created some excellent pool and riffle habitat ideal for both holding adult trout but also potentially good for spawning as well.

The Afan just above Port Talbot where the channel is reveted with steep sided brick and concrete walls.

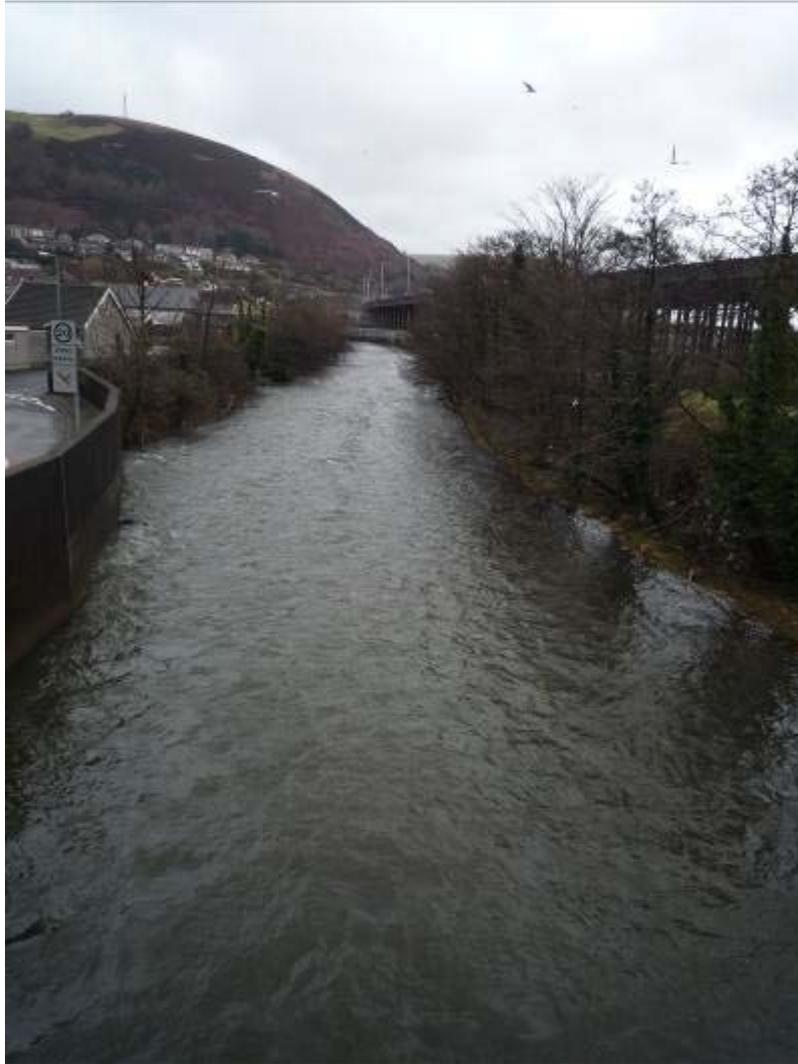
Some sections of channel within this lower urban corridor were much more natural, with tree line margins and sufficient channel width to allow decent shingle banks and side bars to form. The 500m section of channel running parallel with the elevated M4 appears to have some particularly good stands of marginal tree cover (mainly alder) which will provide good bank protection via the root systems as well as a source of food items in the form of invertebrates dropping from overhanging branches. These trees were not inspected closely but some may well benefit from coppicing to extend their life and to provide valuable low bushy cover so important for good holding lies for adult brown and sea trout. Improved marginal cover adjacent to shallow nursery habitats will also help to reduce bird predation pressures.

The Afan just north of the M4. Good marginal tree cover on both banks yet still in the urban environment. Coppicing some of the alders to preserve the trees and promote low growth will improve and protect the river margins.

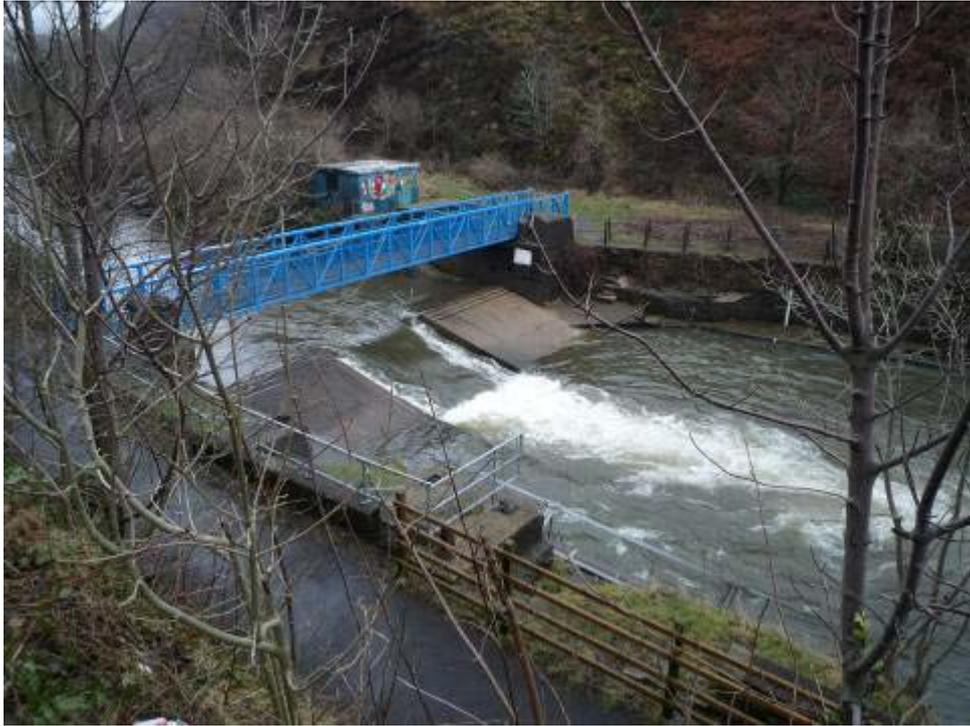
Further upstream between Port Talbot and Cwmafan two sites were inspected. The first was the site of what looked to be a flow gauging crump weir. It is not known if this site is still being actively used by the EA for measuring river flows.

Crump weirs can be a problem for free and easy fish passage. It may well be that during spate conditions, when the head loss at this site is reduced with increasing tail water levels, sea trout can easily navigate their way through. During long periods of low flow, however, structures like this may limit upstream progress, especially for smaller sea trout. It is recommended that the club opens a dialogue with the EA over this structure to ascertain if it is still an important asset in regular use and if there are any plans to remove or modify it to improve access for migratory fish species, including eels.

A crump-style flow-gauging weir. Is this an issue for sea trout migration during a low flow summer?

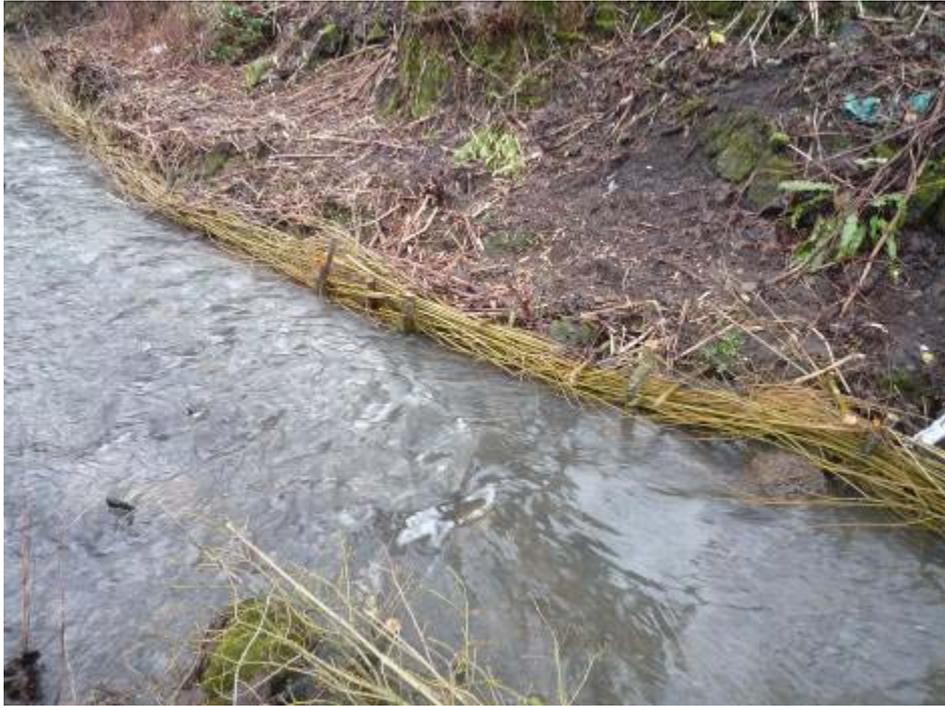
A few hundred metres above the weir a small tributary enters the river from the RB. This stream runs parallel with the Cwmafan road for a distance of approximately 500m. Small tributaries and side streams like this one are potentially of critical importance as spawning and nursery areas. This stream, as the first significant tributary above Port Talbot may well be even more important as a spawning site for late running fish; sea trout in particular are often known to favour side streams or tributaries rather than utilising main stem habitats. The stable flow regimes and shallow water provide an excellent food-rich habitat and refuge from predators for juvenile fish. When these side streams are coupled with good quality gravels, clean water and an abundance of scrubby, overhead cover they can provide a significant contribution towards trout populations running the main river.

The value of this little stream has not been lost on members of the AVAC and they have been engaged in a programme of habitat improvements, aimed at pinching the channel using woven willow revetment to keep central channel gravels clean and silt free. In addition the club has attempted to eradicate the problem of invasive non native plants, in particular Japanese Knotweed, *Fallopia japonica*. This plant, along with Himalayan Balsam (*Impatiens glandulifera*) can be responsible for exacerbating erosion problems by shading out ground flora which leaves soft soils vulnerable to erosion.

An excellent spawning and nursery stream where the margins have been defended with live willow weave.

This programme of improvements should continue and will be even more effective with the addition of more in-channel large woody debris (LWD), discussed below.

- Build on the work already started to improve habitat on the small tributaries and side streams, with an emphasis on providing more bank-side, scrubby cover and improved spawning gravels.

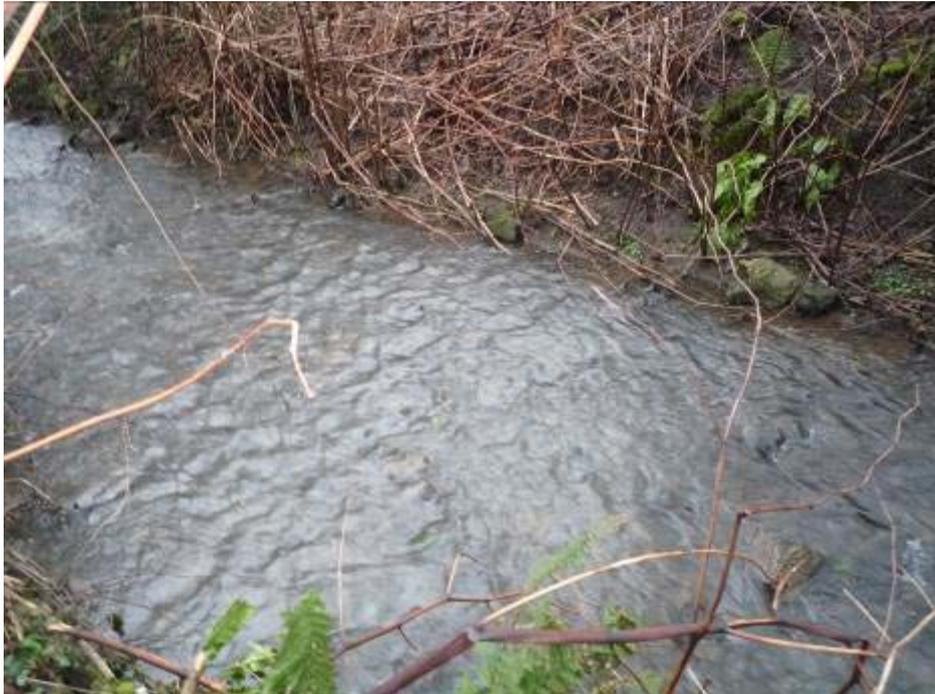
Another section of the tributary lined with Japanese knotweed. Eradicating this plant from the marginal zones should be a priority action

- Continue the programme to eradicate non native plants.
- Make contact with the land owners and authorities responsible for owning and managing the blocks of coniferous forest in the upper catchment. There is no quick solution but many of these trees will be ready for harvest and influencing future plans now may safeguard against a new generation of soft woods being planted.

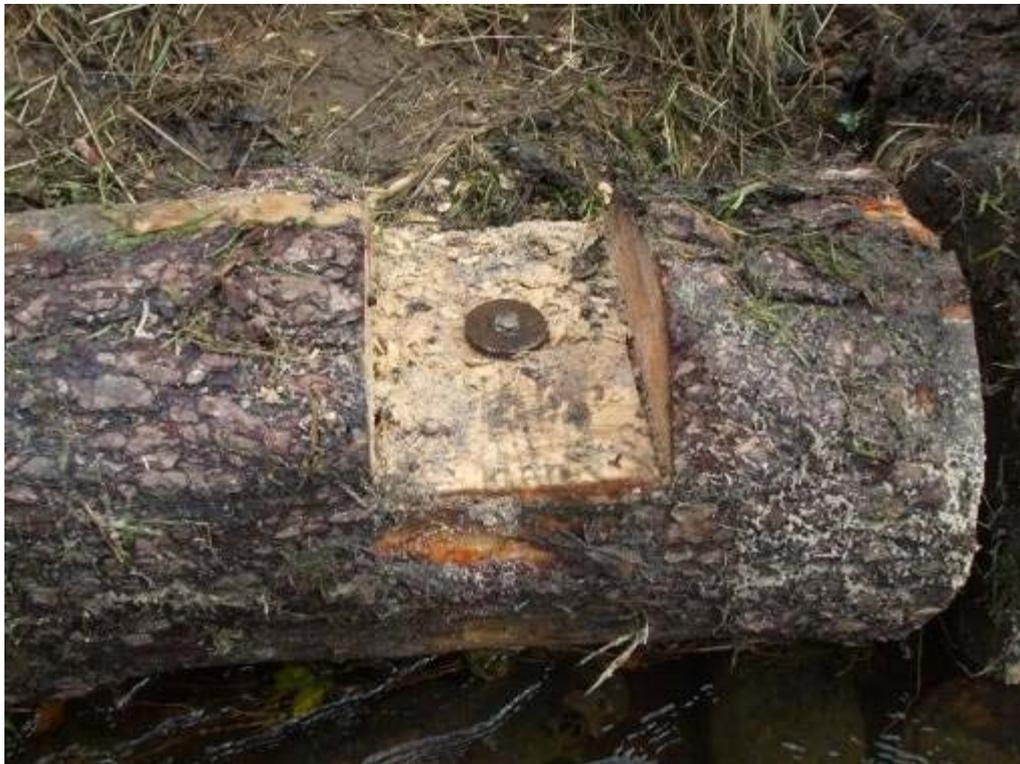
If little or no woody material is available to fall into the channel then importing trunks or large branches and securing them to the river bed is a tried and tested method for cleaning existing river bed gravels and promoting improved holding habitats for pre and post spawners. It should be remembered that poorly secured LWD can break away and potentially cause blockages to small bridge apertures or culverts. If this work is planned on any section of water course designated as a "main river" for flood defence purposes then a written Land Drainage Consent will be required from the EA.

A piece of LWD secured to a stream bed with 2m of 22mm steel reinforcing bar with a welded steel retaining washer

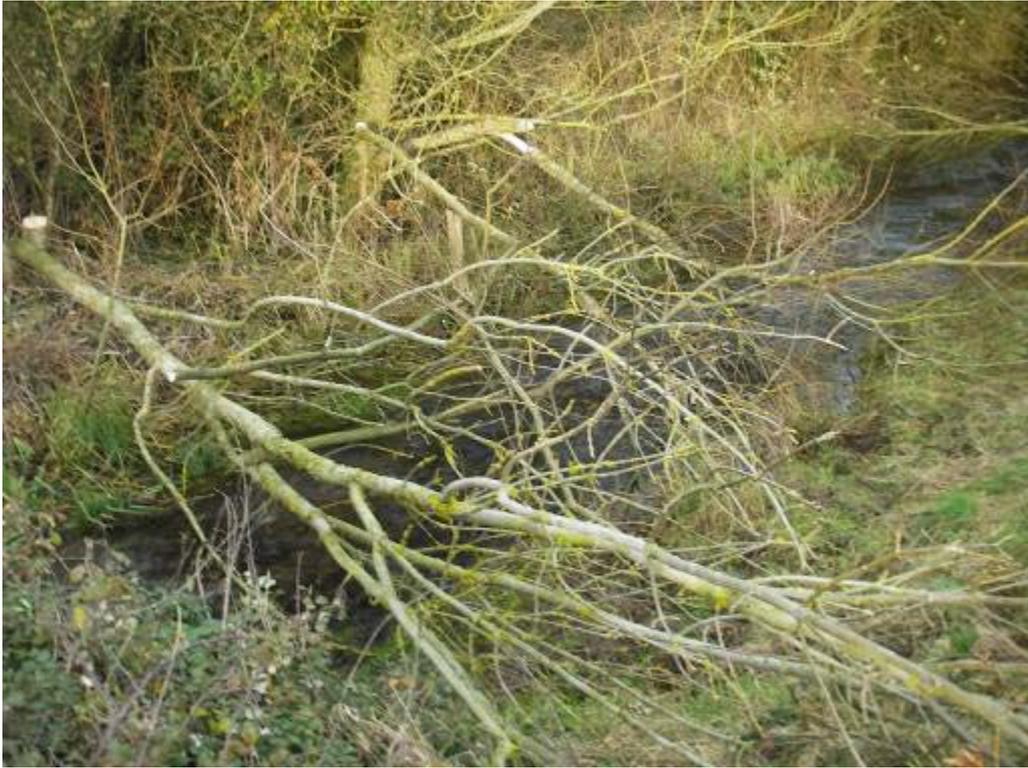
To ensure that those areas that are potentially good for spawning are given the best possible chance of being selected it might be worth providing some temporary overhead fish cover with imported brushings. This is a technique that can be used where bird predation is an issue and where fish feel nervous about cutting redds in open areas. Smooth laminar flows over a ramp of clean loose gravel will almost certainly be used by a combination of resident browns and migratory sea trout for spawning provided there is overhead cover and access to plenty of shallow water to provide suitable nursery environments.

Temporary brushings cut and pegged over a likely trout spawning site.

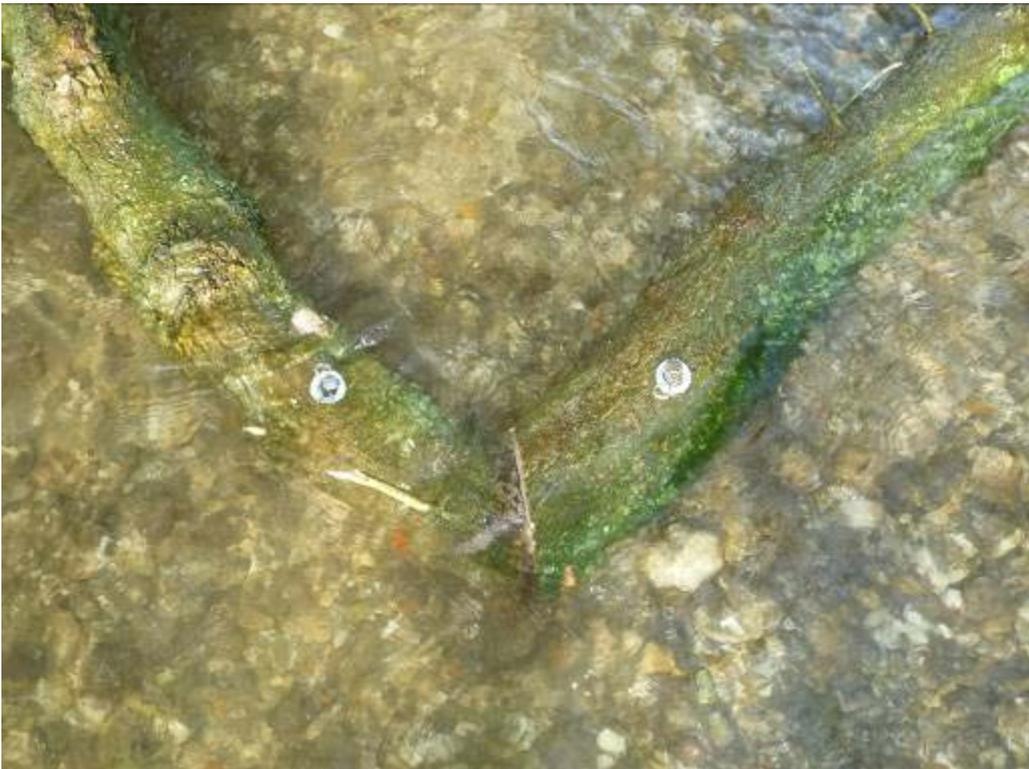
A small upstream V made up of 1m sections of LWD in a spawning stream

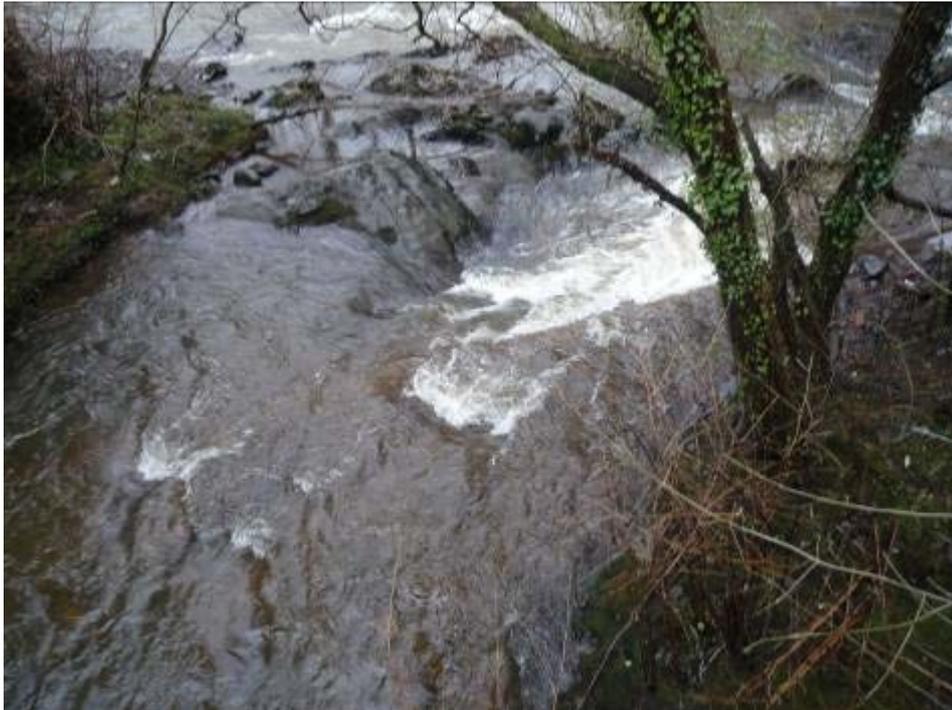
At Pontrhydyfen the confluence the main river with the Afan Pelena tributary was inspected. Apparently this stream has been severely polluted in the recent past but appears to have recovered following works to remediate mine water discharges.

Confluence of the Afan Pelena with the main Afan.

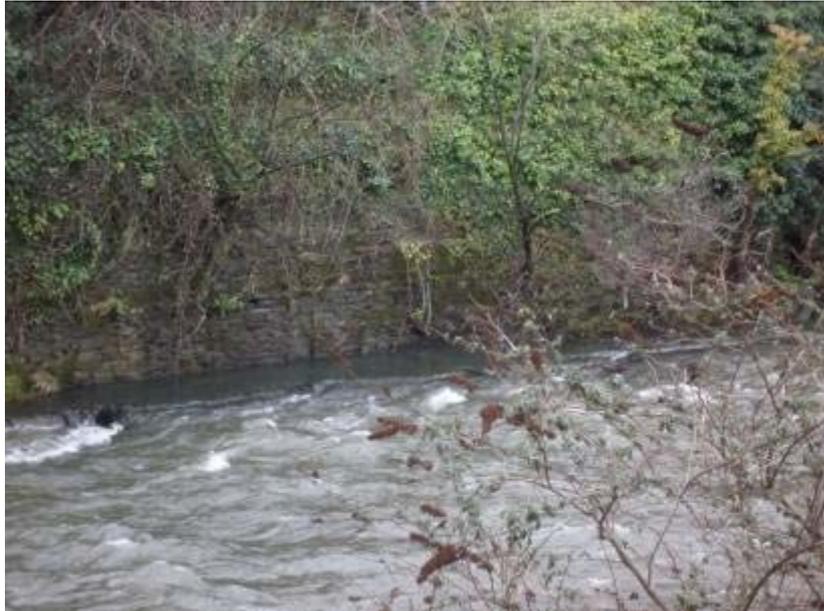
It was noted that throughout most of the length of main river inspected, a major trunk sewer (believed to be a foul water sewer) runs over and next to the river channel. In places the pipe is half buried, in others it crosses the channel. It is hoped that the owners and users of this service are fully aware of the vulnerability of this pipe to damage and although this is most likely to occur during spate conditions, when increased dilution might mitigate against any adverse effects of leakage, there is always the worry that complete failure might occur during high summer, low flow conditions. It is recommended that the angling club asks the water company for reassurance that all necessary precautions are in place to protect the river against the risk of serious pollution.

Exposed major sewer pipe running within the river channel

- Ask the local water company for some reassurances regarding the condition and maintenance checks that are made on the trunk sewer running down the river bed.

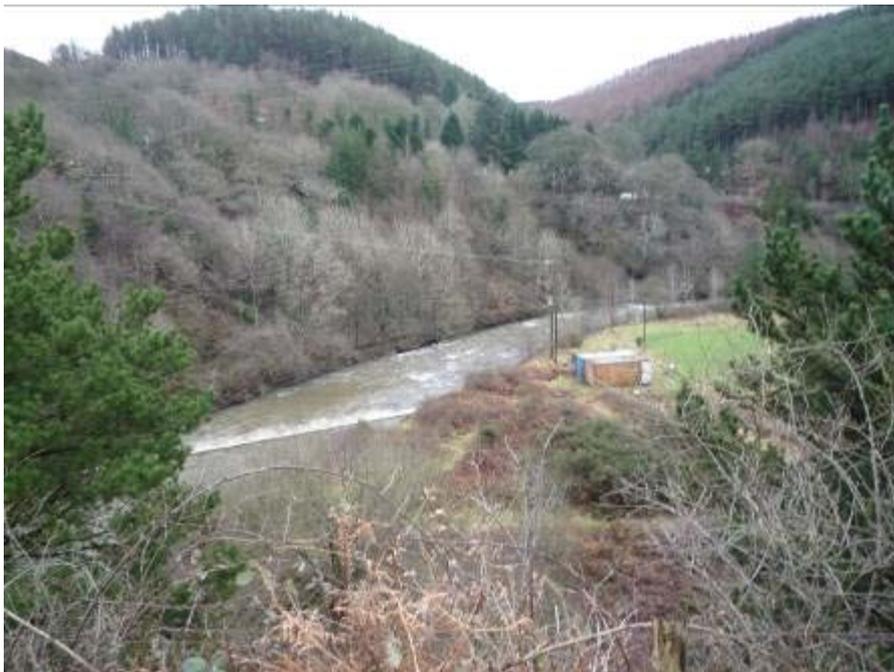
The last site inspection was made at Cymer where the river divides into two upper arms. In-channel habitats on both arms appeared to be excellent with a variety of habitats available for all life stages of the trout. Land use, and particularly the large areas of coniferous forestry are likely to have the biggest impact on habitat quality through this section of river. The well drained soils below coniferous plantations and lack of ground vegetation exacerbates run-off with the net result that rivers suffer from flash flooding events, acid flushes and periods of chronically low flow following even modest periods without rainfall.

Large blocks of coniferous forestry carpet the steep sides of the Afan Valley

These large scale, catchment-related issues are obviously outside of the control of the angling club but it should lobby hard for changes to land management practices through local forums and via opportunities like the River Basin District Management Plans, which are formulated by the Environment Agency as part of the Water Framework Directive. Upland rivers like the Afan cannot reach their full potential unless the issues relating to catchment land use are addressed through a more sympathetic programme of sustainable forestry and landcare. Changes will not happen overnight but the AVAC is a major stakeholder and must fight hard to influence local politicians and decision makers for a better future for the river. Further information on sustainable forestry can be obtained from Coed Cymru at www.coedcymru.org.
