Afon Amman, Bynamman, Carmarthenshire

An Advisory Visit by the Wild Trout Trust, August 2013

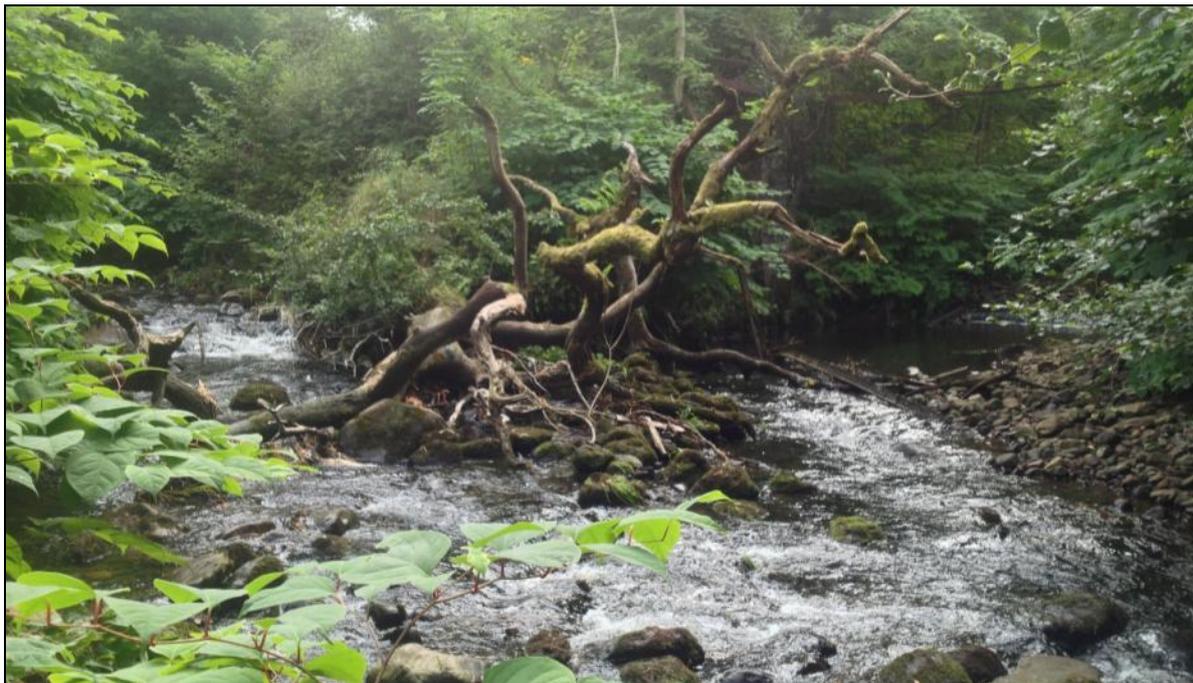
Figure 2: The confluence of the Amman and Nant Gawr

The Amman flows from its source down through open mountain land as a shallow, rocky stream. It flows under the A4068 at Rhosamman, and is confluenced by the Nant Gawr at SN 71748 13999. Here the land is wooded by shrubs and early coloniser tree species such as ash (*Fraxinus excelsior*), elder (*Sambucus nigra*) and hazel (*Corylus avellana*) which have established in the redundant spoil heaps of the Brynamman colliery. The river corridor alongside the old colliery also is heavily infested with Japanese knotweed (*Fallopia japonica*).

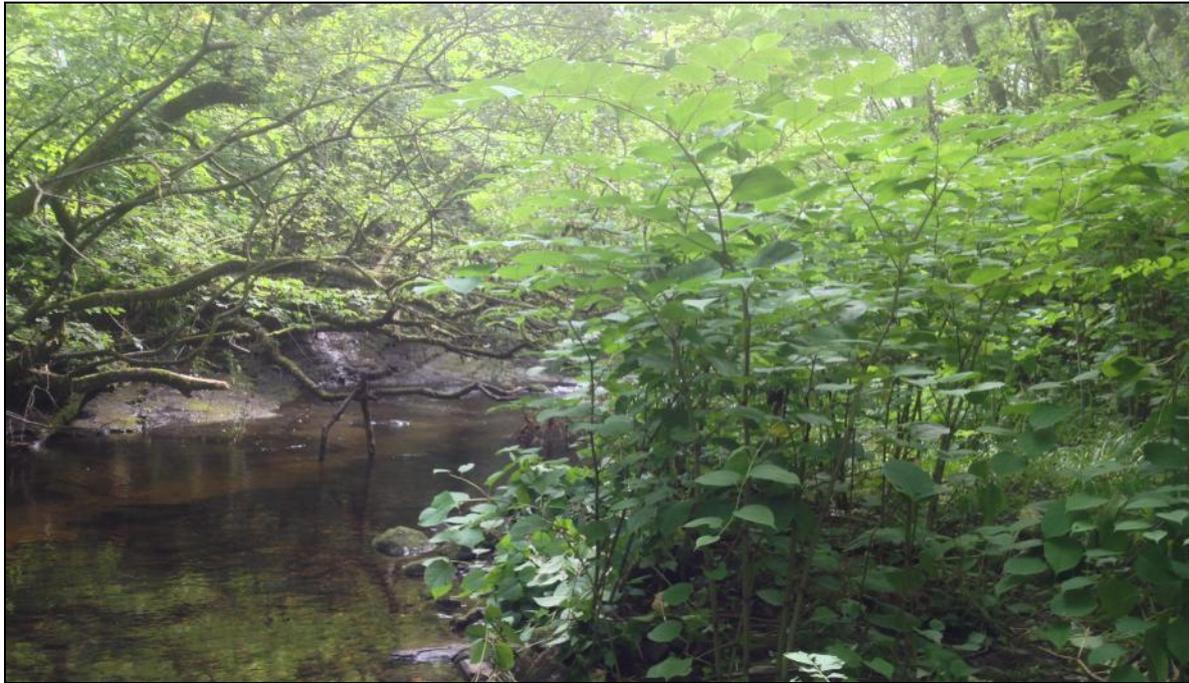
Figure 3: Japanese knotweed infests the river corridor alongside the old Brynamman colliery

JK does not directly support native insects and fiercely out-competes native plants that would normally provide food and habitat for a range of terrestrial invertebrates. Terrestrial invertebrates provide a significant energy subsidy to rivers, including supplement to the trout's diet. This can be especially important in relatively unproductive upland streams.

- The Japanese Knotweed infestation needs to be addressed. As well as posing an increased soil erosion risk, JK, if left unchecked can out-compete most native species, reducing local biodiversity and valuable food-chain subsidies to the river. The knock-on effect could be a reduction in invertebrate diversity or abundance; and a consequent reduction in food for trout.

Treating such a large infestation could be expensive. It may be beneficial to engage with the local council, NRW, and the Carmarthenshire Rivers Trust and explore options for funding a control/eradication programme.

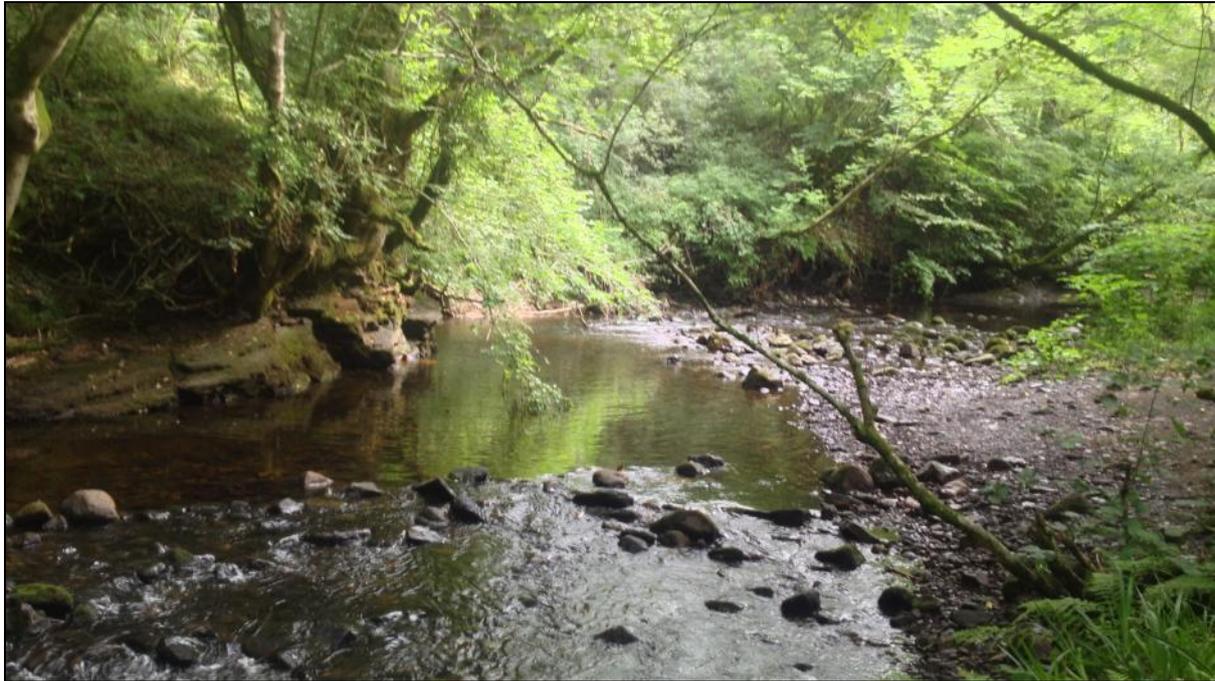
Figure 4: Occasional gravel shoals around pools may provide spawning opportunities

In the upper reaches, the steep gradient and frequent high-energy flows deplete the river of small stones and gravel. However, some gravel shoals have been deposited at the edges of pools. These probably provide some suitable trout spawning habitat. Trout need clean, well-oxygenated gravel approximately 10-50mm in diameter in order to successfully cut a redd (gravel nest) and spawn. If the JK infestation is contributing to soil erosion during winter months, the increase of fine sediment into the river could reduce the quality of spawning habitat.

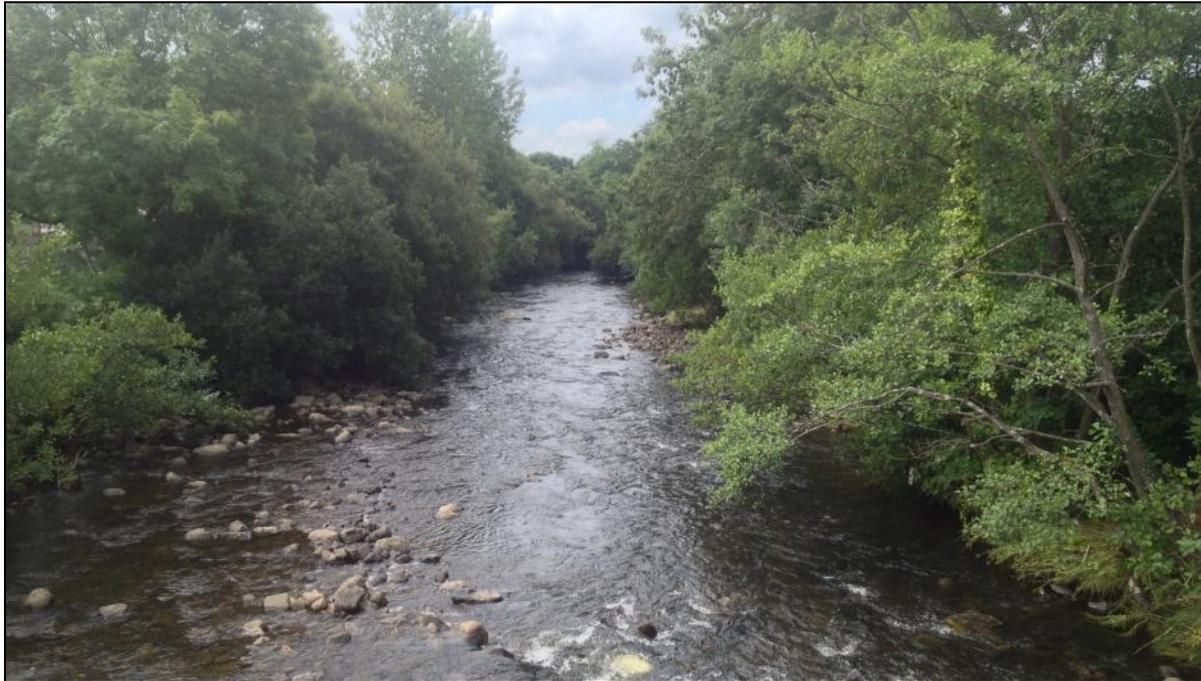
Figure 5: A typical view of the Amman through the centre of Glanamman

Further downstream at Glanamman the river becomes wider and bed depth becomes more uniform with a reduced contrast between pool and riffle habitat. However, the river does retain a relatively pronounced deeper low-flow channel or 'thalweg' providing some depth variation across the channel cross-section.

Large boulders provide pocket-water lies but there is a general paucity of woody debris habitat. In lower-energy systems fallen trees and branches often provide excellent cover for fish as well as habitat for river invertebrates that support the river food-web. However, in upland spate rivers, high energy flows can quickly transport woody debris downstream. In a fully natural system, a steady supply of woody material would enter the river to replace material washed downstream. However, upland rivers flowing through urban and agricultural areas are not supplied with such high volumes of woody debris and many fallen trees are deliberately removed for flood defence purposes.

- Consider introducing some stable woody debris habitat into the upper reaches of the river near Brynamman. Small cabled tree kickers and occasional pleached (hinged) low branches could increase juvenile/overwinter survival/retention during spate flows by creating slack water spots. Fixed woody debris would also provide additional cover from bird predation. Shade is a vital component of trout habitat and it is important to not be too over-zealous with tree works. The introduction of woody debris into the river should not be at the expense of valuable bankside tree cover (especially on upland rivers where so much of the foodweb depends on leaf litter inputs).

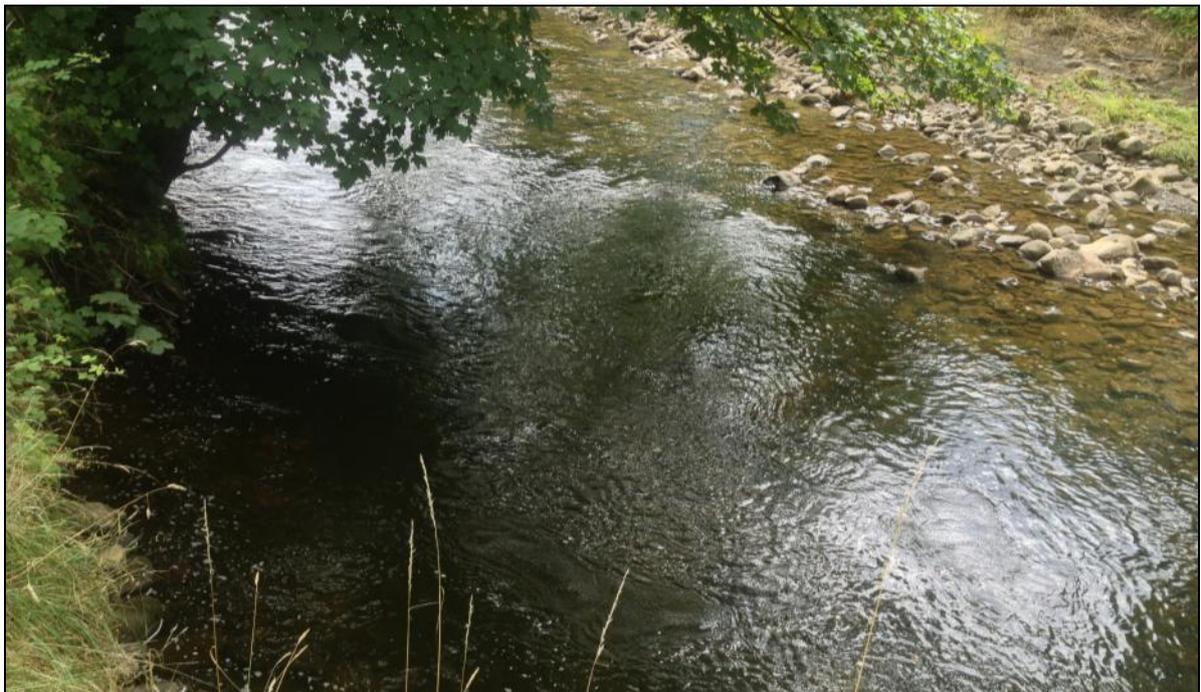
Figure 6: Low-lying branches over deeper parts of the river provide good holding habitat

river. There is some very good holding habitat where branches provide cover over deeper parts of the river (Fig 6).

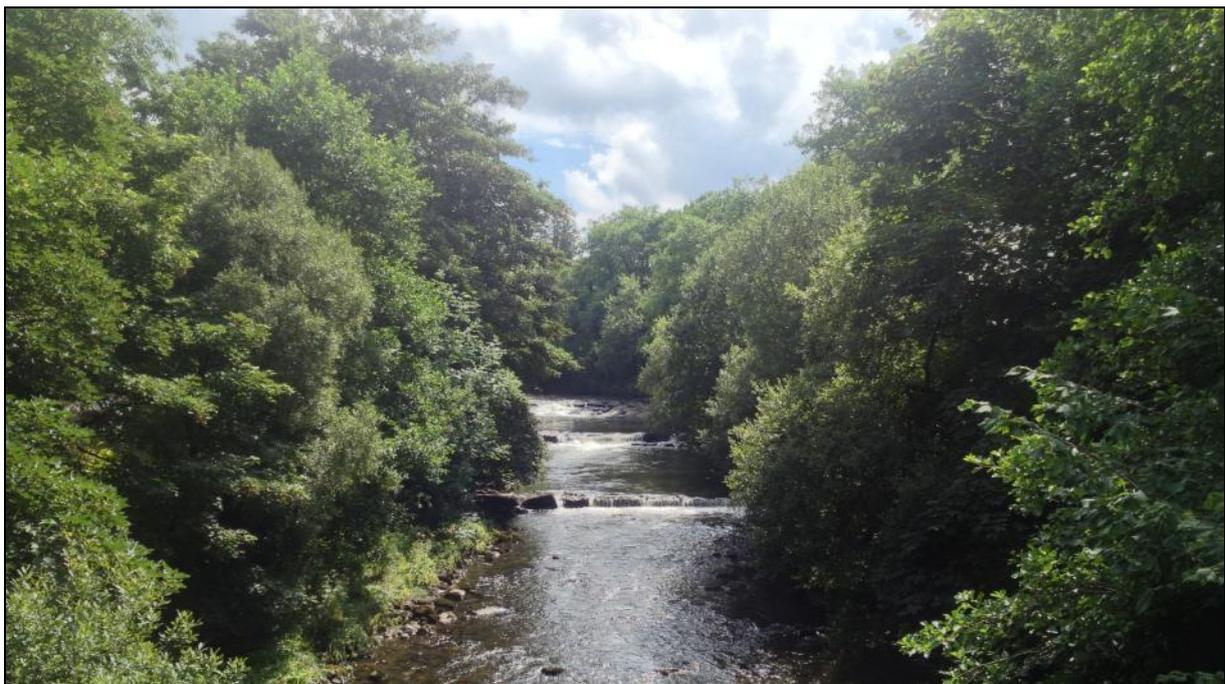
Figure 7: A series of block-stone weirs have been constructed across the channel downstream of Glanamman

From Garnet, through Glanamman to Ammanford, a number of block-stone weirs have been constructed across the channel.

The weirs were installed to control the flow of bed material during high-energy spates and reduce associated erosion and flood risks. The weirs have altered the geomorphology of the river by way of trapping bed load migrating downstream to create shallow glides upstream of the structures and scouring deep pools downstream.

The weir structures act as obstacles for migratory fish running up from the Loughor Estuary and for juvenile salmonids migrating within the river. The cumulative effect of the high number of weirs may significantly impede upstream fish migration, during long periods of low flow.

- Raise awareness within the local community (and anglers) of the importance of fish passage. NRW and the CRT may have records of which structures pose the biggest problems. Explore options to improve fish passage over problem structures.

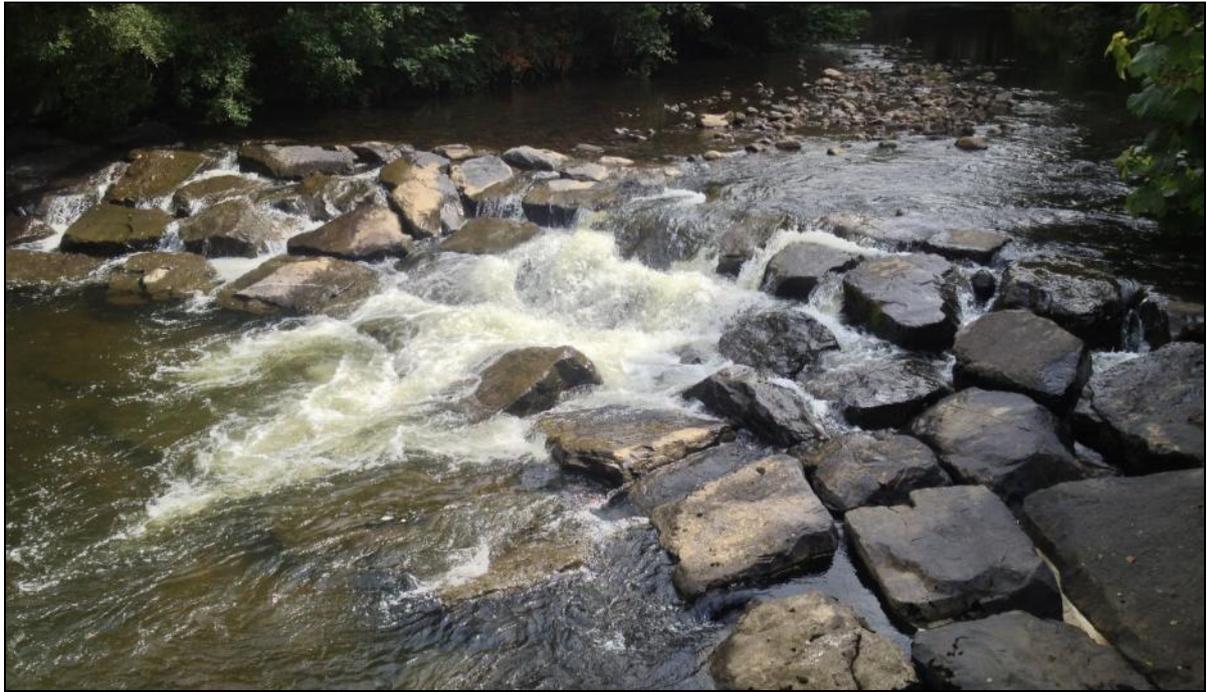
Figure 8: One of a series of weirs near Glanamman.

The weirs vary considerably in terms of their passability for fish, with some appearing to obstruct passage more than others. Fluctuations in water level during spate, or drought conditions, will also affect the head loss across each structure. In times of low-flow the weirs will be more difficult for upstream migration.

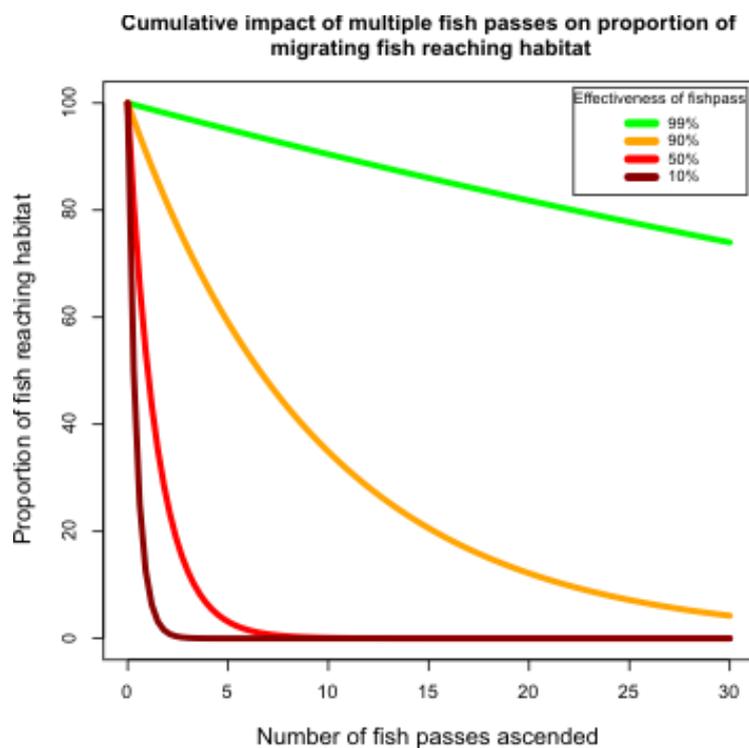
Figure 9: Graph showing the cumulative effect of multiple obstacles to fish passage on upstream migration (courtesy of Dr E Shaw, Catchment Science Centre, University of Sheffield).

In higher flows it is possible that all of the weirs are passable to salmon and sewin. However, research suggests that even the most passable of obstructions can have a considerable impact on fish migration, particularly if fish must overcome consecutive obstacles to reach an upstream habitat.

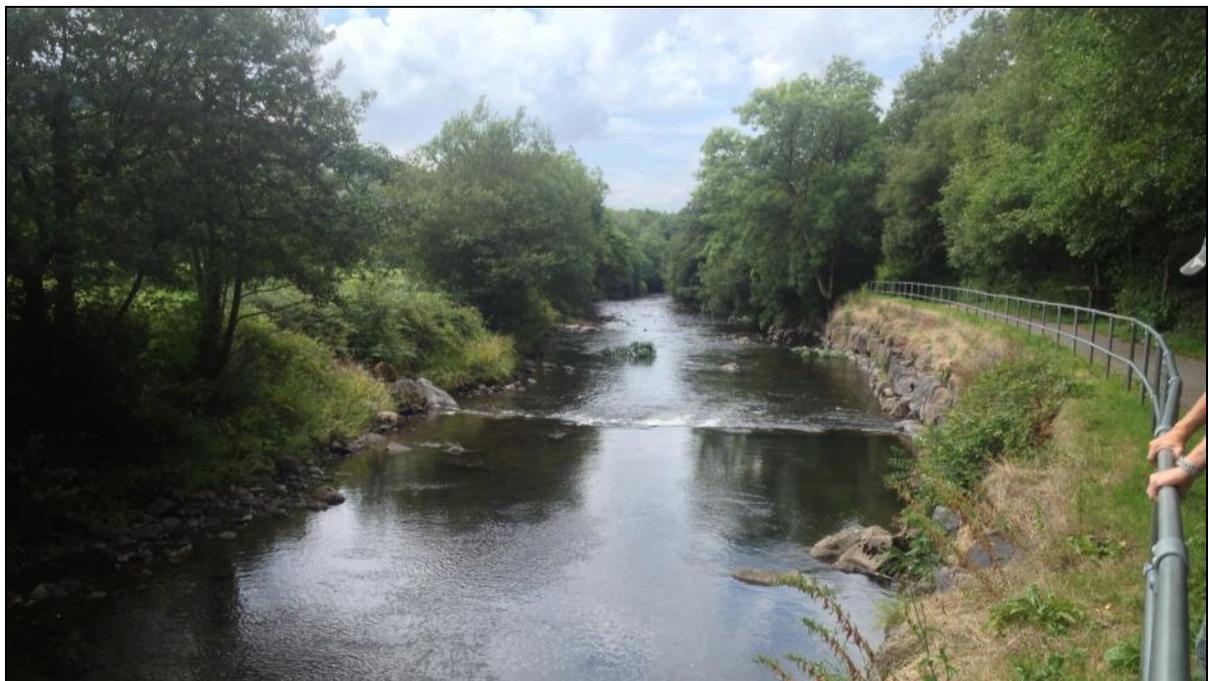
Figure 10: Hard-engineered bank protection on the Amman downstream of Glanamman

During high flows, structures in upland rivers endure considerable erosive forces. Substantial hard-engineering bank protection works have been installed along much of the Amman between Glanamman and Ammanford.

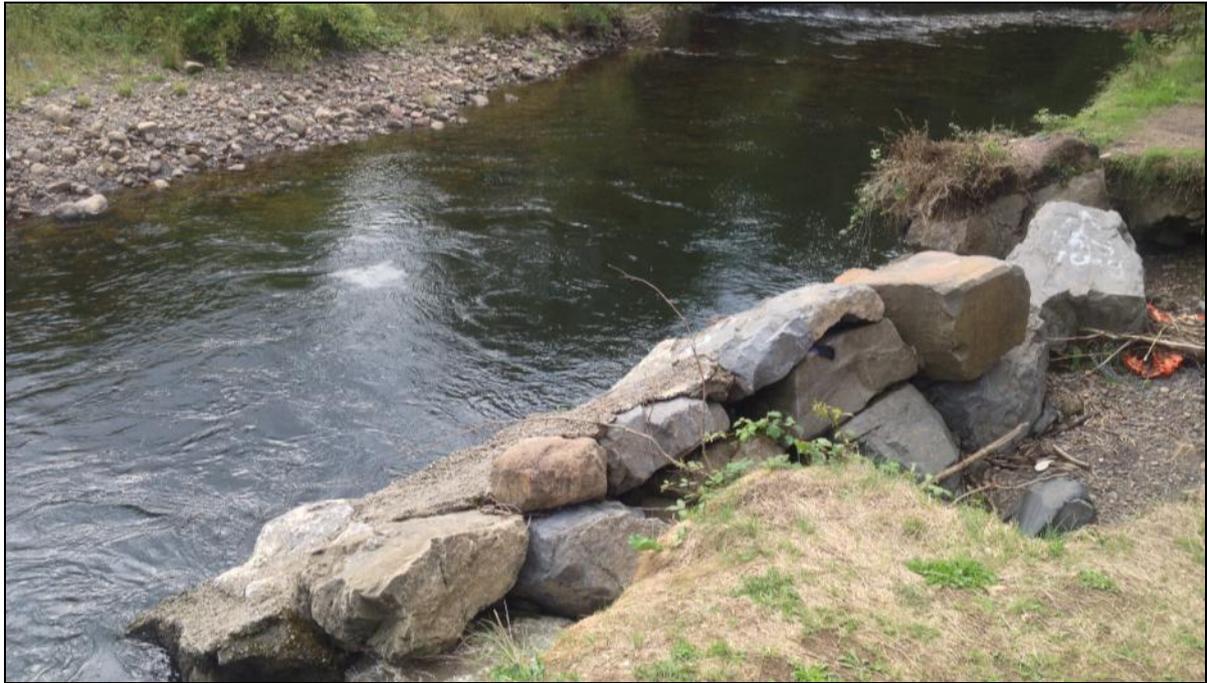
Figure 11: Bank protection works failing at SN 66073 13346

At SN 66073 13346, the bank protection has failed, highlighting the erosive power of the Amman during spate conditions.

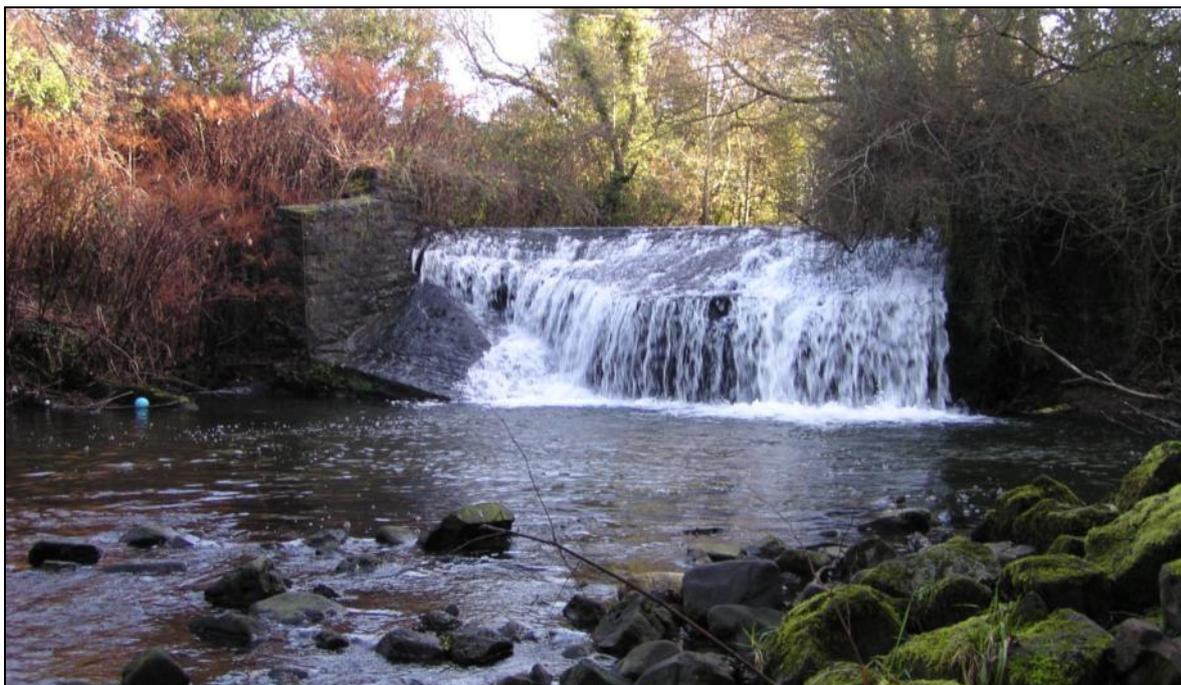
Figure 12: The Weir at Garnent (SN 69406 13131) before collapse (courtesy of Natural Resources Wales)

Downstream of Brynaman at Garnent, a large, impassable weir recently collapsed during a flood. The collapse of this structure provided an opportunity to open up the upper reaches of the Nant Garnent tributary to salmon and sewin and provide access to additional spawning and nursery habitat.

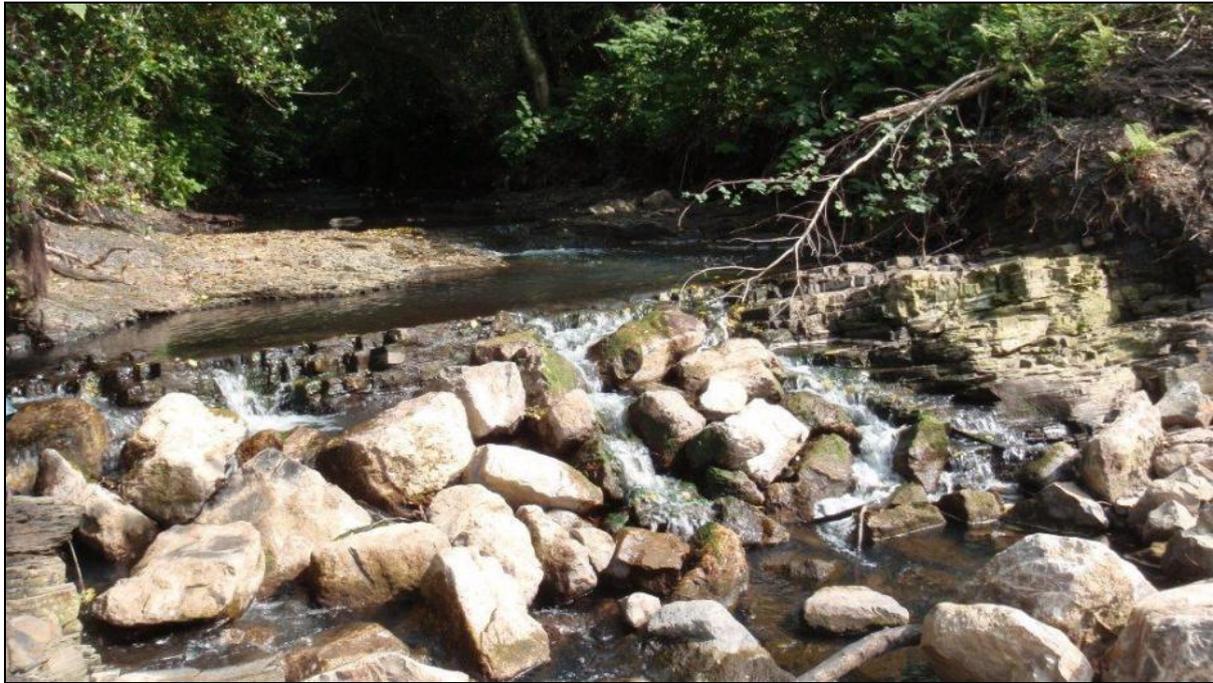
Figure 13: The weir at Garnent, September 2013 (courtesy of Natural Resources Wales)

The Garnent tributary confluences with the Amman downstream of Brynamman and the collapse of the weir may not improve fish passage into the Upper Amman directly. However, this example serves to highlight the impermanence of man-made structures on upland rivers and the opportunities to improve fish passage when structures begin to fail.

The restoring of natural sediment transport and natural erosion/deposition patterns may increase habitat variation, creating different microhabitats that benefit the specific life-cycle stages of salmonids as well as biodiversity in general. How the river responds to the collapse of the weir will be an interesting case study that may provide evidence to support the removal of impoundments on the Amman.

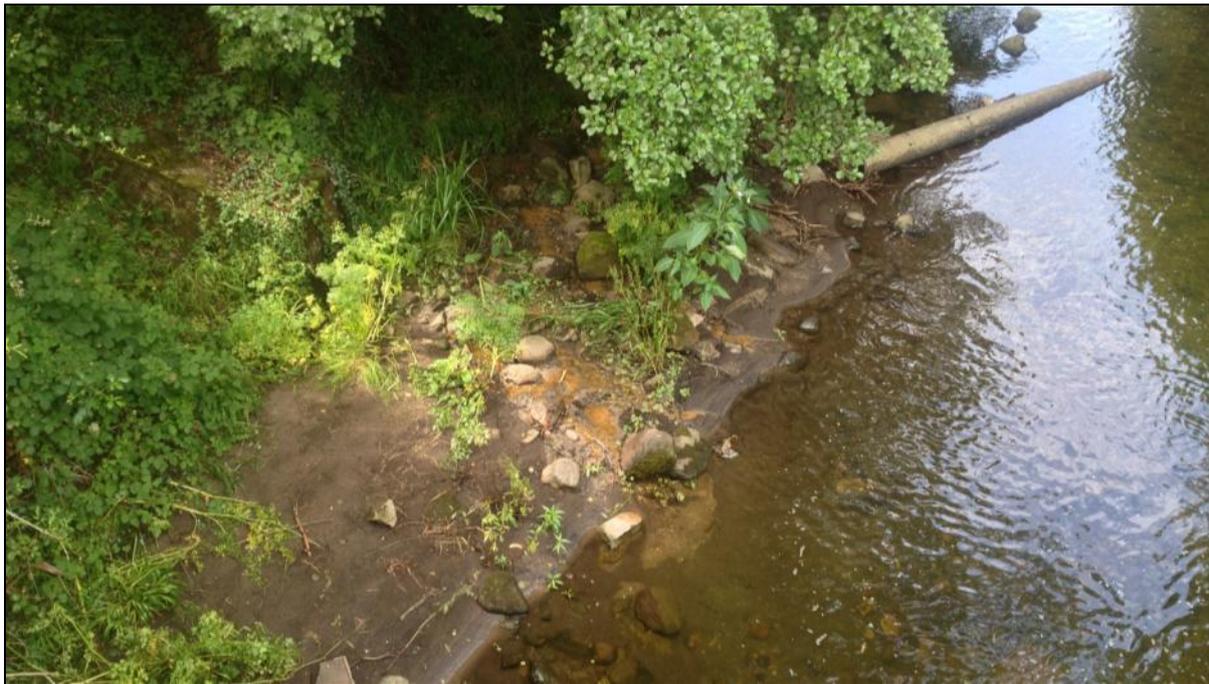
Figure 14: Red-ochre discharge entering the river at Glanamman.

Water quality is an issue for many rivers that flow through areas with an industrial mining heritage. Acidic water draining through mines can mobilise minerals (including heavy metals) from the local geology. Once exposed to oxygen, iron-rich mine leachate often precipitates into a red-ochre coloured ferric hydroxide sludge. In some situations staining can be caused by a group of bacteria that derive energy by oxidising dissolved ferrous iron to produce insoluble ferric oxide. Both chemical and biochemical oxidation of iron can cause

a degree of de-oxygenation within watercourses but the effect normally looks worse than its actual impact on water quality.

The results of chemical monitoring in the Amman suggest that pH and dissolved oxygen are not considered to be problems. Elevated levels of copper and zinc are contributing to the present WFD status but overall water quality has significantly improved over the past 20 years.

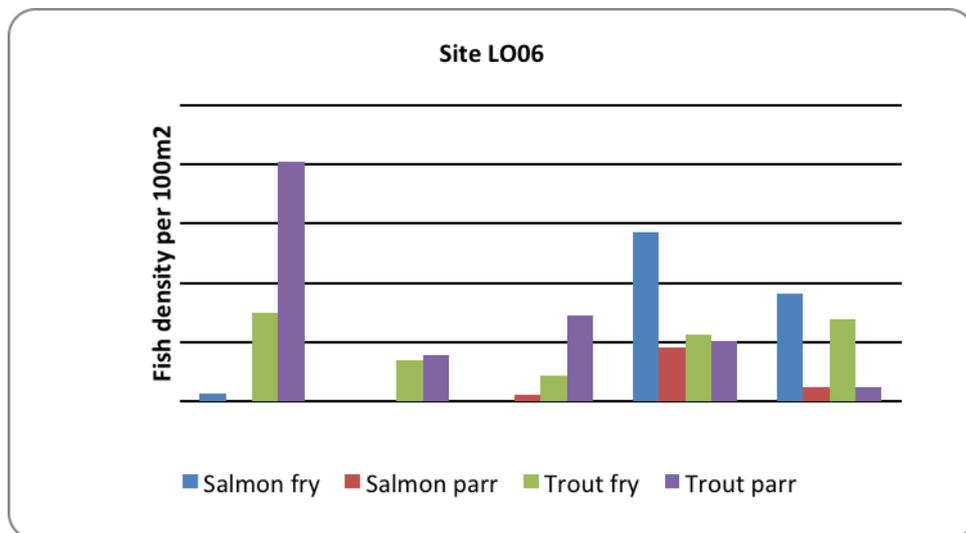
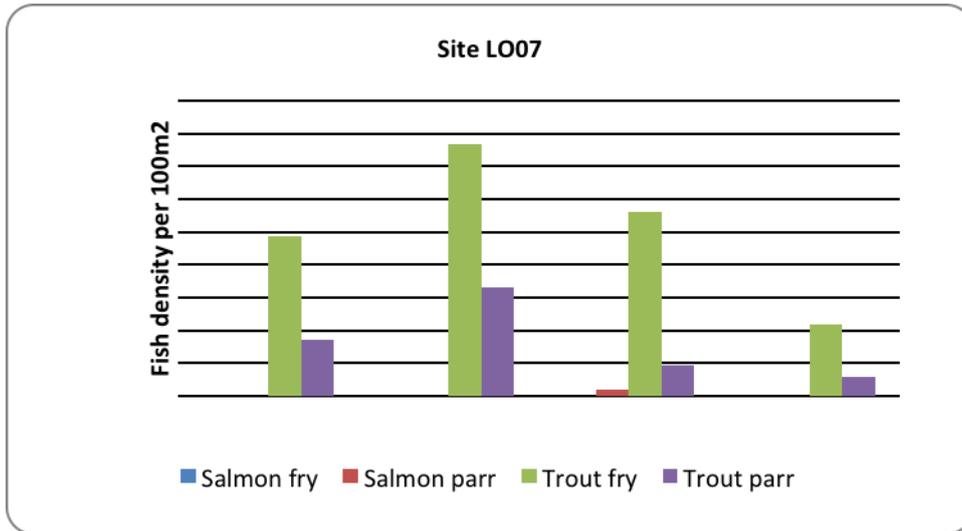
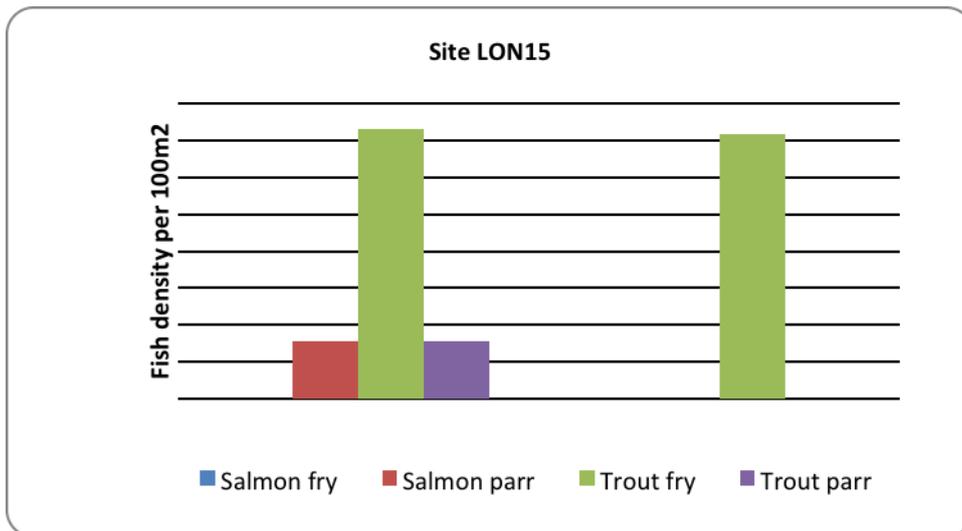
Amman Fisheries Survey Data 1991 to 2009

The data for the lower site (LO06) show that numbers of juvenile salmon have improved at this site in recent years, whilst numbers of juvenile trout are more variable. On the other hand, juvenile salmon have only been recorded on one occasion at the upper two survey sites (LO07 and LON15), whilst juvenile trout numbers show a decline on the most recent survey (2009). All three sites are due to be resurveyed in 2015.
