Afon Machno: WFD waterbody GB110066054810Machno

Existing/historical information

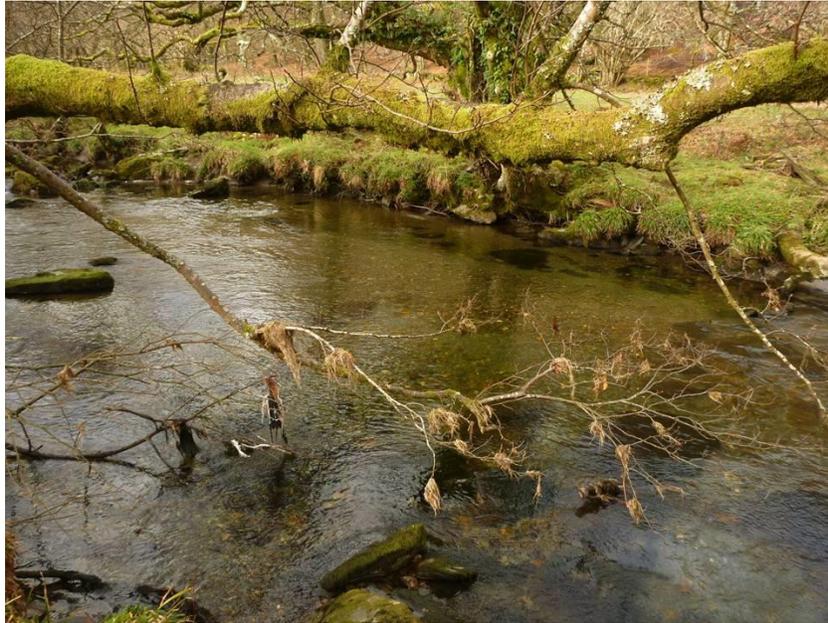
Figure 1: Crystal clear water with some nice submerged structure in the form of boulders. Opportunities for juvenile fish exist here along with some opportunity for adult fish (more areas of greater depth and more cover would increase prospects for adult fish). Far bank stone appears to have been laid deliberately by human hand – a common practice on the Machno.

Examples of good habitat in and around channel (e.g. Fig. 1), with some pool habitat present, good examples of suitable flow and depth for juvenile fish (in places combined with excellent partially submerged brashy/woody cover; e.g. Fig. 2) and substrate of a good potential size for spawning of both trout and salmon. However, there is potentially too much of a good thing, with an apparent oversupply

of pebble and cobble-sized sediment (Figs. 1, 3 and 4). The value of gravels for spawning would also benefit from the presence of debris within the channel that would promote bed-scour and deposition processes that would help to “sort” particle sizes according to local current velocities. In addition, such debris would also increase the available cover for adult fish; improving the general value of habitat to resident adult fish – but also increasing the desirability and utility of adjacent spawning gravels.

Some fenced sections (not always on both banks) with vegetated buffer strip/trees (e.g. of varying degrees of grazing exclusion Figs. 1-4). There was also a short riverside field section that combined grazing exclusion with recent tree planting (Fig. 5). Conversely, also long sections grazed right to river's edge (e.g. Fig. 6). Generally, though, the channel was suffering from the effects of over-grazing.

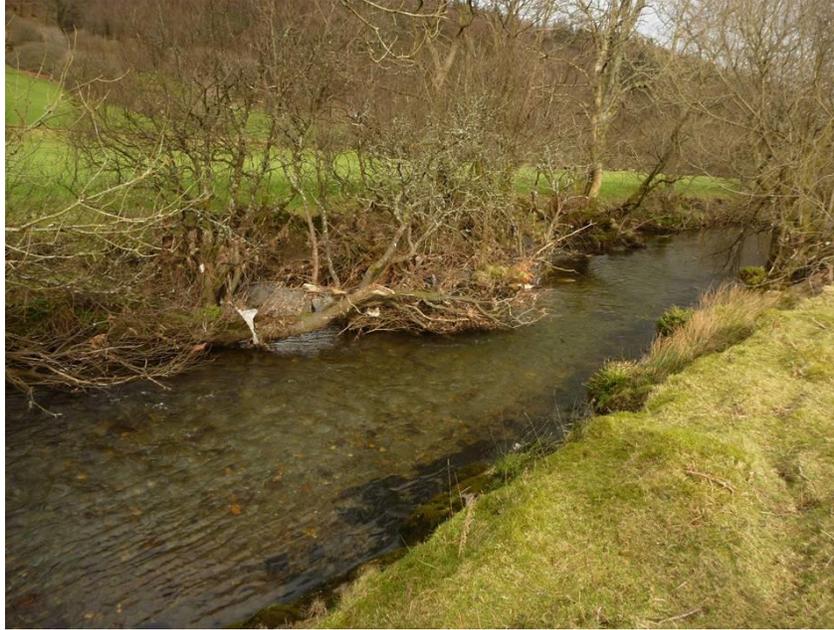
Figure 2: Tremendous cover enhances the potential value of this riffle for juvenile fish. Although there are a number of examples of this type of habitat in this reach - there would ideally be a much greater proportion of similar areas and the grazing regime means that there is little prospect of a succession of such trees to replace the existing specimens (as seedlings will be grazed out).

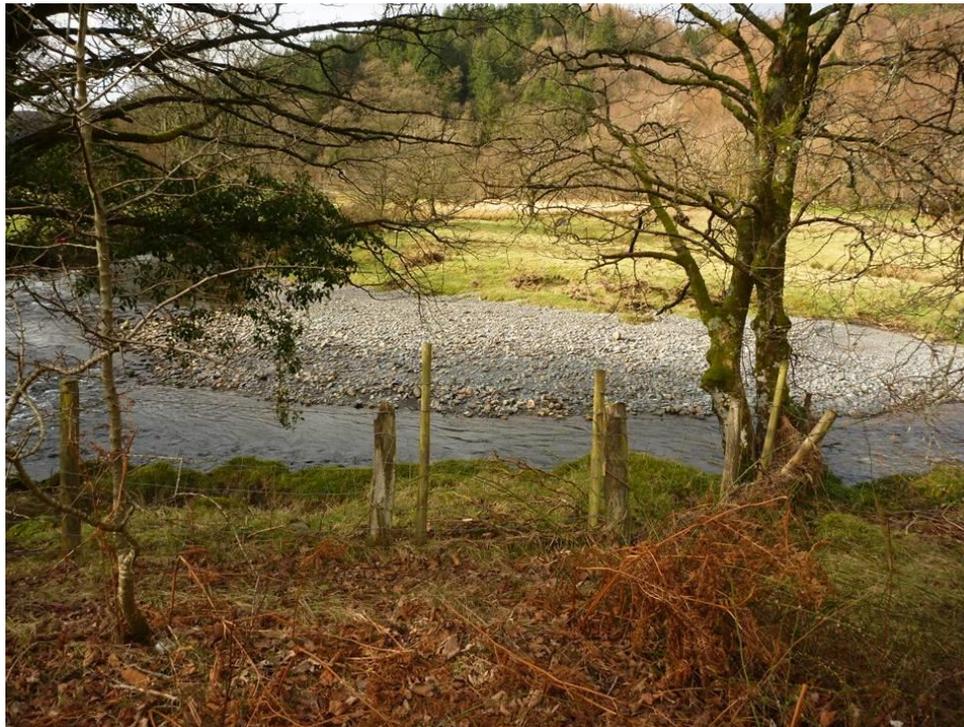
Figure 3: Large gravel point bar on a heavily grazed bank (far bank). Channel consequently over-wide and over-shallow in a large proportion of this reach

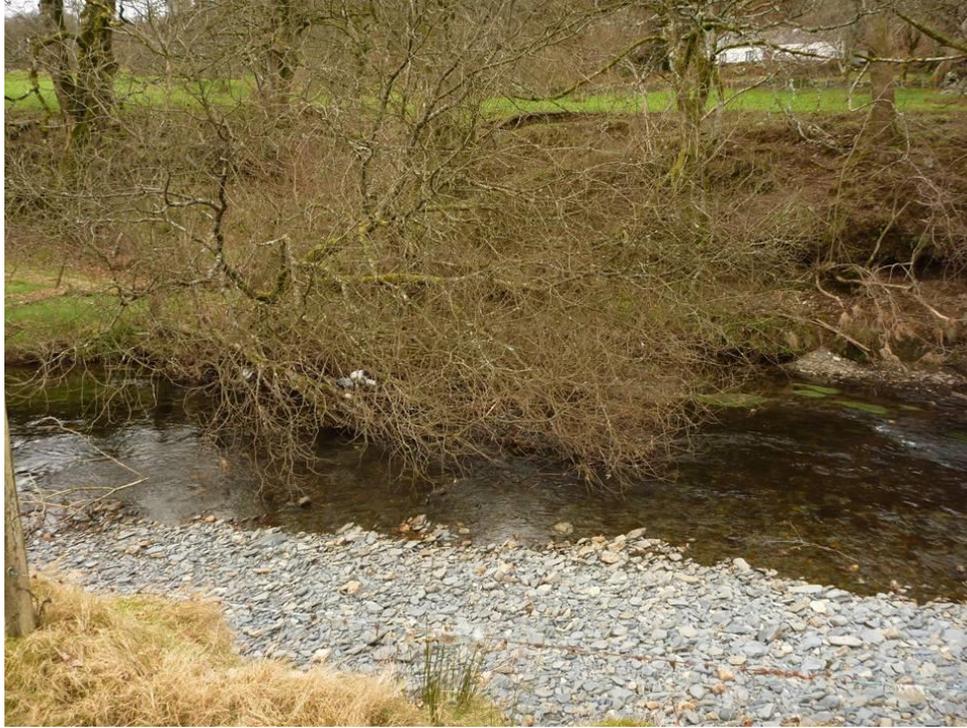
Figure 4: Over-supply of cobbles evident on near bank (side bar), but good juvenile habitat is still present. However, adult fish habitat of equivalent quality was much less common due to lack of depth and cover in over-wide heavily grazed sections. Lack of scour-pool depth was often compounded by infilling effect of over-supplied substrate.

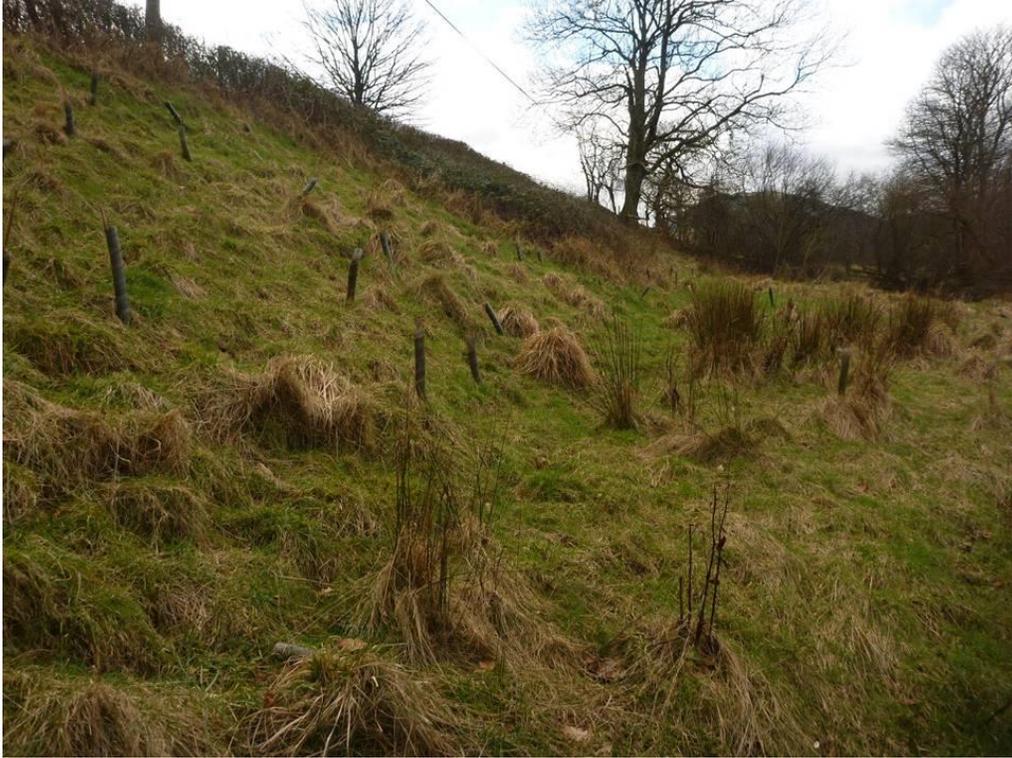
Figure 5: Planting and grazing exclusion scheme on riverside field (RHB). The LHB did not typically enjoy similar provision.

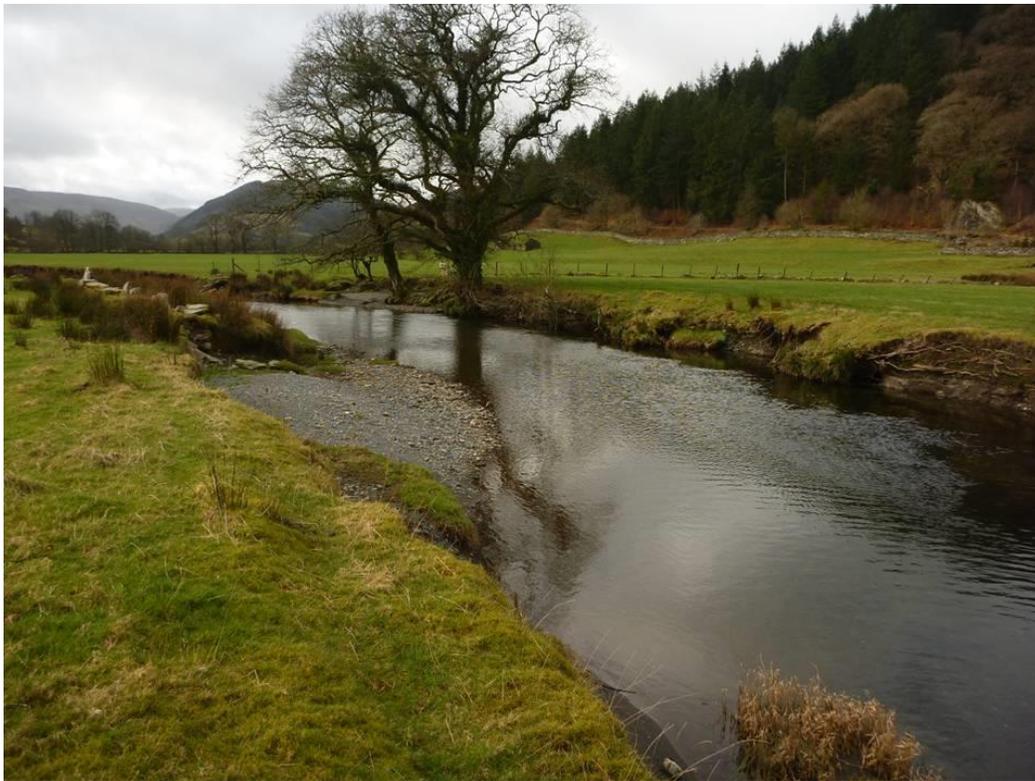
Figure 6: Grazed on both banks

Creating vegetated buffer strips on both banks of the river via livestock exclusion and supportive planting of trees/understory where necessary will result in:

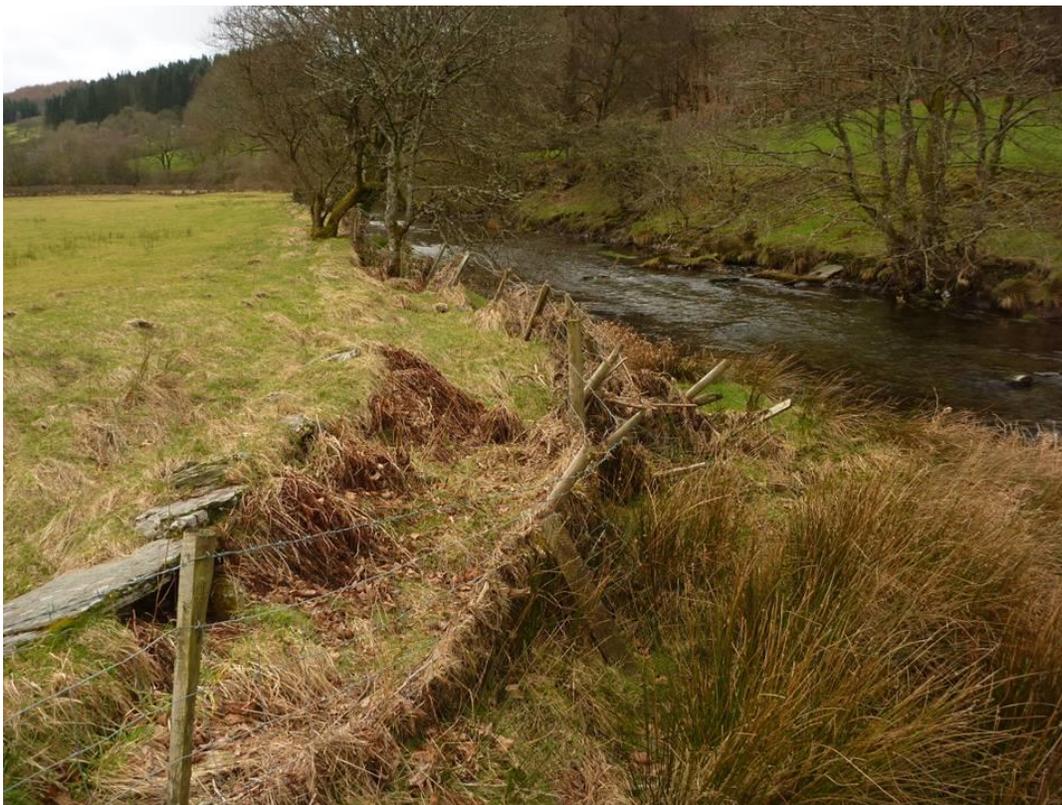
There is known to be a great difficulty in making any economic (or any other beneficial factor) arguments to increase the amount of grazing exclusion from the riparian zone. Because of the very "flashy" nature of the catchment, out of bank spate flows are commonplace and this places a heavy burden of maintenance for any bank-side fencing (Fig. 7). Whilst grant schemes may pay for the fence installation, the resource required for maintenance is typically perceived as too great to be worthwhile.

Figure 7: The fencing just about survived the battering from a previous spate, but fences are frequently flattened during these events. Judging by the topography and the pattern of stranded debris, this is a point that floodwaters re-enter the river channel as water levels recede.

- The identification of areas where fencing will run parallel to out of bank flows (and hence be largely unaffected – even when constructed using standard materials and designs)

- Strategic location of special fencing panels at points where flood waters leave and re-enter the main channel (e.g. top-hung panels used in classic “water gates” used for livestock crossing points) that withstand flood flows and are easy to maintain. Such panels can also be included at points that field boundary fences that are perpendicular to the river are adjacent to the river.

N.B. an alternative to this option is to use standard panels that are designed to deliberately break away during spate flows (requiring only a small number of known panels to be replaced/maintained on a regular basis)

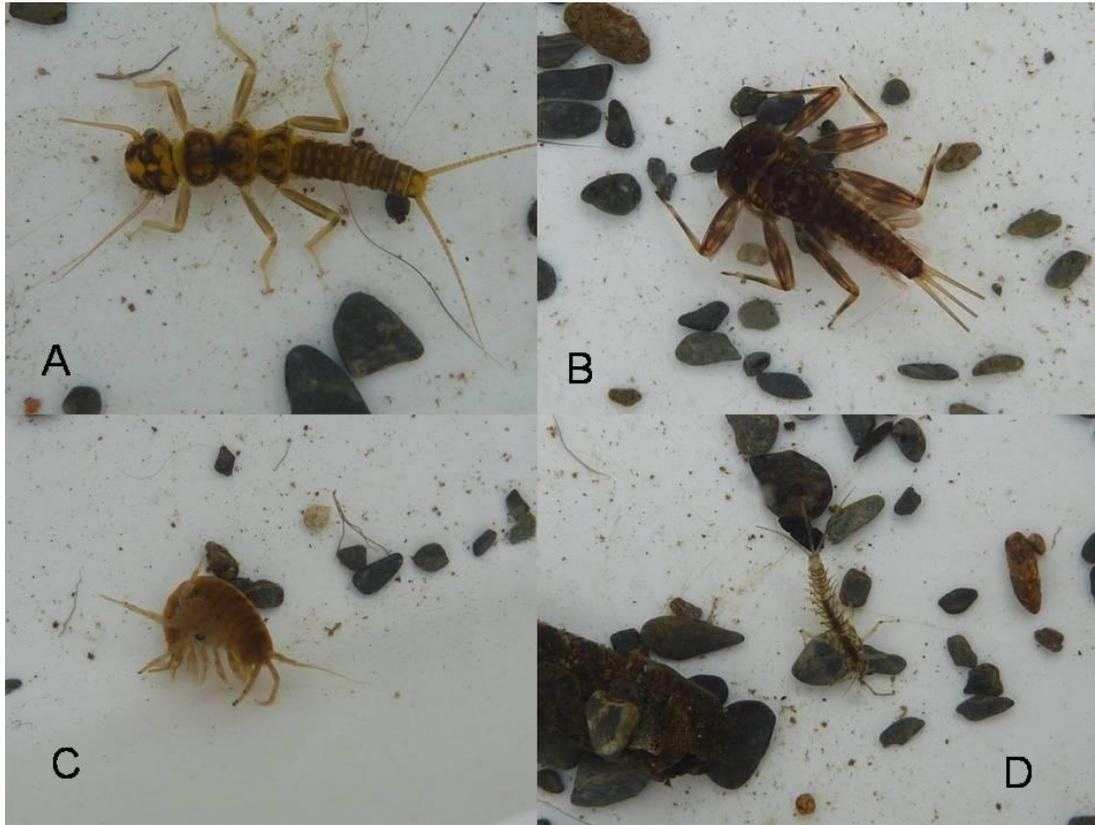
There were no apparent current problems with water quality based on invertebrates found in kick sample performed on site. Several taxa known to be sensitive to a range of pollutants including heavy metals, organic enrichment and pesticides were present. However, very low numbers of individuals were caught during a three minute sample. It was also noted that there was little evidence of leaf material retained in the channel or obvious periphyton (algae or diatoms) on much of the pebble substrate. Again, the highly variable, frequent and highly erosive spate flows are likely to remobilise what little deciduous leaf material falls into the channel as well as constantly disturbing and redistributing gravel and cobble substrate. A likely consequence is the poor retention of leaf litter and

Figure 8: Invertebrate taxa that are sensitive to a range of pollutants were present in the Machno. These include species sensitive to organic pollution (A: Perlid stonefly, B: Heptageniid mayfly) as well as taxa sensitive to pesticides used in sheep dip (C: Gammarid shrimp) and taxa that can tolerate some organic pollution but are very sensitive to metal pollution (D: Baetid mayfly).

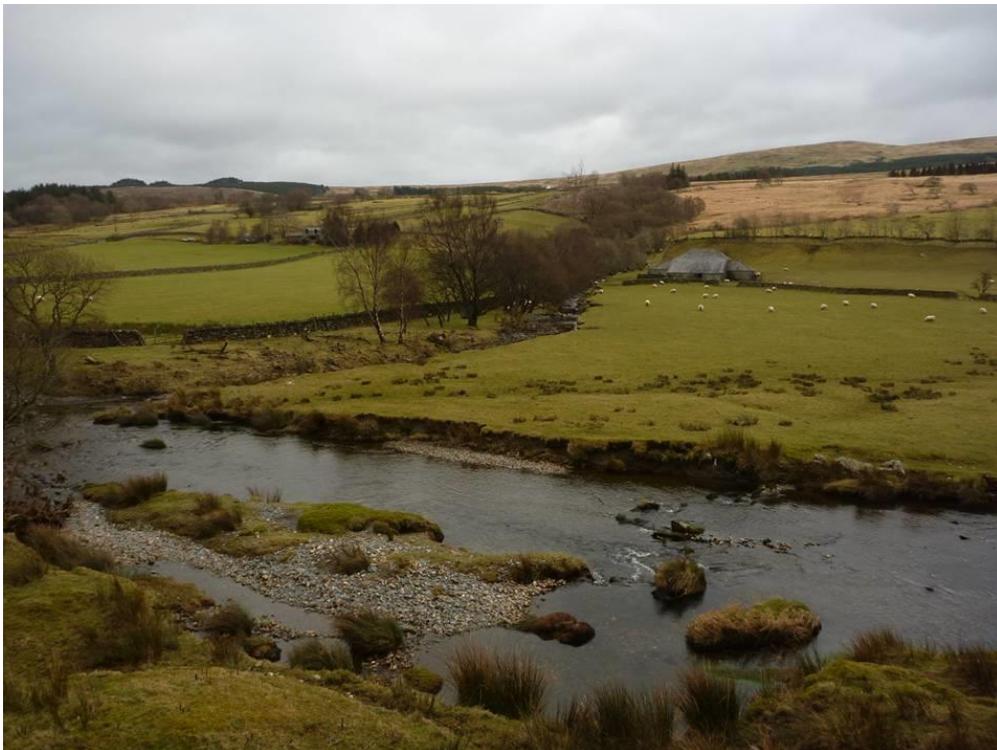
In general, the nature of impacts identified in Reach 1 also apply to Reach 2 (and in intervening sections that were “spot checked” en route; e.g. Figs. 9 and 10 between the two main Reaches that were walked). However, the extent and severity of these impacts was greater in Reach 2. Some additional stressors resulting from physical interventions in the river channel also compound the general effects. In particular, the practice of dredging shoals of cobble and gravel from the river and piling it on the bank top to form flood “bunds” (along with installing hard bank revetments constructed from large boulders) is also compounding the already highly erosive flow regime (Figs. 11 to 14 inclusive). These examples are characteristic of the section walked in Reach 2.

Figure 10: Rapid lateral erosion and highly mobile bed substrate - a continually disturbed habitat. The rate of disturbance appears to be limiting nutrient retention and overall foodweb productivity (Spot check en route at NGR SH 78543 49529)

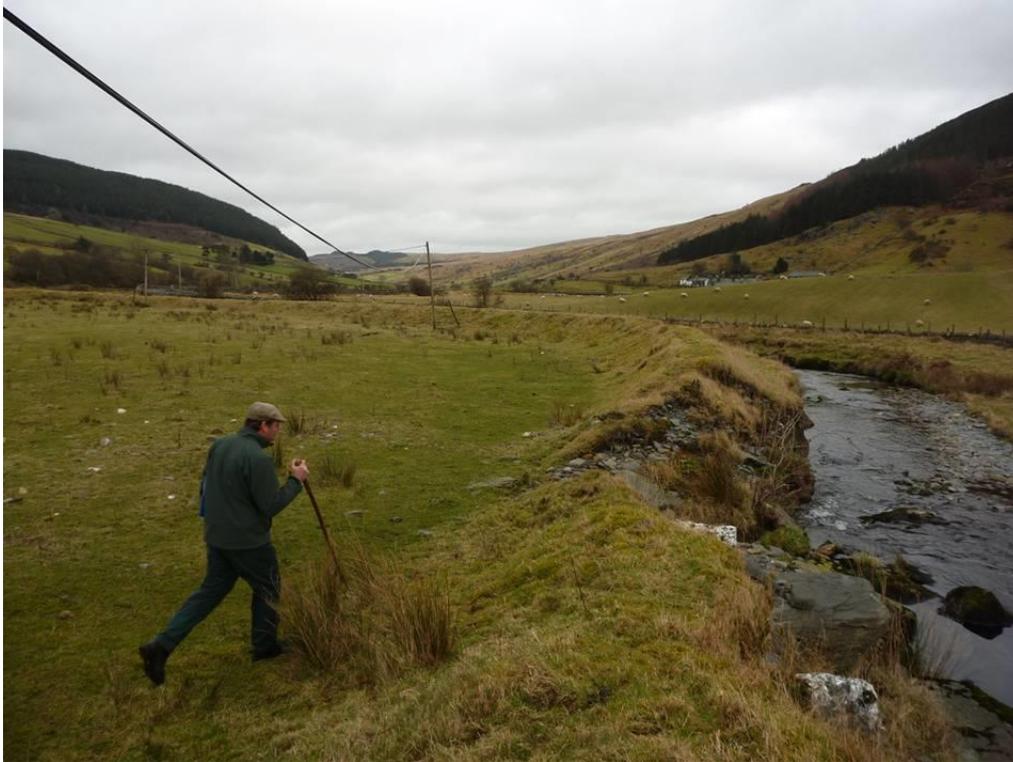
Figure 11: Dredged bed material piled up to form flood bund along the bank top in Reach 2

The major problem with the practice of dredging the riverbed and constructing hard/flow reflecting bank revetments is that it tends to increase the rate of erosion directly downstream of such modifications. In other words, this type of intervention takes what is already a bad situation and makes it worse. The practice of gravel and cobble removal also extends to islands that develop in the stream (Fig. 15)

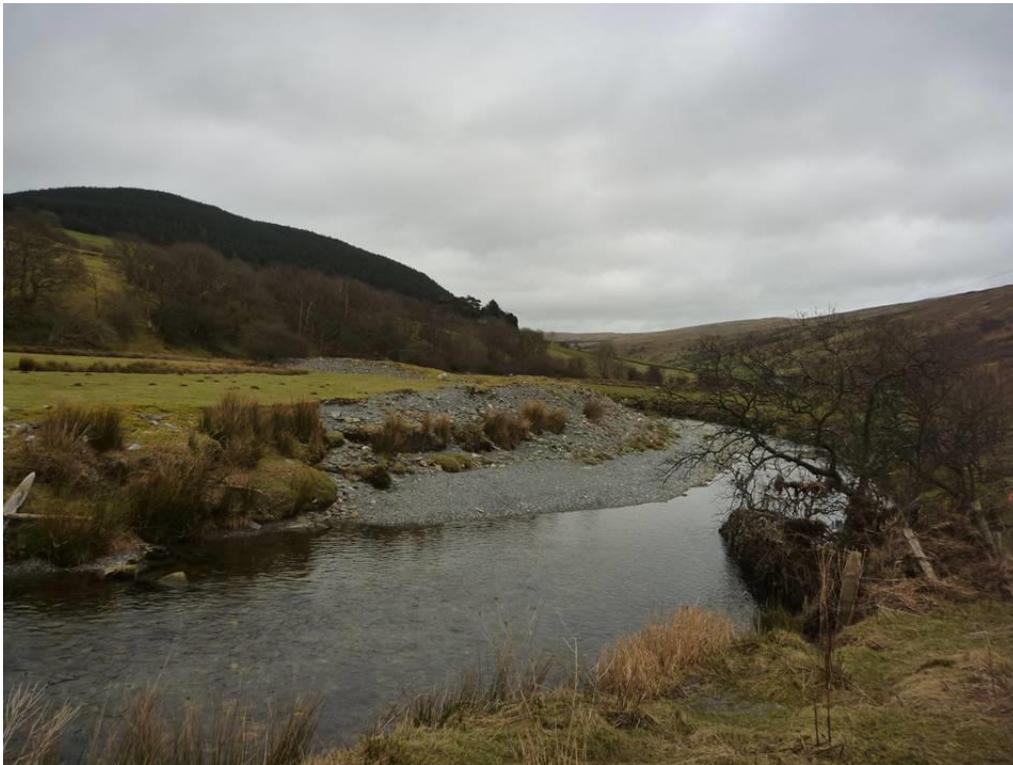
Figure 12: More substrate dredging and flood bund construction on LHB (left of frame) with hard revetment on RHB.

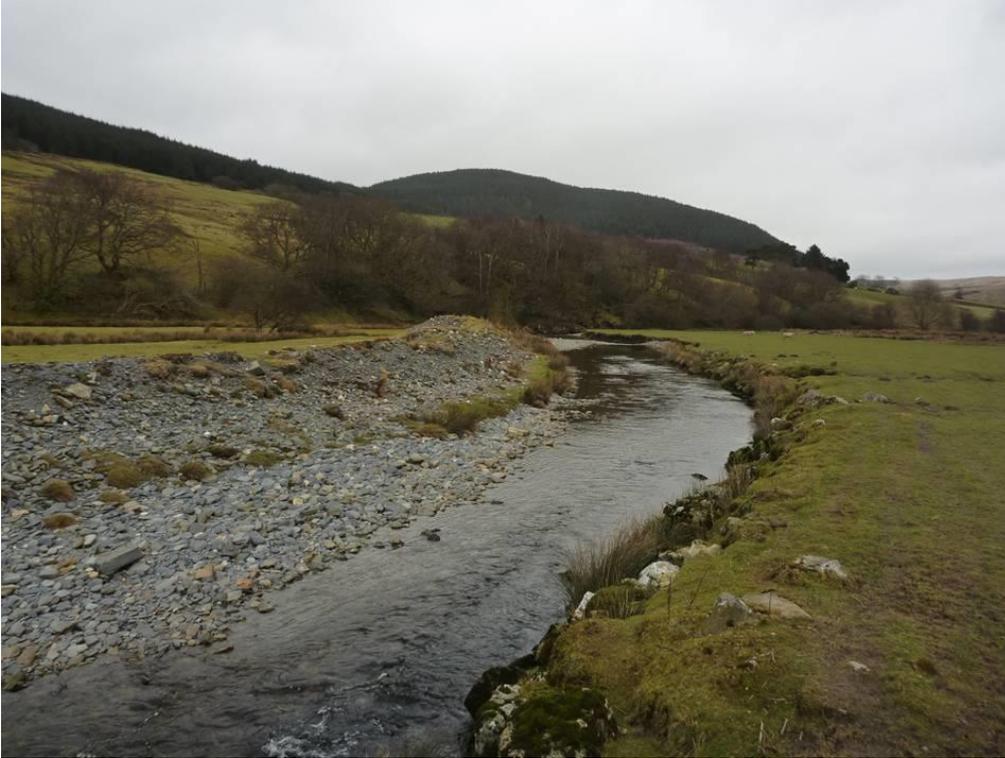
Figure 13: Detail of LHB bund and RHB hard boulder revetment

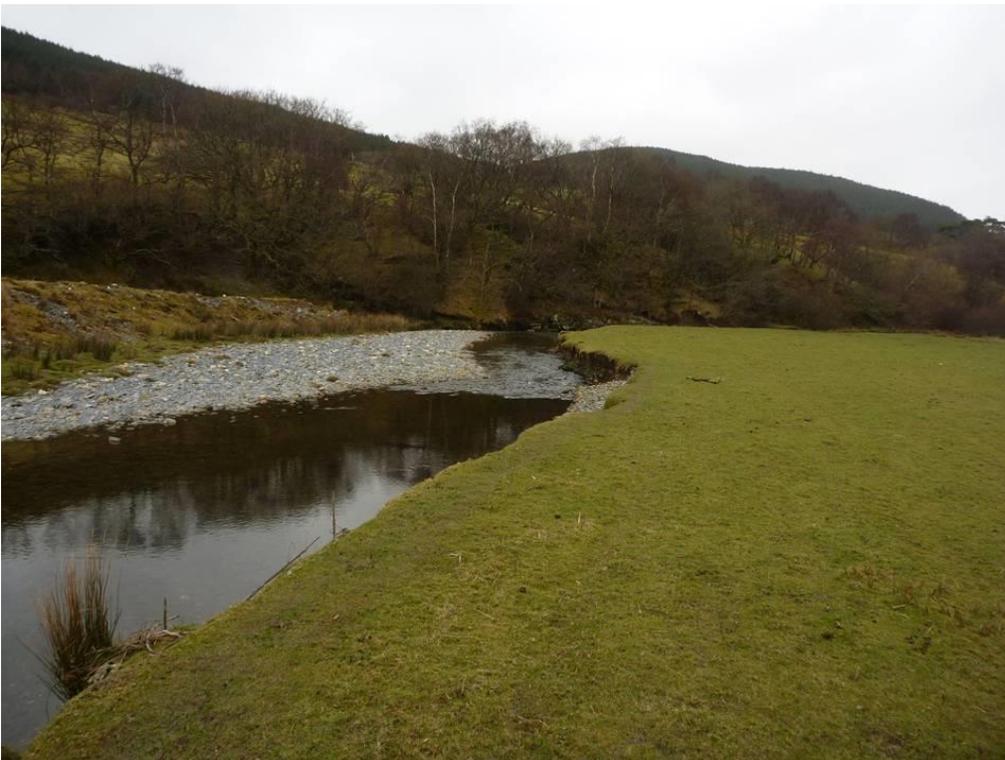
Figure 14: Where hard revetment runs out (and grazing occurs up to river's edge) the cycle of erosion continues at a rate that is harmful to fish populations and overall biodiversity

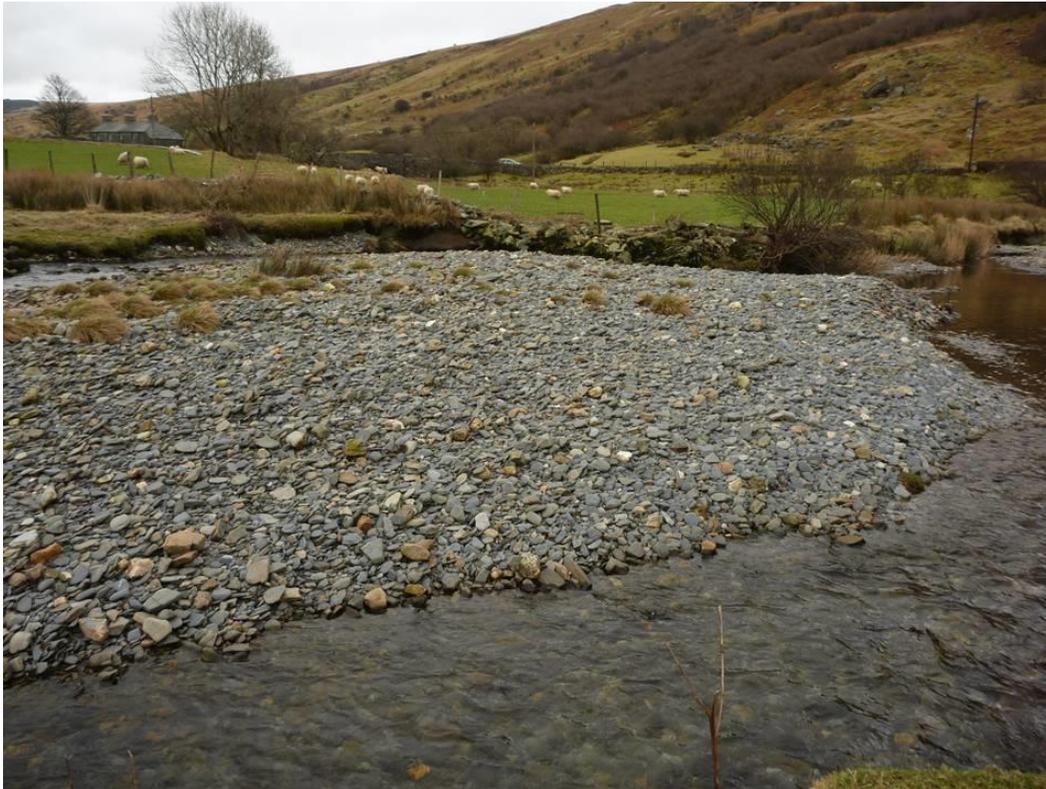
Figure 15: A gravel island that is scheduled for removal in the near future. The rapid rate of its formation (and the rate at which it changes) is indicated by the general lack of vegetation that has been able to colonise since the previous removal of deposited material at this location. The island is shown on the Ordnance Survey map at this point (NGR SH 77145 48059) – indicating that it is a regular feature and that removal is unlikely to be successful.

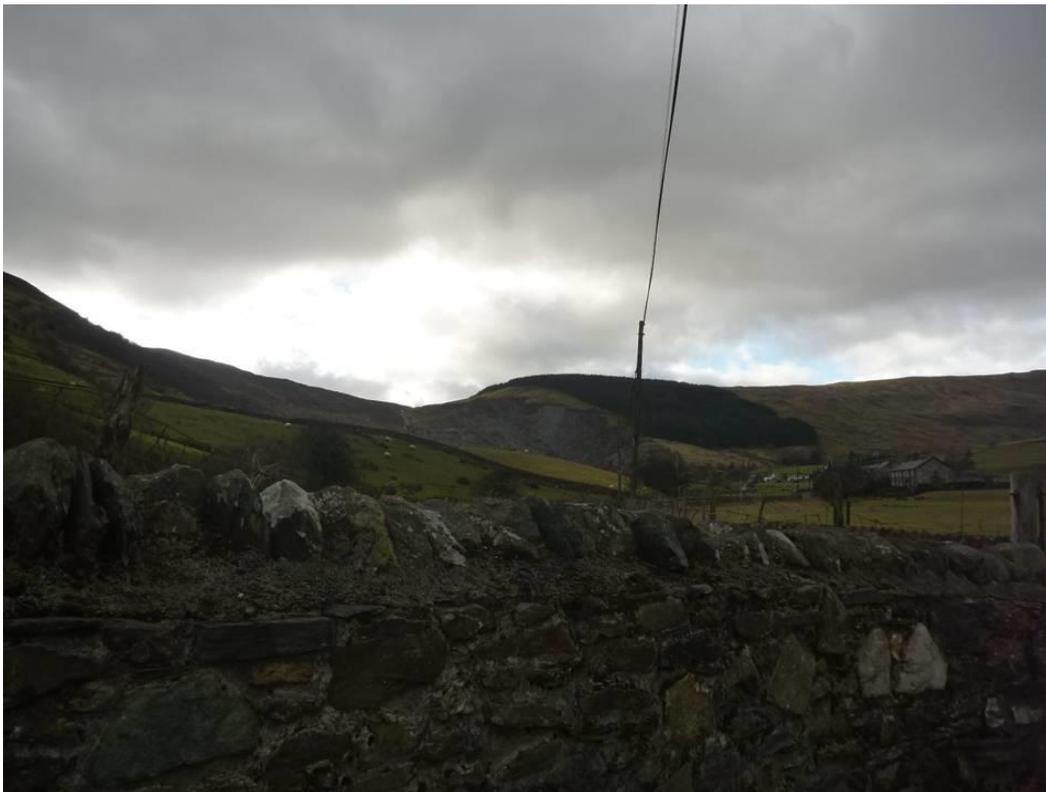
Coniferous forestry drainage arrangements (along with any moorland drainage ditches that may exist) are the worst possible starting conditions for a river that is susceptible to sediment over-supply. Instead of acting as a sponge that absorbs and then slowly releases rainfall at the top of the catchment – water is conveyed immediately downstream from the point that it hits the ground. The result is highly variable, flashy flows that generate much more erosion of river bed and bank material. On top of this, the heavily grazed and hard (compacted by livestock footfall) land surrounding the river when it leaves the high moorland exacerbates the already flashy nature of the headwater catchment running off the high moorland and coniferous forestry slopes (Fig. 16). Because hard compacted ground with close-cropped vegetation is very poor at absorbing rainfall – surface water will immediately run off into the river. Moreover, the lack of complex vegetation (and associated below-ground root structure) renders the banks incredibly susceptible to erosion. The combination of highly erosive, flashy flows and highly

Figure 16: High moorland (left of frame) and coniferous forestry (centre/right of frame) headwaters running past a loose, exposed scree slope.

Consulting the existing forestry plans for the creation of hardwood corridors adjacent to watercourses within softwood plantations (e.g. along the Afon Glas Gwym tributary) and identifying opportunities to improve drainage arrangements for both forestry and moorland management that will reduce the flashy/erosive flow regime (i.e. grip blocking) will:

- Reduce the amount of cobble supply and erosion rate (again saving costs for landowners trying to manage both processes from within the river as well as promoting retention of nutrients/development of aquatic foodweb)
- Increase the efficacy of downstream measures to control erosion/create good habitat
