Advisory Visit
River Aire, North Yorkshire
September 2011

1.0 Introduction

2.0 Catchment and Reach Overview

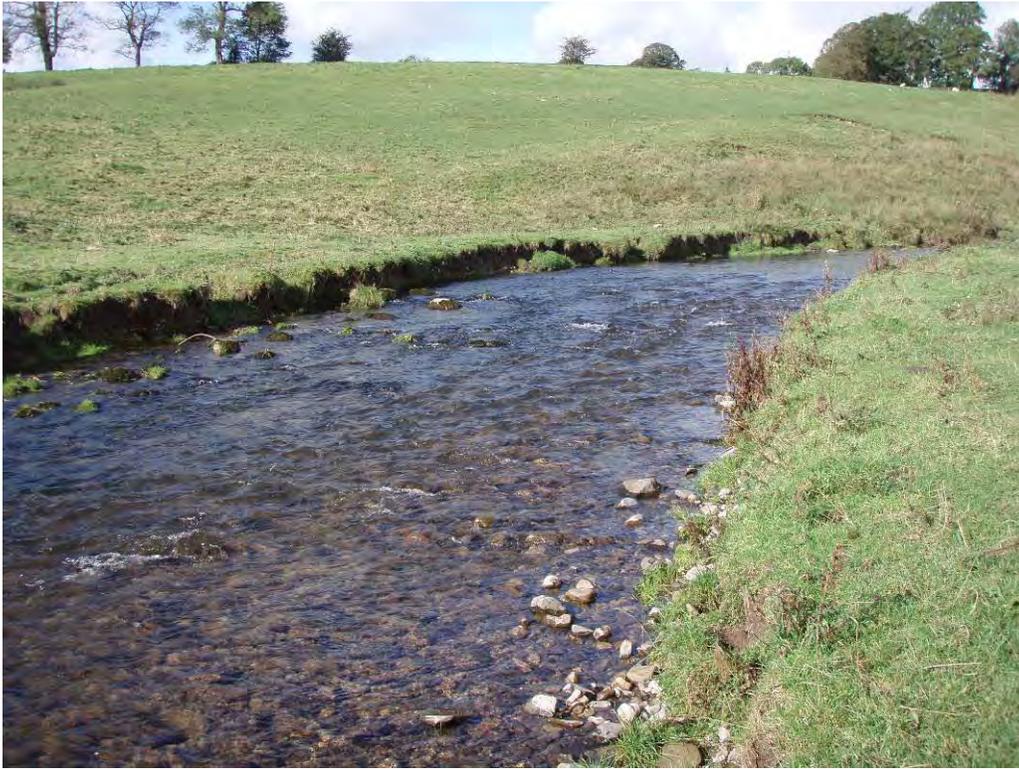
There are two distinct influences on the shape of the river channel on this part of the Aire, namely land use and bank reinforcement. Land use within this reach is predominantly improved grassland with intensively grazed banks. Where livestock have unfettered access to the river this results in a bank with few (if any) trees and trampled (poached) margins which are susceptible to increased rates of erosion; this leads to a shallow, over-wide channel with poor in-stream habitat for fish (Photo 1).

Photo 1 Grazed, tree-less banks resulting in accelerated bank erosion and an over-wide, shallow river channel – poor habitat for fish.

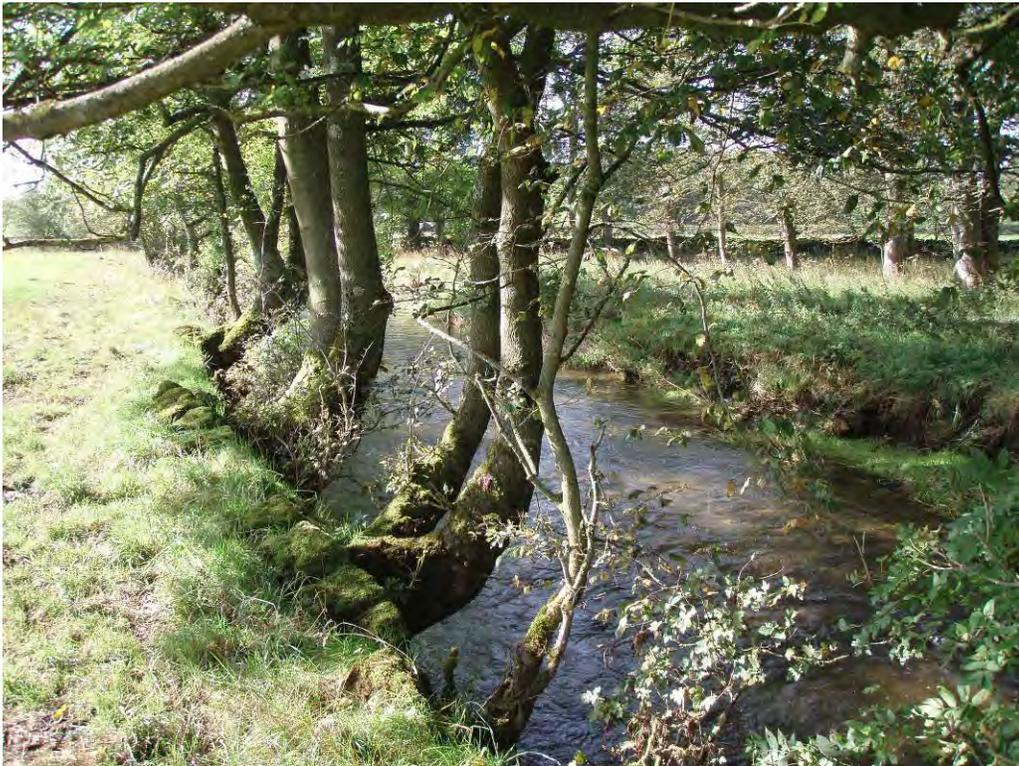
Some lengths of river have banks have been reinforced (probably in the C19th) with stone walls, often with trees growing above. An example of this is immediately upstream of Newfield Bridge (Photo 2). The reinforced banks are much more stable and resistant to erosion meaning that the river channel in these areas tends to be narrower and deeper and much better fish habitat. Potential disadvantages to totally stabilised banks can include a lack of undercuts and overhead cover (good adult fish habitat) and a lack of acceptable rates of erosion to provide input of coarse sediments (gravel) for fish spawning and invertebrate habitat.

Photo 2 Stone wall revetment with mature tree growth above (left bank). This stable bank form creates a narrower, deeper channel (better fish habitat) but limits natural river processes.

Consideration should be given to tree management on the stretch upstream of Newfield Bridge where a single line of mature trees grows above stone wall bank revetment on the left bank (Photo 2). These trees tend to lean out over the river as a result of grazing pressure and there will be an increasing risk with time of a tree falling, the stone revetment being breached and rapid bank erosion continuing from that point. Ideally the establishment of a block of trees behind the existing ones would provide a succession into natural bank stability, but in the absence of that a rotational coppice (say on a 10-year cycle or more) would extend the life of the current bank protection; protection of coppice re-growth by fencing out grazing animals would be required.

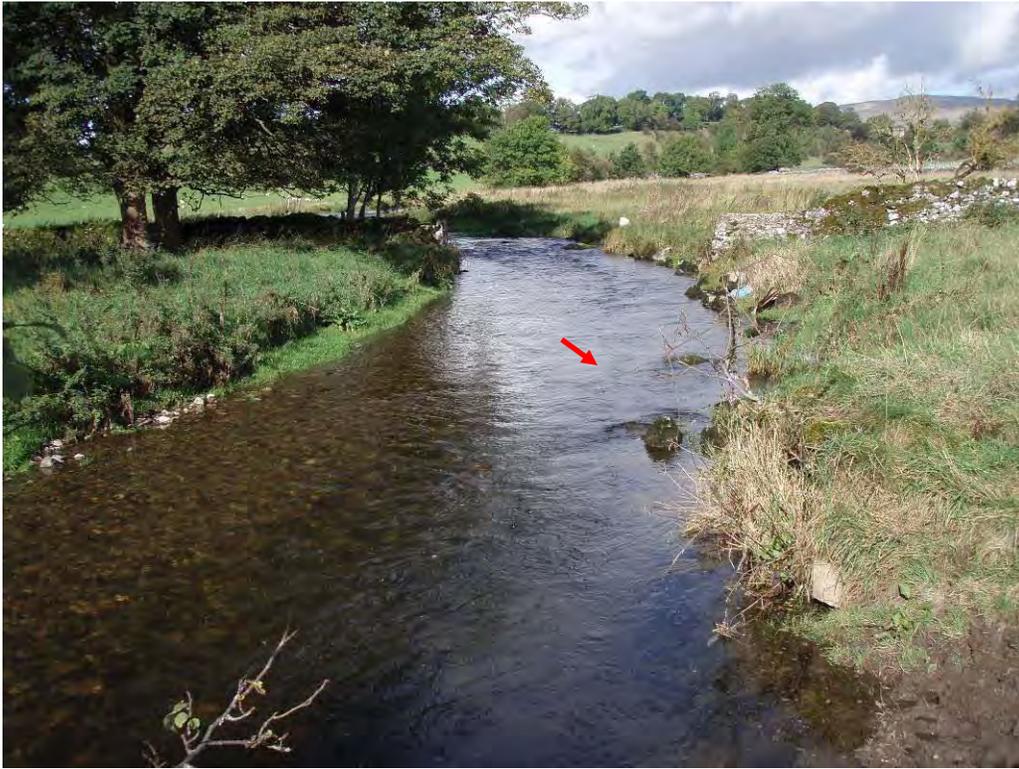
BGFA expressed concern about a particular pool upstream of Newfield Bridge which has become shallower over the last few years, reducing its value as adult trout habitat (Photo 3). The stone wall revetment on the outside of the bend where this pool is located has broken down, although the actual channel width is not reported to have changed markedly. The reason for this pool becoming shallower is most likely to be an area of river a short distance upstream where some more recent bank revetment has failed and bank erosion (lateral scour) is taking place at a much increased rate (Photo 4). This erosion is increasing the rate of supply of sediment locally and the coarser particles (gravels, cobbles) are settling in the pool downstream, reducing its depth.

Photo 3 In-filling with coarse sediment of a well-known trout holding pool here (arrow) is causing concern.

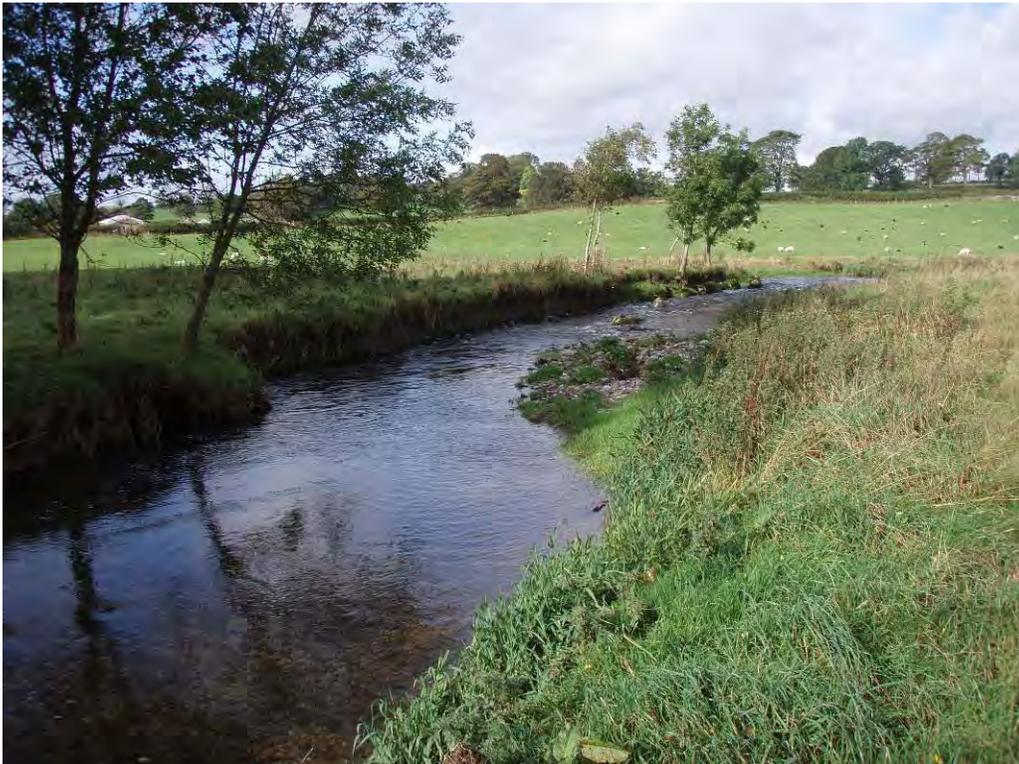
Photo 4 The likely cause source of the sediment causing the in-filling is just upstream where failure of relatively recent bank protection (stone revetment and tree planting) has resulted in excessive rates of erosion.

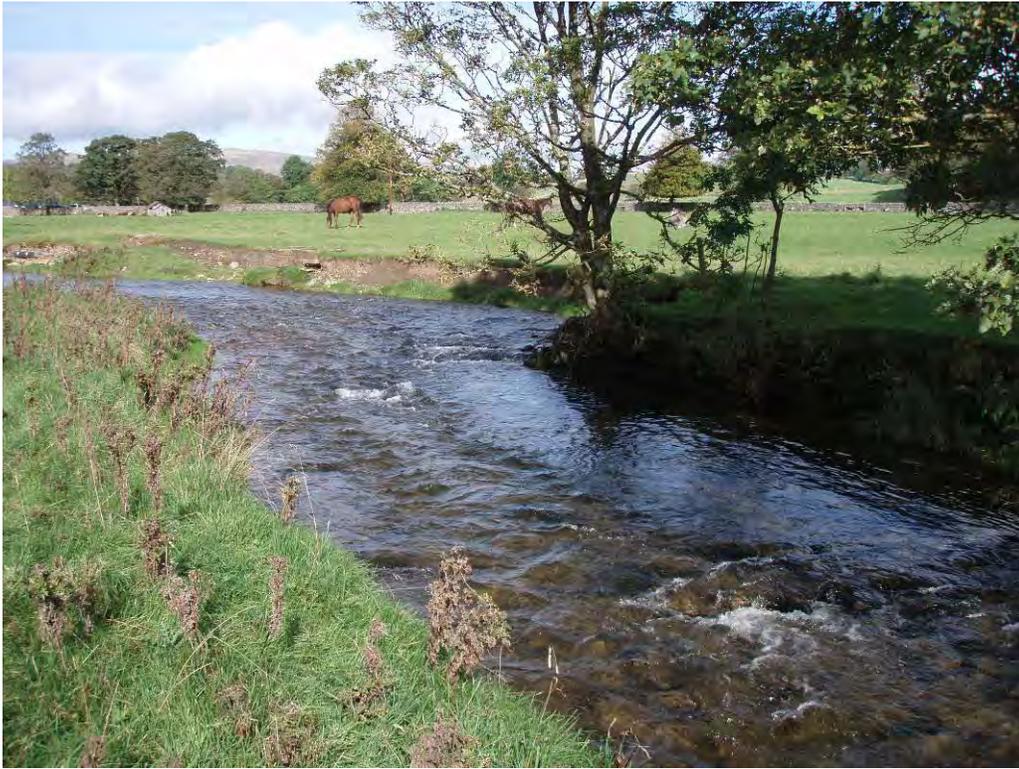
At present, some sections of river have failing C19th stone bank reinforcement which is going to lead to rapid bank erosion for the reasons mentioned above (Photo 5). If these areas are re-instated it will be expensive and success will be uncertain, because land use and bank instability remain the same behind the walls – failure in one area will quickly spread. For longer term improvements, the land use and vegetation structure of a zone alongside the river needs to change. Some great examples of this can be seen where BGFA have worked previously.

Photo 5 Loss of stone wall revetment is leading to channel widening. Note the contrast between upstream (background) and downstream (foreground, where the bank revetment is still present on the far bank)

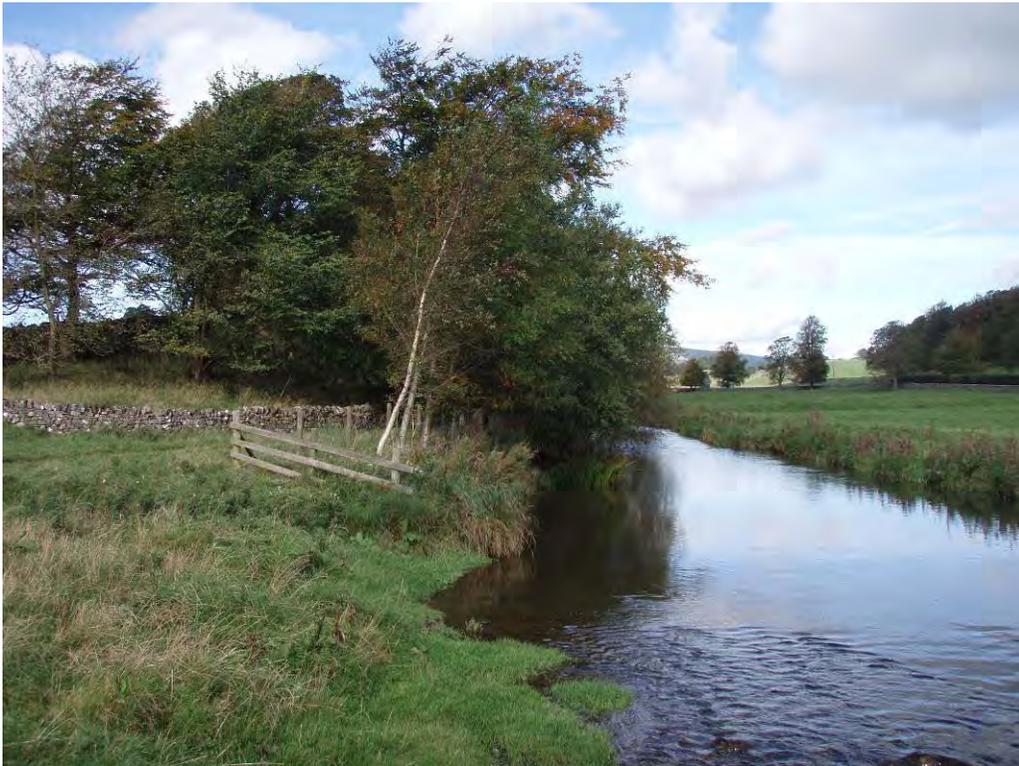
Downstream of Newfield Bridge, BGFA fenced out some lengths of bank and planted blocks of trees about 25 years ago. These have been very successful, resulting in a much more stable bank with good low cover over the river margins. The trees are a mix of species including ash, alder and willow and all of a similar size; they are now at a stage where some maintenance is required to produce a variety of sizes and levels of shading and cover. It is recommended that some of the willows are pollarded to encourage low bushy growth; the trimmings can be woven or pegged to the toe of the bank at the base of the trees to encourage sprouting and more valuable dense low cover. Some willows could be partially cut through at the base and hinged over alongside the bank to achieve a similar effect. Alders can be coppiced and left to sprout from the base, but only a small proportion should be done each year in order to achieve a good mix of sizes of re-growth. Species like ash should be left to establish large mature trees.

Photo 6 Line of trees established about 25 years ago by BGFA. These provide excellent cover over the water and improve bank stability

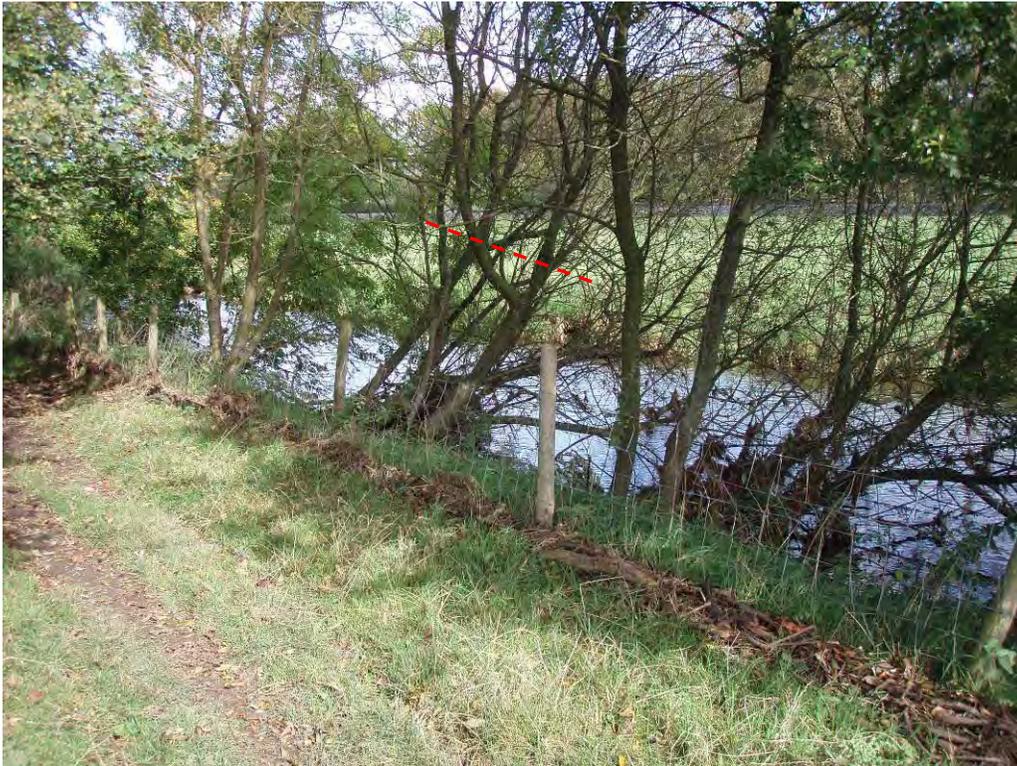
Photo 7 The trees are ready for some maintenance work as described above, for example pollarding the willows at the height indicated and leaving as much low cover over the water as possible.

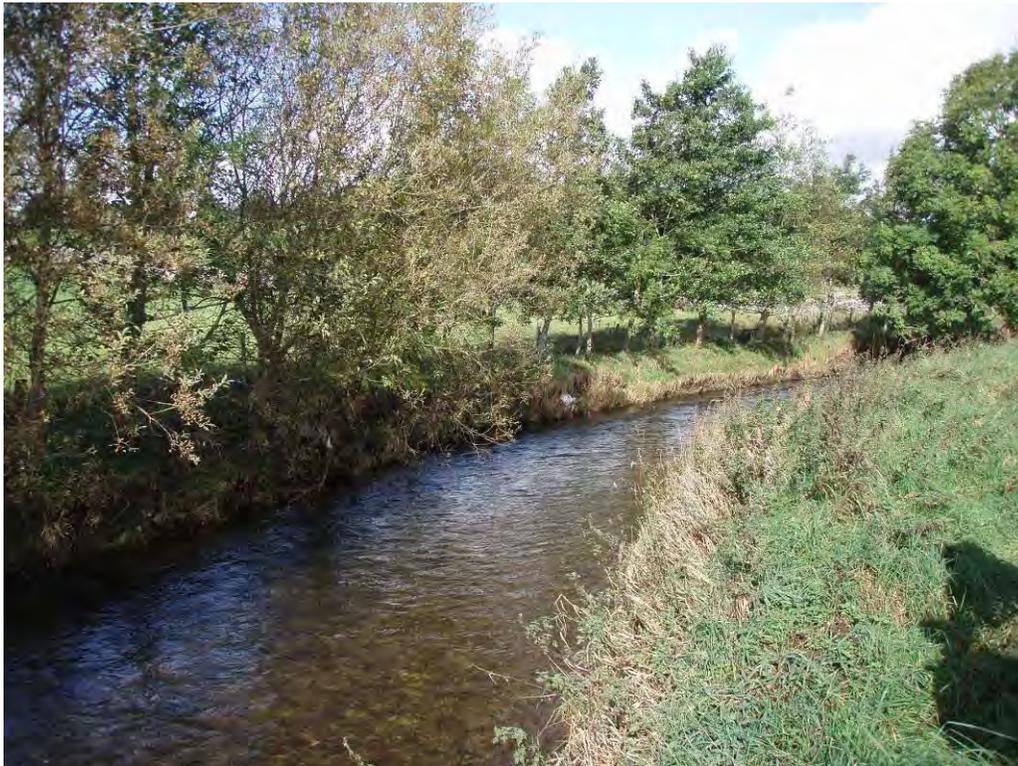
Photo 8 Younger trees planted as part of a habitat improvement scheme upstream of Newfield Bridge

Further upstream on the right bank are some younger trees planted as part of a habitat improvement scheme (Photo 8). Similar management to that mentioned above for the trees planted by BGFA is recommended (selective coppicing, pollarding and hinging) with a view to improving the amount of low cover over and within the river margins.

| Activity | Location(s) | Cost | Achievable by |
|---|---|--|---|
| Maintenance on the younger trees (planted in the last 25 years) | <ul style="list-style-type: none"> Upstream of Newfield Bridge (Photo 8) Downstream of Newfield Bridge (blocks planted by BGFA) Alongside vortex weirs below footbridge (Photo 11) | Volunteer labour | BGFA working party |

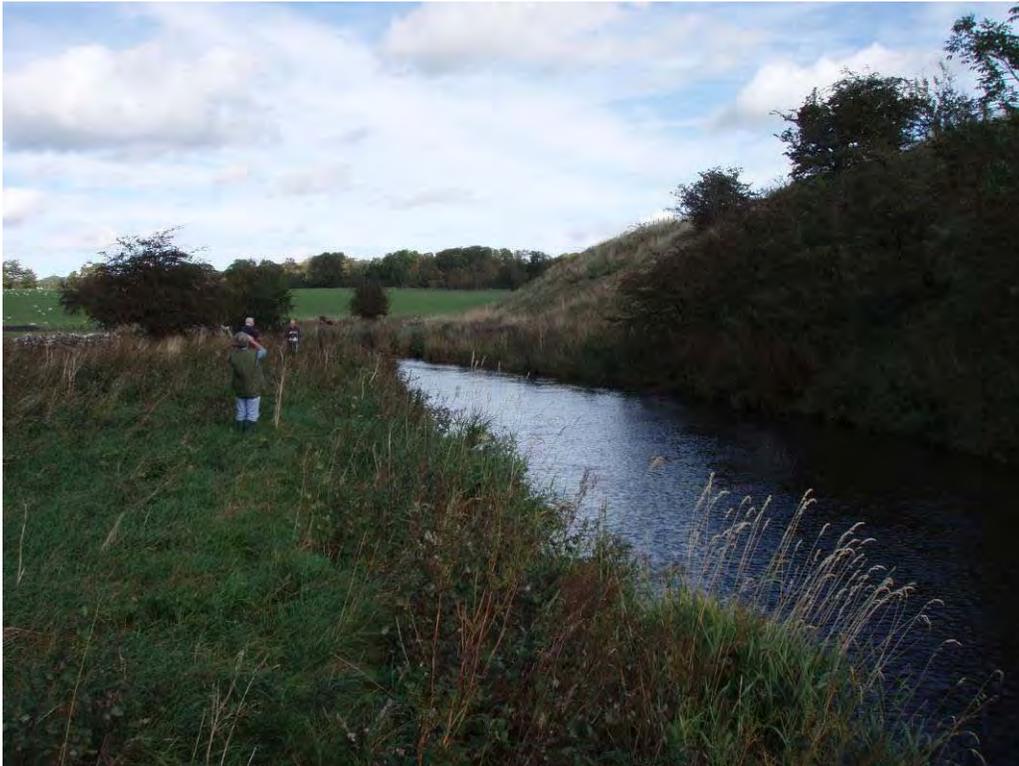
At the downstream end of the reach inspected was a length known as the 'canal stretch' which has been fenced and is bounded by water gates across the river (Photo 9). This section represents the ideal in terms of width of riparian zone from which livestock is excluded. Some trees could be established here (for example by pegging willow bundles from trimmings elsewhere in the margins; Photo 10). Narrowing of the river channel by natural encroachment of vegetation is already evident within this section, which is very encouraging.

Photo 9 The 'canal length'. Removal of grazing pressure is allowing good marginal vegetation to develop here.

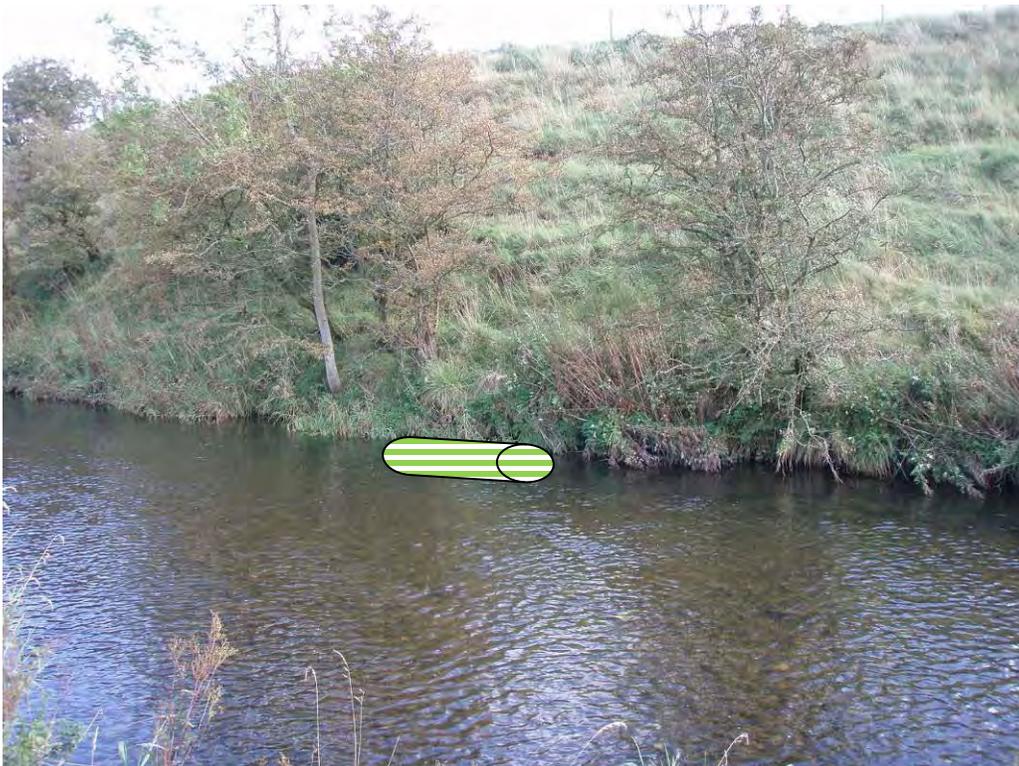
Photo 10 Pegging bundles of willow trimmings into the margins in the canal length will improve low cover on this section.
Alternate the bundles on opposite sides of the channel.

| Activity | Location(s) | Cost | Achievable by |
|---|---|--|---|
| Propagate new willow growth using trimmings from above maintenance | <ul style="list-style-type: none"> At low levels within existing blocks of planting Pinning bundles in margins in canal length and other places inaccessible to livestock | Volunteer labour | BGFA working party |

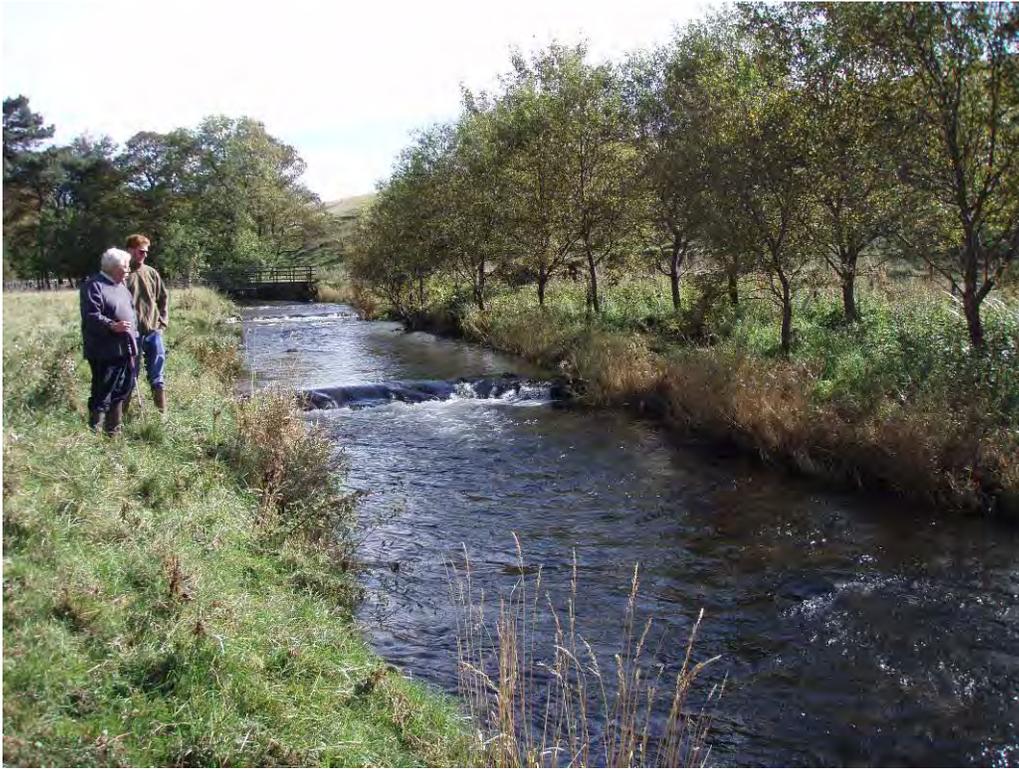
Downstream of Newfield Bridge and downstream of the Pennine Way footbridge BGFA and the Environment Agency have created some pool habitat by installing vortex weirs (Photo 11). These have been hand-constructed using stone-filled gabion baskets and have largely achieved the desired results of creating downstream scour pools where small trout are now caught. A couple of the structures have failed where the gabions have split and one structure appears to be exacerbating bank erosion (Photo 12).

Photo 11 Vortex weirs. Laying and pegging down some of the willows on the far bank is recommended to encourage low growth alongside the scour pools. This will increase fish holding capacity.

The vortex weirs are located (correctly) on straight sections of the river and could be improved by providing more low cover alongside the deeper scour pools. Really this technique is best suited to straightened, heavily modified channels and more fishery benefit would accrue from tackling the bank stability issues discussed above, rather than building more vortex weirs.

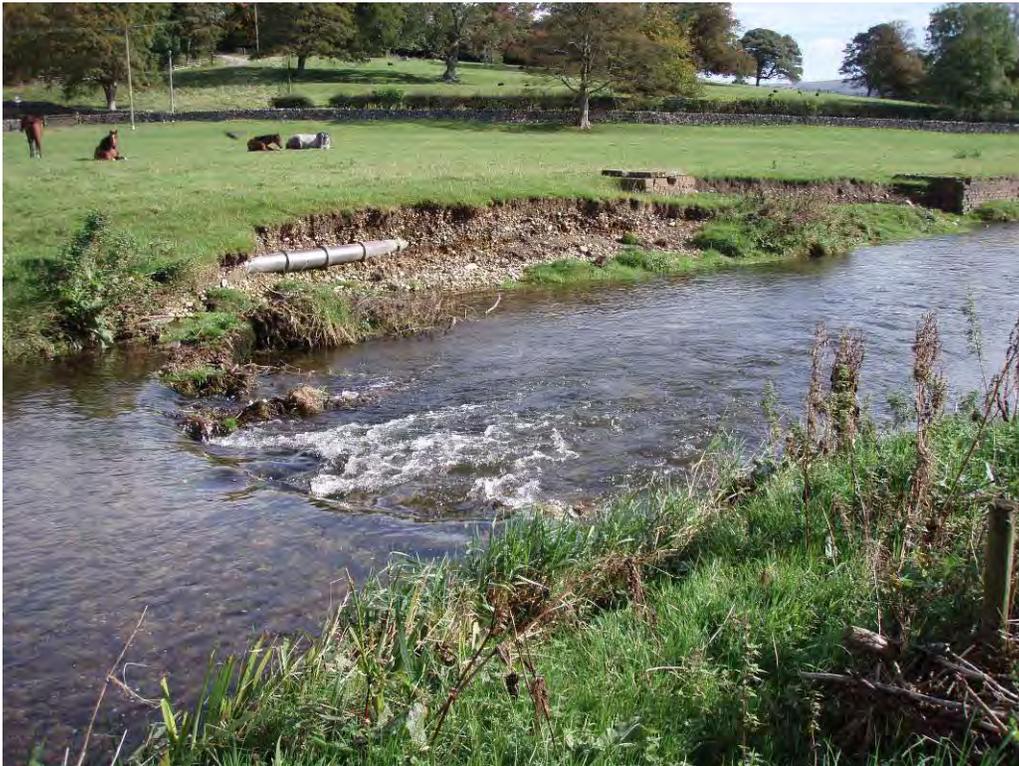
Photo 12 This vortex weir appears to be contributing to bank erosion on the far bank, exposing a redundant pipe. Removal of the weir is probably the best option.

| Activity | Location(s) | Cost | Achievable by |
|---|---|--|---|
| Remove vortex weir contributing to bank erosion | <ul style="list-style-type: none"> Downstream of Newfield Bridge | Volunteer labour | BGFA working party |

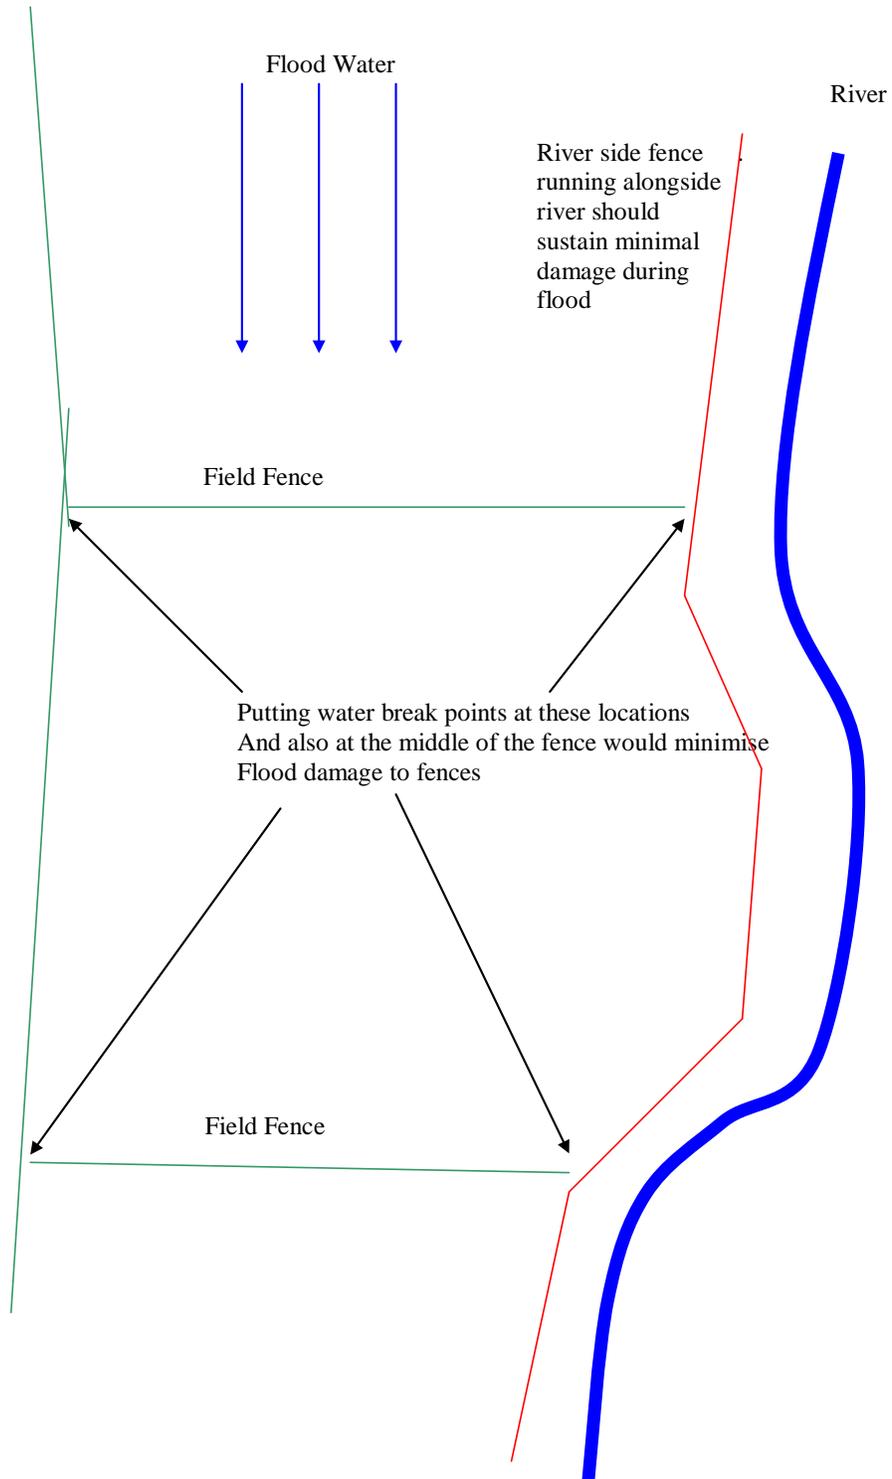
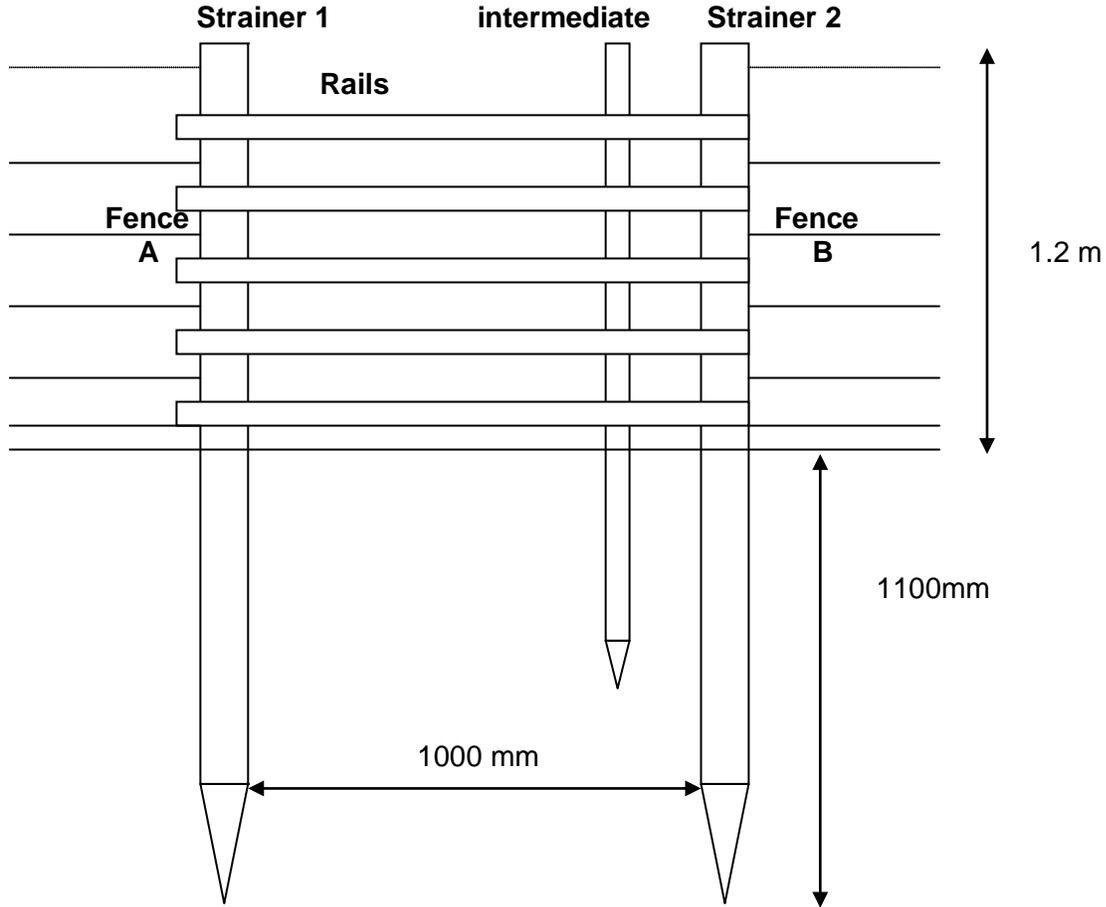
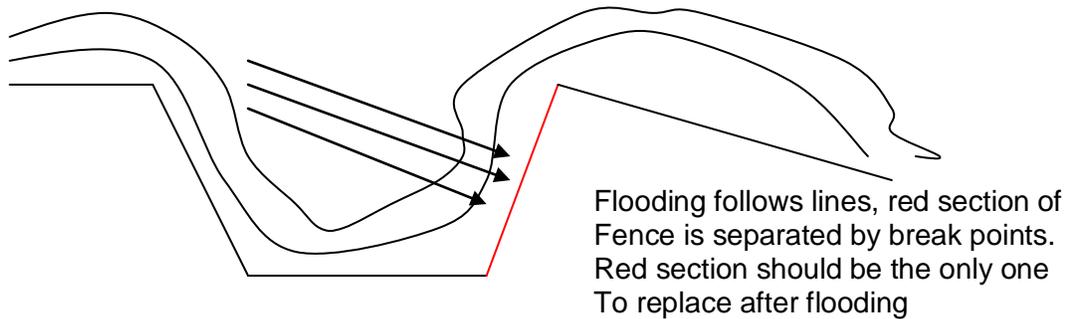
Details for setting up water break points to separate one fence into two

Water Break Point:

- Straining posts 1 and 2 set at approx 1m apart
- Intermediate post set 200mm of strainer 2
- Rails are nailed to strainer 1 and intermediate post
- Rails sit flush to strainer 2 but not attached to it

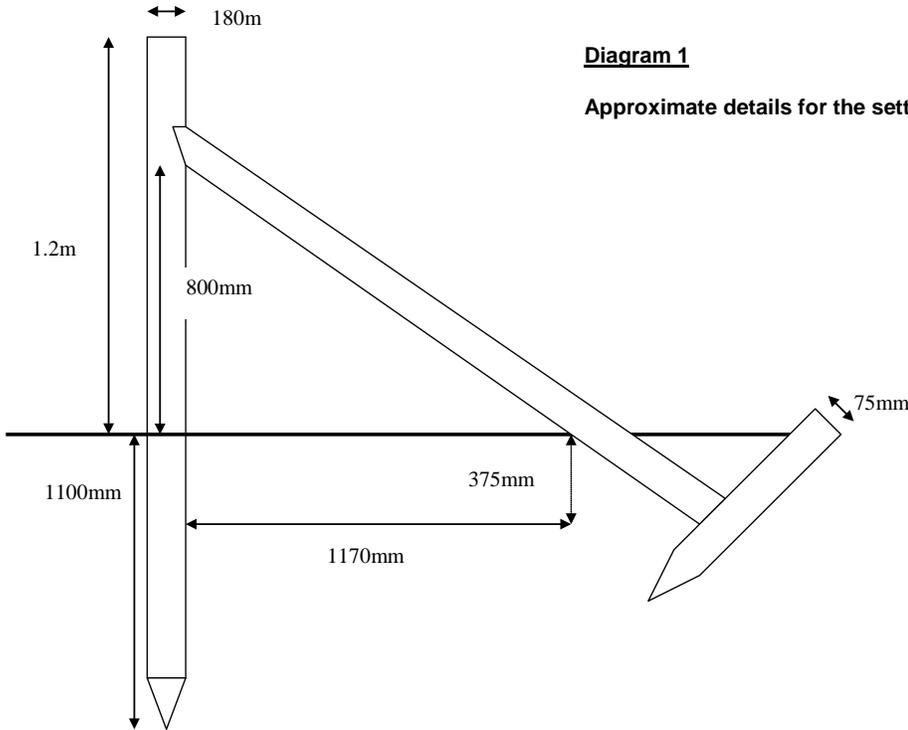
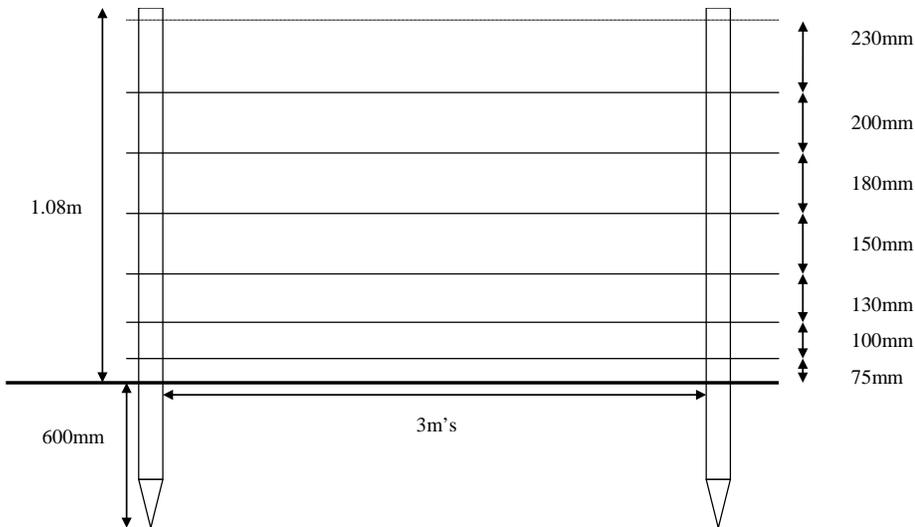
Diagram 1

Approximate details for the setting up of the strainer

**6 STRAND HIGH TENSILE
1 STRAND BARBED WIRE**

High tensile wire (diagram 1)

- Shall not be less than 1.06m high from ground to top wire.
- Wire shall be galvanised (BS4102), 3.15 mm diameter.
- Straining Posts shall be 180mm minimum top diameter x 2.4m's to be driven into the ground.
- Strainers to be set at centres not exceeding 50m's.
- Turning posts shall be 155mm top diameter x 2.1m's. May be pointed and driven to 900mm into the ground.
- Struts shall be 120mm dia x 2.1m long and notched into the straining post at an angle no greater than 45 degrees. Allow two struts for strainer/turner where angle is less than 135 or one bisecting the angle where the internal angle is greater than 135.
- Intermediate post shall be 75 - 100mm dia x 1700mm to be driven to 450mm. To be set at no more than 3 m intervals.
- Galvanised steel radisseurs to be used to tighten strands.

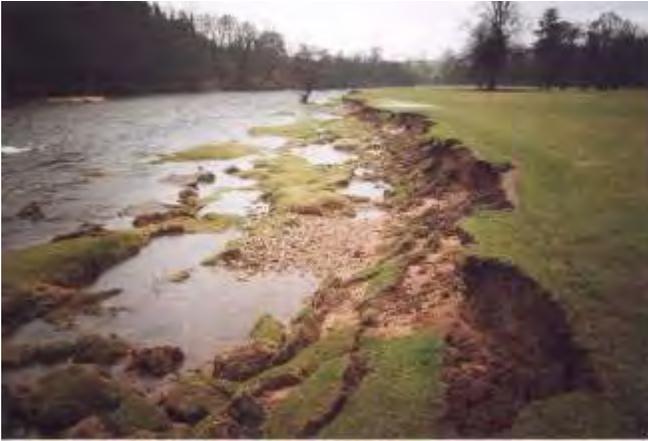
River Eden, Crackenthorpe, November 1998

- Examples of fencing projects – before and after

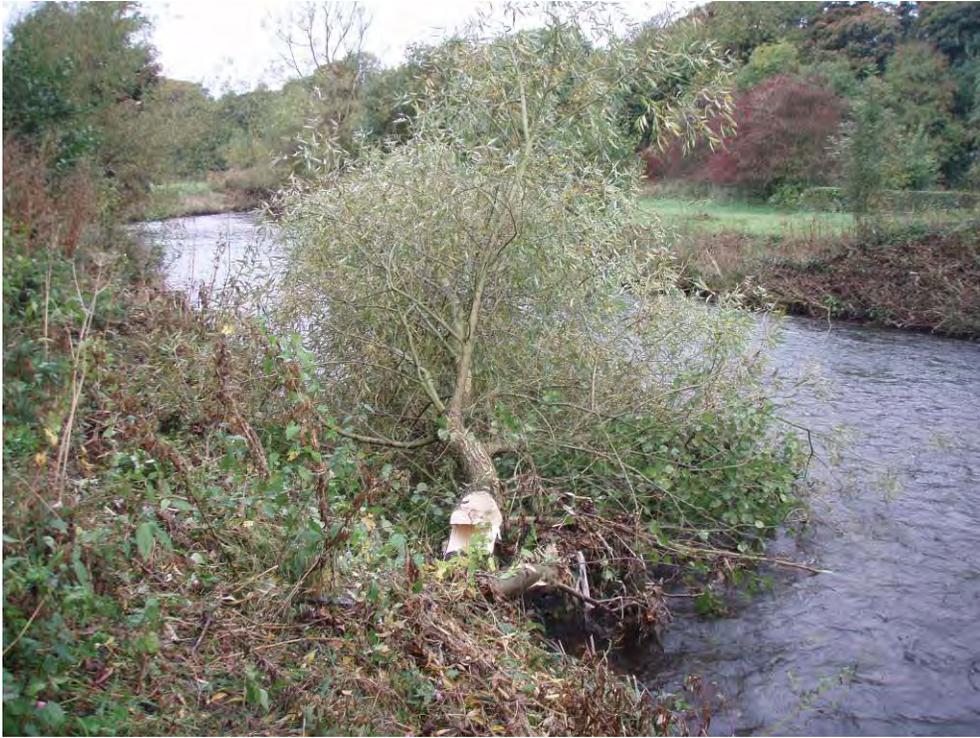
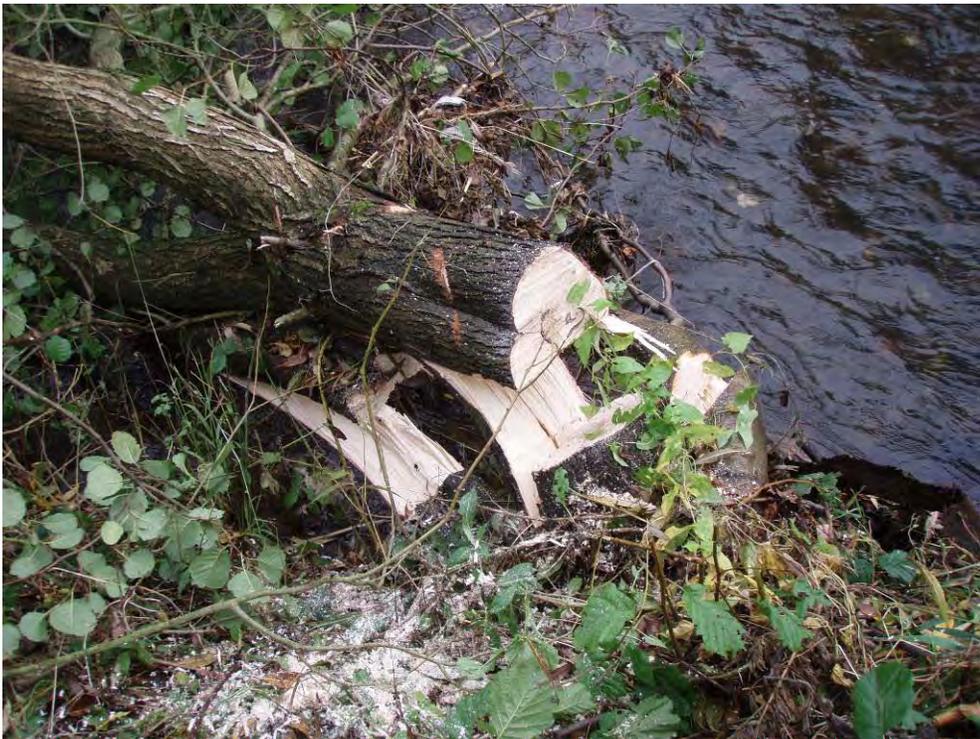
Partial cutting and laying of willow (like hedge laying) is a quick way of creating low cover which is firmly fixed to the bank. The willow should root along its length.

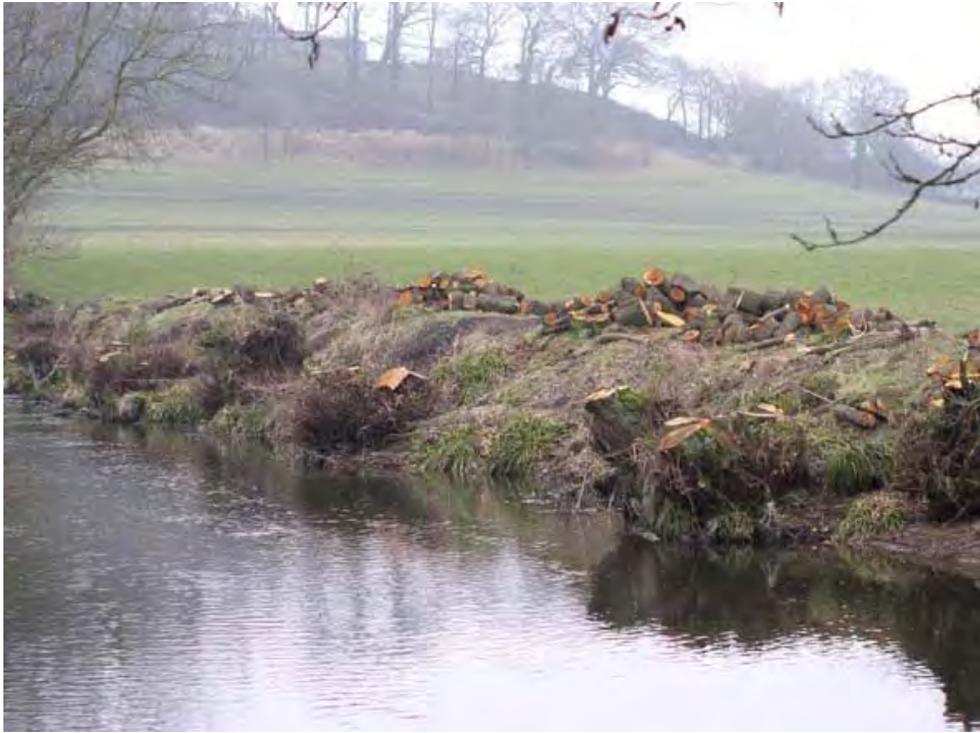
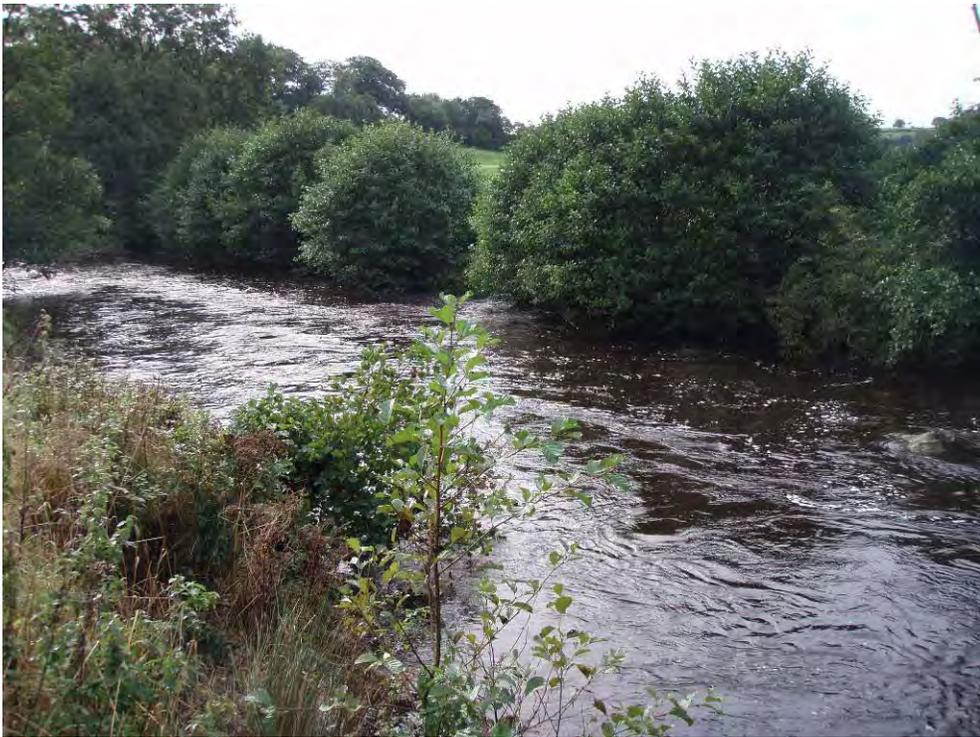
Coppicing trees produces bushy re-growth which creates excellent low cover over the water (if protected from grazing) but doing it all in one go like this produces a uniform size of trees. Better to adopt a rotational coppice to increase variety. The lower picture represents 4 years re-growth (River Dane, Cheshire/Staffs.)

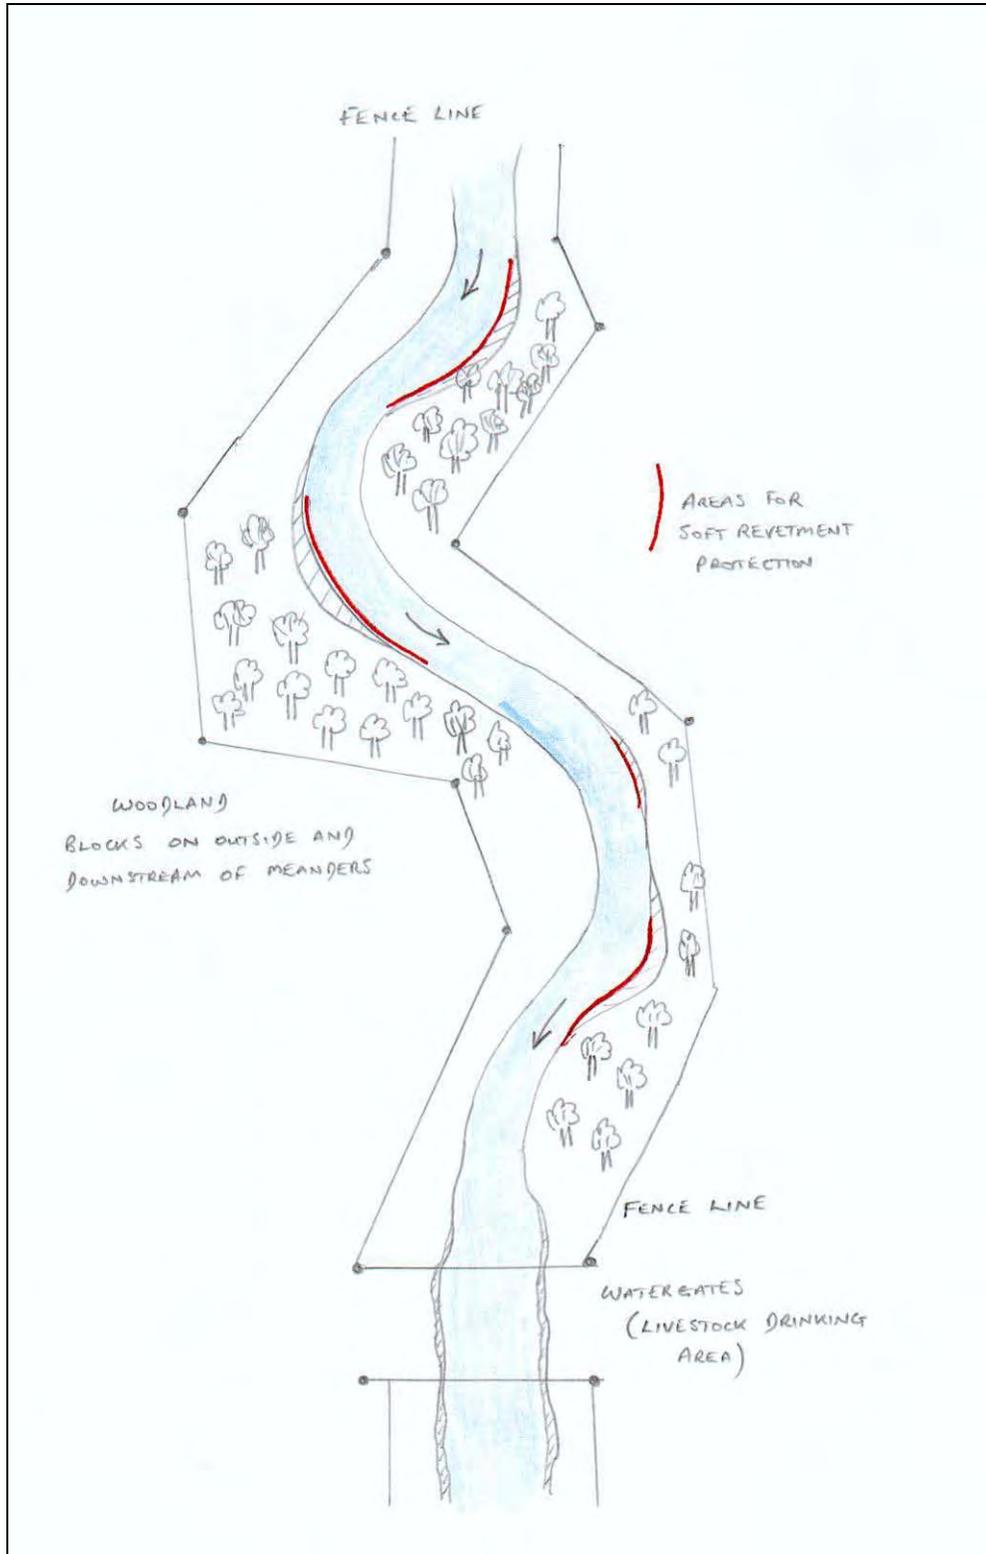
Stylised diagram of fencing and tree planting to increase the resistance of banks to erosion in the areas on the outside of and downstream of meanders. Soft revetment to allow time for trees to establish.

- Stands of trees need to be established in the correct locations (i.e. where the river channel is likely to migrate if rapid erosion continues, such as the outside of and downstream of meanders; Appendix 2).
- Blocks of trees are required, not just a single line through which the river could break and continue the rapid rate of erosion.
- Fencing livestock out of the areas where trees are to be established is vital to success. Both banks may need to be fenced if the river can be forded by livestock (see Appendix 1 for guidance on fencing).
- The rate of erosion needs to be slowed in the short to medium term to give trees a chance to establish. This is best achieved by soft revetments, for example using brushwood or log and Christmas trees. These tend to reduce the erosive power of the river and encourage deposition of sediment and consolidation of the bank.

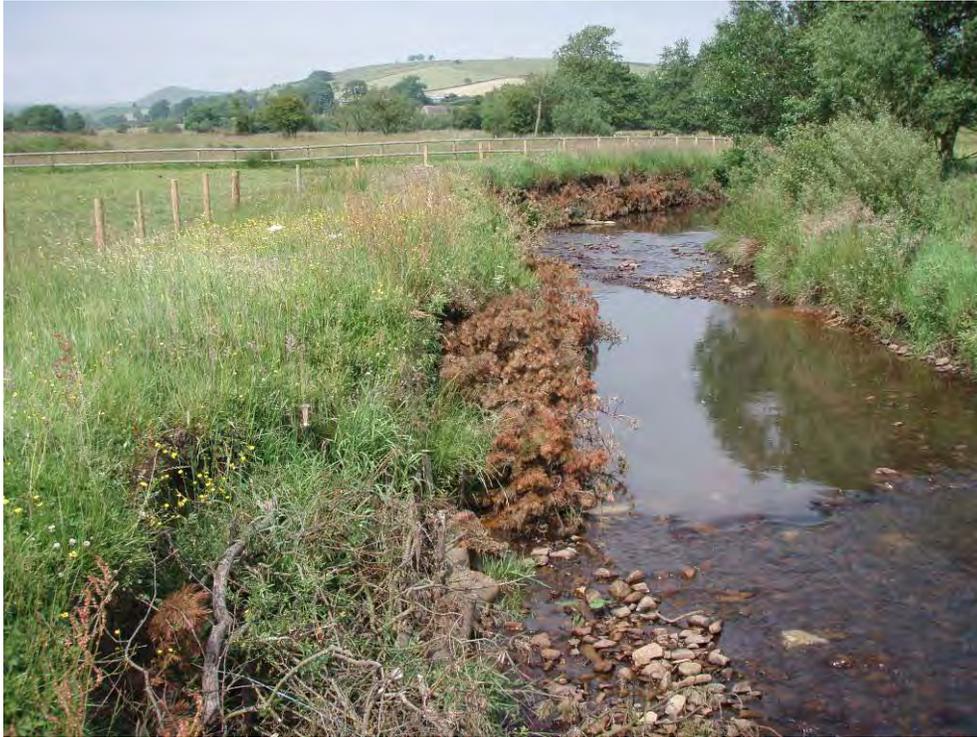
Conifer top revetment against an eroding bank on the River Manifold, Staffs. Note wide fenced adjacent margin which has also been planted with willow slips.
