## **River Allen, Deans Court, Wimborne Minster, Dorset**

**An Advisory Visit by the Wild Trout Trust December 2014**

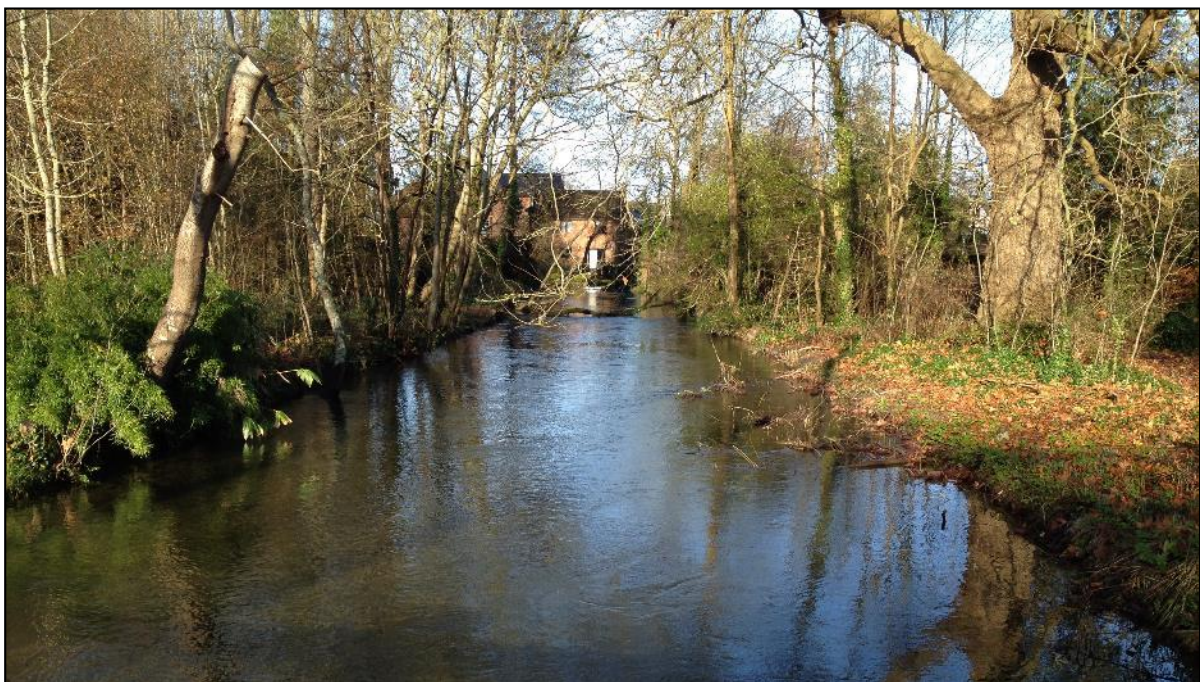
At the top of the reach, upstream of a triple-arched bridge visited the river is over-wide and straightened with densely wooded banks. The straightness of the channel here is a limiting diversity of flow conditions and the abundance and range of habitat features. The density of bankside trees is also over-shading the channel, inhibiting the establishment and growth of marginal and in-stream river plants (Figure 2).

Figure 2: The straightened and over-shaded channel limits habitat diversity

Recent works including tree works and the installation of brushwood mattresses (visible right of image) and mid-stream deflectors have been undertaken by Dorset Wildlife Trust. These have improved habitat diversity through this reach but the installation of some additional structures at some point in the near future to further improve light and flow diversity would be beneficial.

1. If possible, undertake some additional tree works upstream of the bridge at the top of the reach. These should be undertaken in a 5-10 year rotation, ensuring that a good diversity of canopy heights and densities is maintained and resulting in a sustained diversity of light conditions. A guide to coppicing works is included in the appendix.
2. Utilise some of the woody material arising from the tree works to introduce a few more woody debris habitat features to deflect flows and further improve channel sinuosity (Figure 11). Any additional brushwood mattresses should be introduced in areas with sufficient direct sunlight for marginal plants to establish and thrive. (Figure 12)

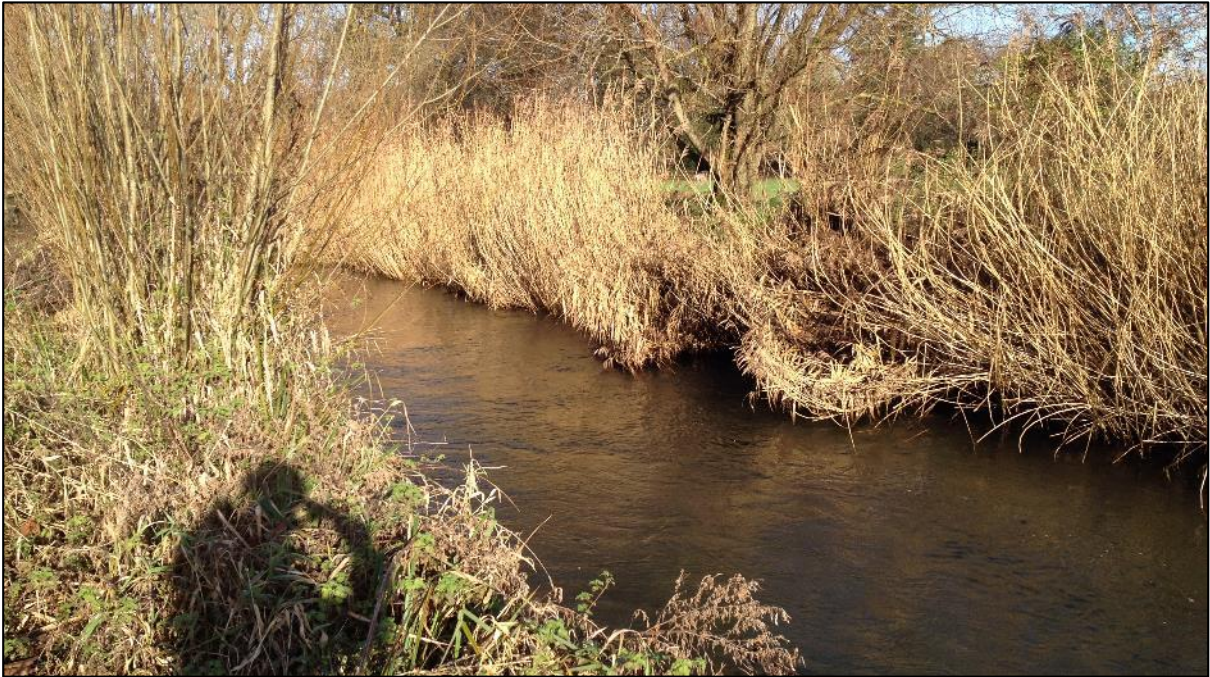
Downstream of the bridge, habitat diversity improves as a more natural morphology resumes and marginal vegetation becomes more abundant in the open sunlight. Beds of common reed (*Phragmites australis*) help to naturally pinch the channel, speeding up flow and increasing bed scour, leading to a greater diversity of depth conditions (Figure 3). At NGR SZ 01145 99520 a wide bay has

Figure 3: Marginal vegetation helps to narrow the channel and speed up flow

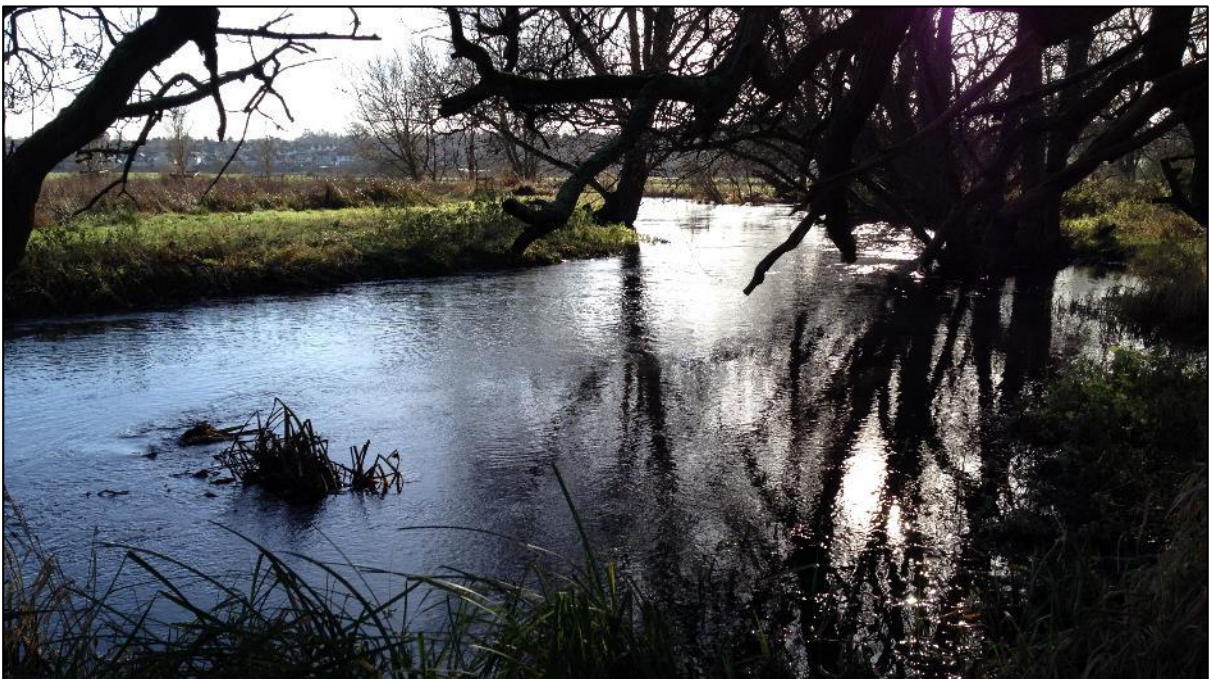
formed under the shade of bankside trees on the RB (Figure 4). Occasional wide and shallow bays are important habitat for juvenile fish and can be potential spawning sites. The introduction of some secured woody debris features at this location could help to keep gravel scoured clean of fine sediment, making the site more attractive to spawning trout and helping to improve the survival of eggs and alevins.

Figure 4: A wide bay could benefit from some secured woody debris positioned to create occasional pockets of scour to locally clean the gravel bed and improve spawning habitat

3. Introduce some LWD to deflect flows and promote scour and bed 'sorting' at other key areas within the reach such as the locations shown in figures 4 and 8.
4. Hinge over and secure the willows growing mid-channel shown in Figure 6. This will create a valuable refuge for juvenile fish and will help focus scour around the outside of the feature

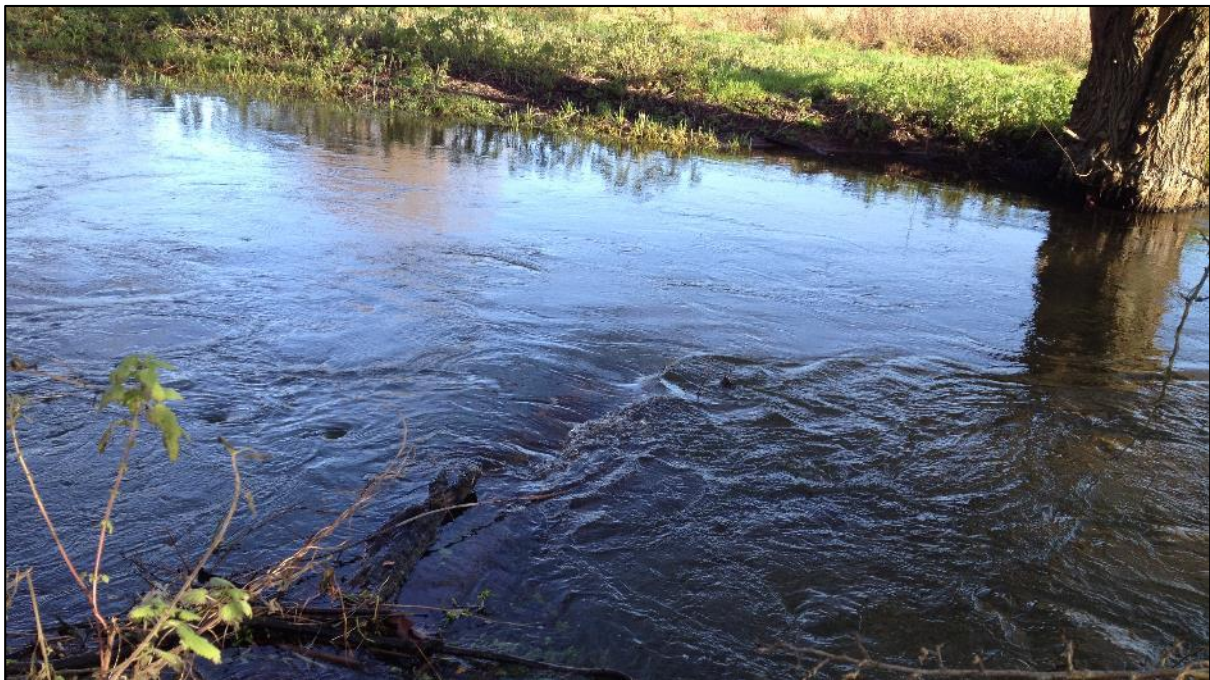
A short distance downstream some natural woody debris was spotted providing the type of flow deflection that would be beneficial in the shallow bay (Figure 5). Large woody debris (LWD) in the form of fallen trees or limbs provide a range of useful functions within the watercourse. Flow deflection creates scour on the bed which helps to form pools and naturally 'sort' gravel, grading bed material by size as finer sediment is transported further than larger, heavier, cobbles. LWD also provides cover for fish and pockets of slack water where fish can lie up out of the flow, conserving energy whilst predating on invertebrates drifting past in faster flows.

Figure 5: A naturally occurring piece of LWD helps to diversify habitat

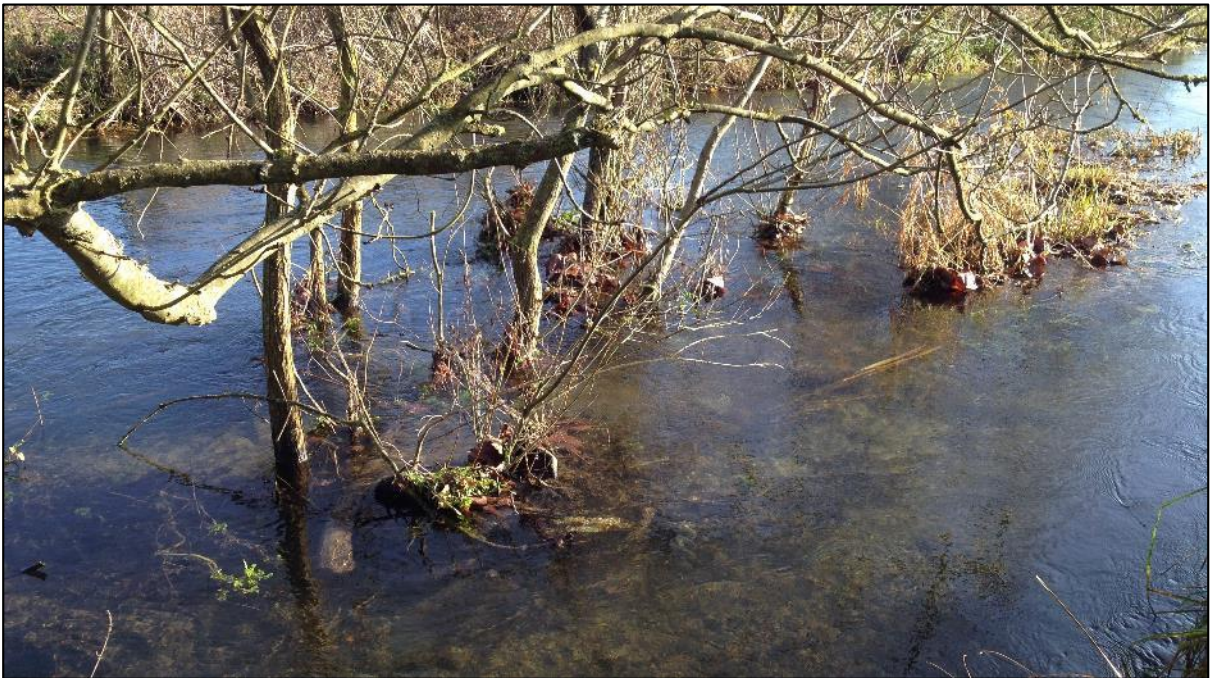
A few metres downstream at SZ 01155 99494 some small willows (*Salix* sp.) have sprouted from the centre of the channel (Figure 6). This may have occurred by some loose willow branches becoming lodged and eventually rooted in the bed. Whilst the willows do not presently pose an increase to flood risk, they could become a maintenance problem if not addressed. Hinging over the willows into the channel could create some valuable juvenile refuge habitat and locally slow flows, helping to trap fine sediment within the feature and accelerate flow around the outside. This would also allow spate flows to over-top the feature and reduce, although not eliminate, the amount of maintenance required.

Figure 6: Willows sprouting from the centre of the channel provide an opportunity to create some juvenile refuge habitat

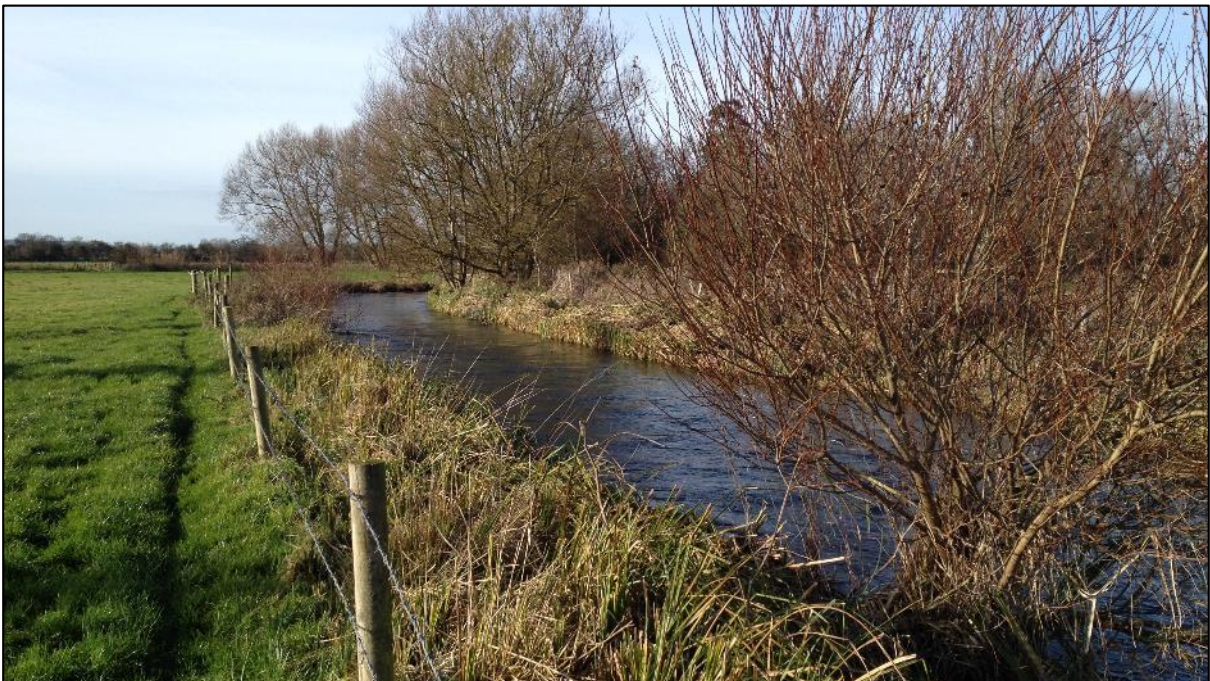
As the river flows out into open pasture, tree cover lessens and a wide and diverse margin of emergent plants is established on both banks (Figure 7). In addition to

the increased sunlight, the abundant margins are in part due to the banks being fenced from grazing livestock.

Figure 7: A wide and diverse marginal community has established where the banks are fenced from grazing livestock and there is adequate sunlight.

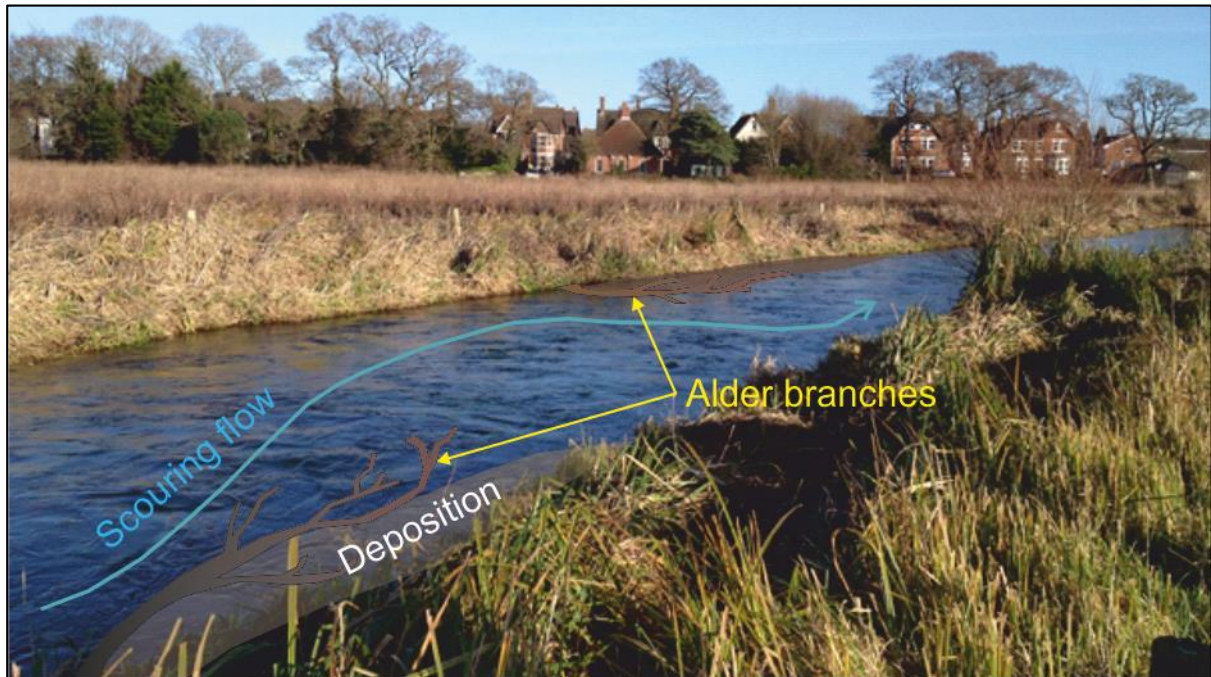
Livestock exclusion is also protecting a number of small saplings which, as they grow, will diversify light conditions over the margins, helping to increase biodiversity and bank sinuosity. In the meantime, sinuosity through this section of the river could be enhanced by securing some branches cut from the alders

upstream into the margins at regular spacing to deflect flow from bank to bank (Figure 8).

Figure 8: An illustration showing where some LWS could be secured to introduce greater flow diversity

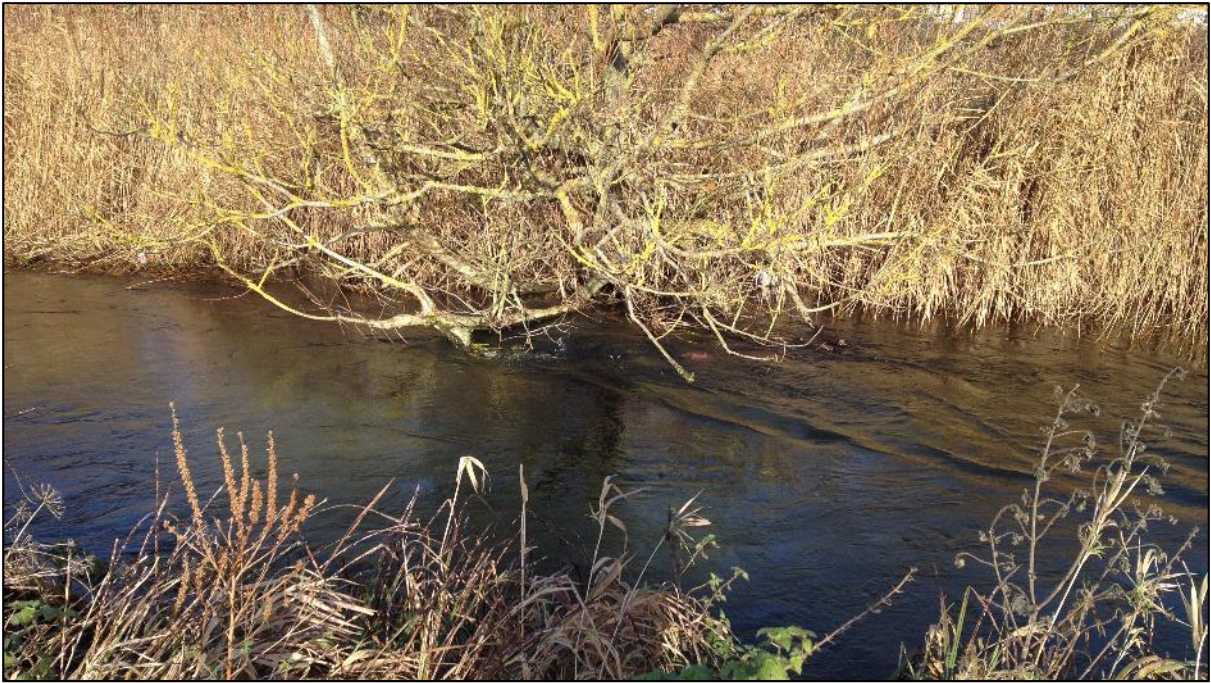
At SZ 01370 99456, as the river approaches the B3073 (Poole Rd), a small willow with low trailing branches provides some excellent cover habitat (Figure 9). This type of low cover is favoured by trout and other fish as a refuge from predators such as piscivorous birds. Whilst some fishery managers may feel pressured to remove or cut back such features in an attempt to reduce 'snags' for anglers, retaining low trailing cover will be of great benefit to the fishery and will ultimately benefit anglers by providing a good trout lie to target.

Figure 9: Low trailing branches provide great cover and protection from predators

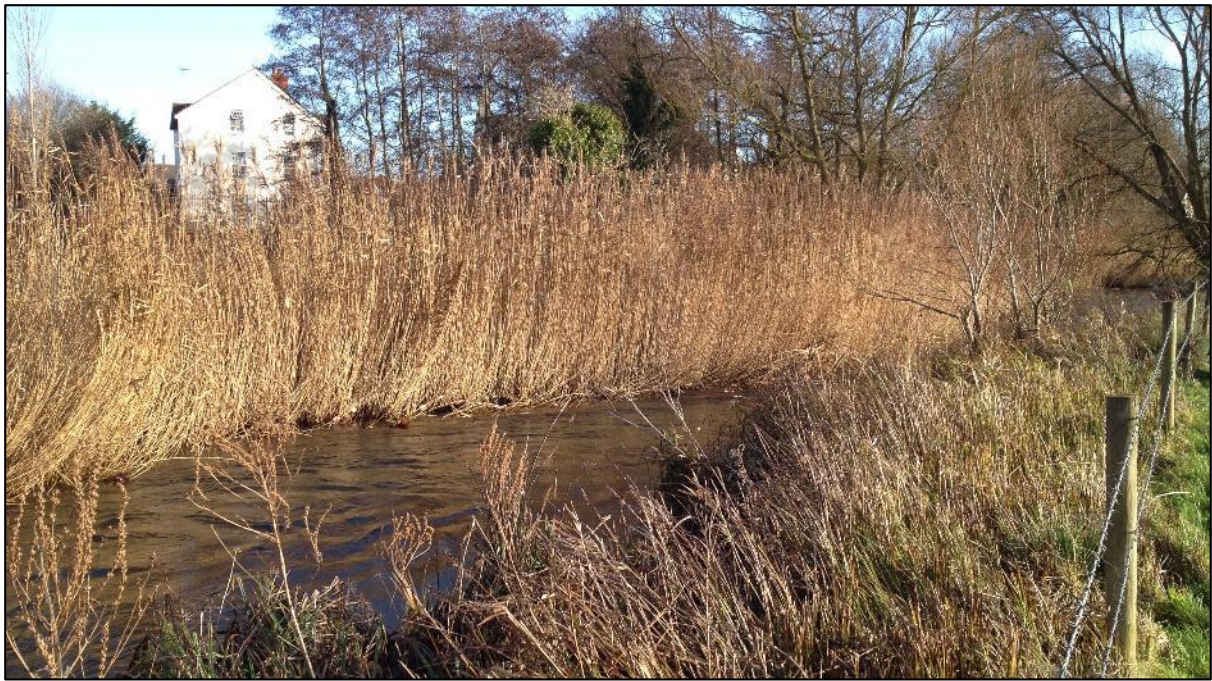
The majority of the River Allen visited at Deans Court was in very good condition with a good diversity of depth and flow conditions and abundant 'shaggy' margins. However, much of the margin on the LB is dominated by a monoculture of common reed, limiting overall marginal biodiversity (Figure 10). A good range of marginal plant species correlates with a good diversity of associated wetland and aquatic invertebrates. This is important to ensure that fish have an abundance of prey throughout the year and can often result in a prolonged period of good dry fly fishing. Planting a few additional willows by driving live willow stakes into the bank will help to diversify light conditions on the RB and could boost biodiversity over time.

The RB is more diverse and the already established saplings will help retain biodiversity. It should however be noted that fenced banks can sometimes develop into monocultures if left unmanaged. Allowing grazing livestock onto the margin once or twice a year, or undertaking annual light strimming works can help prevent this from happening. Initially, the bank should be annually inspected to check that any one particular marginal plant is not becoming too dominant.

Figure 10: A monoculture of common reed, although not necessarily bad for the river, does limit marginal biodiversity

5. Consider planting some additional willows by driving live willow stakes cut from bankside trees into the banks presently dominated by common reed.
6. Monitor marginal biodiversity within the fenced margins and, if necessary, undertake annual light strimming or allow occasional grazing to maintain a diverse range of species

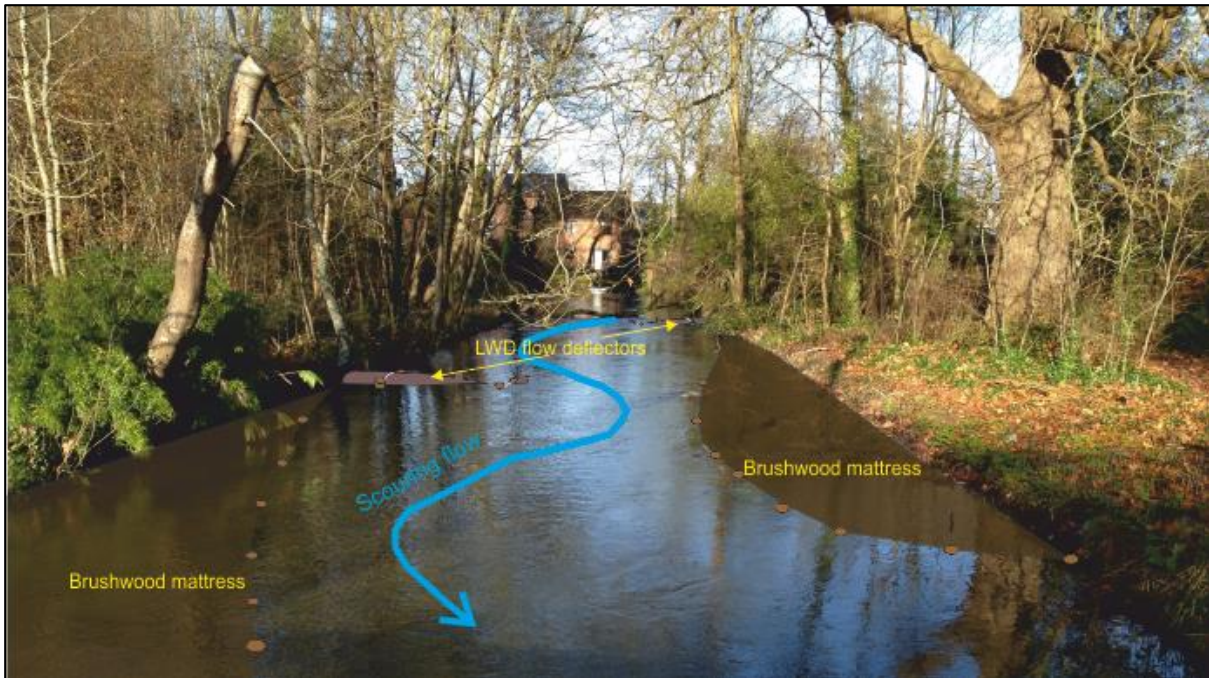
Figure 11: An illustration showing where LWD and brushwood mattresses could be introduced to improve habitat

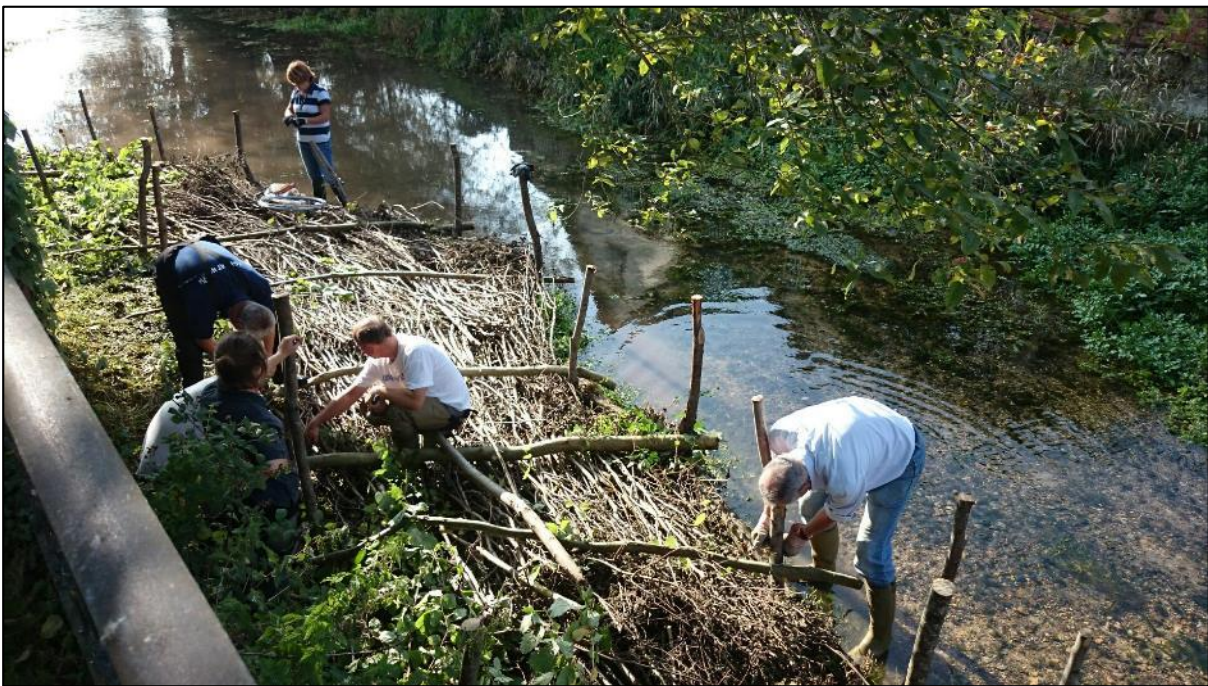
Figure 12: An example of a brushwood mattress installed on the River Allen at Witchampton Mill last summer
