## River Allen – Stanbridge Mill Farm

An advisory visit carried out by the Wild Trout Trust – July 2008

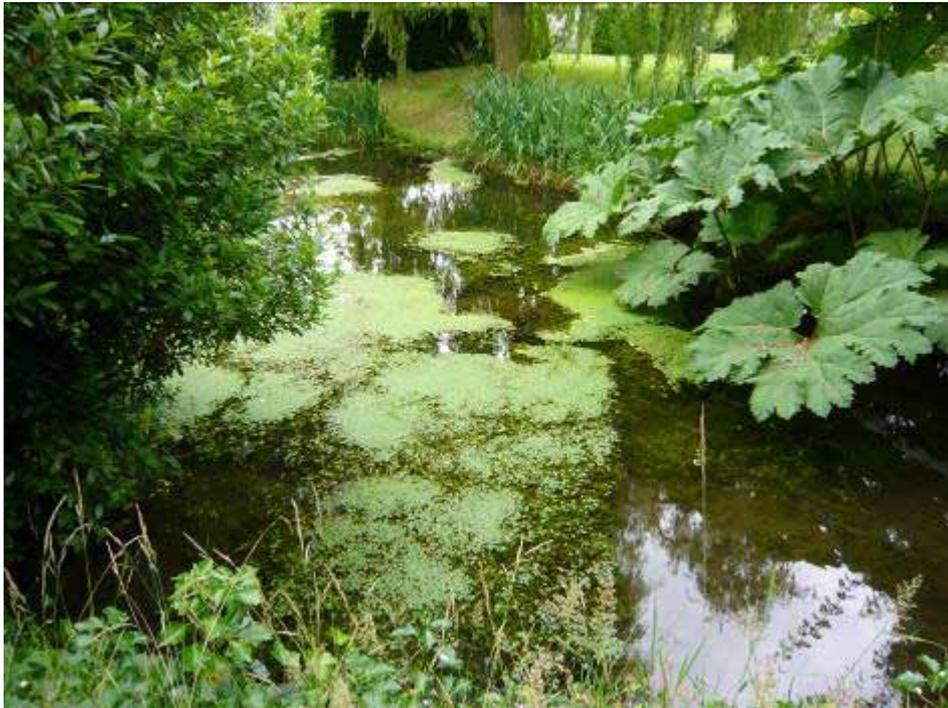
Old milling outlet channel within the formal gardens

Care should be taken to ensure that only appropriate local native plants are allowed to colonize the margins of the River Allen. The current mill exit channel can be considered an exception as it forms a central part of the formal gardens. Extending the range of the ornamental planting to other reaches of the river and side streams should be avoided.

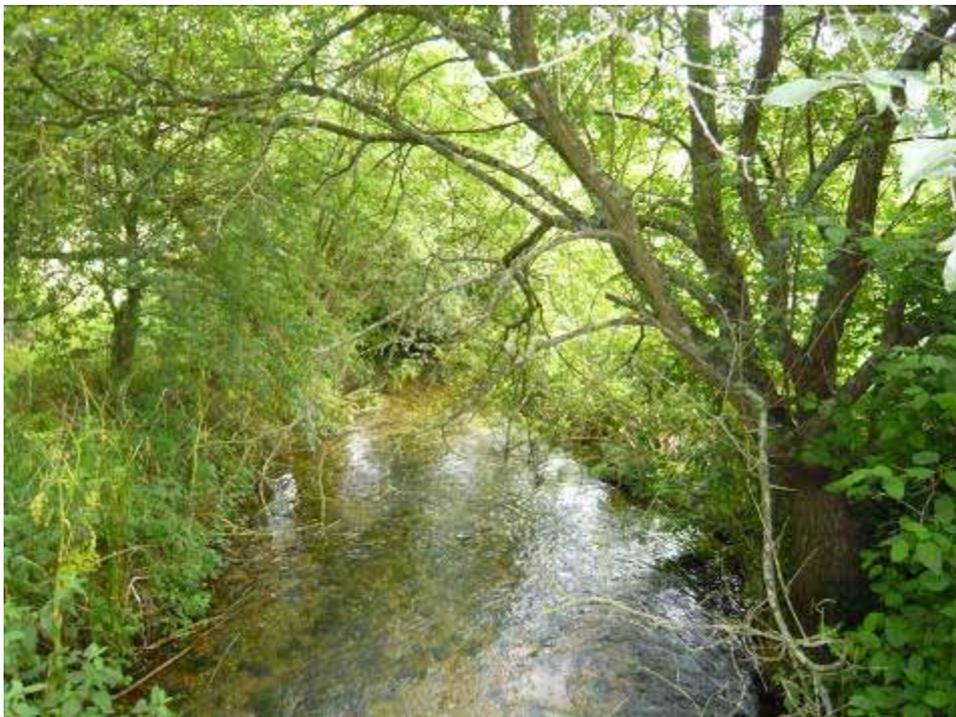
Good quality trout spawning and nursery habitat on adjacent carrier

- Maintain the current “scruffy” nature of the shallow carriers and main river margins which provide excellent habitat for brown trout.

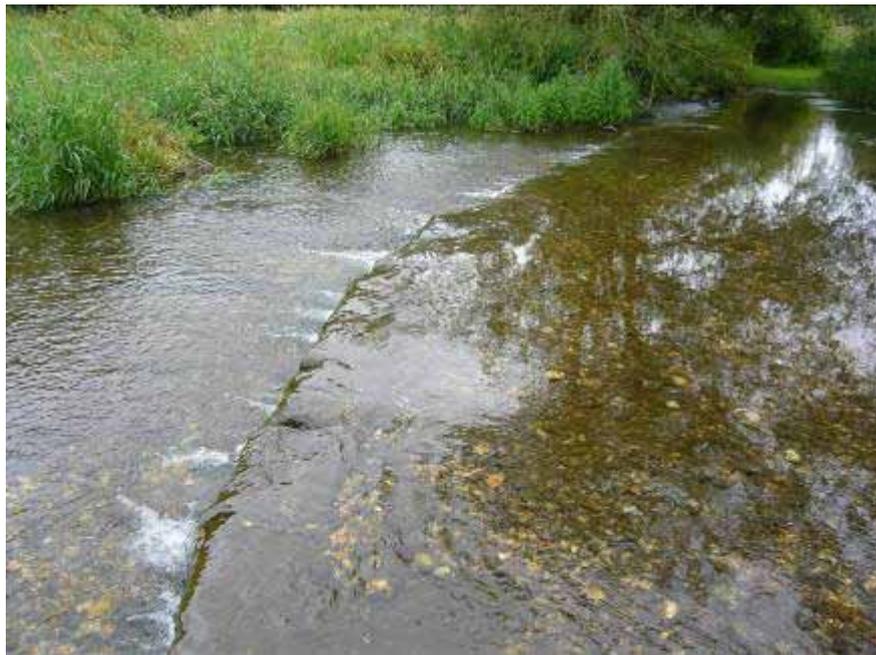
Removing a stone, or notching a section out of the centre of this weir would improve access for juvenile trout. Such a low impoundment would not fragment trout populations but could pose a challenge for small species such as bullhead *Cottis gobio*.

It is unrealistic to expect that the land owner would wish to undertake wholesale changes to some of the very old and possibly listed structures that influence habitats throughout this reach. It is possible, however, that enhancements could be made to some of the structures to improve fish migration. This process would require the support and major input from the Environment Agency and may not be seen as a priority by the current owners of the property.

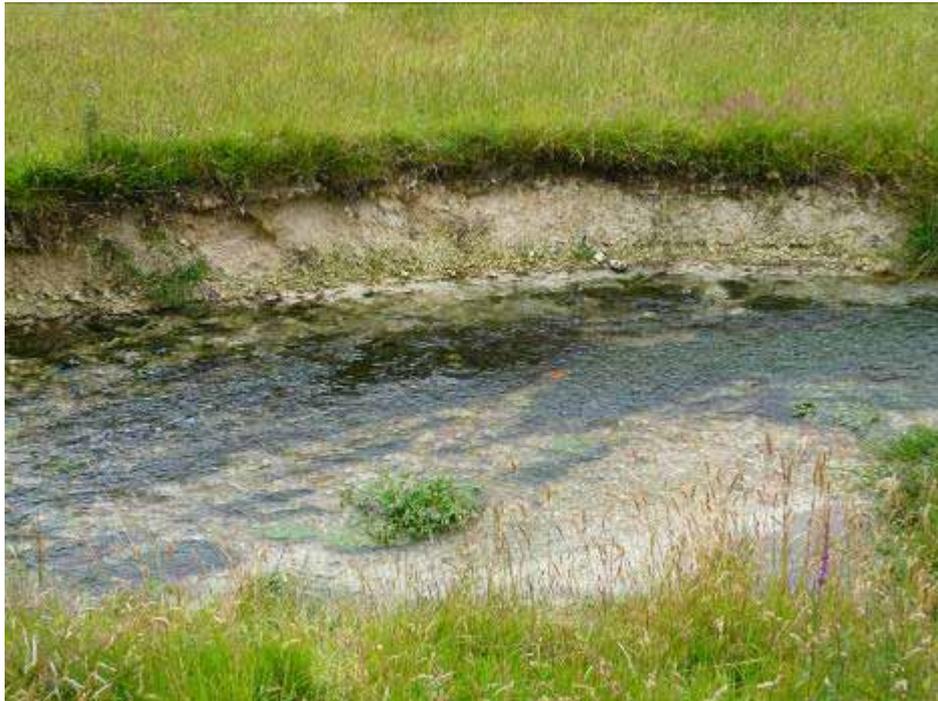
The network of channels through much of the property provided some good habitats for fish. Near the top boundary above the impounding influence of the mill there were some gravel riffles providing good spawning and nursery opportunities for brown trout. Adjacent to one such riffle there was some evidence of bankside erosion. This eroded bank face did not pose any significant threat to local riparian land and provided a different habitat niche that may well be important for some species such as kingfisher. Some erosion can be important in freeing up fresh gravels which settle downstream and form vitally important habitats for fish. Unless there was particular concern over the potential loss of riparian land, then it is recommended to leave this section to find its own equilibrium.

Good in-channel spawning habitat promoted by the steep gradient. Note the eroded bank

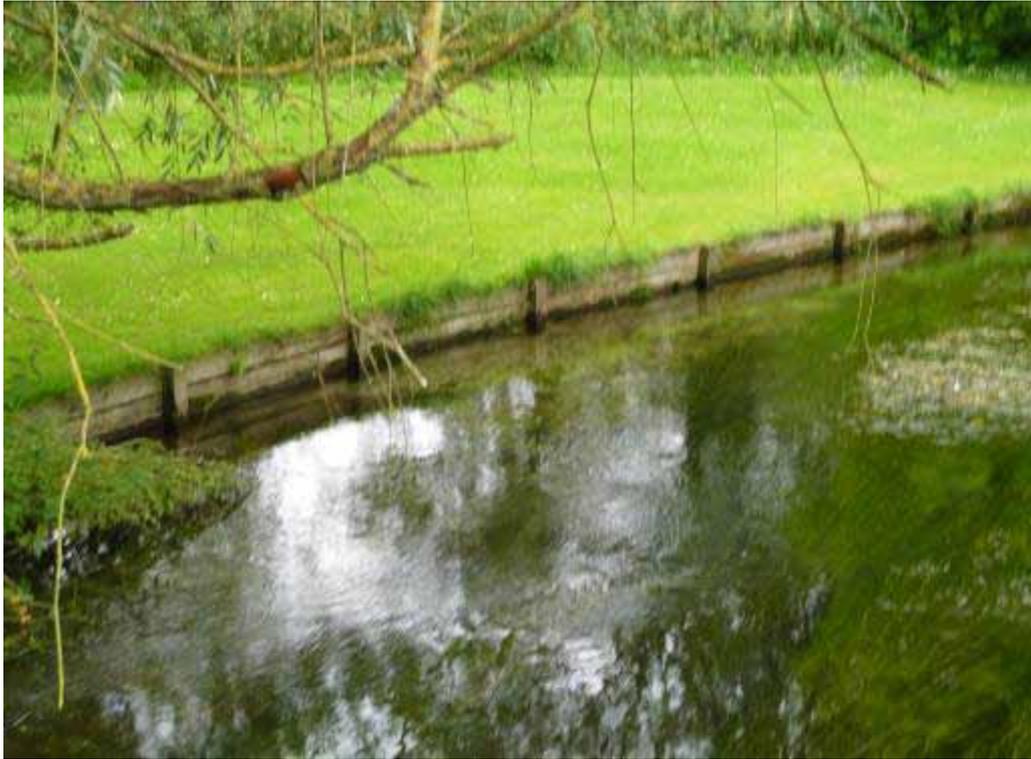
One potential area for significant enhancement would be the currently revetted river bank adjacent to the main lawn (picture below). The use of toe boarding to create a formal end to the lawn does not provide any useful habitats for chalk stream plants or animals. The mid channel area does provide some potentially good spawning habitats for trout. Spawning value could be compromised, however, in the absence of shelter for juvenile fish that would be provided by a soft bank, shallow river margin and extensive low scrubby cover. Without this type of habitat fish fry will perish shortly after emerging from the gravel post spawning.

River bank revetted with wooden toe boards.

Toe boarding has a very limited life span and is usually expensive to replace. Establishing a more natural river margin in front of the current boarding may extend the life of the revetment and also potentially provide an alternative to the hard edged approach. Pre planted rolls of coir (coconut fibre) could be pegged in front of the current boarding and not only provide a very attractive fringe but also a biologically valuable habitat in keeping with the high conservation value of the River Allen.

Some thought should be given to the treatment of banks and margins, particularly in the formal garden areas. The use of toe boarding to revet the bank is not recommended as best practise. Current boarding could be softened (and its life extended) with the introduction of pre-planted coir rolls to provide a soft "living" margin more appropriate for a river with such a high conservation value.

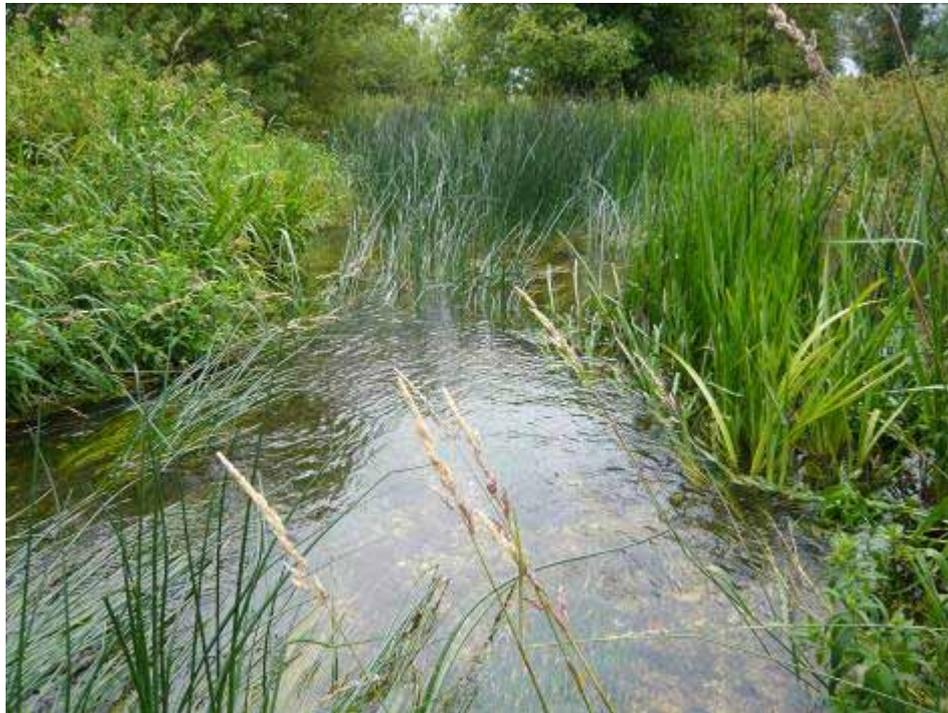
Another area of concern relates to the encroachment of marginal emergent plants into central channel areas. If left unchecked, it is possible that some carriers will become completely choked, backing up flows and compromising the diversity of in-channel habitat. The success of plants such burr-reed *Sparganium erectum* and pipe reed or common club rush *Schoenoplectus lacustris* appears to be a common problem on the river Allen and one which is quite difficult to combat. Both plants can be physically grubbed out of the river bed but this can prove to be extremely hard work. Another potential option is to consider controlling the plant with a contact herbicide.

Club rush blocking the central part of the channel

A priority action is to control marginal emergent plants where they threaten to choke mid-channel sections of river.

- Control mid channel emergent plants, especially club rush and burr reed.
- Consider softening the hard toe board revetment with pre planted coir facines or faggot bundles planted with local plants such as sedge and Iris.
- Consider the requirements of migrating fish species with regard to the use and operation of water level control structures. Ask the Environment Agency if they have undertaken any assessment of the status of the structures with regard to fish migration.

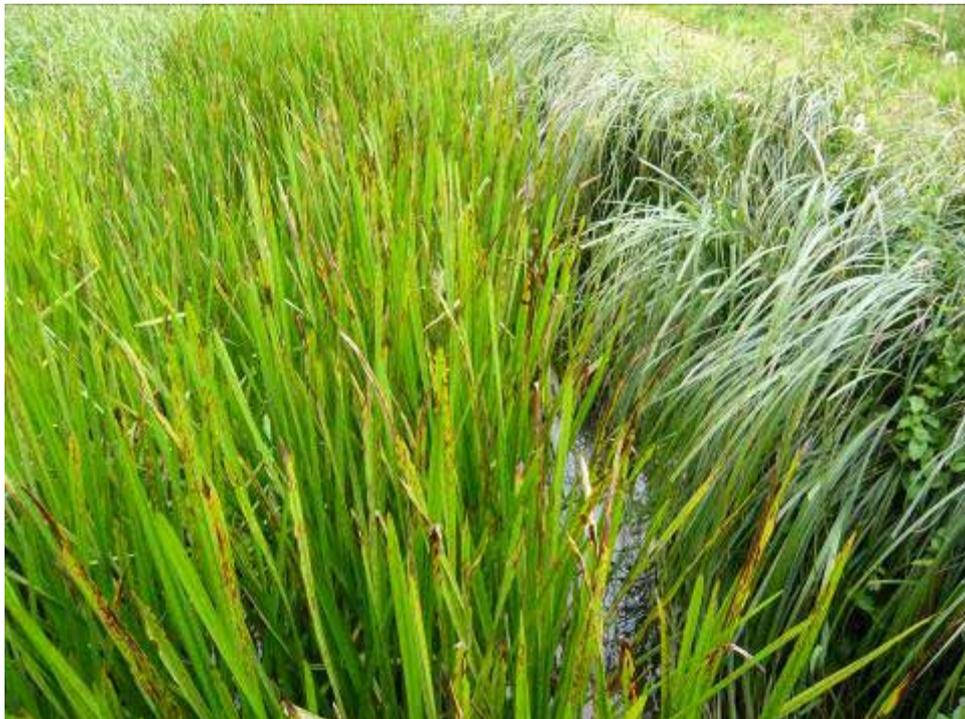
Burr-reed choking a small side carrier
