River Allen – High Hall

An Advisory visit by the Wild Trout Trust – April 2012

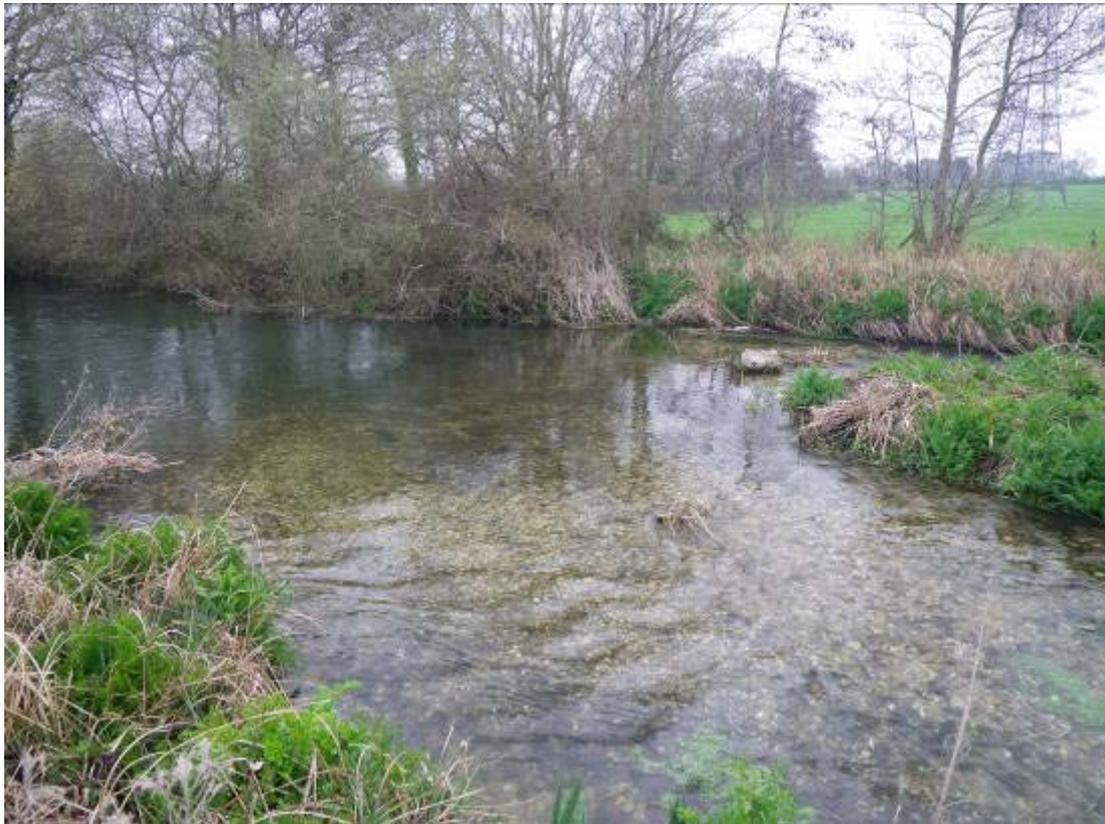
Photo 1. Pool, glide and riffle. Good adult holding and potentially good spawning and nursery habitat

The fishery at High Hall supports a wide range of habitats suitable for all life stages of trout and grayling. The Allen here is blessed with a relatively steep gradient, which promotes brisk water velocities flowing over varied bed topography of pool, riffle and glide habitat (photo 1). This classic flow regime provides the High Hall syndicate with a superb base to further develop and enhance the wild trout fishery.

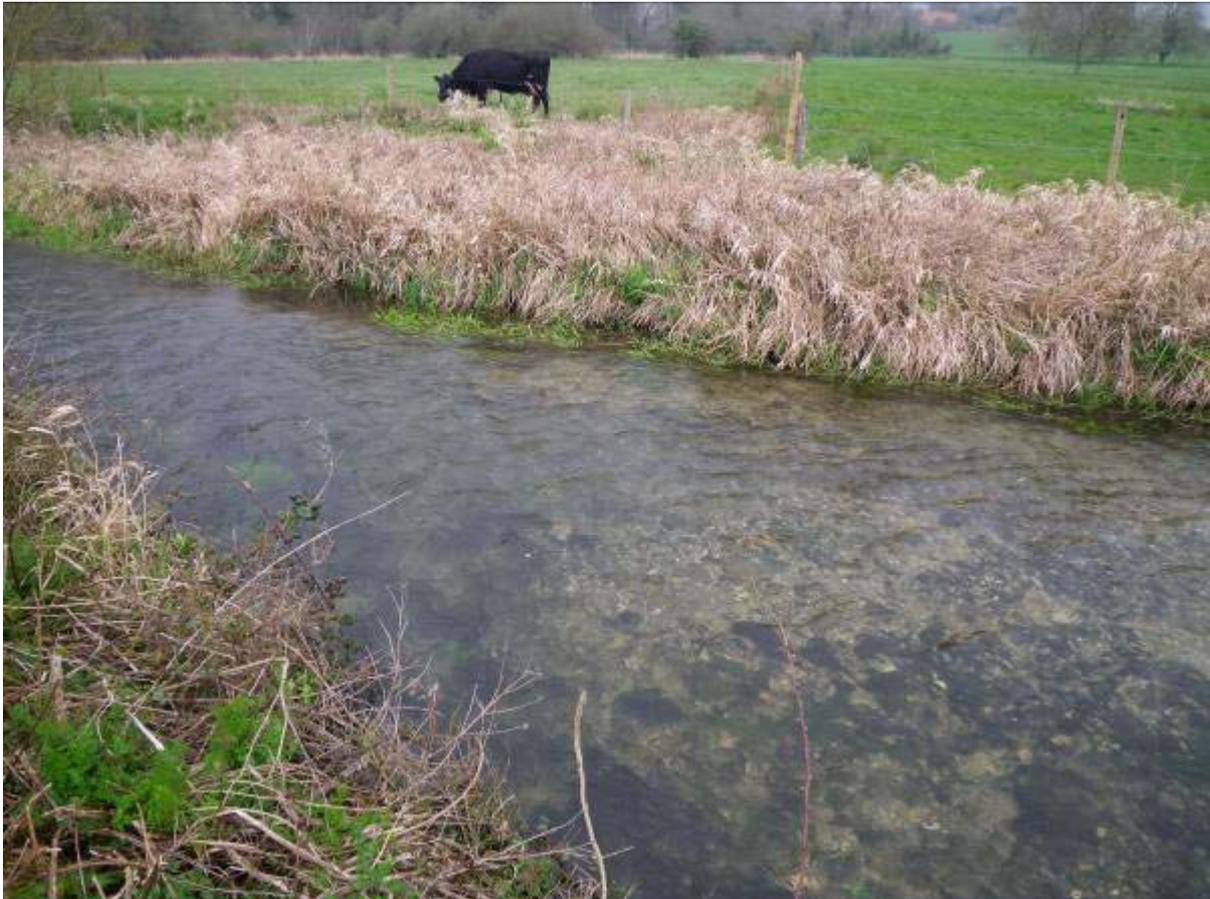
Photo 2. Some grazed-off beds of crowfoot present on what should be superb parr habitat. Decent sized strips of scrubby cover line the bank in many areas.

Some attempts to plant new beds have been made recently by the syndicate. There is also evidence that the crowfoot is still present in many areas (photo 2) but is being severely grazed off, presumably by the swan population. This is

thought to be a small resident community rather than a large accumulation of adolescent birds. Large densities of immature swans are known to have the capacity to decimate crowfoot beds on many river systems. The issue of poor crowfoot growth is not restricted to the Dorset Allen and the long period of below average flow is thought to be strongly linked with poor crowfoot growth across many chalk river catchments this year. This issue is discussed further in the recommendations section of this report.

- Provide improved cover in shallow margins with brash bundles or tree sweepers constructed from brashy trees cabled to a live trunk or stake. This is particularly important during the winter and periods of poor weed growth.
- Introduce some large flints or locally sourced stones in fast shallow sections to create lies for small fish and habitat for crayfish.
- Plant overhanging willows or thorns to promote marginal cover in some of the more open sections.

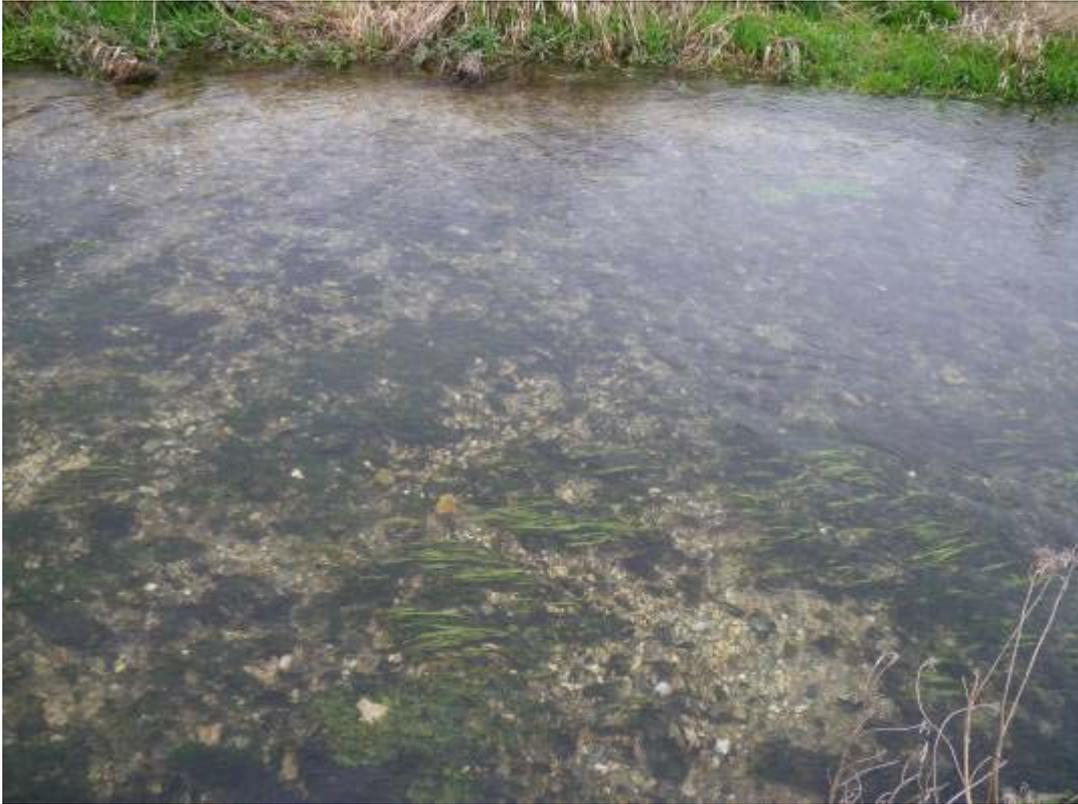
Photo 3. Flat, shallow glide habitat with poorly sorted bed gravel heavily infiltrated with fine sediments.

In many areas, the bed topography is surprisingly varied for a chalk river. Some sections of flat shallow glide (photo 3) would benefit from even more variation in bed shape, to provide improved opportunities for both spawning and juvenile trout cover. The provision of the odd piece of secured Large Woody Debris (LWD) onto this shallow glide habitat will help to scour and sort bed material and provide improved habitat for all trout life stages.

- Break up the crust of gravels in areas on the tail of glides rising up between pool and riffle habitat.
- Secure LWD flow deflectors to shallow glides where the bed is currently flat and the gravels unsorted.
- Monitor the success and growth of club rush beds and intervene when plants begin to choke the channel.
