River Allen – Allendale Centre

An Advisory visit by the Wild Trout Trust – April 2012

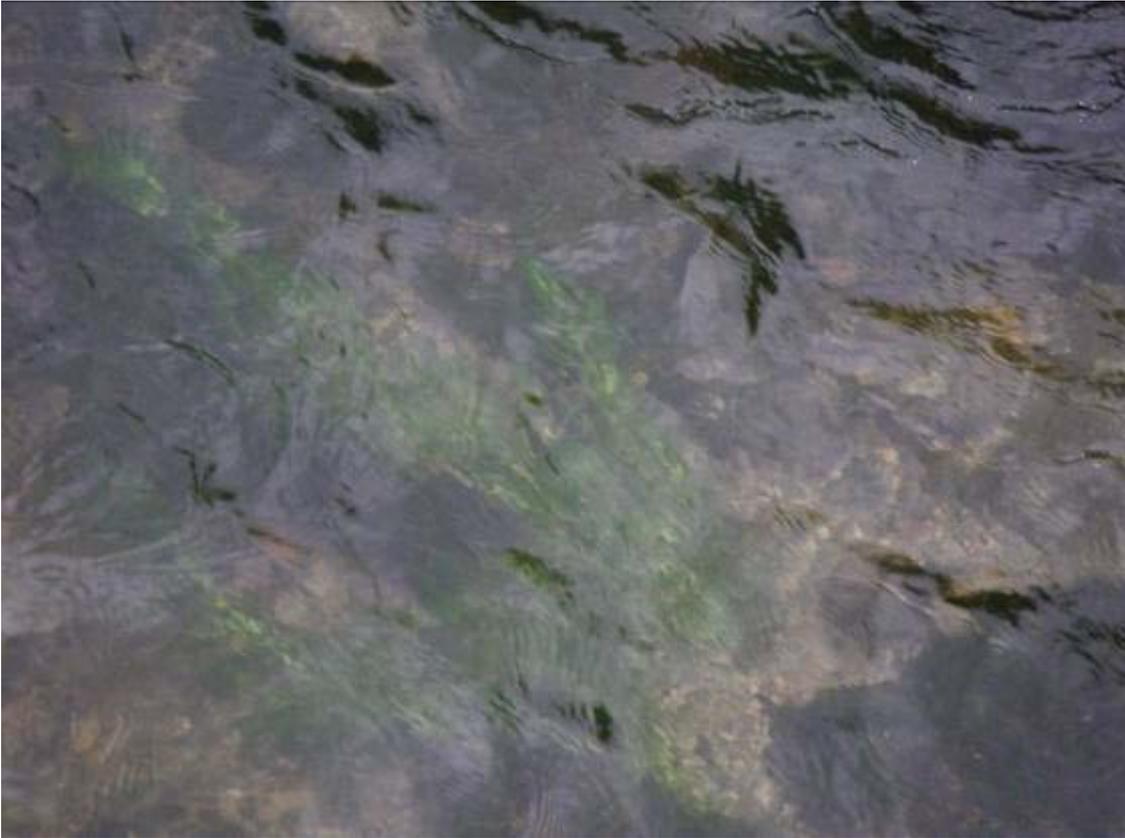
Photo 1

The section of river running adjacent to the Allendale centre comprises approximately 100m of modified channel flowing through the urban centre of Wimborne. The channel is a straight shallow glide running over an unsorted gravel and fine sediment river bed. Habitat quality is enhanced near the top boundary where the channel is slightly pinched, and this has promoted elevated water velocities.

Although the channel is constrained by hard bank-side development, particularly adjacent to the public footpath running parallel with the LB, there is still a soft, semi natural toe to the banks in most areas. The RB adjacent to the Allendale Centre supports a range of marginal native and ornamental plants species. Efforts to control dense shading and open up a vista to the river have been sensitively undertaken.

Some in-channel cover for juvenile fish is to be found in central channel locations in the form of the occasional larger stone and bricks, however both marginal and in-channel cover was limited. At the time of the visit, in-channel weed growth was scarce, but it is understood that the section supports emergent ribbon weeds, which are probably a combination of common club rush, burr reed or reed sweet grass. Some small beds of submerged water crowfoot (photo 1) were seen near to the top boundary. This plant provides a high quality refuge for fish, as well as being a favoured habitat for several species of aquatic invertebrate. Opening up the canopy by removing some branches from tall river-side trees will help to promote improved crowfoot growth. One large horse chestnut tree growing out from the RB would benefit from some surgery to one or two overhanging branches. Woody material won from this operation could be usefully used to enhance in-channel habitat quality (more information in the recommendations section of this report.)

Overall the section provides reasonable habitat for juvenile fish. There are, however, opportunities to further enhance the section by enabling more light to penetrate through to the centre of the channel which will encourage weed growth. River margin habitat could also be improved by providing more low-level scrubby cover by introducing woody brash and planting some goat willow, or sallow *Salix caprea*.

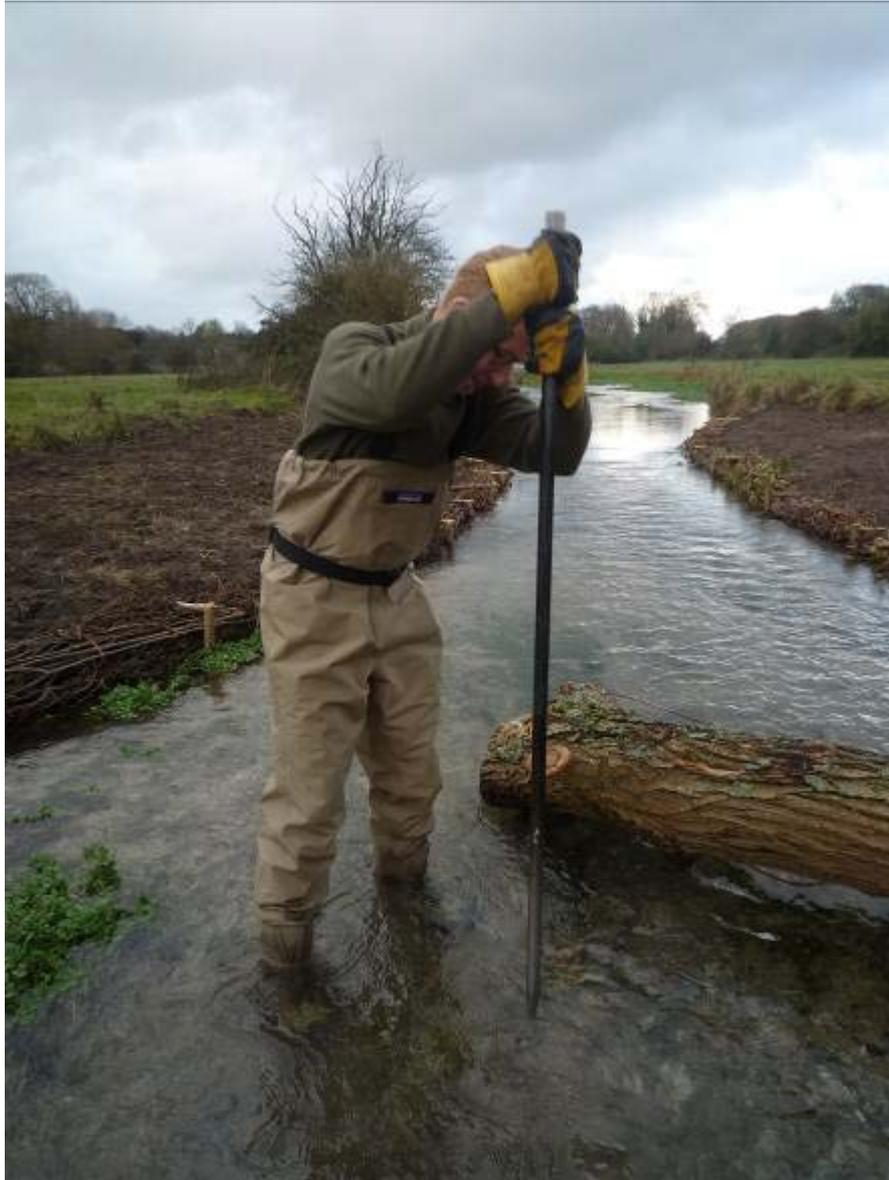
Photo 4

cemented with calcium carbonate deposits. Once installed, the river bed gravels immediately below and to the sides of the deflectors should be broken up with a large fencing spike (photo 4). This will allow the soft bed material to be blown away and the gravels to be graded by the river, creating pots to hold fish and clean gravel ramps for spawning. The LWD deflectors also provide ideal cover for crayfish.

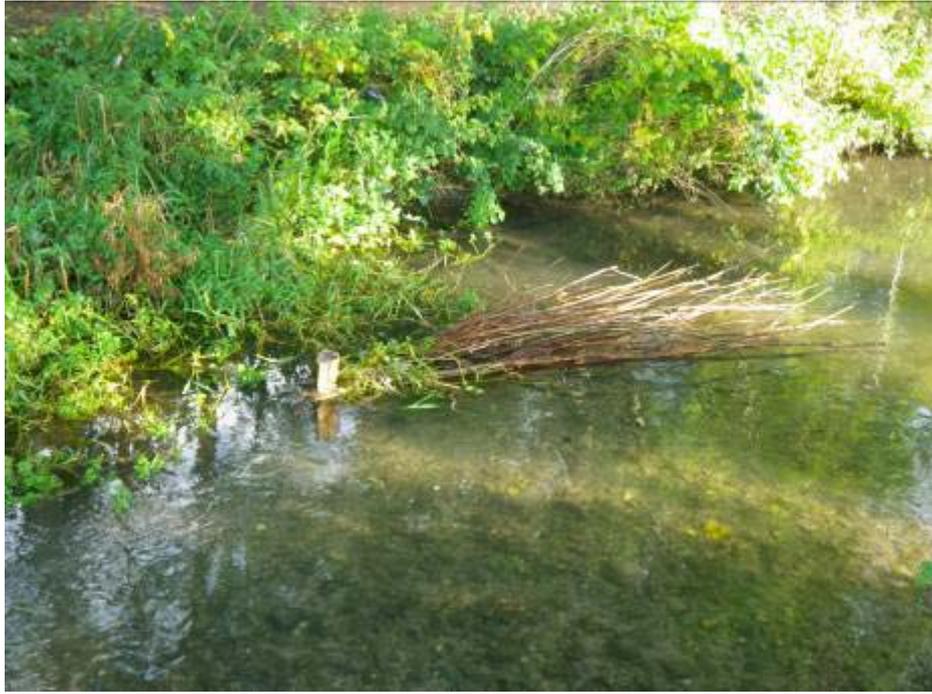
Photo 5

Improved cover in the shallow margins can be achieved by pegging in brash bundles (photo 5), or creating 'tree sweepers' by laying in small trees such as thorns and securing the trunks to either a live tree stump, or to a driven stake (photo 6). The idea is to provide a scrubby matrix of cover where small fish will feel comfortable and be safe from predators such as herons.

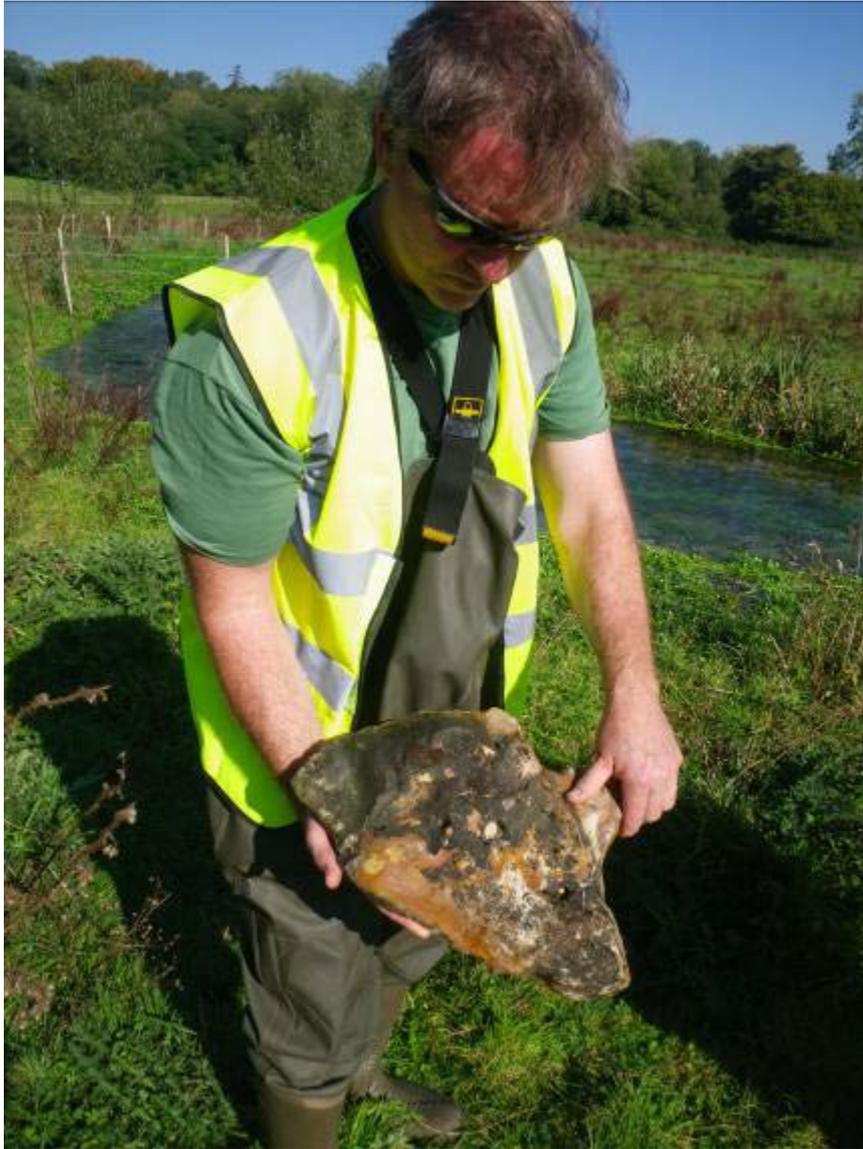
Photo 7

Additional cover for crayfish and juvenile trout can be achieved by dotting some larger flints into shallow fast flowing sections (photo7).

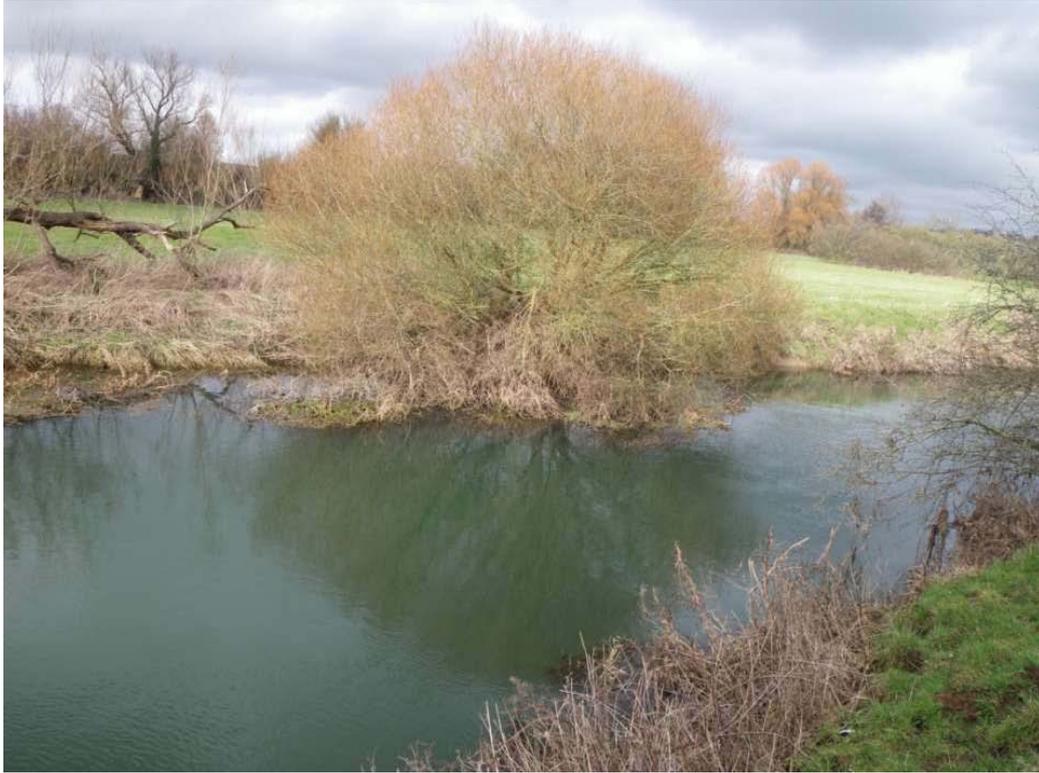
Photo 8

Low over hanging cover can be encouraged by planting one or two willow whips at 45° to the water level. The whips should be pushed into the margins a little above normal winter water levels. Although these trees will require on-going maintenance, they do not grow too large and provide ideal low level cover for a range of fish species. A mature willow is shown in photo 8.
