Advisory Visit
Annan Water - River Annan
Scotland
30/08/2016

1.0 Introduction

This report is the output of a site visit to a short section of the Annan Water at the request of Tony Donnelly, director of the River Annan Trust. The purpose of the visit was to assess bank erosion and riverine habitats and offer recommendations for future management at the site.

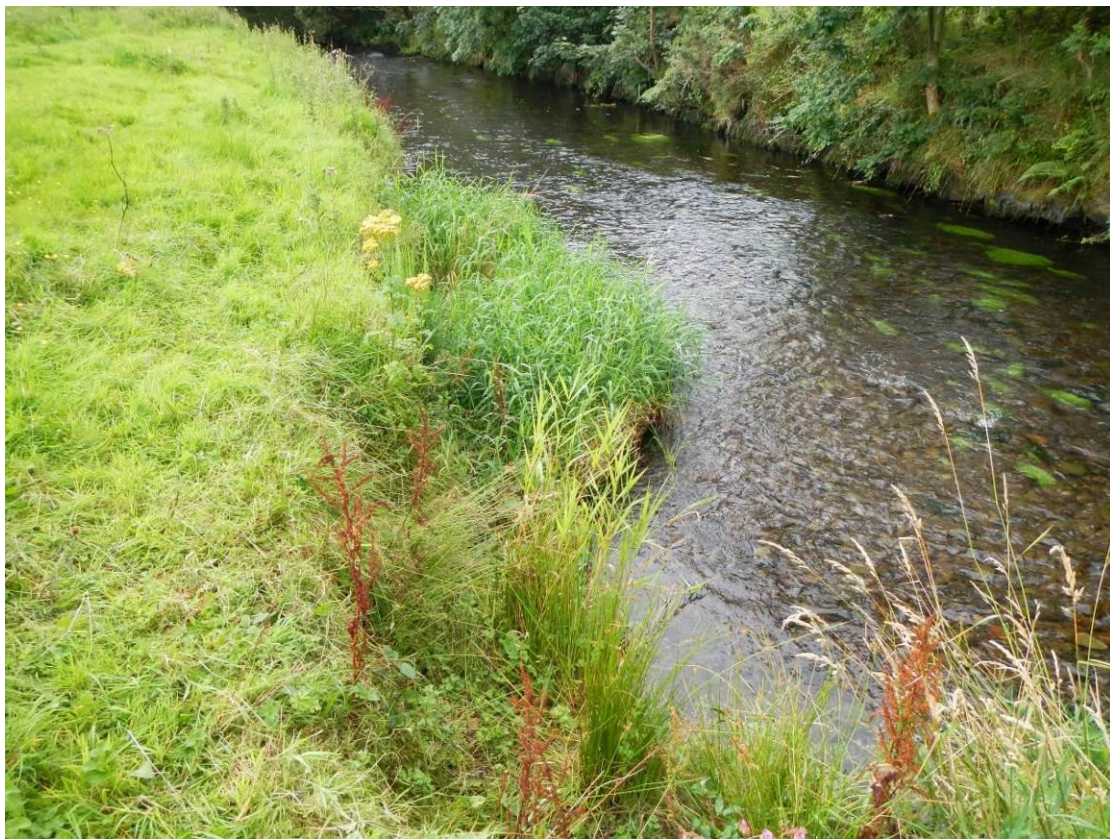
Figure 1. Signs of natural bank regrading where slumped bank material has remained in place long enough to become consolidated. Vegetation that then trails into the channel provides important cover and shelter for fish and invertebrates. Note the straight channel and hard, rock-lined/walled far bank. Some reasonable quality juvenile habitat is available but the area lacks the natural habitat diversity that would be expected within a sinuous channel.

When assessing river banks within pasture fields it is common to find over-grazing to be a major issue but at this site grazing pressure appeared relatively low (Fig. 1). Even so, light grazing still limits the diversity of herbaceous vegetation (and natural tree regeneration) that can establish, as only grasses are capable of withstanding continual grazing pressure (leaving only grasses and unpalatable species).

In most areas, root structure within the banks remains sufficient to consolidate slumped bank material, retaining turfs intact at the toe of the bank (possibly less-so at times of greater grazing pressure)(Figs 1 & 2). This is important if the material is to remain part of the bank and facilitate natural regrading, rather than being washed away. Some of the slumped areas facilitate the formation of small grassy bars which encroach into the channel; these provide beneficial width variation and habitat features within the straightened and rock armoured (RB) channel. Modified channels invariably provide poorer habitat than sinuous ones, where meanders provide greater width and depth variation.

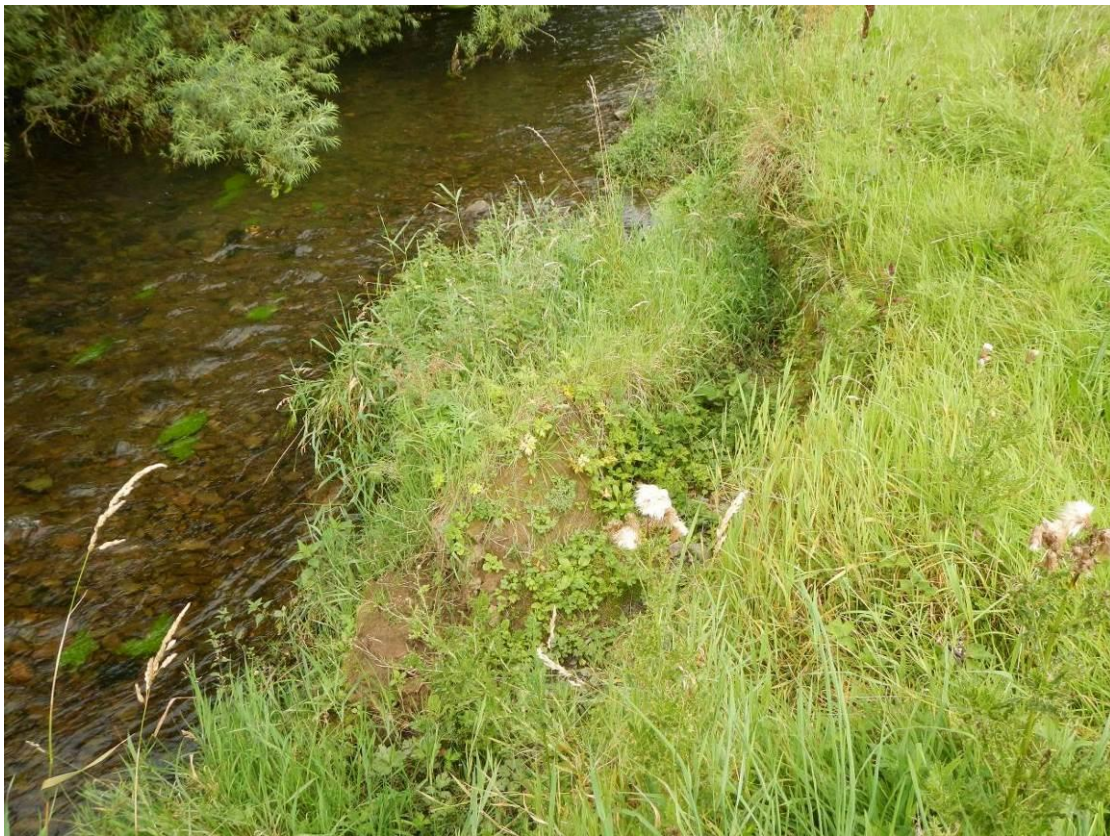
Figure 2. A large clump of bank material that has remained intact due to the presence of good root structures within it. Some such pieces will be lost in high flows but others will be retained to form a more stable, sloping bank that is less susceptible to erosion than the steep vertical banks. If retained, such features also provide valuable channel width variation.

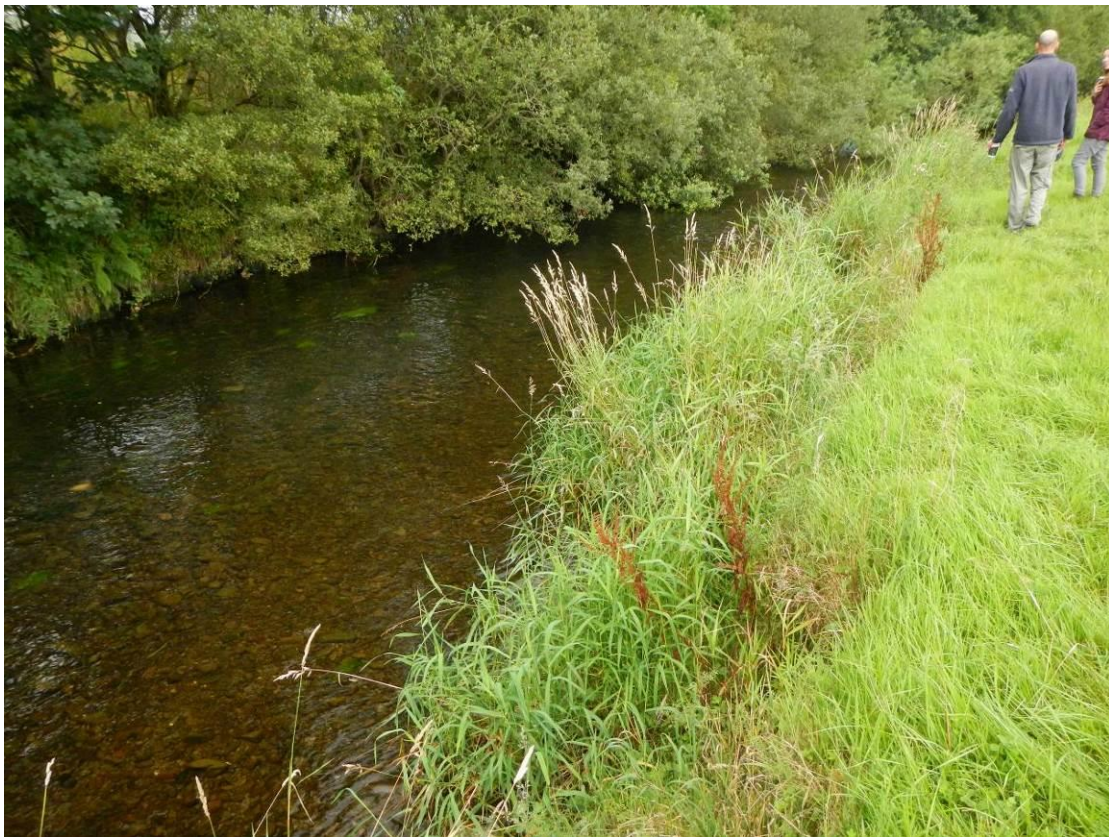
Figure 3. Overhanging and trailing willows provide vital cover and structure within the channel and help develop deeper pool habitat.

Where willow trees have become established they provide much needed cover and structure within the channel, creating refuge for fish from high flows and predators. The structure also helps to focus higher flows, driving scour into the bed to develop vital deeper pool habitat – something that is unlikely to occur otherwise within a straightened channel. It has to be conceded that structure within the channel may place some additional pressure upon the banks in high flows and could exacerbate erosion on the adjacent bank. For this reason, it is important to maintain a healthy diversity of vegetation on those banks by excluding livestock, if possible, but also by addressing other potentially significant issues such as Himalayan balsam (*Impatiens glandulifera*). Balsam often outcompetes native species but then dies back in winter, leaving a dearth of protection on top of and within the bank, thereby greatly exacerbating erosion issues.

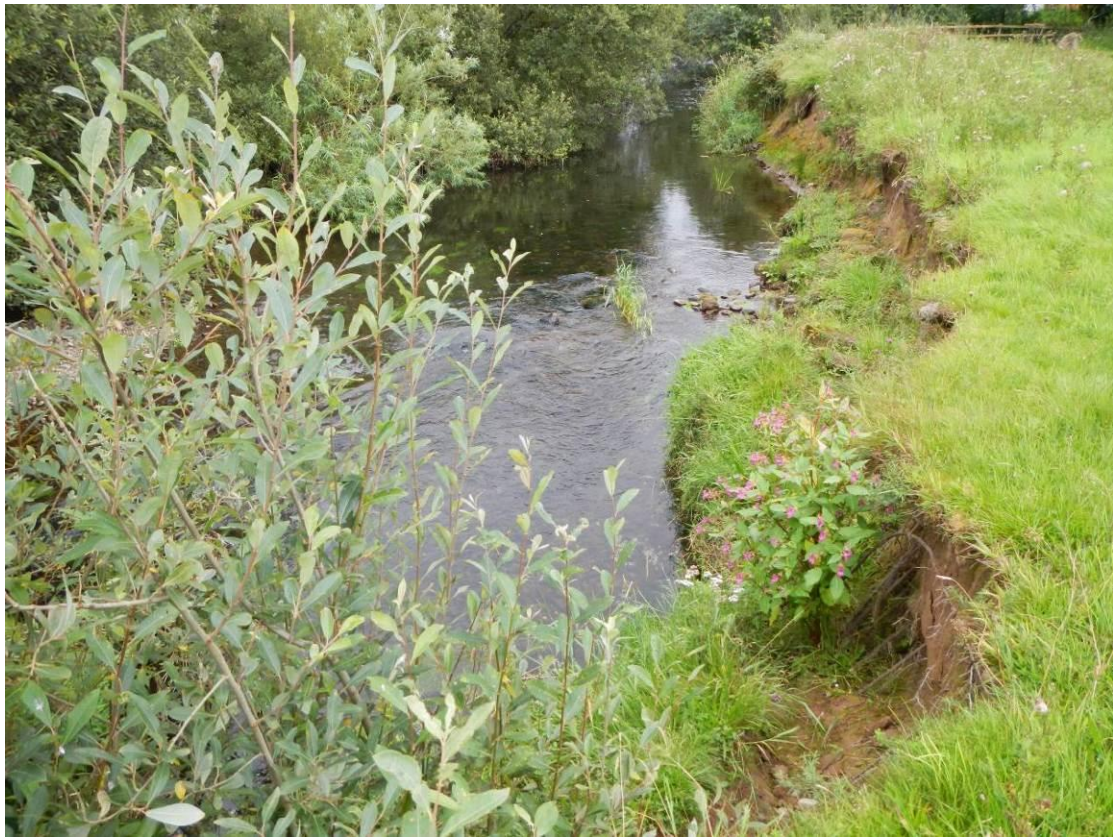
Figure 4. The area of greater erosion, likely exacerbated by high winter flows, balsam, dredging u/s, grazing (still limiting the root structure within the bank) and the willows on the far, RB (left of shot). Of these impacts they could all be addressed to the benefit of the surrounding habitat, except the willows, which provide vital in-channel habitat in their own right and should be retained. If the bank can be naturally protected with vegetation the erosion can be controlled and erosive forces will, instead scour the bed of the watercourse, developing and maintain the pool feature.

Other than that, the habitat throughout the majority of the field is reasonably good and the banks are naturally stabilising. Planting the odd tree, out of the reach of the horses may also be beneficial to increase species diversity. At the upstream end of the reach, where the greater extent of erosion is occurring, some intervention may be desirable but is not necessarily required if the bank face can be encouraged to revegetate.

Planting the eroding section of bank, ideally along the waterline as well as the bank face is likely to increase bank stability. This would create additional low-level cover and flow dissipation. However, bank erosion was not considered to be a major issue from an ecological perspective, and some degree of erosion is beneficial, being a natural aspect of riverine processes.

The quickest and easiest way of establishing willow trees is by pushing short sections of freshly cut whip into the ground. This can be undertaken at any time of the year, but will have the greatest success during the dormant season, shortly before spring growth begins (ideally late Jan-March). Whips should be planted into soft, wet ground so that there is a greater length within the ground than out of it, to minimise the distance that water has to be transported up the stem; 30-40cm of whip protruding from the ground is sufficient. Whips of 5mm-25mm diameter tend to take best, but even larger branches can be used. Care should be taken not to leave excessive amounts of foliage on the whips as these greatly increase the surface area of the plant and can lead to their dehydration.

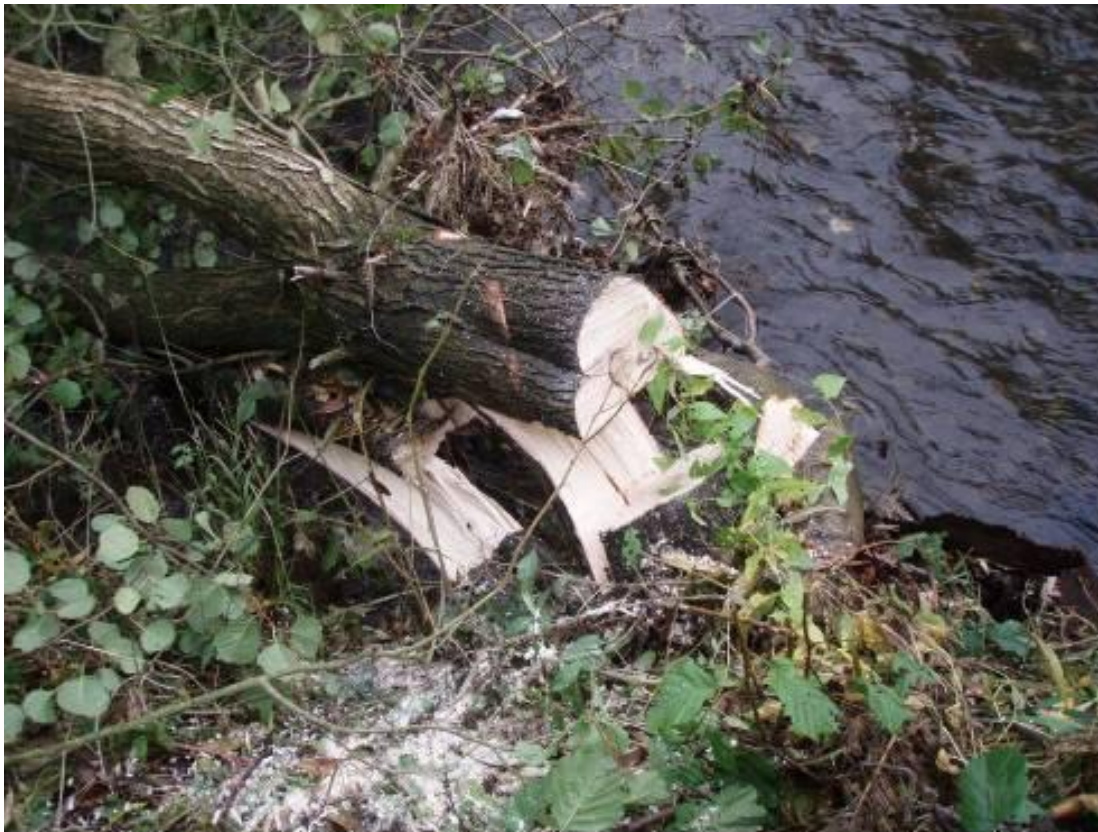
Figure 5. Laid willow.

The method used to lay a tree or branch is simple: it involves cutting part way through the stem/trunk, a little at a time (ideally while it is under light tension), until it can be forced over into the river (Fig. 5). The depth of the cut should be limited to only that which is required to bend the limb over,

as this will maintain maximum strength in the hinge and the health of the tree/shrub. On smaller shrubs, simply cutting the stem/trunk at a very shallow angle and then putting an axe blade into the cut and hitting it with a hammer can also help the laying while retaining a good strong hinge.

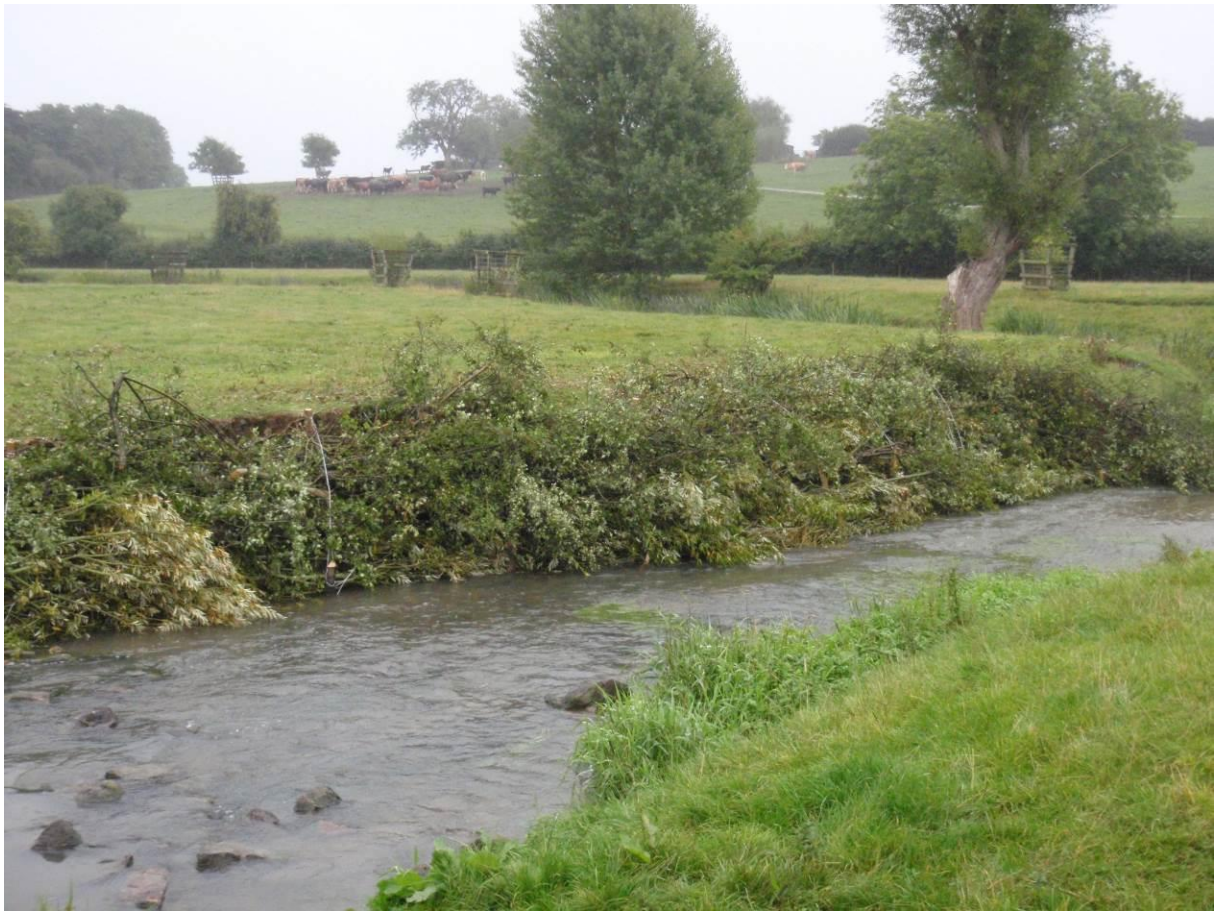
Figure 6. Mixed brush bank protection.

If it is considered that a greater level of intervention is required, a more formal brash (small branches) bank protection could be installed. The method involves securing a line of diffuse brash structure along the bank to dissipate flow energy before it hits the bank, encouraging suspended sediment to be deposited within the structure which will subsequently become consolidated by vegetation. The technique usually employs at least some live willow which will ultimately take root and form a line of shrubs along the bank. However, if the potential requirement for maintenance is considered particularly undesirable, the same technique could be used employing dead brash which would not take root. The idea being to simply protect the bank long enough for it to fully revegetate and become stable. Posts are driven into the bank, to which the brash is wired.

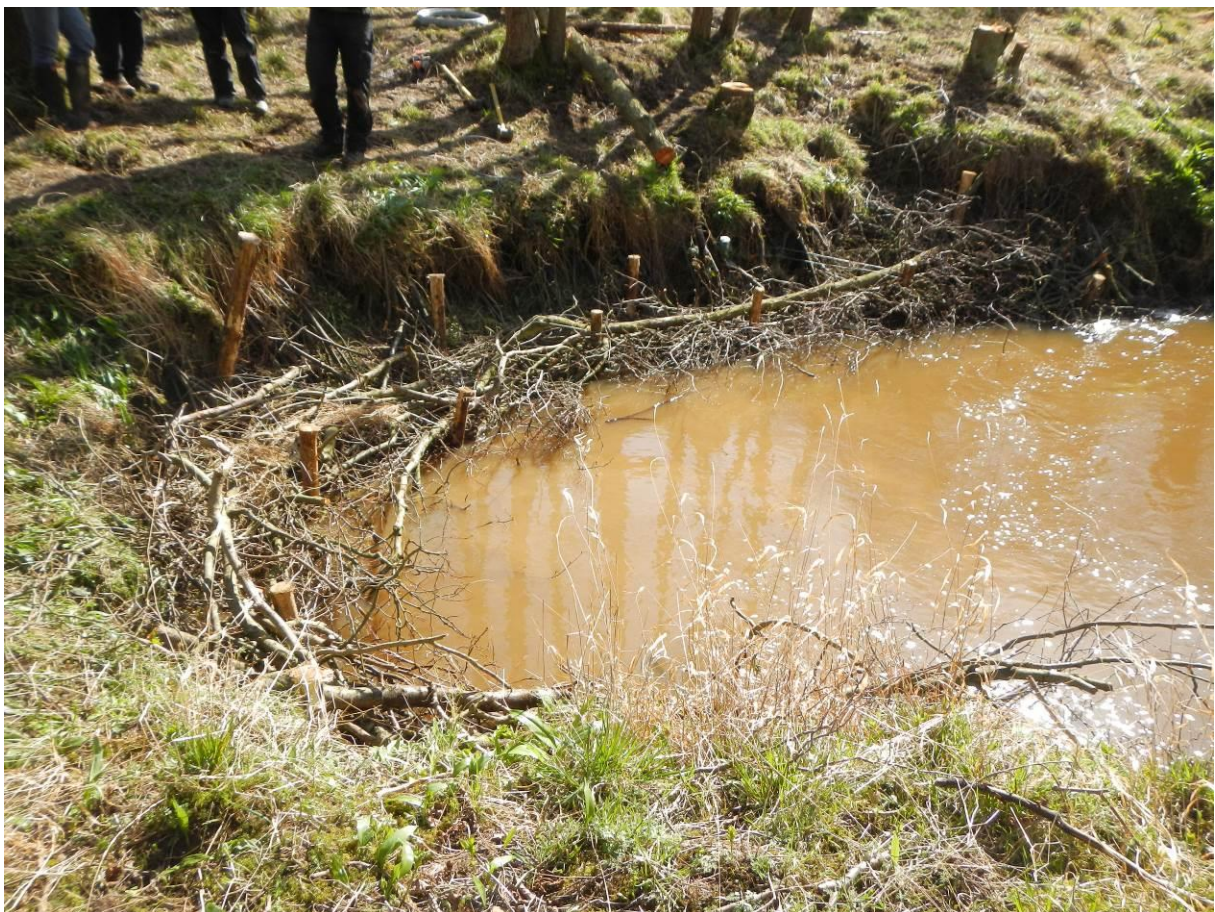
Figure 7. Dead brush bank protection employed to create a diffuse barrier along the bank.
